<b>AIRCRAFT ACCIDENT SHORT REPORT</b>
---------------------------------------

**CA18/2/3/9706: ZU-RLE, Forced landing after take-off following an engine stoppage**

**Date and time** : 4 May 2018 at 0837Z  
**Location** : Honeymoon Game Farm, Limpopo Province  
**Occurrence type** : Accident  
**Aircraft registration** : ZU-RLE  
**Aircraft manufacturer and model** : AS341-F2 Gazelle  
**Last point of departure** : Honeymoon Game Farm  
**Next point of intended landing** : Makoppa  
**Location of incident site with reference to easily defined geographical points (GPS readings if possible)** : GPS co-ordinates 24°24'00.09" South 027°07'50.29" East  
**Meteorological information** : No wind was reported, Temperature: 28°C, CAVOK  
**Type of operation** : Private, Non-type certified aircraft (Part 94)  
**Persons on board** : 1 + 1  
**Injuries** : None  
**Damage to aircraft** : Tail boom was severed by the main rotor blades (Figure 1)

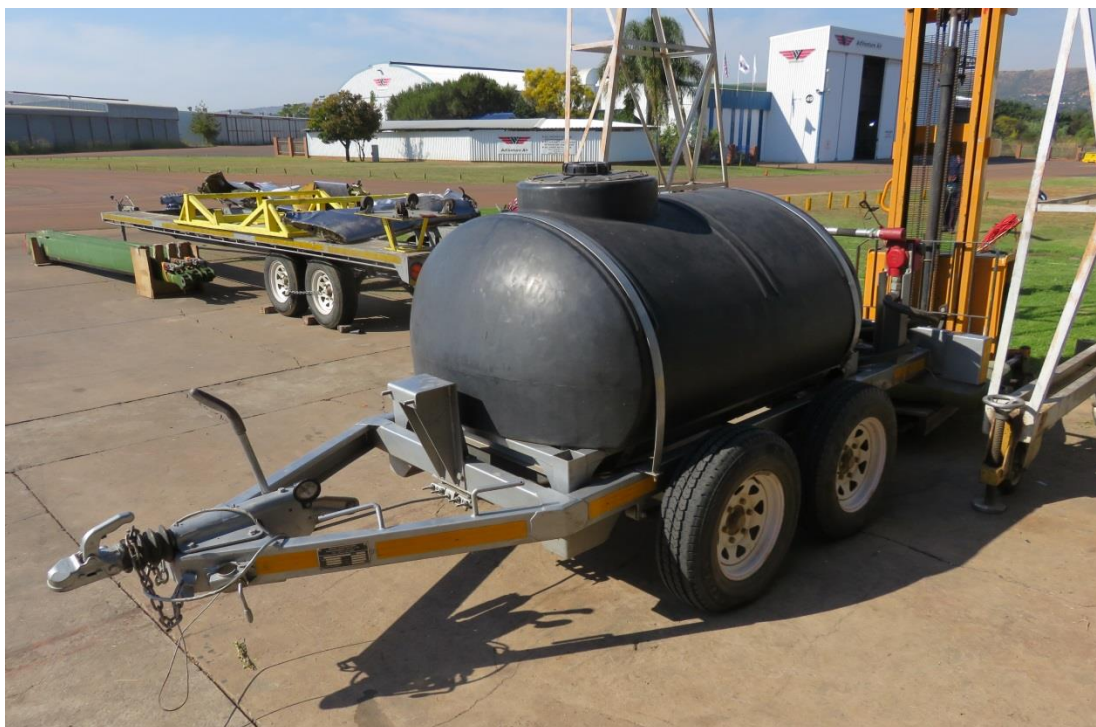
**Figure 1:** The fuel trailer/bowser that was used for refuelling the helicopter (photograph taken at Wonderboom Aerodrome (FAWB) by an Accident and Incident Investigation Division (AIID) investigator)

The pilot refuelled from the fuel trailer/bowser but did not check the fuel as the fuel trailer was parked in a secure location and was fitted with a 1-micron fuel filter. The fuel trailer was for the sole use of refuelling the helicopter.

The possibility that fuel was stolen from the fuel trailer/bowser and the content replaced with water could not be ruled out.

The fuel trailer/bowser refill cap was not equipped with a locking mechanism and could therefore be easily opened by hand. This was considered to be a serious safety shortcoming.

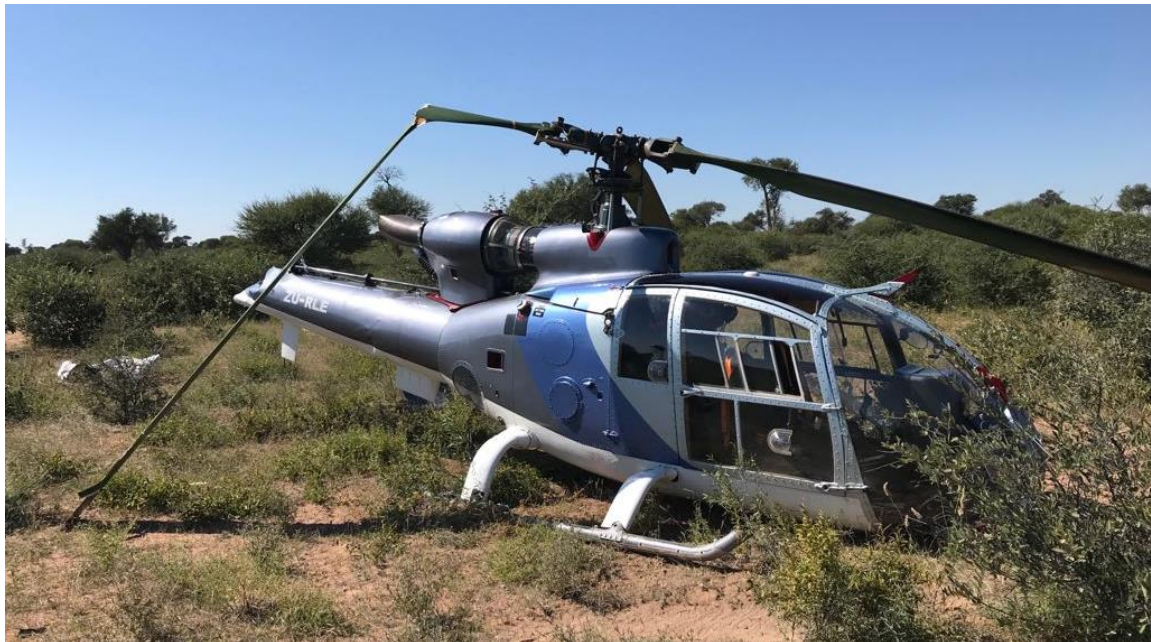
The pilot stated that the engine started normally and he waited for the engine parameters to settle in the green arc before he opted to take off. Once in hover flight, he checked all the engine parameters again, and all appeared normal. He then proceeded into forward flight. When they were above some nearby trees, the helicopter suddenly yawed to the right; the pilot thought his son might have touched the controls (dual flight controls were installed in the helicopter at the time). He then heard the engine sound change and they immediately started to descend. The pilot identified a small opening for an emergency landing. He performed a skid on landing but due to some trees in front of them he pulled back on the cyclic – he also had maximum collective pitch applied – to cushion the landing. Due to the low main rotor inertia and the aft cyclic control stick input, the main rotor blades made contact with the tail boom and severed the structure. The pilot stated that the helicopter then lifted off the ground and rotated clockwise through 90° before coming to a halt in an upright position (Figure 2).

**Figure 2:** The helicopter as it came to rest

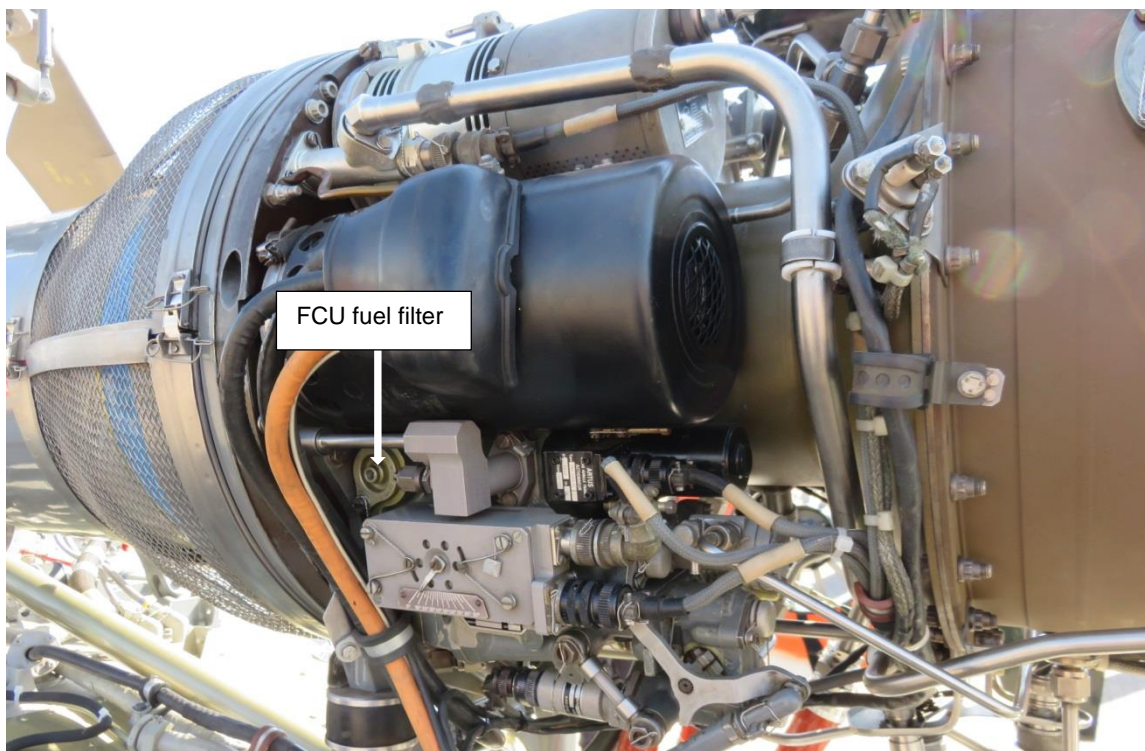
**Figure 3:** The location of the FCU fuel filter

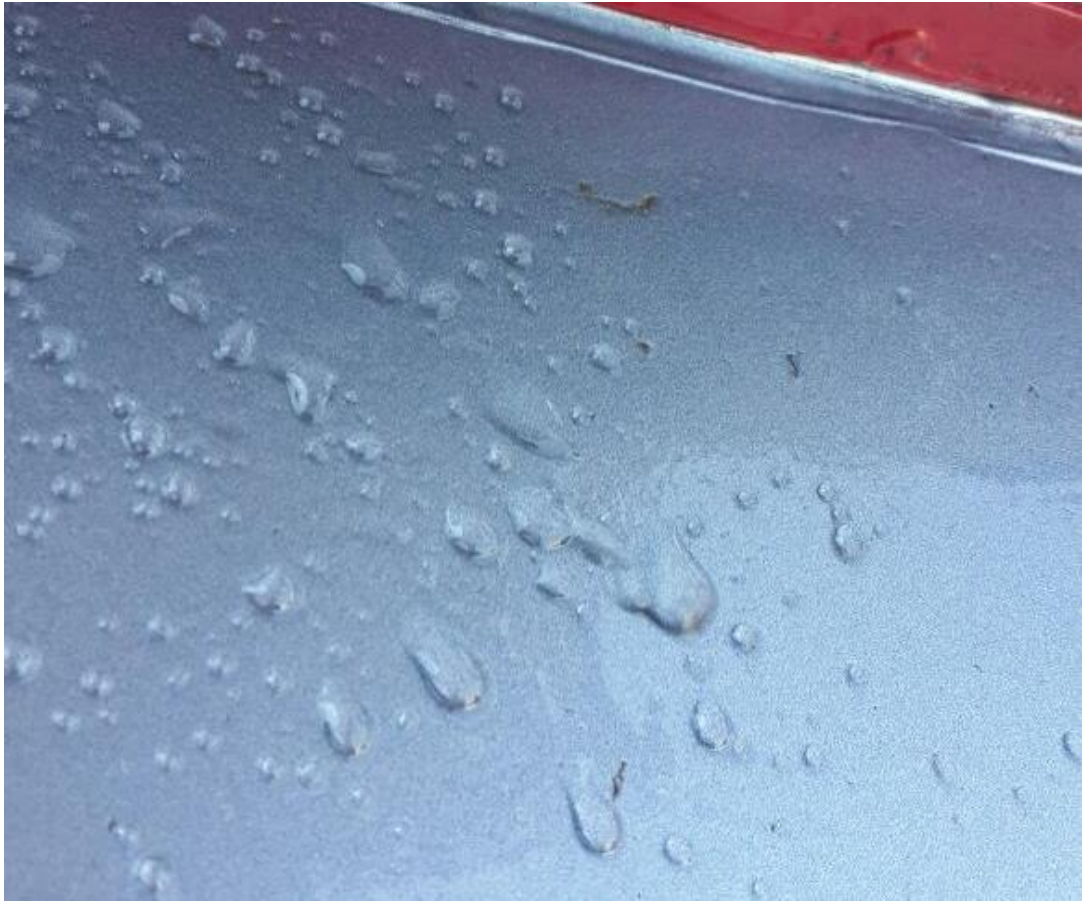
The helicopter was recovered to an aircraft maintenance organisation (AMO) at FAWB where fuel was drained from the main fuel tank and fuel filter, which was located on the fuel control unit (FCU) (Figure 3). The FCU fuel filter displayed evidence of excessive amounts of contamination (water) (Figure 4). Fuel was also drained from the fuel trailer/bowser (Figure 5). The fuel sample, which nearly filled a 2L container, displayed a brownish colour with additional sediment (dirt) being present in the fuel.

**Figure 4:** Water droplets from the FCU fuel filter following the removal of the filter unit

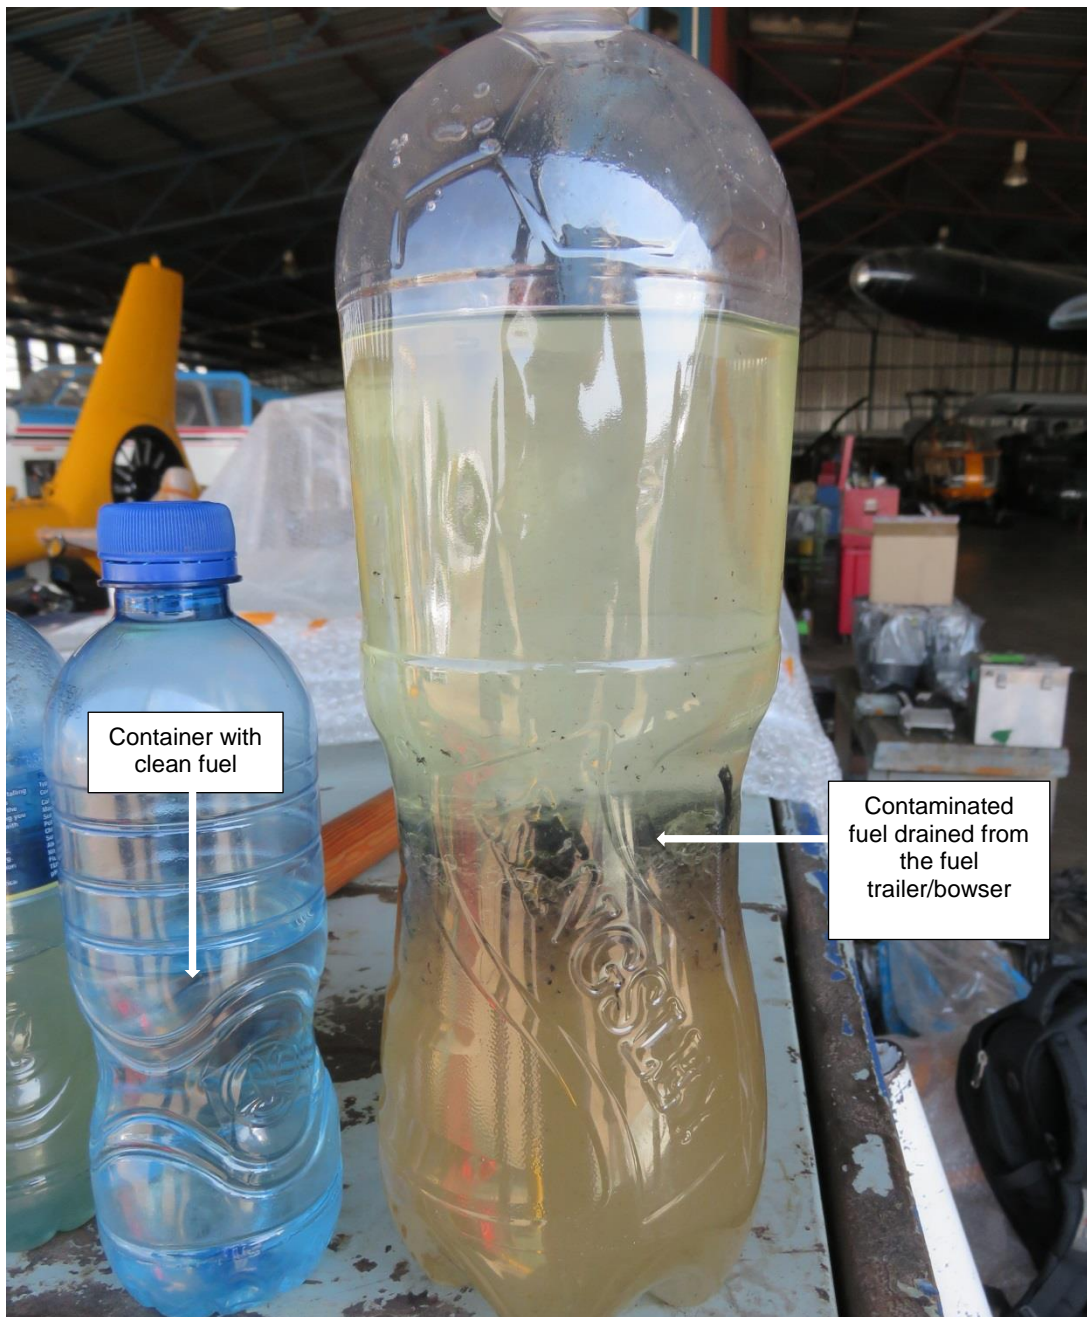
**Figure 5:** A fuel sample (right) taken from the fuel trailer/bowser, displaying contaminated fuel

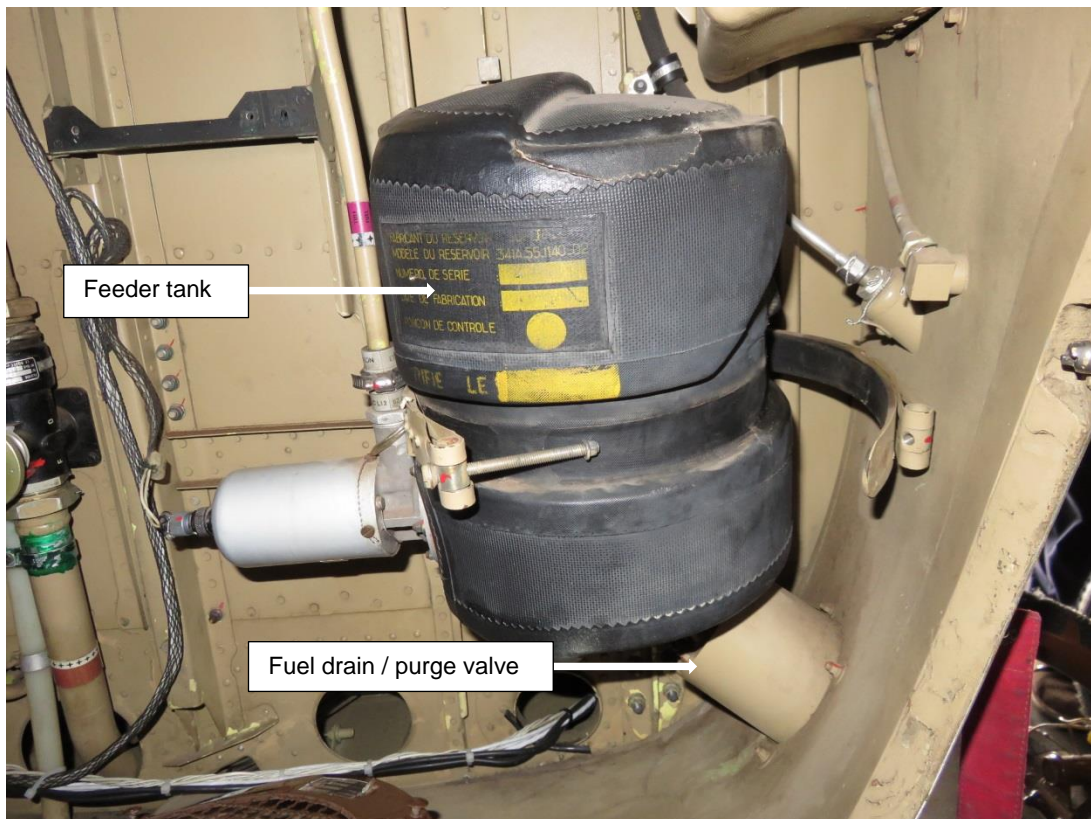
The fact that the pilot was able to start the helicopter and lift off before the engine stoppage occurred can be attributed to engine being equipped with a feeder tank, which is located in the aft compartment below the main fuel tank. The feeder tank was most probably still filled with clean fuel from the previous flight, and this allowed normal engine operation for several minutes. Only once the clean fuel in the feeder was exhausted and the tank started to fill with contaminated fuel, which was fed to the engine, did the engine stoppage occur. Contamination, especially water, tends to settle at the bottom of the fuel tank or container and gets sucked into the fuel system fairly quick depending on the design of the fuel system. Even though there might be several fuel filters incorporated in such a

system, they do not have the capacity to stop excessive amounts of contamination/sediment, which can bypass the filter system and enter the engine fuel system.

**Figure 6:** The feeder tank from where fuel is fed to the engine (photograph was taken at an AMO)
