<b>AIRCRAFT ACCIDENT SHORT REPORT</b>
---------------------------------------

**CA18/2/3/9707:** ZS-RBJ, forced landing after take-off following an engine stoppage

**Aircraft manufacturer and model** : Schweizer Aircraft 269C

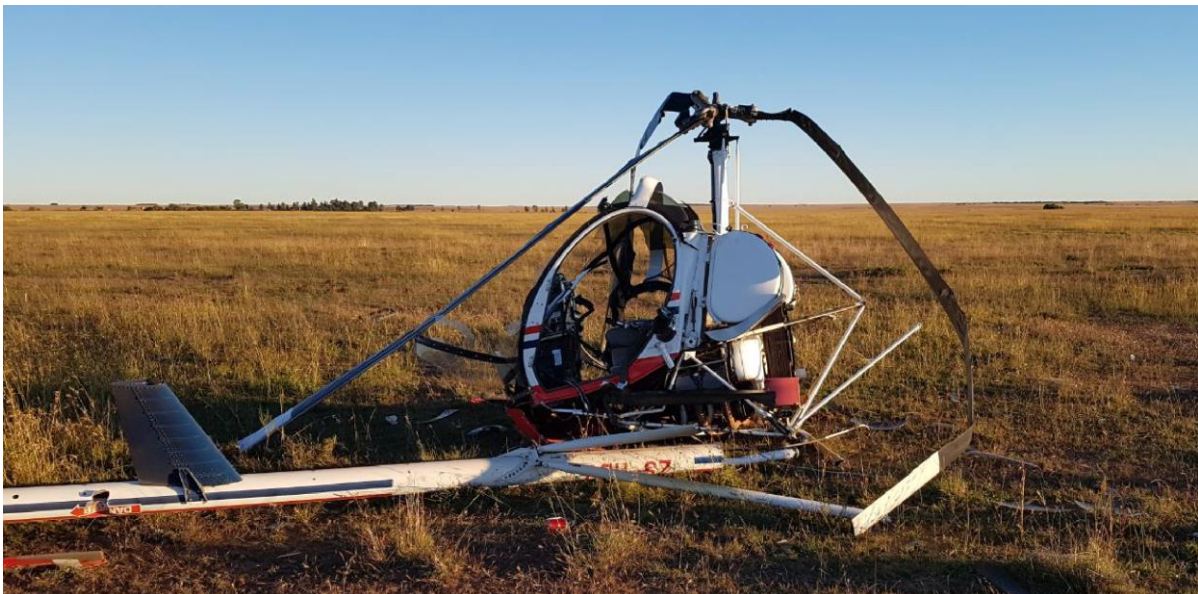
2.1.3 The pilot executed a forced landing onto an open flat terrain and the helicopter impacted the ground hard. The helicopter sustained extensive damage during the accident sequence.

**Figure 2:** The helicopter as it came to rest

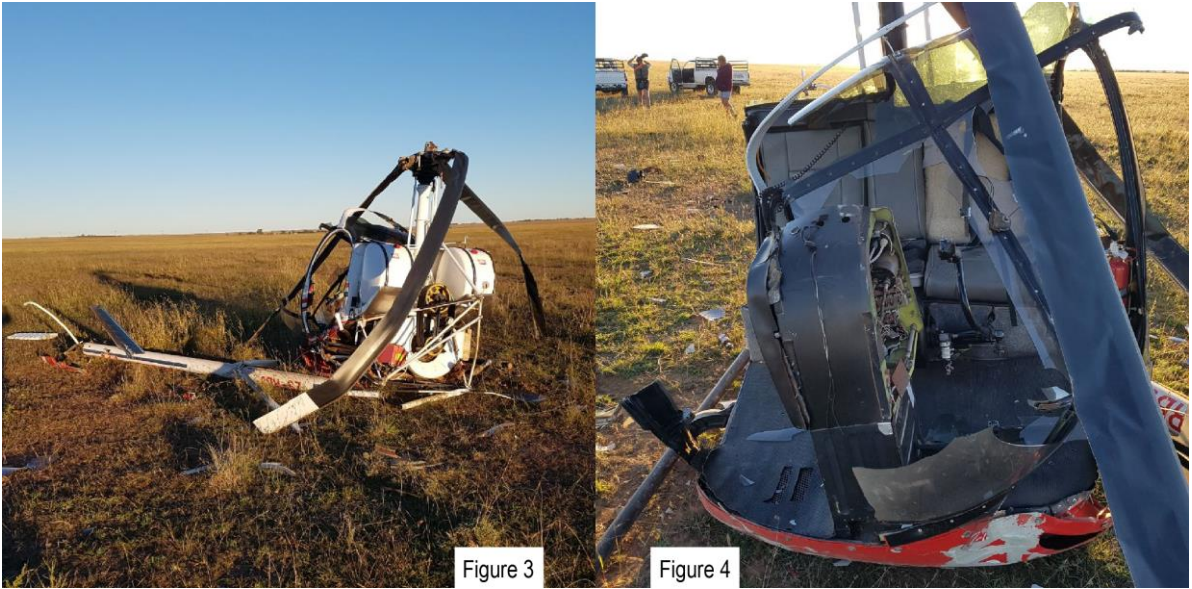
**Figure 3 & 4:** Shows the forward and aft damages of the helicopter

- 3.4 The helicopter sustained extensive damage during the impact sequence.
- 3.5 The helicopter was refuelled out of drums.
- 3.6 An official weather report was obtained from the South African Weather Service. The meteorological report for that area indicated the weather to be: Surface wind: 025°/5 kts, Temperature: 22°C, Dew Point: 6°C, Visibility: 10 km CAVOK.

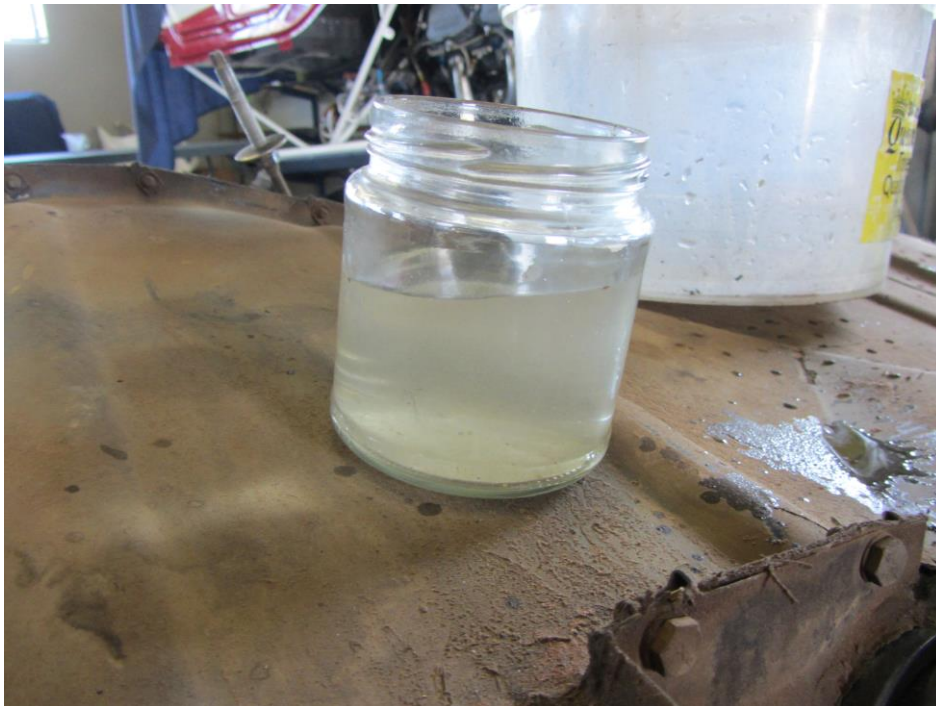
2.1.6 The wreckage was recovered to an approved aircraft maintenance organisation where a detailed inspection of the fuel system was conducted, as the engine itself did not display any evidence of a mechanical malfunction. Water was found in the fuel lines when the engine was being disconnected and removed from the airframe. The fuel used by the pilot was purchased in drums and was obtained from different service providers.

**Figure 5:** The glass container displaying water that was found in the fuel lines of ZS-RBJ.

- 2.9 Water that was found in the fuel lines of ZS-RBJ when the engine was being disconnected and removed from the airframe.

4.1 Unsuccessful forced landing following an engine stoppage after take-off, which was attributed to fuel contamination.

4.2.1 Improper pre-flight inspection by the pilot. If he had drained the fuel tanks prior to the flight it would have been highly probable that he would have found that water was evident in the fuel.

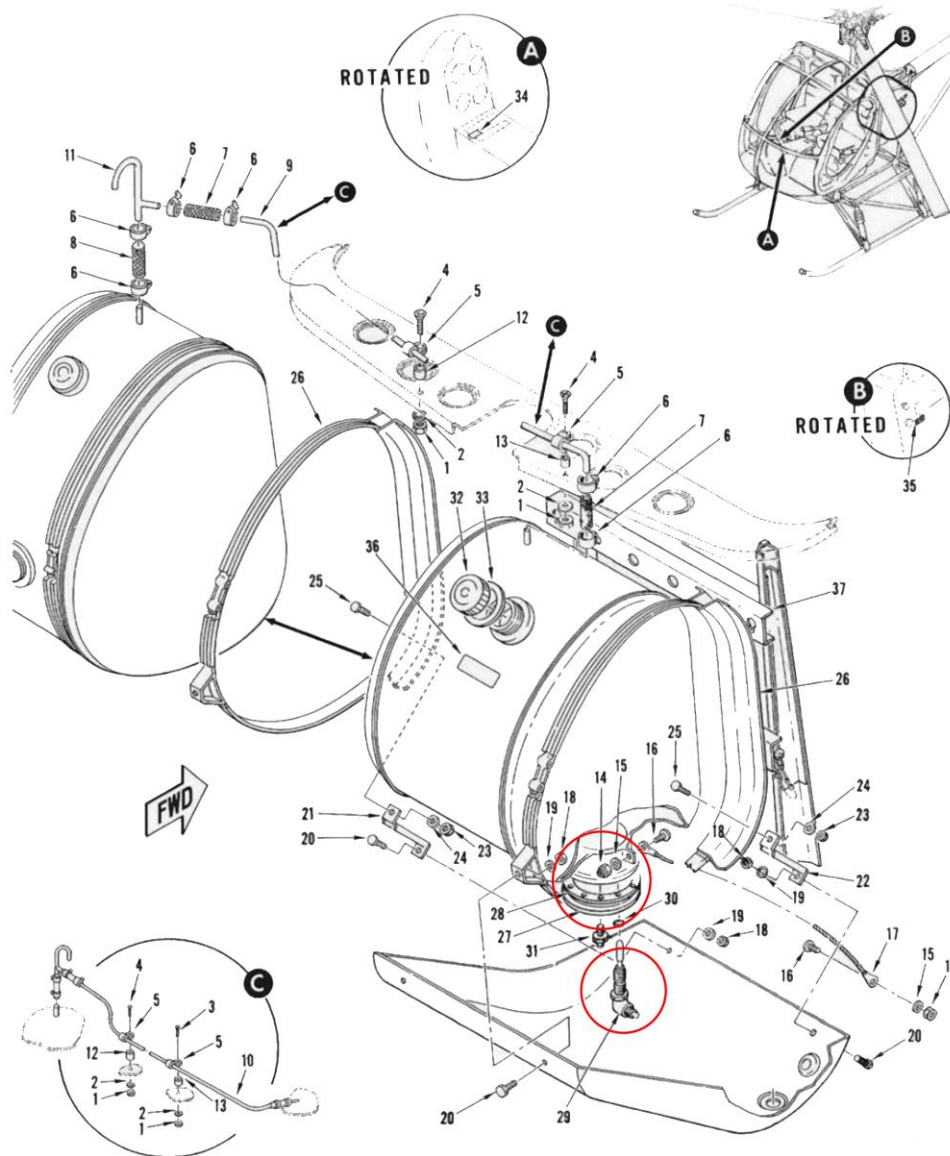
**Figure 6:** The fuel system illustration, extracted from the illustrated parts catalogue, highlights the fuel strainer and the sump cap (red circle) which allows for checking the condition of the fuel in the main tank.

2.1.7 The pre-flight instructions in the POH require the inspection of the fuel sump and strainer for any signs of water or contamination (Annexure B – highlighted in red).

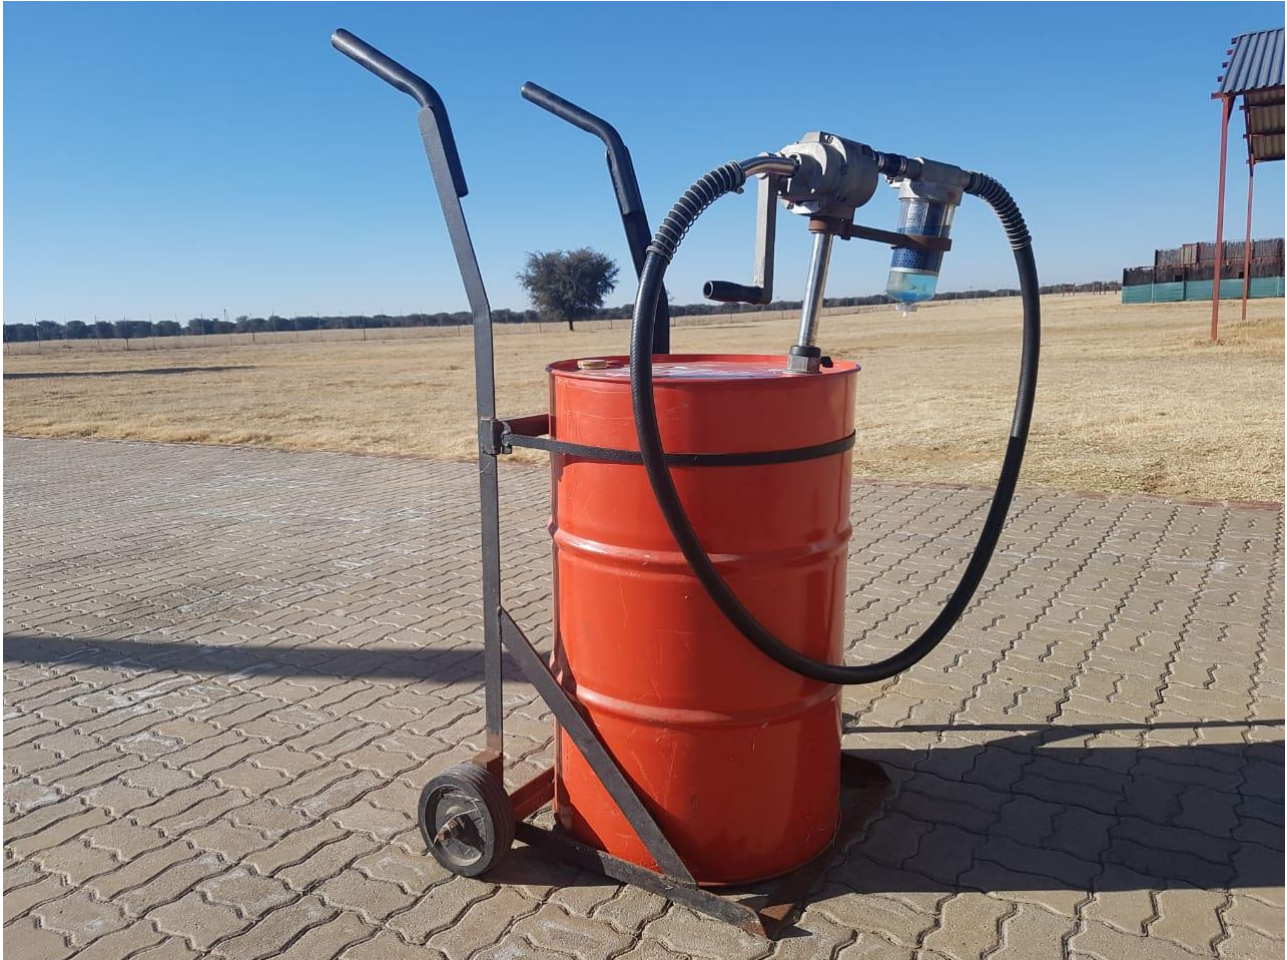
2.1.8 The pilot forwarded the photograph as seen in Figure 6 of the fuel drum to the Investigator. This being an off-site investigation by AIID, it could not be established that the contaminated fuel originated from this drum, which was equipped with an external fuel filter, nor was the service provider of the fuel known to the writer, nor was any fuel sample taken from the drum and tested by an approved petroleum laboratory.

**Figure 7:** The drum mentioned in paragraph 1.4.2 which contained Avgas used to refuel ZS-RBJ  
(This photograph was obtained from the pilot / owner of the helicopter)

4.3.1 The pilots operating from remote locations ensure the fuel supply, whatever the source might be, is clean and meets the requirements to ensure that flight safety is not compromised in any way.
