AIRCRAFT ACCIDENT REPORT AND EXECUTIVE SUMMARY

Reference:	CA18/2/3/9710	
Aircraft Registration	ZU-DLY	Date of Accident	11 May 2018		Time of Accident	1450Z
Type of Aircraft	Windlass Aquilla		Type of Operation	Private (Part 94)		
Pilot-in-command Licence Type		National Pilot Licence	Age	36	Licence Valid	Yes
Pilot-in-command Flying Experience		Total Flying Hours	80		Hours on Type	80
Last point of departure		Brits Airfield (FABS), North West Province				
Next point of intended landing		Brits Airfield (FABS), North West Province				
Location of the accident site with reference to easily defined geographical points (GPS readings if possible)						
Private farm in Brits (GPS position: 25°30'48.89" S 027°46'33.67" E, elevation 3780ft)						
Meteorological Information		Wind: 290° 2kts; temperature: 24°C; dew point: 4°C, QNH: 1019				
Number of people on board	1 + 1	No. of people injured	2	No. of people killed	0	
Synopsis						
<p>The aircraft took off runway 02 with two occupants on board for a scenic flight around the Brits Area. The pilot stated that he entered into a circuit and on finals elected to do a fly past. As he flew past the airfields club house he applied full throttle to incr

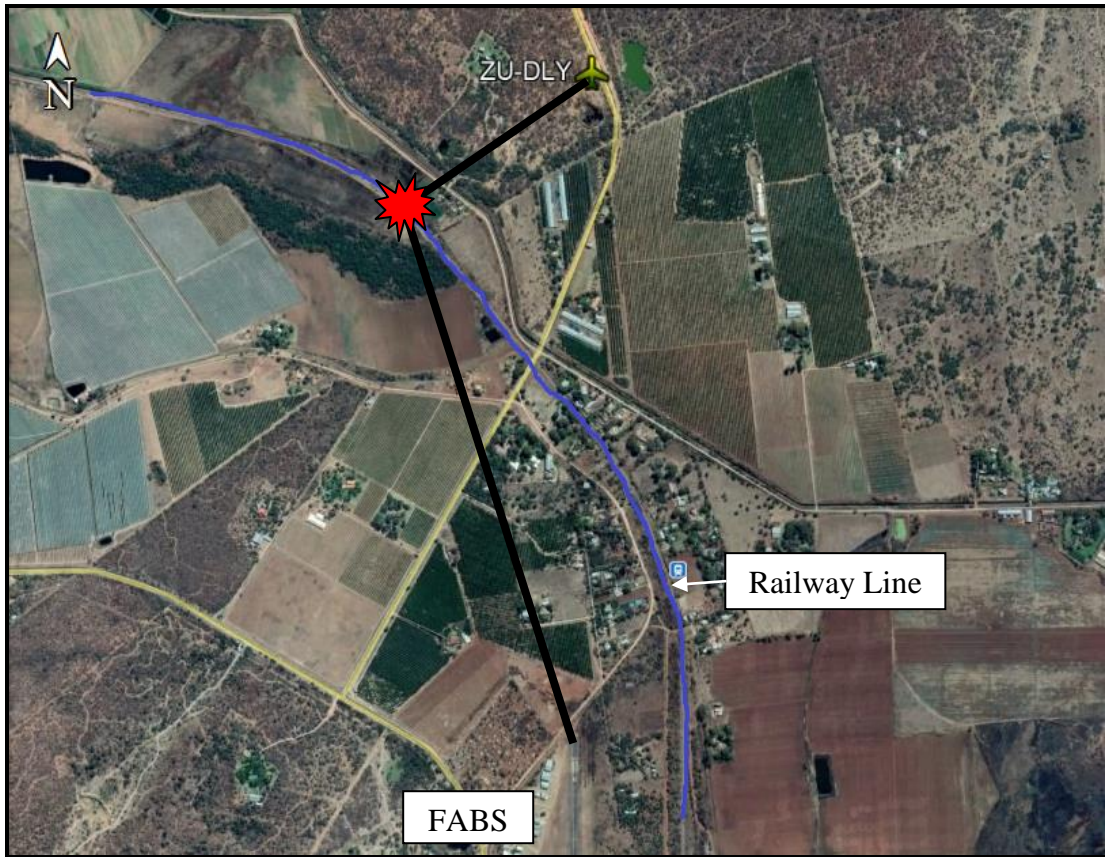
Figure 1: Aircraft flight path

1.1.1 The aircraft took off Brits Airfield (FABS) runway 02 with the pilot and a passenger on board for a scenic flight around the Brits Area. The aircraft climbed to a circuit height and entered the right hand circuit. The pilot then descended the aircraft on final approach but elected to do a fly past. At the bottom of his descent, he applied full power to climb. Shortly after commencing the climb, the engine had power loss and the pilot immediately searched for a place to execute a forced landing. During the descent, the left rear wheel got caught by the railway overhead power line and the aircraft subsequently impacted the ground a few meters from the railway line.

1.1.3 The accident occurred during daylight conditions on a private farm north of Brits Airfield at a position with GPS coordinates determined to be: 25°30'48.89" South, 027°46'33.67" East and an elevation of 3 780 ft.

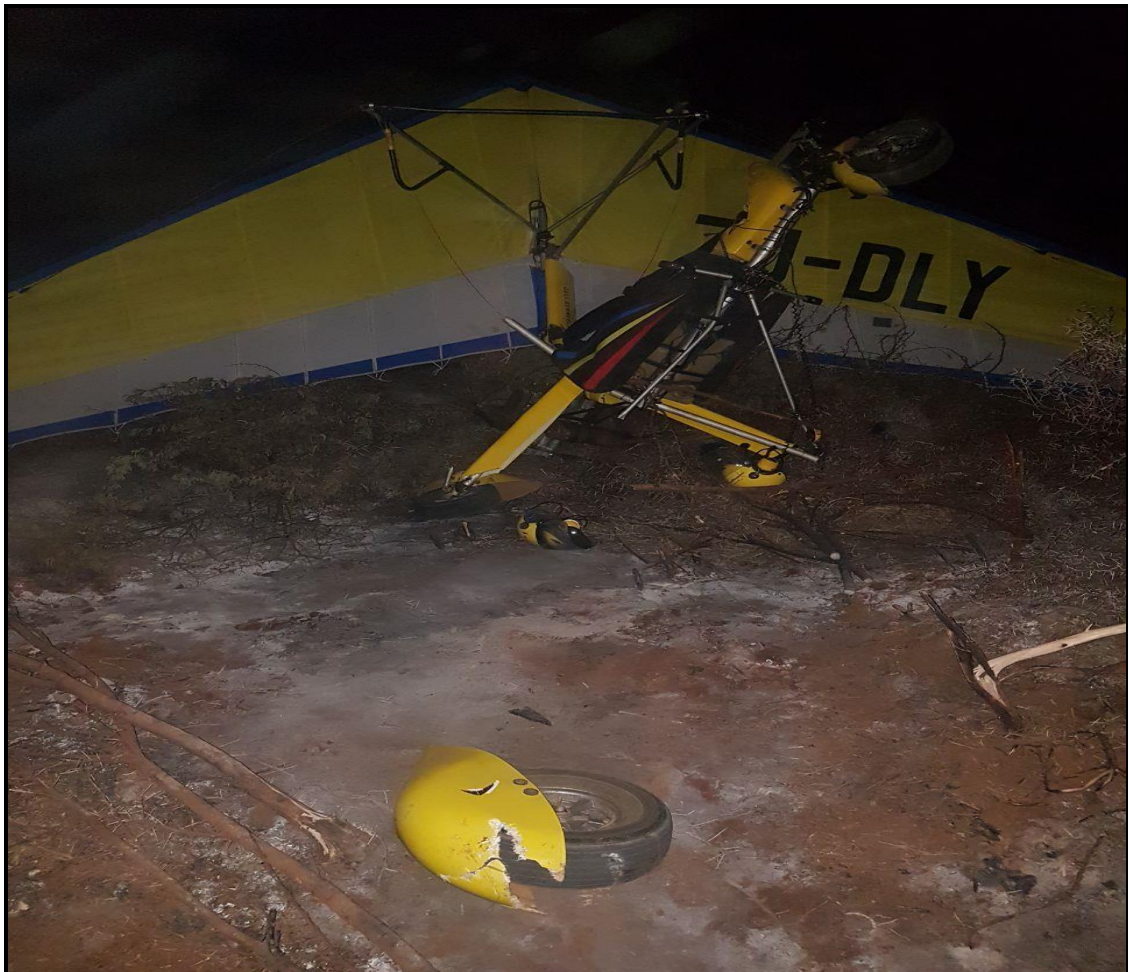
Figure 2: Aircraft as it came to rest

1.1.2 The aircraft was substantially damaged. Both occupants sustained injuries.

1.3.1 The aircraft sustained damage to the left main gear, 1 propeller blade, instrument panel and the engine mount support tube.

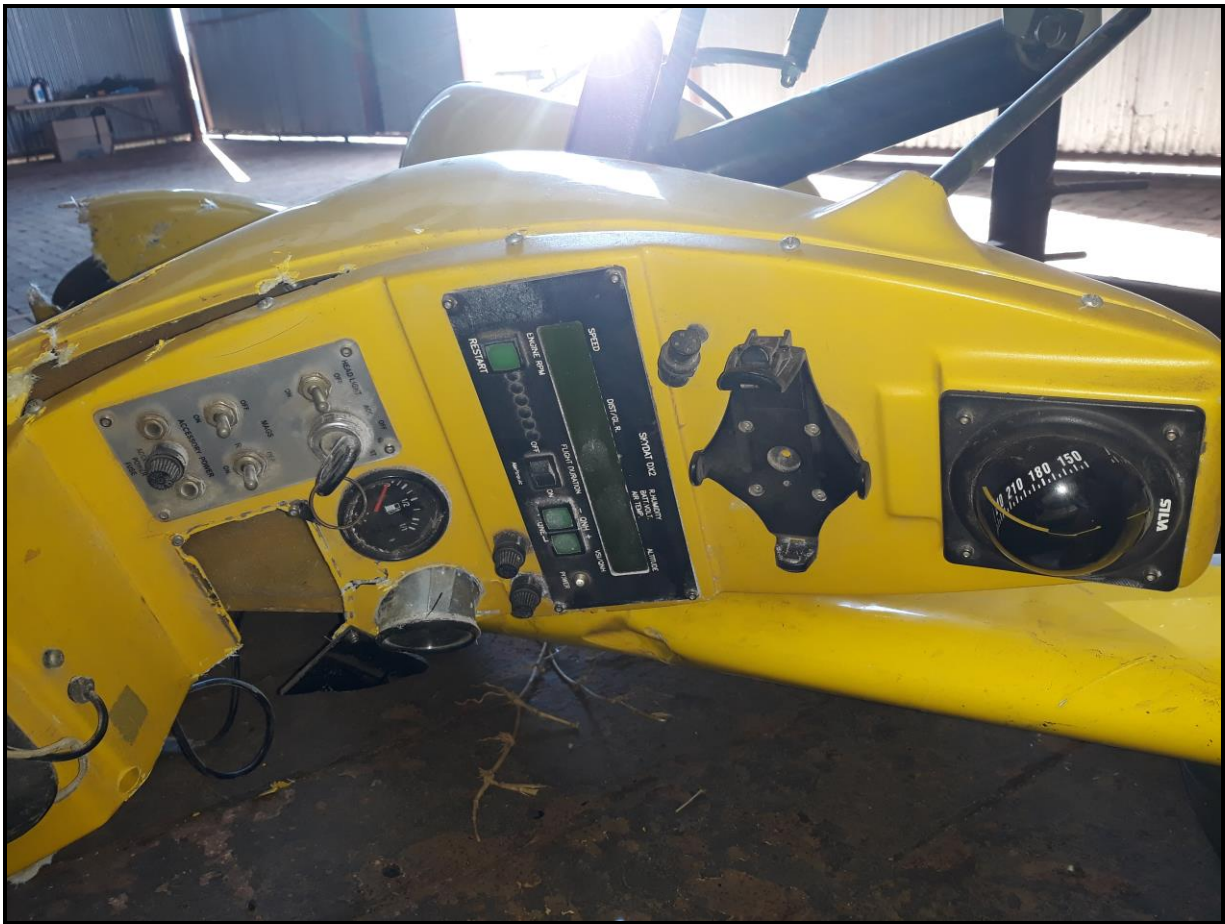
Figure 3: Damage to the cockpit

1.12.1 The aircraft collided with railway overhead lines as it descended during a forced landing. The aircraft subsequently impacted the ground with the propeller facing towards the ground. One of the propeller blades had snapped off from the mid-section and the left wheel was broken off and lying a few meters from the main wreckage. The cockpit was also damaged and the wing was observed to be intact.

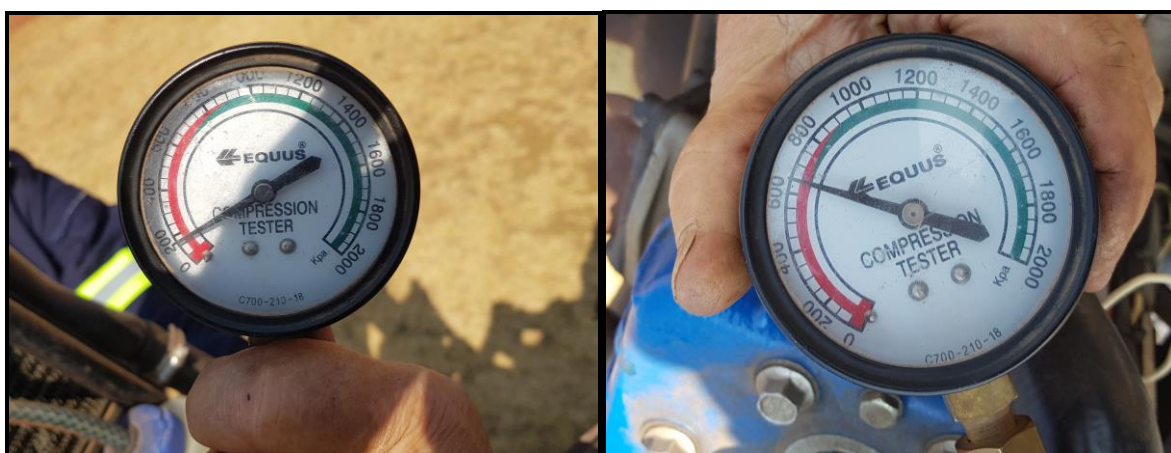
Figure 5: Cylinder no.1 left and Cylinder no.2 right

1.16.1 The aircraft with the engine fitted was recovered to an AMO and the engine was subjected to an engine run in the presence of investigators. The following was found: Only one blade of the propeller was broken which shows that the propeller was stationary on impact and that therefore the engine was not running on impact. The spark plugs were removed and a compression gauge was inserted in each spark plug receptacle. The engine was then cranked by pulling on the handle four times to build compression of the cylinders. Compression on cylinder no.1 was indicating 100kPa and compression on cylinder no.2 was indicating 625kPa. The cylinders were inspected and it was determined that the piston in cylinder no.1 had seized.

It is most probable that when applying full throttle it increased the engine temperature but there was a thermo-imbalance between the pistons and the cylinders due to their different materials composition, therefore the piston expanded faster than the cylinder due to a phenomenon known as cold seizer. This normally occurs when hot expanding piston due to thermal expansion is inside a cylinder which is cooled by cooling liquid resulting in the piston seizing in the cylinder sleeve leading to the failure of the engine. The compression test indicated 100kpa for cylinder no: 1 as compared to cylinder no: 2 which indicated 625kpa.

- 3.2.1 The aircraft had a cold seizure of no:1 piston during a fly past and the engine lost power, the pilot decided to do forced landing however the aircraft rear wheel collided with power lines and the aircraft subsequently impacted the ground.
