## AIRCRAFT ACCIDENT REPORT AND EXECUTIVE SUMMARY

Reference:	CA18/2/3/9711	
<b>Aircraft Registration</b>	ZU-FFA	<b>Date of Accident</b>	12 May 2018		<b>Time of Accident</b>	0730Z
<b>Type of Aircraft</b>	Zodiac CH601 HD (Aroplane)		<b>Type of Operation</b>		Private (Part 94)	
<b>Pilot-in-command Licence Type</b>		National Pilot Licence	<b>Age</b>	43	<b>Licence Valid</b>	No
<b>Pilot-in-command Flying Experience</b>		Total Flying Hours	265,12		Hours on Type	20,8
<b>Last point of departure</b>		Panorama AerodromeAerodrome, Gauteng Province				
<b>Next point of intended landing</b>		Rand Aerodrome (FAGM) Germiston, Gauteng Province				
<b>Location of the accident site with reference to easily defined geographical points (GPS readings if possible)</b>						
260 meters from the threshold of runway 11 at FAGM, (GPS position 26°14'33.06" South 028°8'16.84" East at an elevation of 5383 ft AMSL.						
<b>Meteorological Information</b>		Surface wind 350° variable between 330° and 030° at 10 kt, temp 17 °C, dew point 3 °C,CAVOK

**Name of Owner** : Coenraad de Beer  
**Name of Operator** : Jaco Neethling  
**Manufacturer** : Zenith Aircraft  
**Model** : Zodiac CH 601 HD  
**Nationality** : So

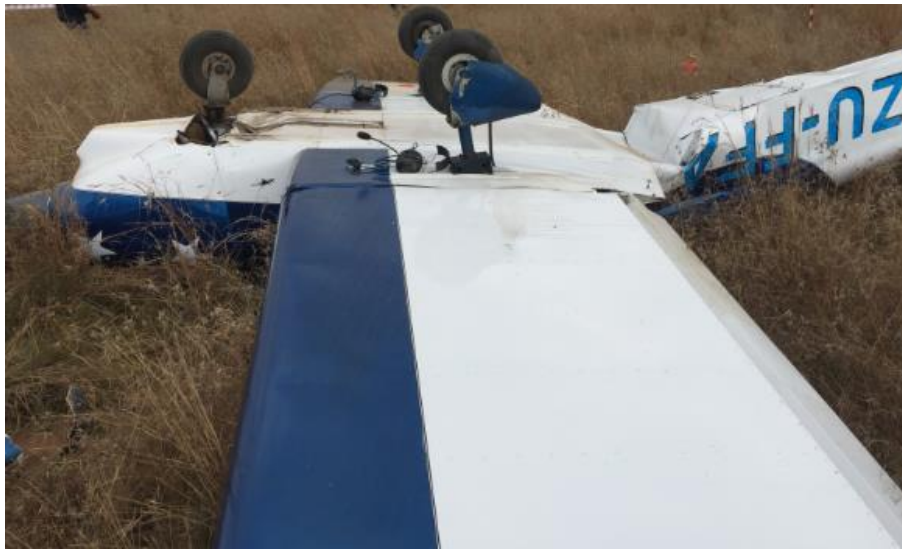
- 1.3.1 Substantial

Figure 1: Aircraft after impact.

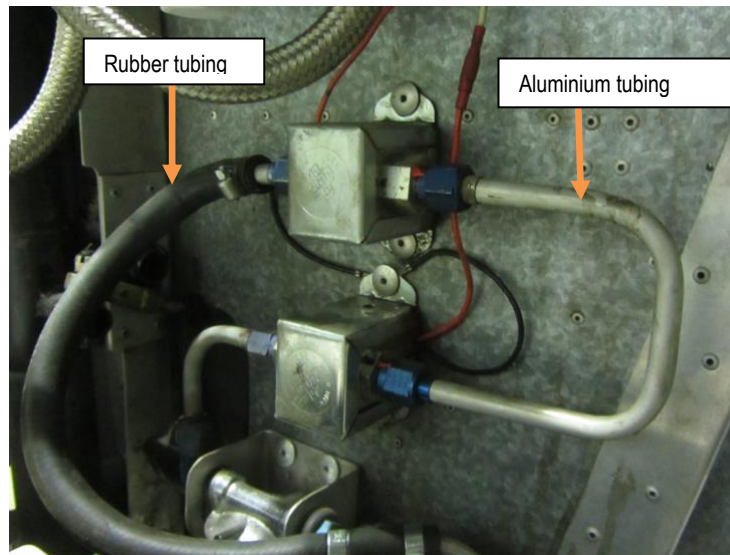
The aircraft fuel system was modified with two electrical pumps that were connected in series via aluminium tubing similar to pipes used for hydraulic systems. The pumps were mounted on the forward fire wall with blind fasteners. It was discovered that the outlet pipe from the pump was a normal hardware rubber hose used and not a standard fuel hose, as seen in figure 2 below. In this modification both pumps, including the aluminium pipes, were not shielded against heat from the exhaust pipe.

Figure 3: Fuel plumbing layout

It was noted that the fuel system integration as found on the aircraft comprised two electrical pumps interconnected via aluminium pipe with non-aviation standard rubber hose for delivery to the engine. It was noted that this modification was done to accommodate a Lycoming engine. No records of this modification were found. The fuel system was mounted on the firewall, with the left exhaust pipe situated in close proximity to the fuel pumps and lines. It was noted that the fuel system was not shielded against heat from the exhaust pipe. According to the temperature test that was conducted on the Lycoming O-320-E2D, the temperature of the exhaust at full power was 329 °C.

- 3.1.11 The engine stopped due to fuel starvation as result of vapour lock caused by heat from the exhaust pipe, which ran in close proximity to the fuel pumps and fuel lines.

- 4.1 In the interest of safety, it recommended to the Director of Civil Aviation to enforce measures for non-type certificated aircraft operators to comply with necessary requirements when major modifications which might affect the design and flight characteristics of the aircraft as well as expediting of a form to be used for application of modification for non-type certified aircraft.
- 4.2 Safety message: It is recommended to the owners of aircraft to install a heat shield in the exhaust pipe to prevent excessive heat transfer to the fuel plumbing.

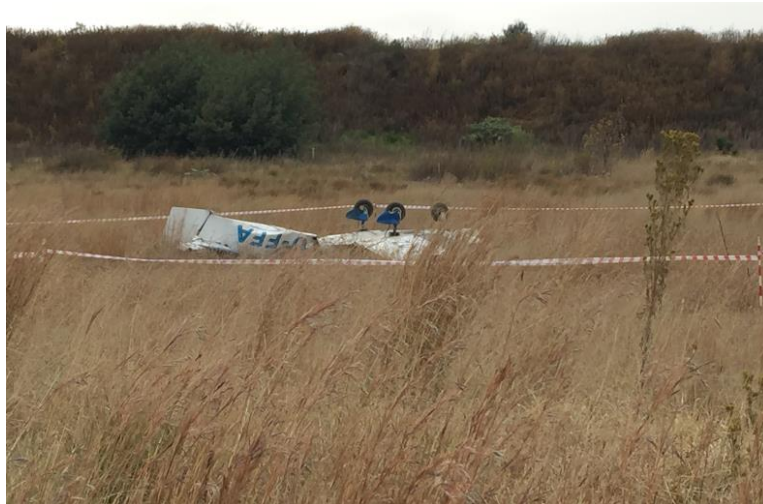
1.12.1 According to the witness marks observed on the ground, the aircraft impacted the ground with all three wheels. The aircraft skidded for approximately 2 m, when the nose gear dug in and the aircraft nosed over, coming to rest in an inverted attitude.

Figure 5: The aircraft as it came to rest

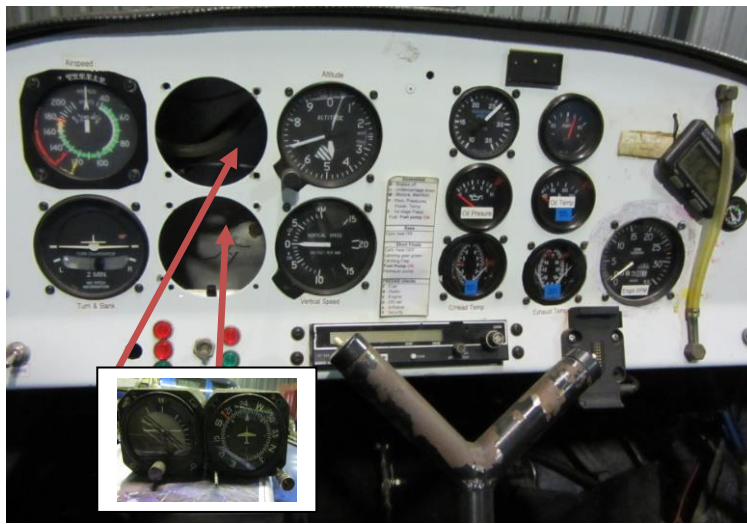
1.12.2 Two of the instruments became dislodged during the accident sequence (i) the directional indicator and the (ii) attitude indicator.

Figure 7: The instrument panel. (photo taken after recovery)

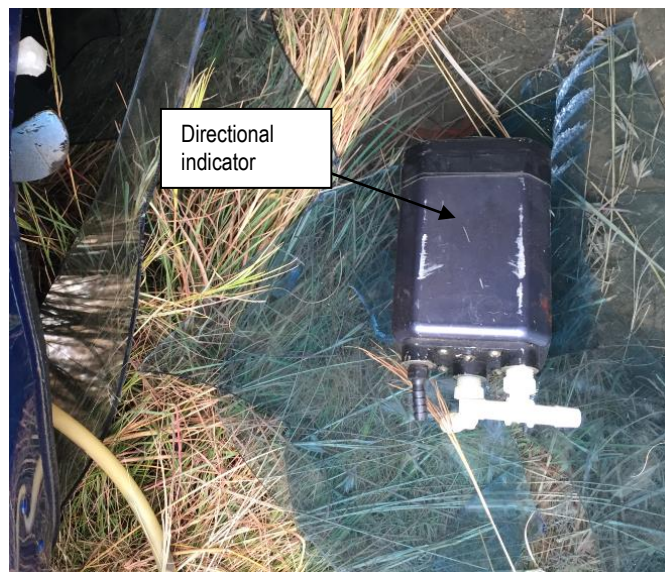
Figure 8: The directional indicator instrument.

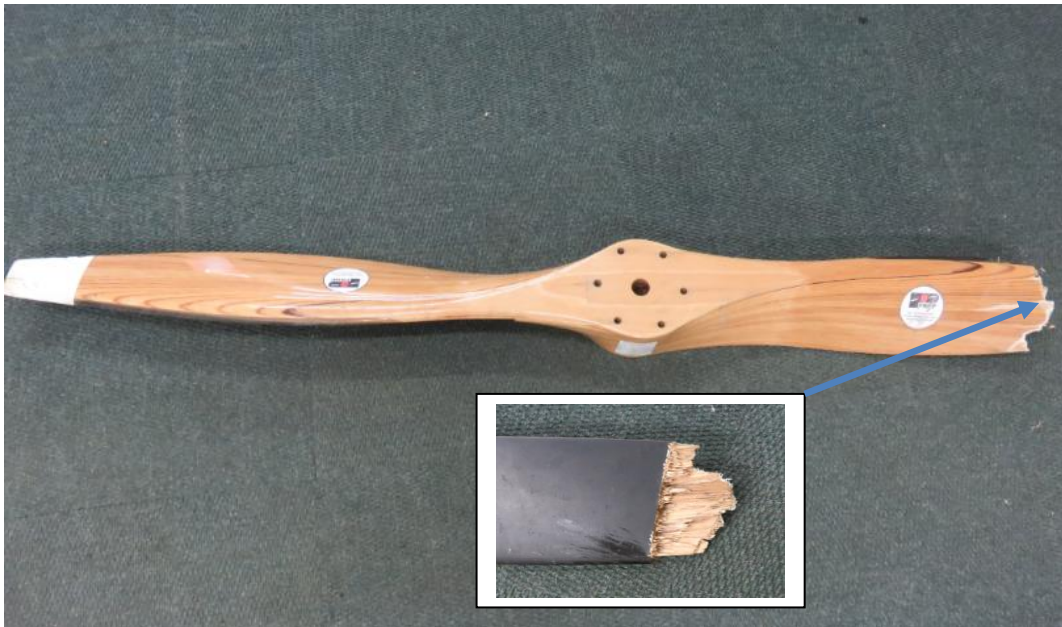
1.12.3 One of the propeller blades was broken in mid section. The other propeller blade was still intact, with no signs of rotational damage. The spinner was observed having scratch marks from the nose towards the back. The screws that attach the spinner on the flange were all missing. The engine thrust mounts were still intact.

Figure 9: A propeller (picture taken after removal)

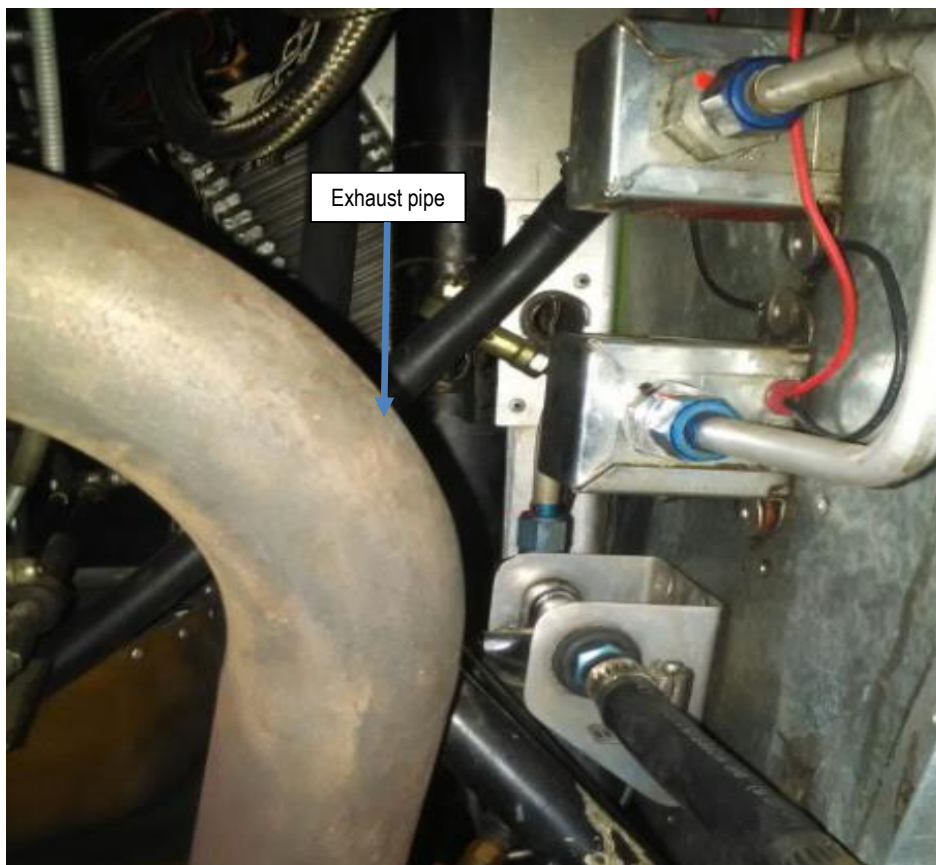
Figure 10: Exhaust pipe position

According to the Lycoming O-235 C operator's manual, the cylinder head temperature is 320°C. Due to the heat being concentrated at one point (exhaust pipe), the fuel inside the pipes reached boiling point, which led to vapour being present in the pipes. It was noted that the initial boiling point of the Mogas is 28 °C. The pilot stated that the engine was running rough, followed by a sudden stoppage. The fuel pressure and temperature influence vapour lock. Temperature and pressure also affect gasoline's vapour forming qualities, the capability of the system to hold vapour, in addition to the operating state of the engine. According to research done by Ferrara and Wares (1988), vapour bubbles may crop up at any part of the fuel system. However, the most crucial segment is typically the fuel pump. At the fuel pump, a bulk heat transfer to the gasoline occurs. Here pump suction lessens the pressure, which increases vapour development. The volume of the vapour at fuel system temperatures is around 160 times the volume of liquid. Based on this, it is apparent that a pump with a maximum volume flow pace will not be able to administer a sufficient mass flow rate of gasoline to the carburettor for maximum power if a bulk of the fuel has turned into vapour. It was noted that the aircraft was fitted with a transponder and that the pilot did not squawk 7600, which is a frequency for radio failure procedure. However the ATC continued to transmit blind on the frequency.

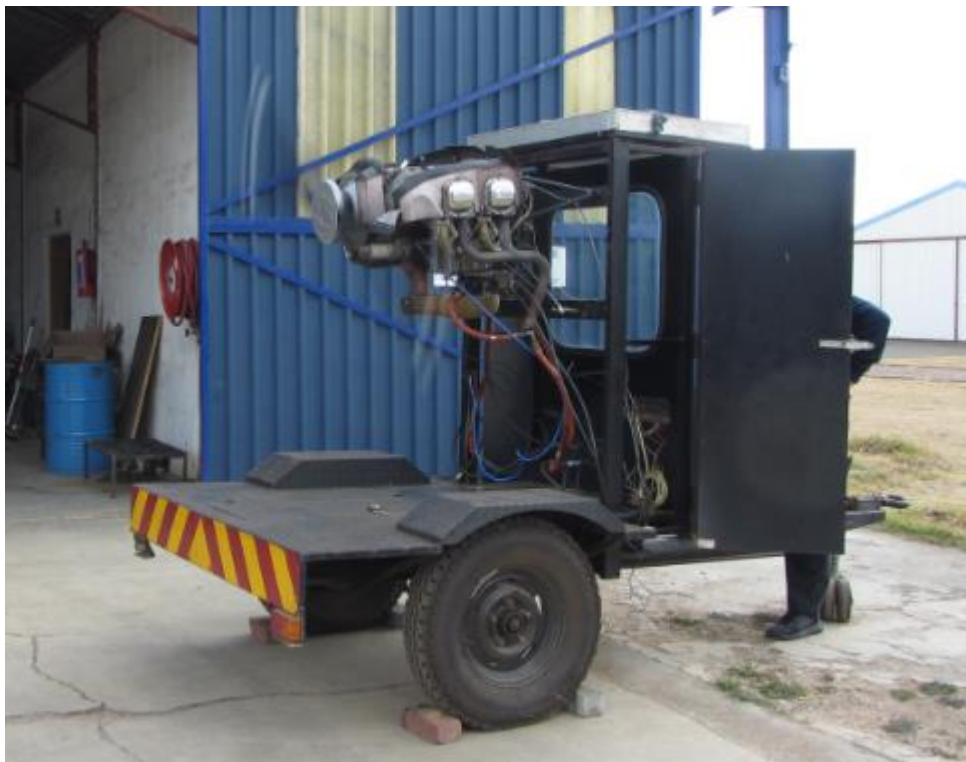
1.16.1 The engine was removed from the wreckage and was found to be in an overall good condition, which allowed for a bench test. The bench test was conducted at an approved engine maintenance facility in the presence of the investigator-in-charge. Prior to commencing with the test it was noted that the engine's crankshaft was slightly bent. A loaner propeller was fitted to the crankshaft flange for the purpose of the bench test. The engine started without difficulty and was operated at idle speed for some time before the throttle was advanced to full throttle setting for approximately 5 minutes. Both magnetos were also tested during the test run and was found to be within its operating limitations. The instruments were showing normal engine operation, the oil pressure was 65 psi and the manifold pressure was 250 psi while the engine rpm was at 2200 rpm.

Figure 11: Engine on the test bench running at full throttle.

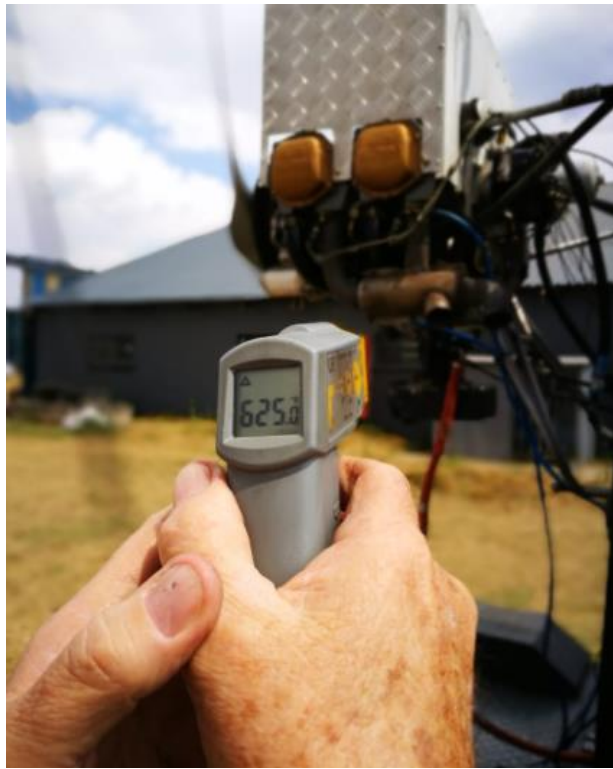
Figure 12: Exhaust pipe temperature (photo courtesy of Clack Air)
