<b>AIRCRAFT ACCIDENT SHORT REPORT</b>
---------------------------------------

**CA18/2/3/9712:** The aircraft landed hard during aborted take off

**Date and time** : 23 May 2018, 16:01Z  
**Aircraft registration** : ZU-CWI  
**Aircraft manufacturer and model** : Aviate Products cc, Raptor  
**Last Point of departure** : Microland Airfield (FABA), Gauteng Province  
**Next point of intended landing** : Jakkalsdams Airstrip  
**Location of accident site with reference to easily defined geographical points (GPS readings if)** : Runway 03 (RWY03) clearway, FABA (GPS S25°58'34.0" E028°23'17.7")  
**Meteorological Information** : FALA 231600Z 30004KT 250V310 CAVOK 20/05 Q1026 NOSIG=  
**Type of operation** : Private, Part 94  
**Persons on board** : 1 + 1  
**Injuries** : 2  
**Damage to aircraft** : Substantial Damage

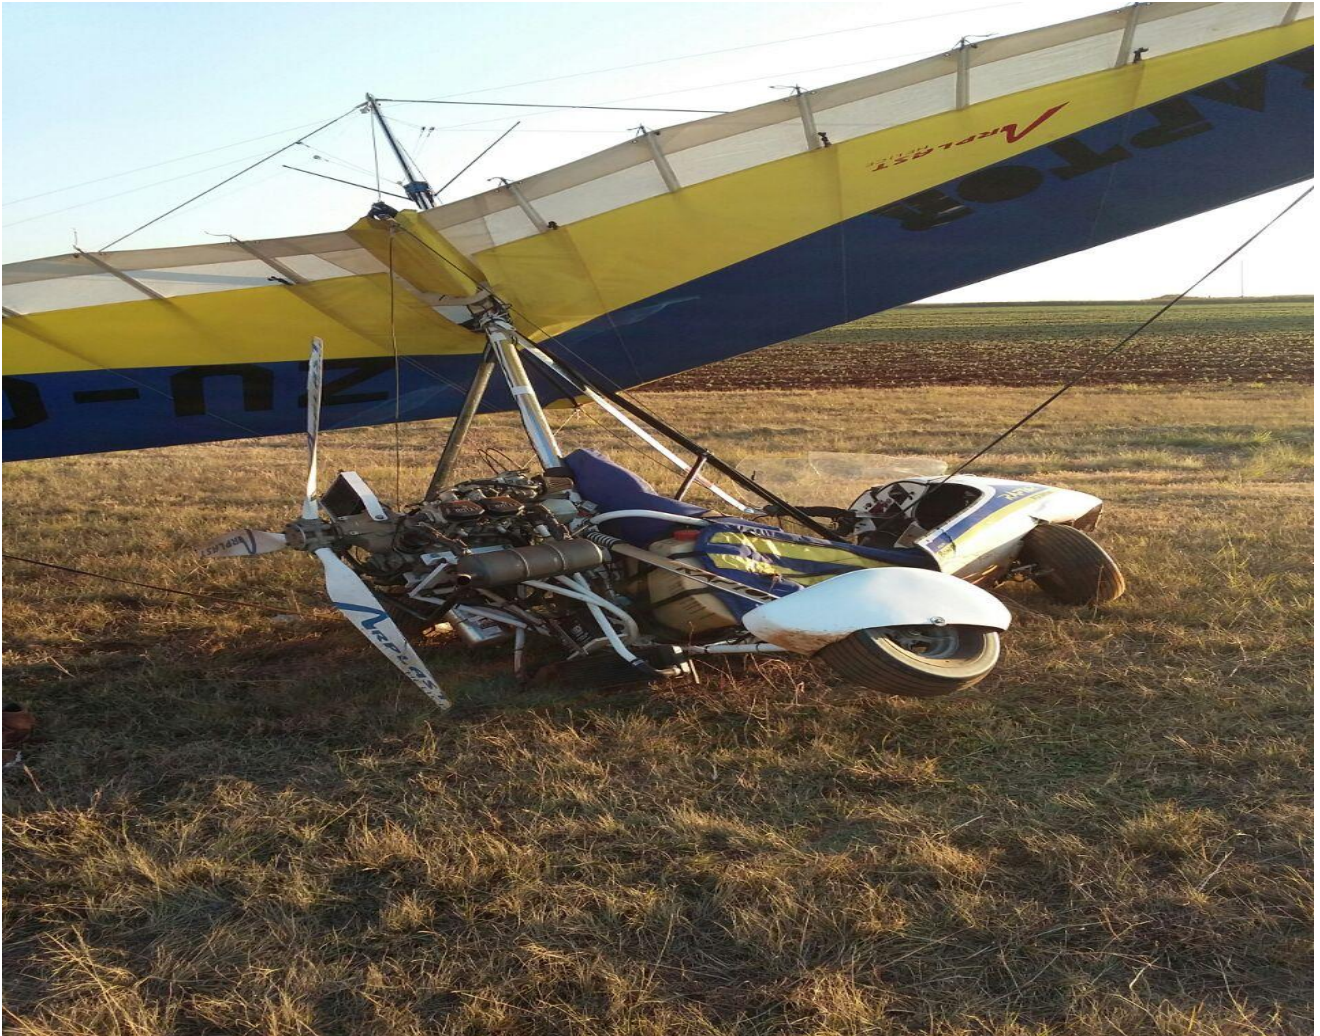
- 2.3 The aircraft sustained substantial damage to the undercarriage, wings and fuselage. The pilot and the passenger sustained minor injuries but disembarked the aircraft unassisted.

- 3.8 The investigation revealed that the aircraft was rotated before reaching the required take-off speed and failed to climb. The pilot decided to land back on the remaining runway. The aircraft landed hard and sustained damage to the undercarriage and the pilot lost directional control. The aircraft veered off to the left of the runway before coming to a stop 150m from there the take-off roll started.

Figure 2: The aircraft as it came to rest.
