AIRCRAFT ACCIDENT SHORT REPORT

CA18/2/3/9713 Piper PA-31-350 Navajo Chieftain: Left gear collapse

Date and time	30 May 2018: 1004Z
Aircraft registration	ZS-LVJ
Aircraft manufacturer and model	Piper Aircraft Corporation – PA-31-350
Last Point of departure	Baragwanath (FASY) Aerodrome
Next point of intended landing	Wonderboom Aerodrome (FAWB)
Location of accident site with reference to easily defined geographical points (GPS readings if possible)	GPS Coordinates S25°39' 9.75" E028°13'.23.84"
Meteorological Information	Wind direction, 290°: Temperature, 22°C: Wind speed, 10 knots: Visibility, 10km
Type of operation	Private (Part 91)
Persons on board	1 + 2
Injuries	None
Damage to aircraft	Substantial

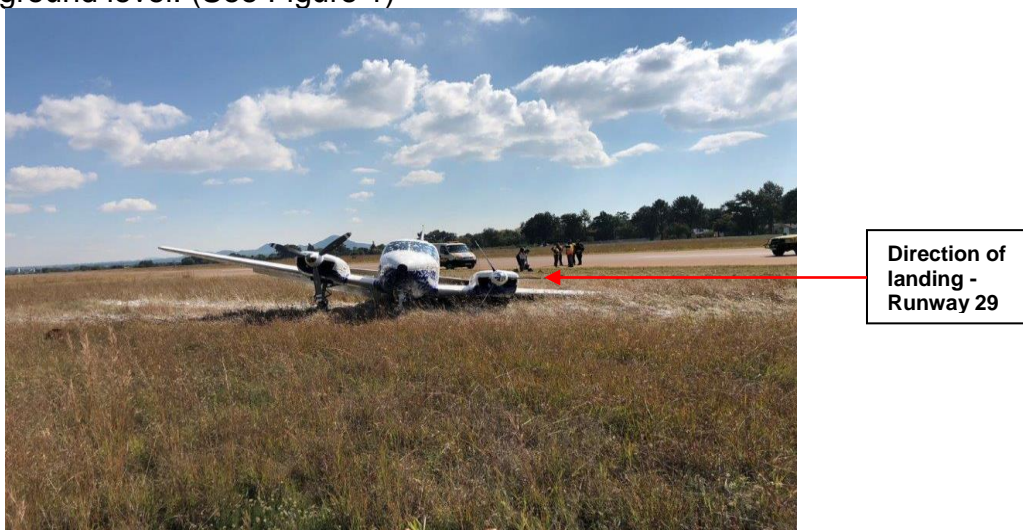
Figure 1: The aircraft as found at the accident site.

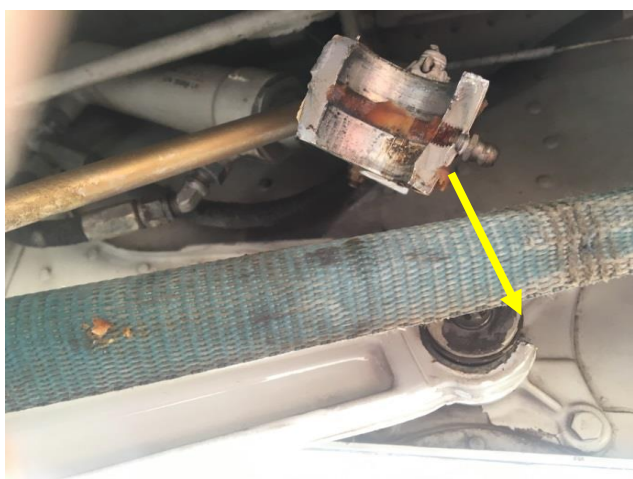
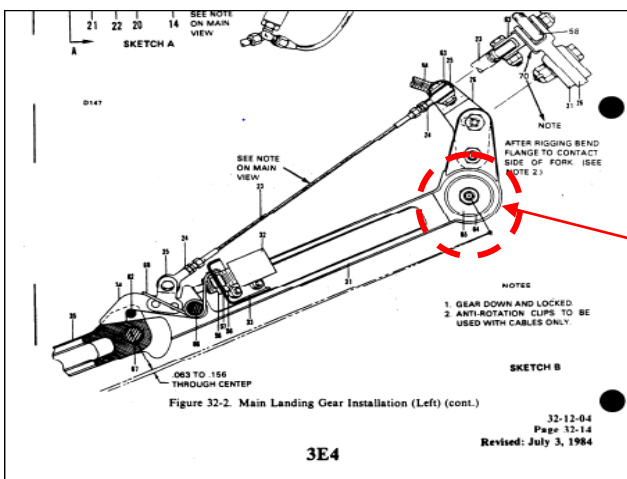
Figures 2 and 3: A picture showing a fractured left main gear side brace and an illustration from Piper Maintenance Manual.

- 3.11 There was no evidence observed that the condition of runway could have been a factor in the accident.
- 3.12 On-site visual inspection of the left wheel well area showed that the hydraulic lines were intact. Both oleo struts were normally extended. Further examination revealed that the left main gear leg side brace (P/N 40277) had fractured and had caused the gear to retract.

- 3.13 The investigation revealed that the left-hand main landing gear collapsed as a result of the left side brace failure due to fatigue and, in some areas, due to overstress fracture.

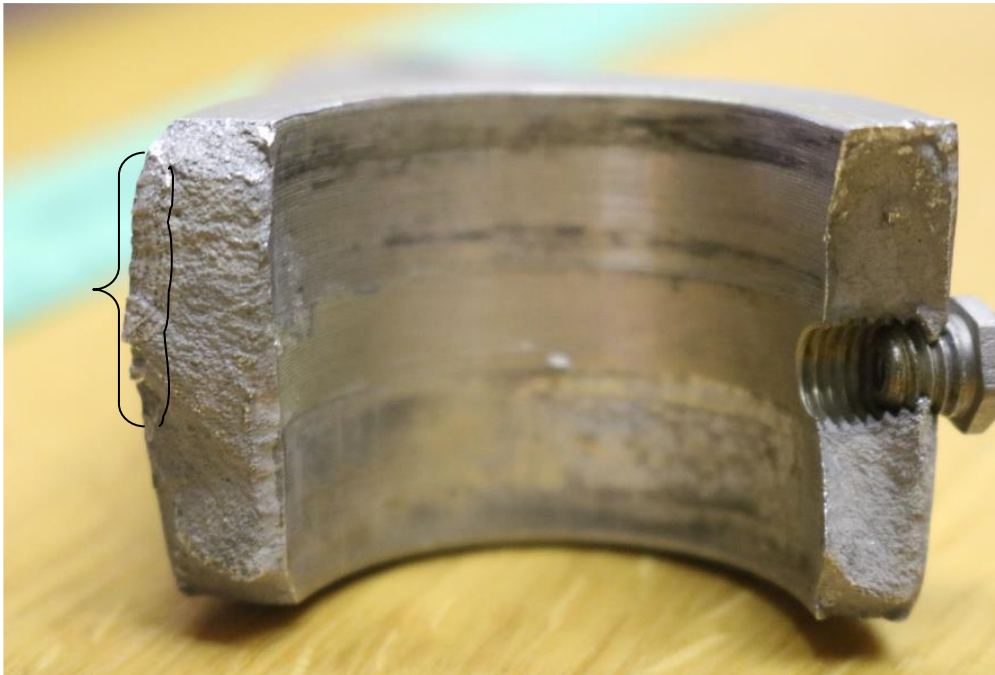
2.15.1 A fractured main landing gear forward side brace from the Piper PA-31, registration number ZS-LVJ, was reviewed by a metallurgist. The side brace was painted white and had fractured at the pivot point. The side brace was removed from the aircraft, upon which the paint was stripped from the entire part. (See Figure 4)

Figure 4: The side brace showing a fractured pivot point.

2.15.2 The report indicated that a portion of the side brace pivot point was fractured in a plane perpendicular to the surface. This portion of the fracture on a perpendicular plane was located at the upper side of the brace and had curving crack arrest lines and a smooth curving boundary, features consistent with fatigue. Radial step features consistent with ratchet marks were also observed.

Ratchet marks are step features on the fracture surface that form due to fatigue crack initiation on slightly different planes. The ratchet marks and the overall shape of the fatigue boundary were consistent with multiple fatigue origins located at the upper surface. Dashed lines on the images of the fracture surfaces figure 5 above indicate the approximate fatigue boundary, and brackets in the same images indicate the fatigue origin area. The remainder of the fracture surface had rough matte grey fracture features consistent with ductile overstress fracture. The presence of multiple fatigue origins and the relatively small size of the fatigue region relative to the remainder of the fracture area were consistent with relatively high cyclic stresses on the part.

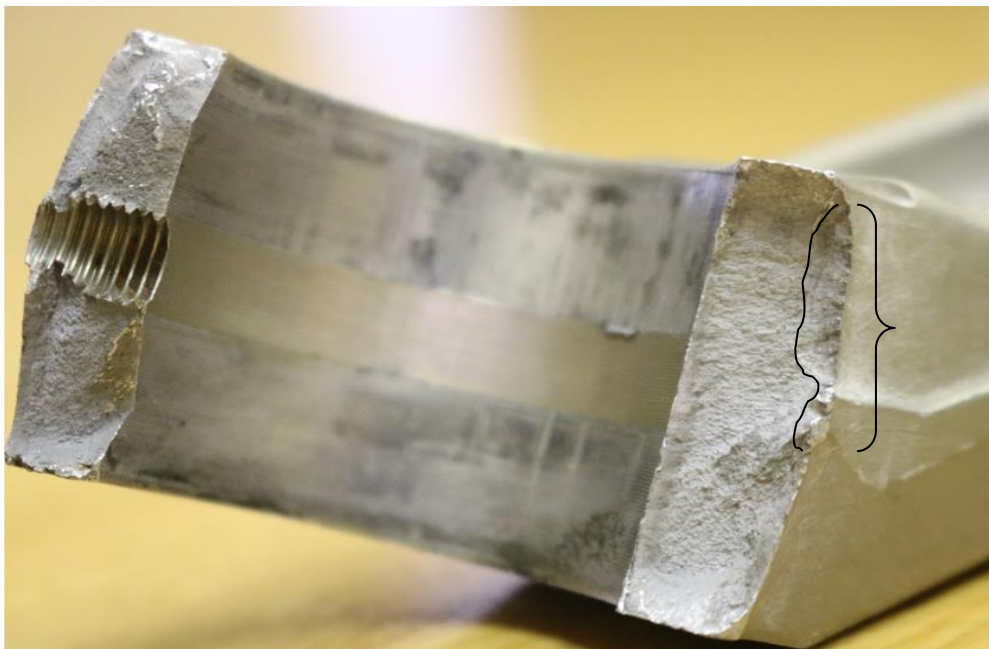
Figure 5: The side brace from a different angle showing a fractured pivot point.
