Accident and Incident Investigations

HELICOPTER ACCIDENT REPORT AND EXECUTIVE SUMMARY

Reference:	CA18/2/3/9714	
Aircraft Registration	ZS-MZS	Date of Accident	1 June 2018		Time of Accident	0940Z
Type of Aircraft	Robinson R44 Raven II		Type of Operation	Private (Part 91)		
Pilot-in-command Licence Type	Private Pilot (Helicopter)		Age	36	Licence Valid	Yes
Pilot-in-command Flying Experience	Total Flying Hours		±406.8		Hours on Type	±68.6
Last point of Departure	Rustenburg Aerodrome (FARG), North West Province					
Next Point of Intended Landing	Zebula Golf Estate & Spa Aerodrome, Limpopo Province					
Location of the accident site with reference to easily defined geographical points (GPS readings if possible)						
Lumarie Game Farm, 8 nautical miles south-west of Zebula Golf Estate & Spa Aerodrome at GPS co-ordinates S24°52'07.71" E027°52'27.97" at an elevation of 3 920ft						
Meteorological Information	Wind: 280°/10 kts, visibility: >10km, temperature: 21°C, dew point: 15°C

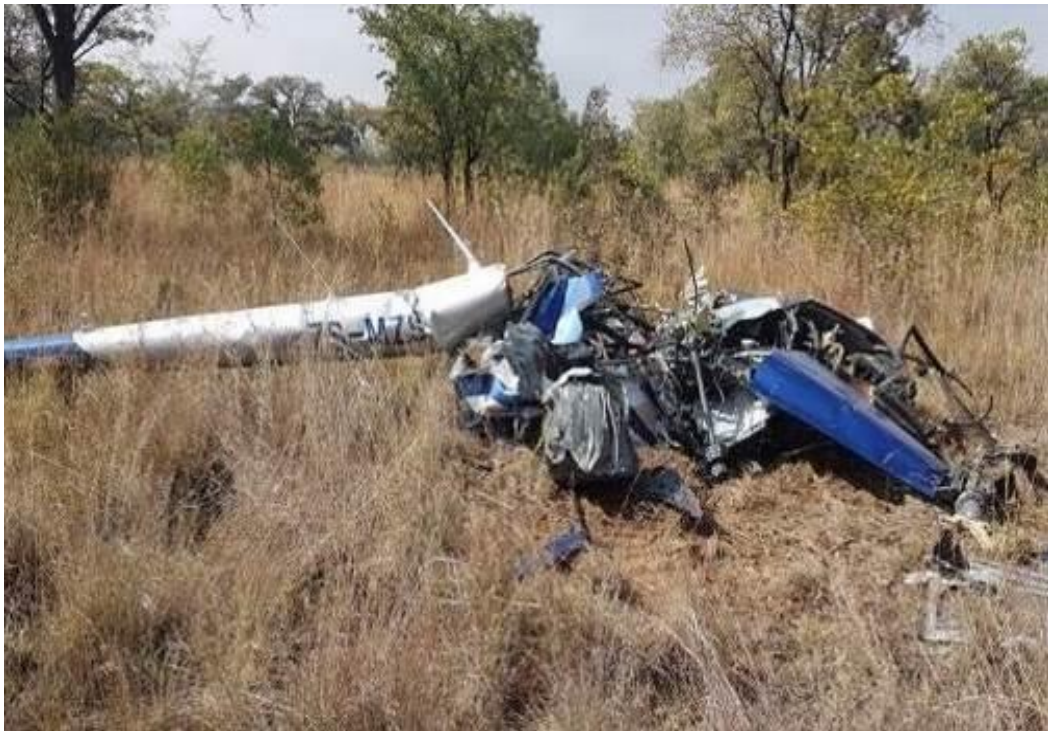
1.3.1 The helicopter was destroyed during the accident sequence.

Figure 2: The main wreckage as found on site.

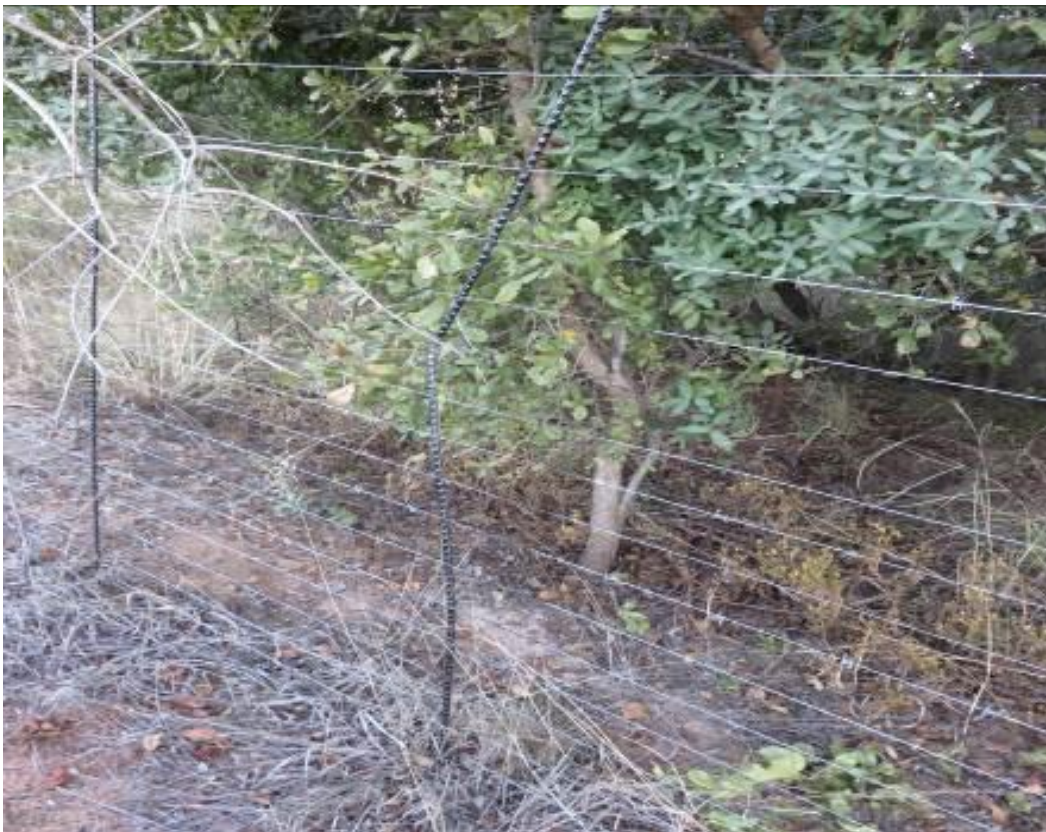
- 1.4.1 A perimeter fence was damaged by the main rotor (MR) blade that separated during the accident sequence.

Figure 3: Damage to the steel rod and fence.

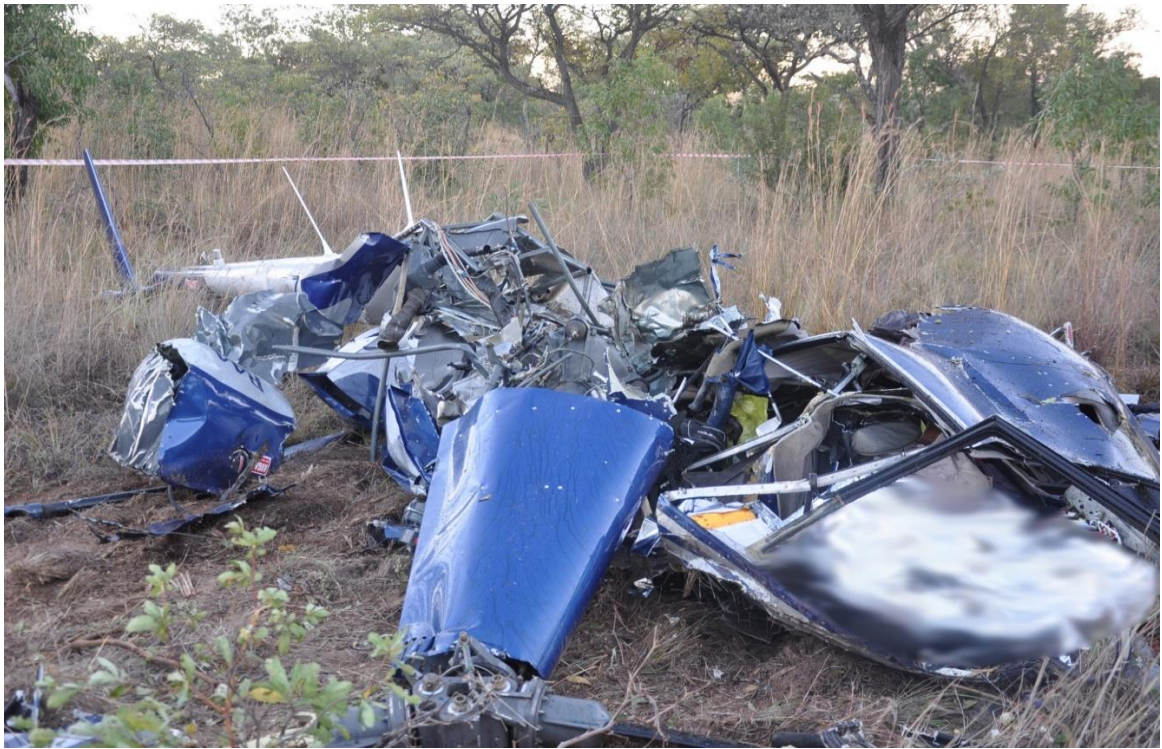
1.12.1 The helicopter crashed in Lumarie Game Farm, about 187m from the position of the eyewitnesses. According to the fuselage position and damages, it is evident that the helicopter impacted the ground with the right-hand side of the cabin and then bounced to the left-hand side before coming to rest in an upright position, facing south. This also resulted in both the left and the right skip separating from the fuselage.

Figure 6: The final position of the helicopter after the accident.

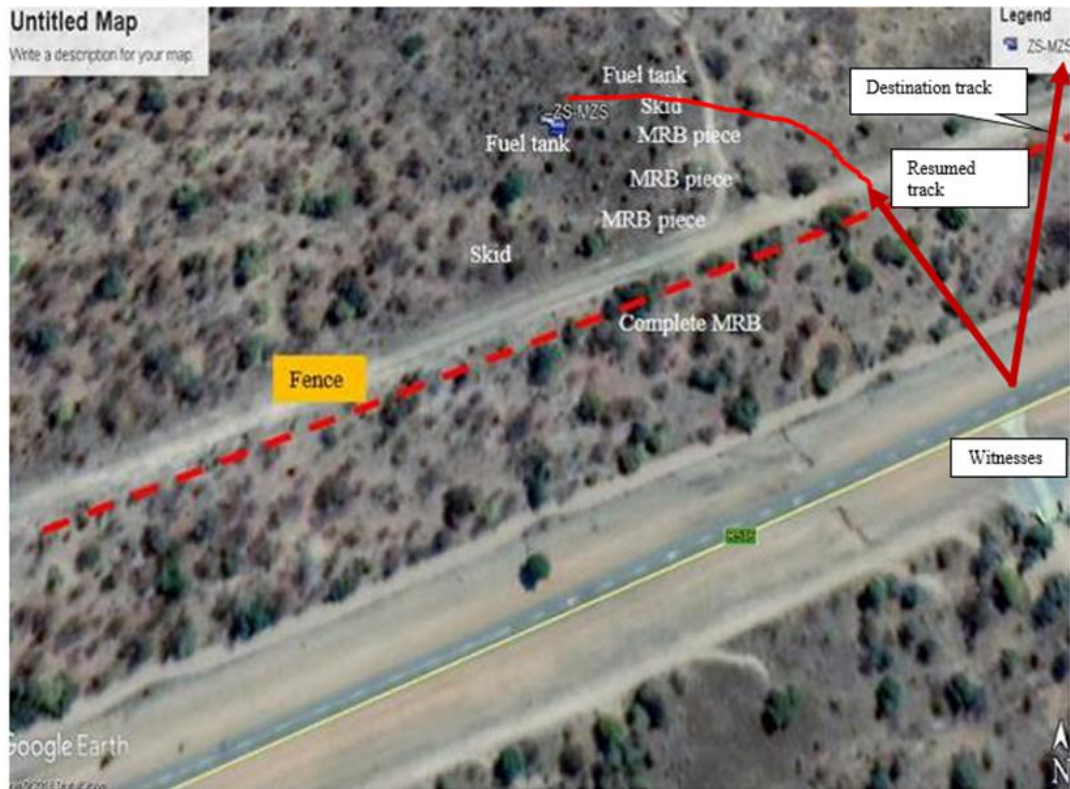
1.12.2 The main wreckage contained the main fuselage, flight deck, mast, tail boom and engine. The wreckage displayed severe damage from a high-energy vertical impact. The main gearbox and the mast were still attached to the main wreckage and were resting on its right-hand side. The main gearbox attachment points were found separated from the frame as a result of impact forces. One of the rubber stops was crushed, indicative of mast bumping during impact sequence. The main gearbox housing was cracked at the bottom, indicative of internal components that came into contact with a housing due to high rate of descent (RoD). All three hydraulic servo actuators were still attached to the main gearbox. The outside condition was good and there were no visible signs of leaks which might have occurred prior to impact.

Figure 7: Wreckage distribution.

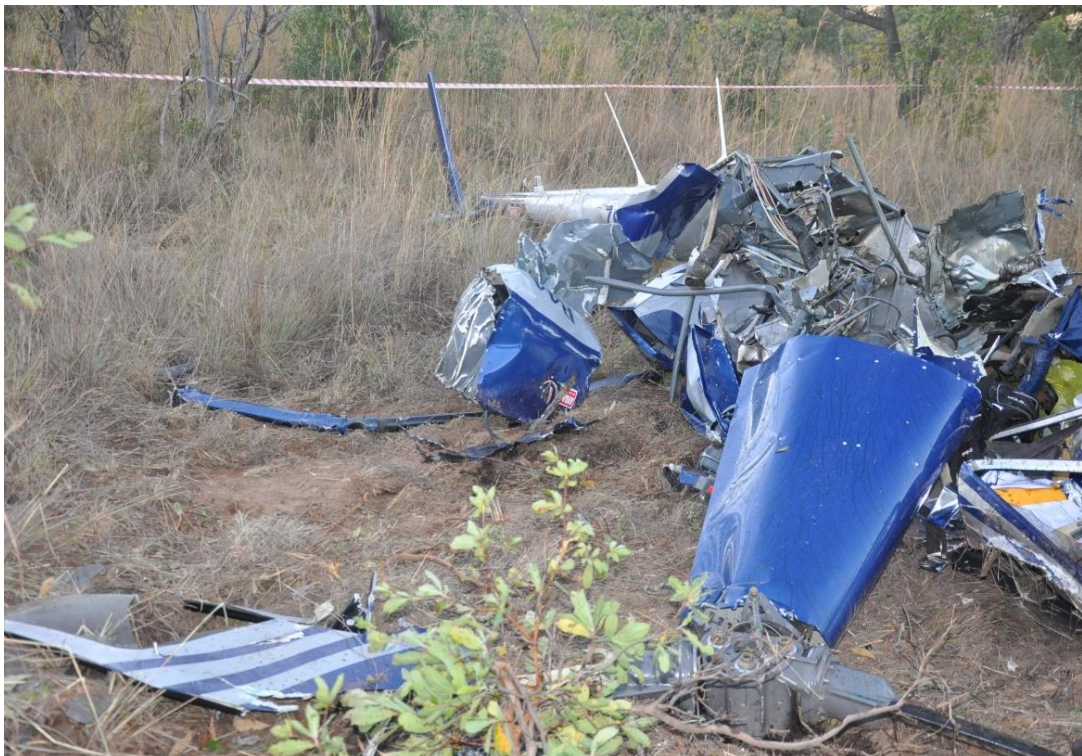
Figure 8: Right view of the main wreckage.

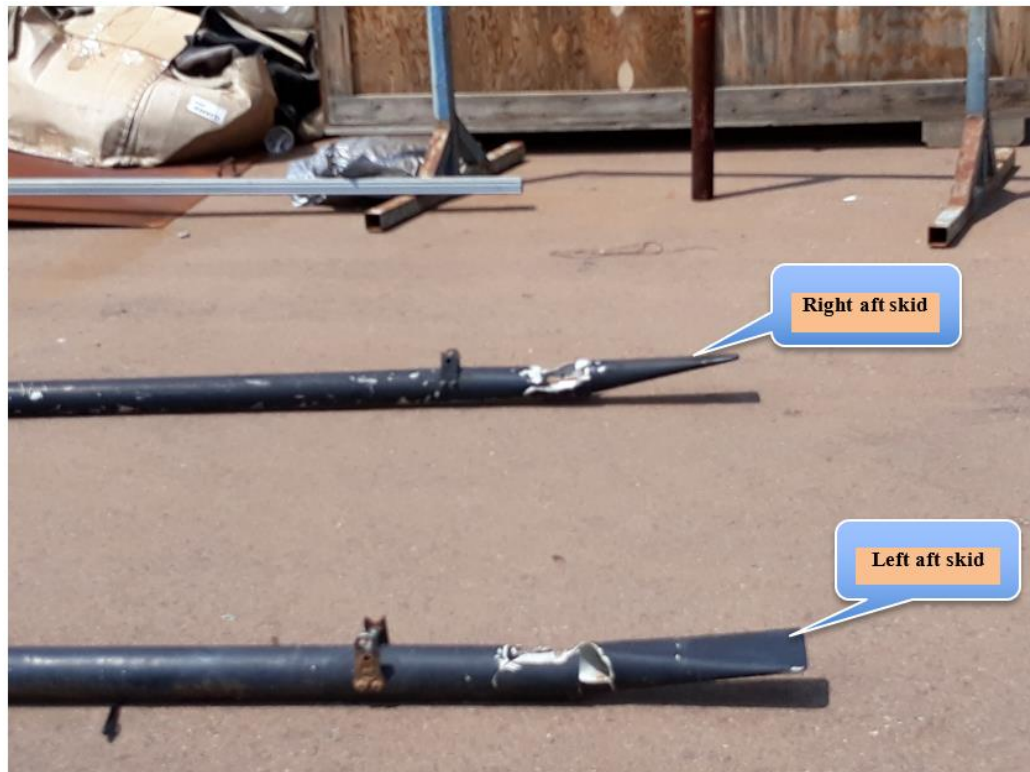
1.12.3 The directions of fracture at the cross-tube or strut assembly and skid connection points indicated that impact loads were in upward and aft directions. As depicted by the picture below, the skid gear damages indicate that the helicopter impacted with the ground at high RoD. The skid gear broke off from the cross section and was found on the right-hand side of the main wreckage.

Figure 9: Left- and right-hand skids.

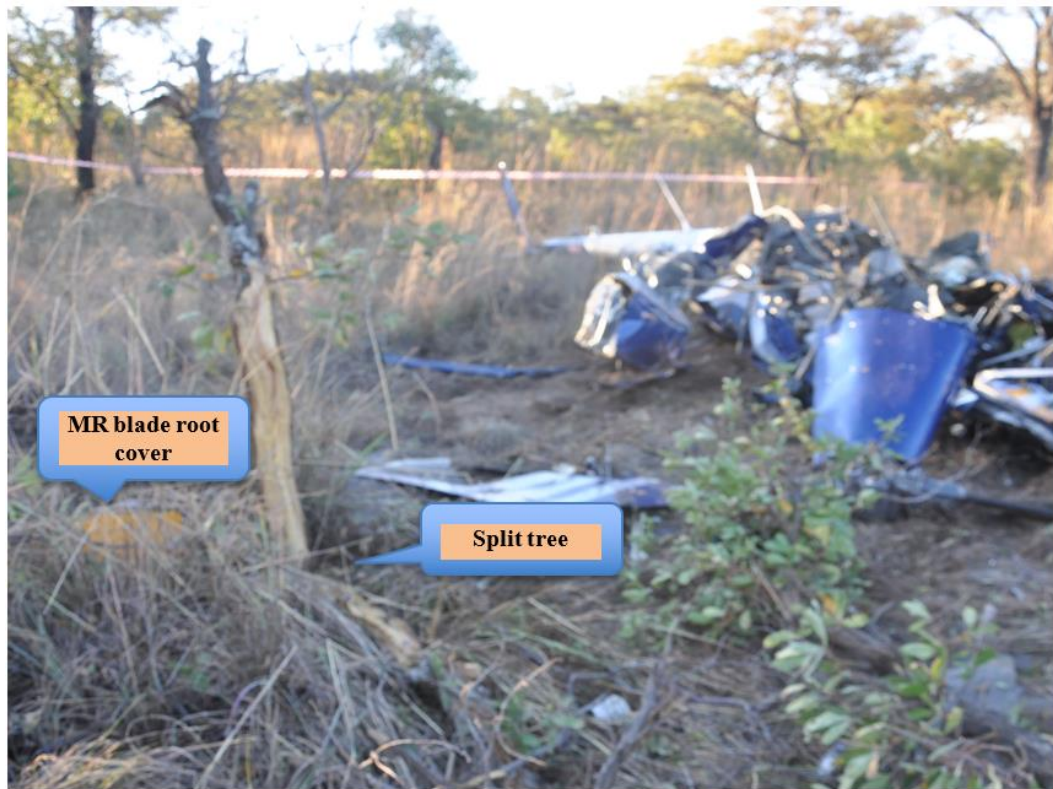
1.12.4 Both eyewitnesses stated that the helicopter moved forward for approximately 100m and then turned left in a nosedive attitude. One of the helicopter MR blades impacted a tree stem and the other blade was fragmented into pieces and was scattered a few metres around the main wreckage. The less damaged blade was found resting on the farm perimeter fence. It could not be confirmed which of the two blades impacted the tree. The front tip and the main spar of the destroyed blade could not be found at the accident site and the blade root was still attached to the main rotor hub.

Figure 10: Image shows the split tree and a MR blade root cover.

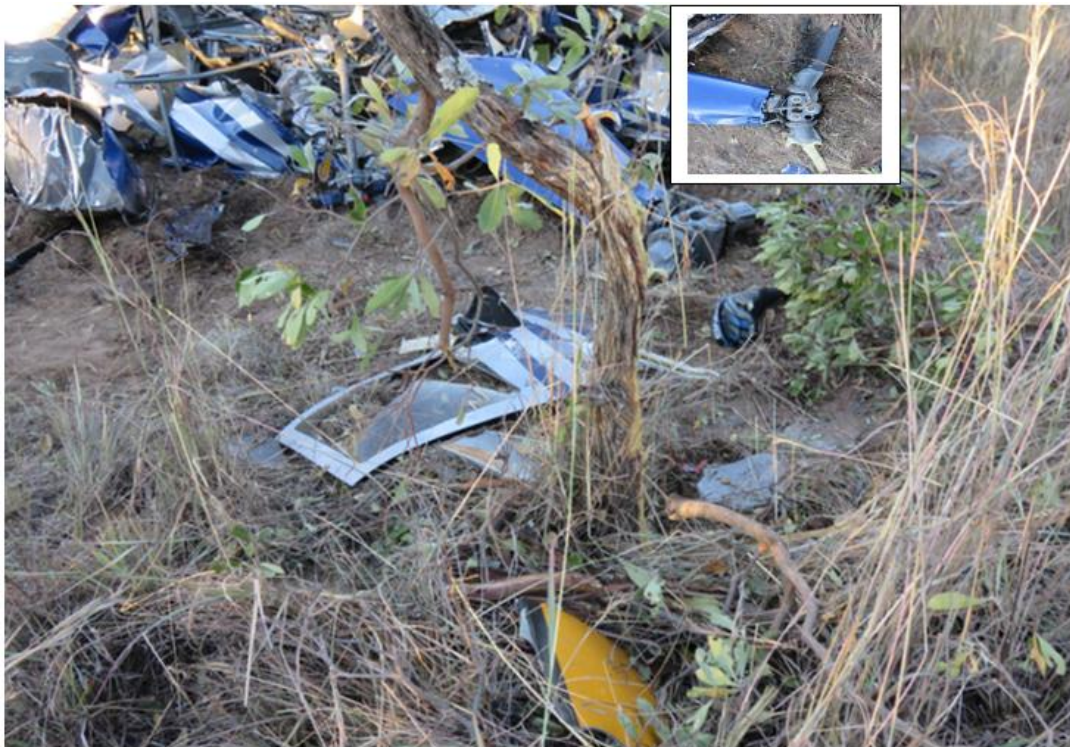
1.12.5 The separated MR blade was found approximately 63m away from the main wreckage. The other small piece of the complete blade was found next to the tree which was approximately 10m away from the main wreckage.

Figure 11: Shows the blade root still attached to the main rotor hub

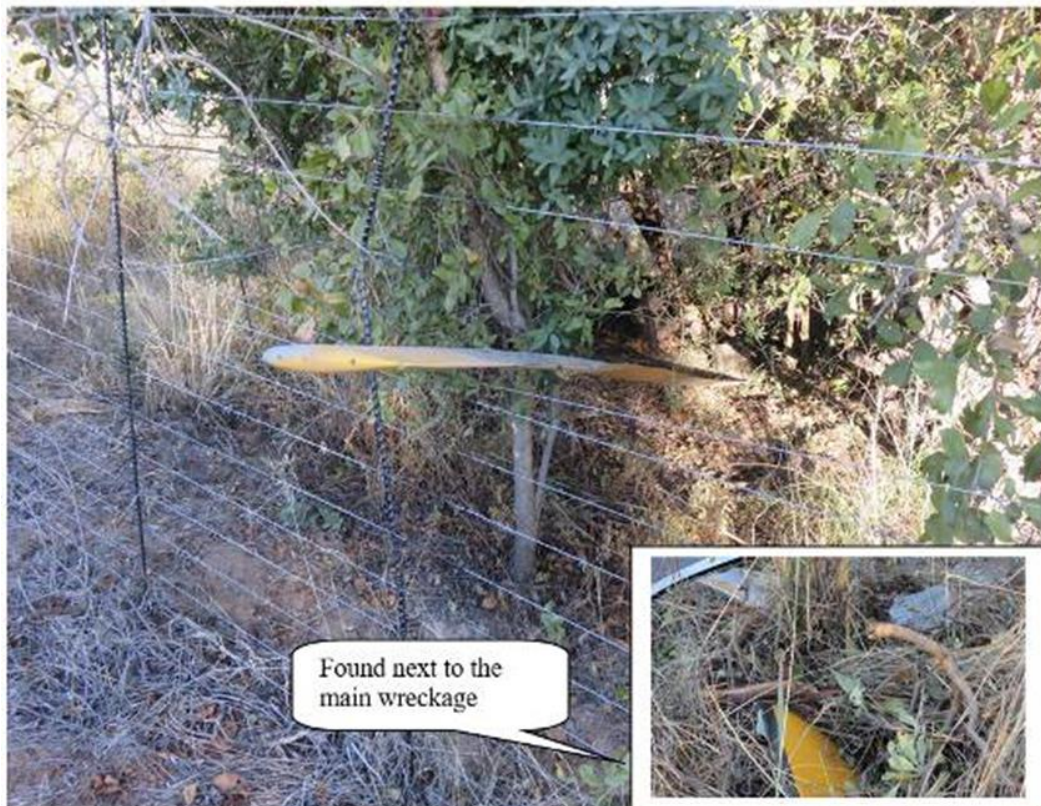
1.12.6 This MR blade had significant compression loads on the top surface for the entire length, which suggests impact with object while not turning at full revolutions per minute (rpm). The damage found approximately 1m on the inner surface of the MR blade was consistent with impact by the blade.

Figure 12: The MR blade as found at the accident site.

- 4.1.1 It is recommended that the SACAA, through the relevant division(s), ensures that all operators of Robinson R44 and R22 helicopters comply with AD 2014-23-16, which must be carried out strictly before every first flight of the day. In addition, the inspection must be entered into the aircraft records to show compliance.

4.1.2 It is also recommended that operators who are still flying helicopters fitted with MR blades P/N C016-5 include the daily inspection on their checklist until such blades are replaced.

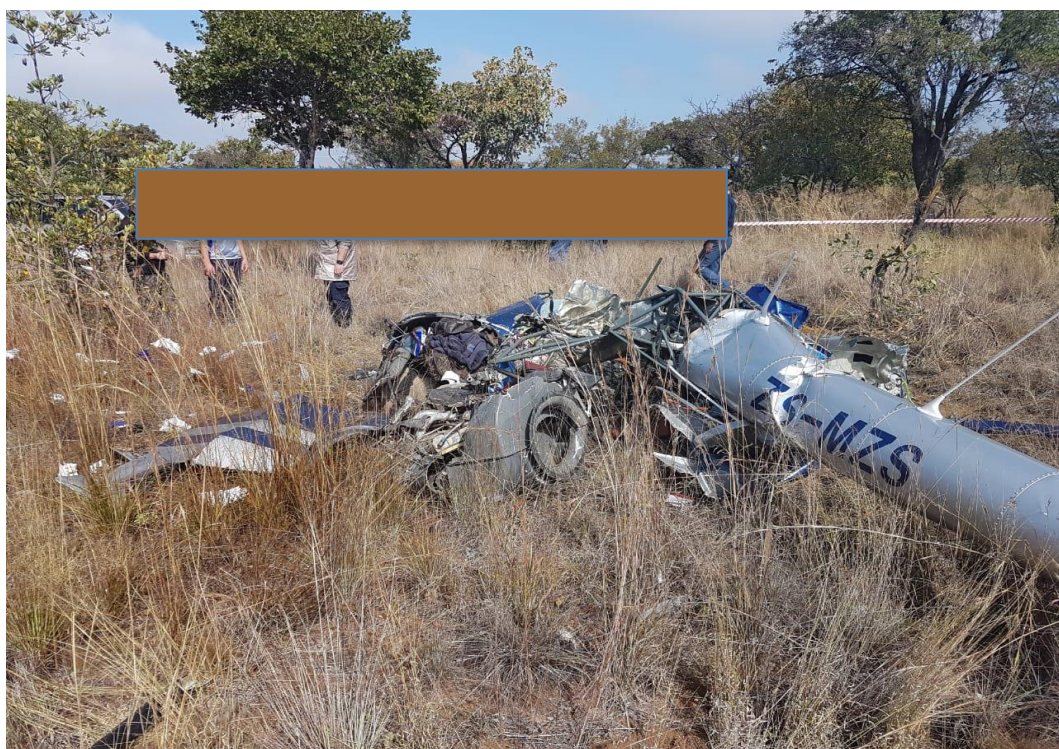
Figure 13: Left view of the main wreckage.

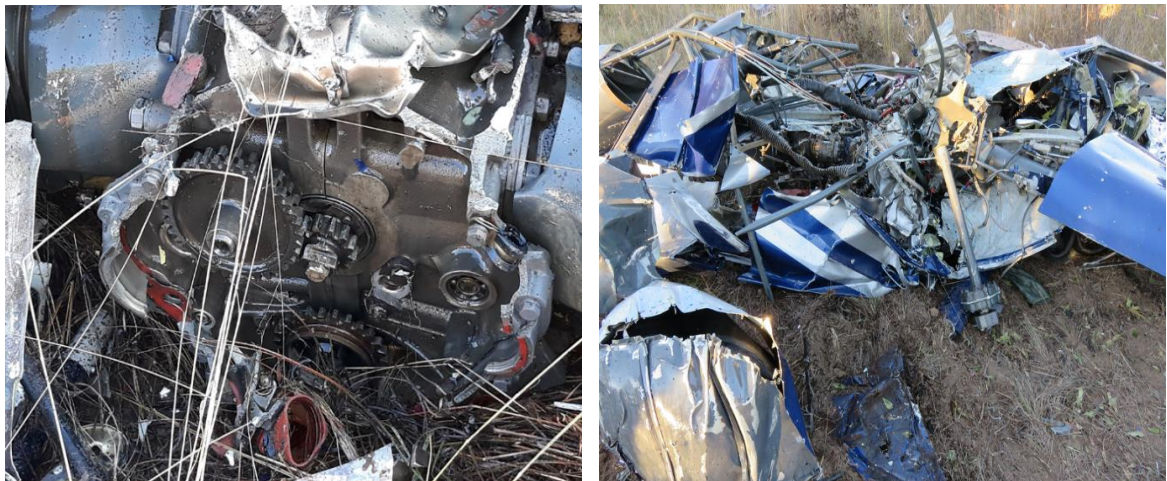
1.12.7 Components of the engine were scattered in different directions. The upper sheath broke off from the drive shaft, indicative of sudden stoppage damage on a rotating component. The lower sheath was found 3m from the main wreckage and having rotational impact marks on the surface. The upper bearing was still intact in the middle shaft and was turning freely. The middle shaft was fractured due to impact forces. The outer flexible coupling was broken at two attachment points while the inner flexible coupling broke off in all attachment points. The last flexile coupling was still intact with the tail gearbox input shaft.

Figures 14 & 15: Images show damage to the engine and drive train.

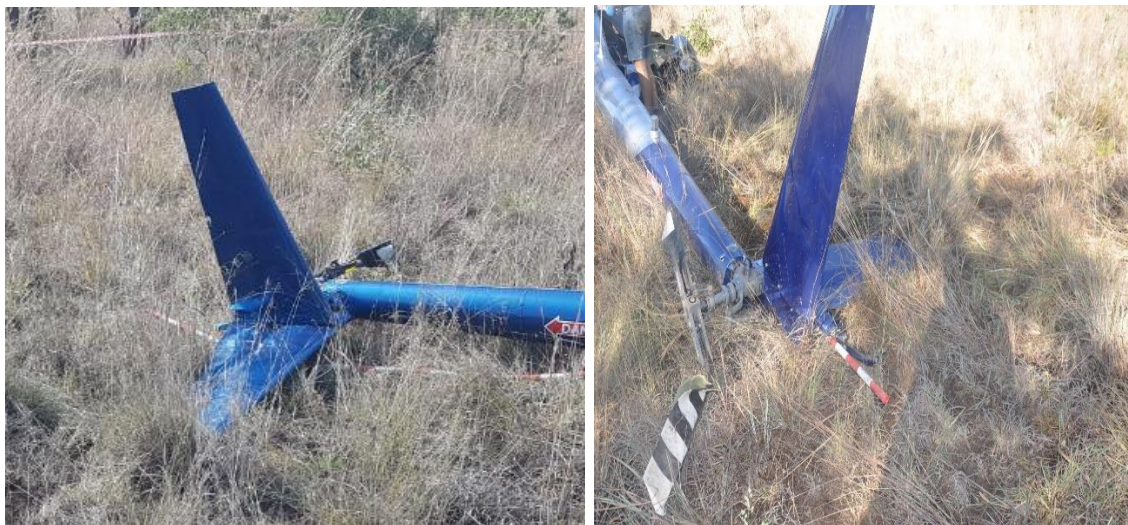
1.12.8 The tail gearbox was still intact, had freedom of movement and did not reveal any signs of overheating. One of the tail rotor blades revealed signs of high rotation impact with the ground and it sheared off from the root as seen in Figures 16 and 17. The tail fin and horizontal stabiliser had impact compression loads, indicative of contacting the ground. The tail rotor guard was crushed and flattened, indicative of high RoD.

Figure 16 & 17: Images show broken tail rotor blade and a damaged horizontal stabiliser.

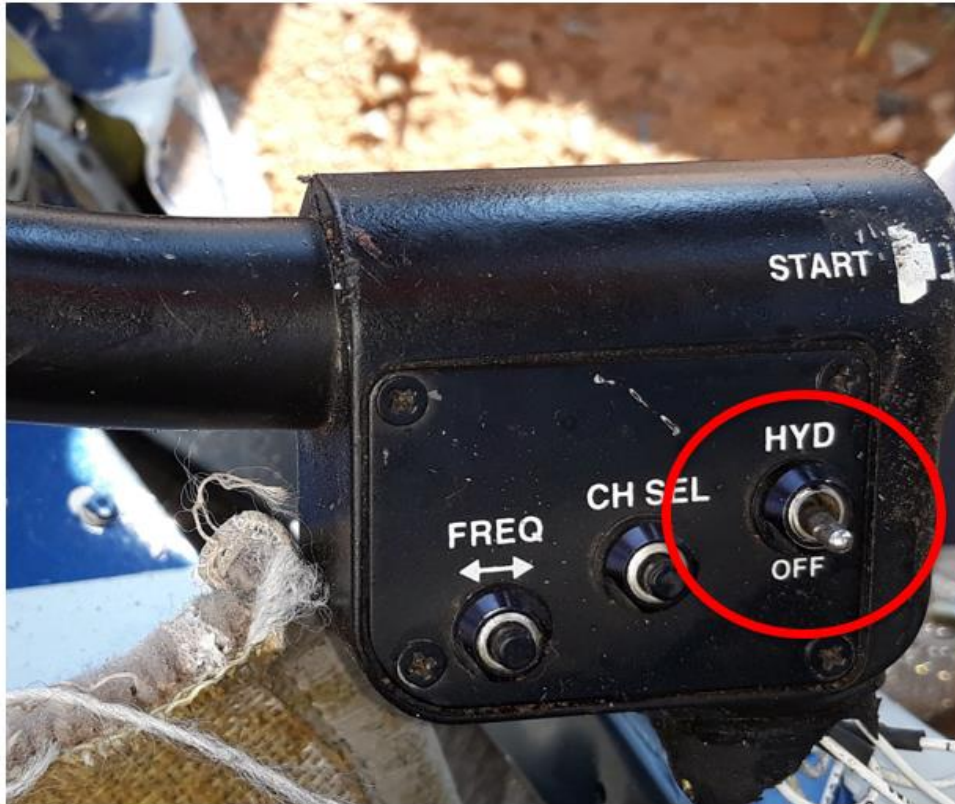
1.12.9 The position of the hydraulic switch was found in an off position after the accident. It is possible that it might have been moved during the recovery process.

Figure 18: Shows a hydraulic switch

- 2.2.6 The hydraulic switch was found in an off position after recovery of the helicopter. If the switch had been off during flight, it would have been difficult to operate the helicopter and the pilot would have landed on the road. It is unlikely that the pilot moved the hydraulic switch to the off position.

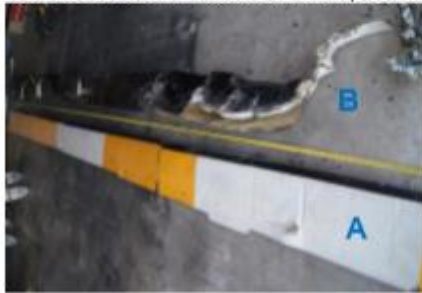
The visual inspection revealed the Main Rotor Blades (Blade A Serial No 5699, Blade B Serial No 5688, Part No's C016-5) to be in a conspicuously contrasting post-impact condition (Combined Pictures 1 and 2, Photo 5).

Photo 5: MR Blades A and B (digital)

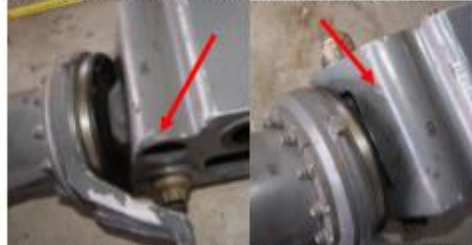
The Main Rotor Hub assembly revealed severe impact damages (Photo's 7 and 8, red arrows). Although it could not be conclusively confirmed, the severity of the damages can most probably be attributed to impact forces and not in-flight fluctuations of the assembly

Photo 7: Impact damages to MR Hub assembly (digital)

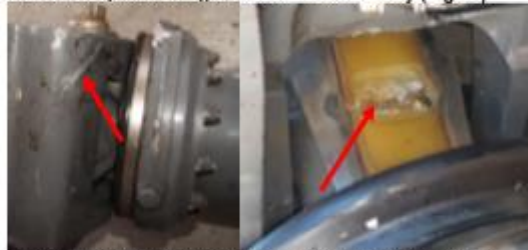
Photo 8: Impact damages to MR Hub assembly (digital)

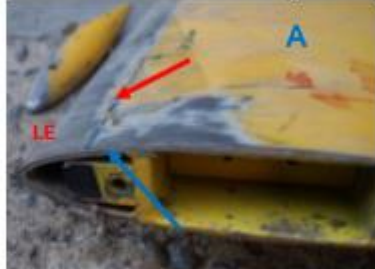
Section 1, Top Side: No clear indications of LE impact damages except slight scraping marks were noted (Photo 10). Following the removal of the Blade Tip Cover, no clear indications of blade skin debonding were detected as per RHC SB-72 (Photo 11, blue arrow, Extract 1). No indications of blade skin debonding were noted at the skin/main spar bond-line (Photo 11, red arrow).

Photo 11: Blade A, blade tip, cover removed (digital)

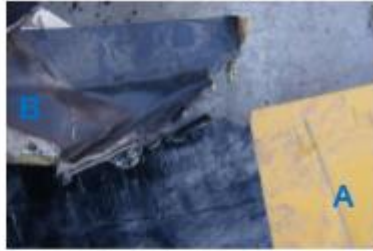
Section 1, Bottom Side: Clear scraping marks were noted (Photo 14) indicating rotation on impact, albeit at an angle supporting impacting with hard ground while in a (forced) downward orientation relative to the position of the MR Hub assembly at the moment of impact. No indications of blade skin debonding were noted at the skin/main spar bond-line.

Photo 14: Blades A and B, impact scraping marks (digital)

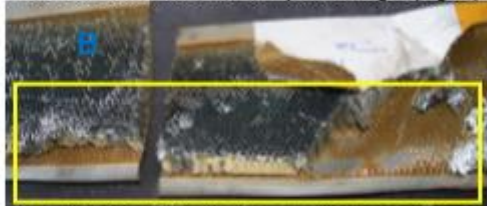
Section 2, Top Side: A large segment of the top side blade skin separated (Photo 16) as well as the Main Spar segment from this section. The damage attributes to the now exposed honeycomb structure on the LE end (Photo 17, yellow square) suggest that the top side blade skin remained attached to the Main Spar during the failure sequence while the bottom blade skin separated from it.

Photo 17: Blade B, Section 2, impact damages to honeycomb structure, loss of skin (digital)

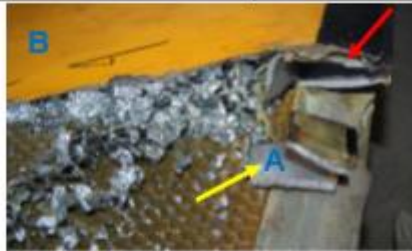
The Main Spar fracture surface revealed no clear indications of pre-impact fracture initiations and/or other discrepancies.

Photo 19: Main Spar fracture surfaces, Blades A and B (digital)

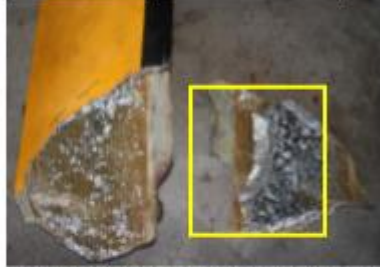
Damages to the inner honeycomb structure (Photo 20, yellow square) suggest that the Main Spar was still in relative position, albeit fractured as discussed above, on final impact.

Photo 20: Blade B, Section 3, impact damages to honeycomb structure (digital)

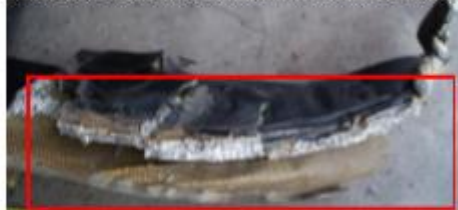
The remainder of section 1 proved to be extensively impact damaged (Photo 15). No clear indications of scraping marks were noted.

Photo 21: Blade B, Section 1, impact damages (digital)

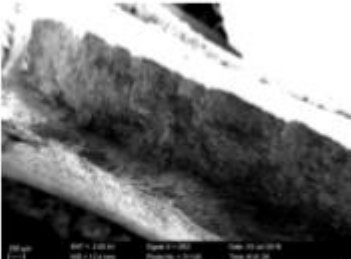
Inspection at higher magnifications of the Main Spar fracture surfaces revealed no clear indications of pre-existing fracture or other material discrepancies (Fractographs 1, 2, 3 and 4).

Fractograph 1: Overload fracture morphology (x120, SE2, FESEM)

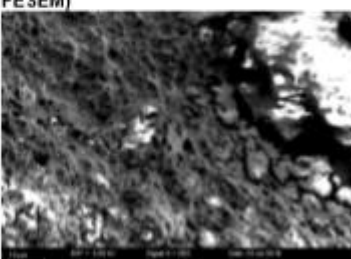
Fractograph 3: Ductile surface morphology (x1500, SE2, FESEM)
