AIRCRAFT ACCIDENT REPORT AND EXECUTIVE SUMMARY

Reference:	CA18/2/3/9722	
Aircraft Registration	ZS-BRV	Date of Accident	10 July 2018		Time of Accident	1451Z
Type of Aircraft	Convair 340/440		Type of Operation	Private (Part 91)		
Pilot-in-command Licence Type	Validated Australian PPL		Age	65	Licence Valid	Yes
Pilot-in-command Flying Experience	Total Flying Hours		18240.5		Hours on Type	63
Last Point of Departure	Wonderboom Aerodrome (FAWB), Gauteng Province					
Next Point of Intended Landing	Pilanesberg Aerodrome (FAPN), North West Province					
Location of the accident site with reference to easily defined geographical points (GPS readings if possible)						
The accident occurred approximately 1 kilometre east of the N4 highway in Derdepoort industrial area, and approximately 5.78 kilometres to the east of FAWB Aerodrome. Geographical position was determined to be S26°67.031" E028°28.461" at an elevation of approximately 4095 feet above mean sea level (AMSL).

Reference Number : CA18/2/3/9722
Name of Owner/Operator : Rovos Rail
Manufacturer : General Dynamics
Model : Convair 340/440
Nationality : South African
Registration Marks : ZS-BRV
Place : Wonderboom Aerodrome
Date : 10 July

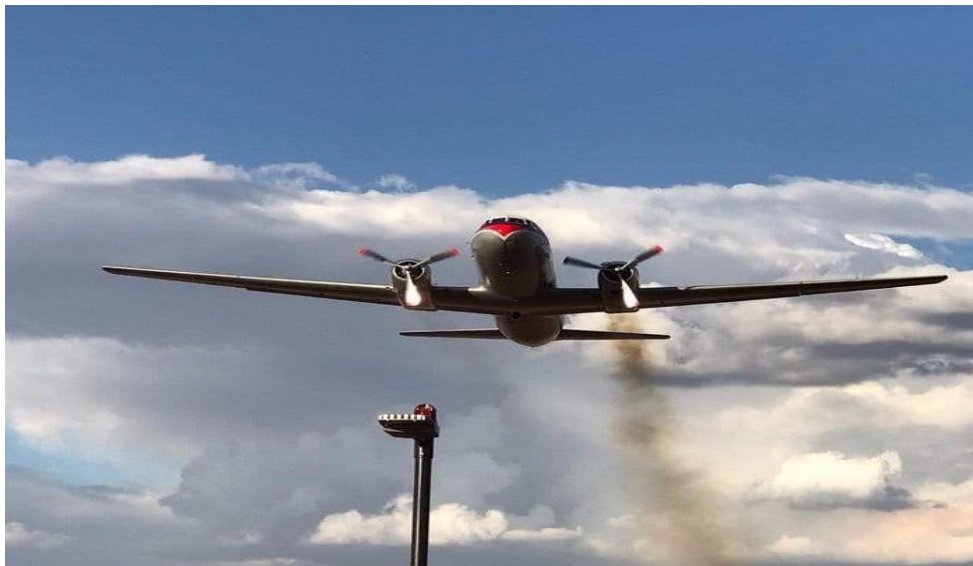
Figure 1: The aircraft with black smoke trailing from the left engine/No 1 engine.

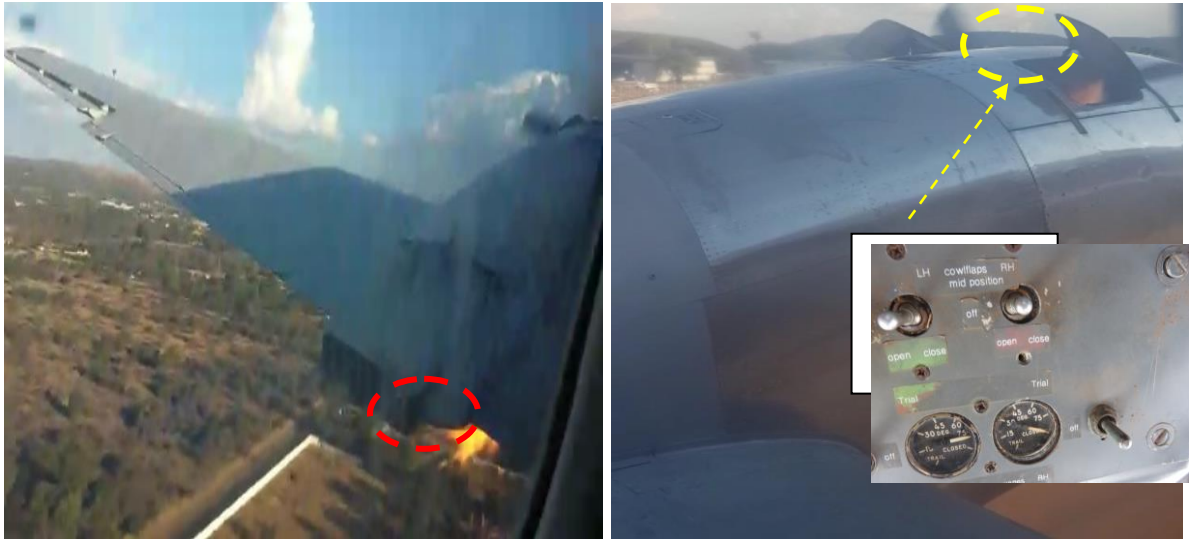
Figures 2/3: Images of the left wing and engine taken from the cabin. The image circled in red (left) shows the fire trailing underneath the left wing. The one circled in yellow (right) shows fire emanating from the left engine (No 1) compartment with the cowl flaps in the open position.

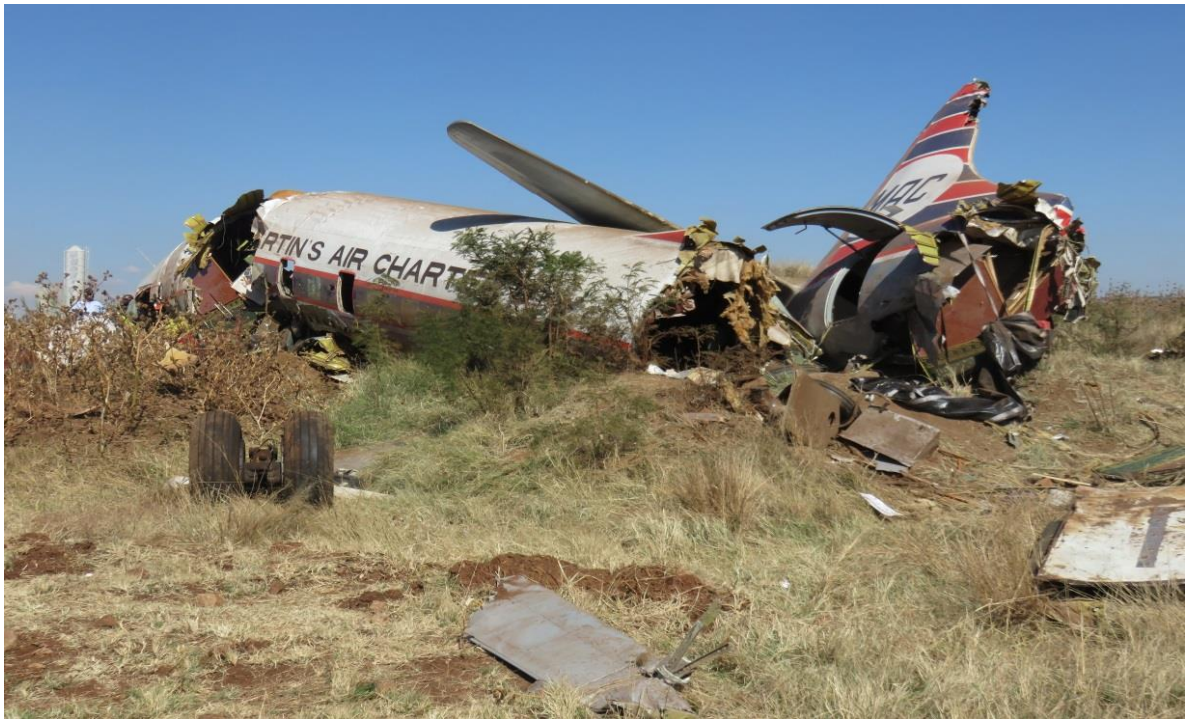
- 1.3.1 The aircraft was destroyed on impact. The in-flight left engine fire caused damage to the left wing and the post-impact fire caused damage to the right main gears and right engine. See Figure 5.

Figure 5: ZS-BRV wreckage as found at the accident site.

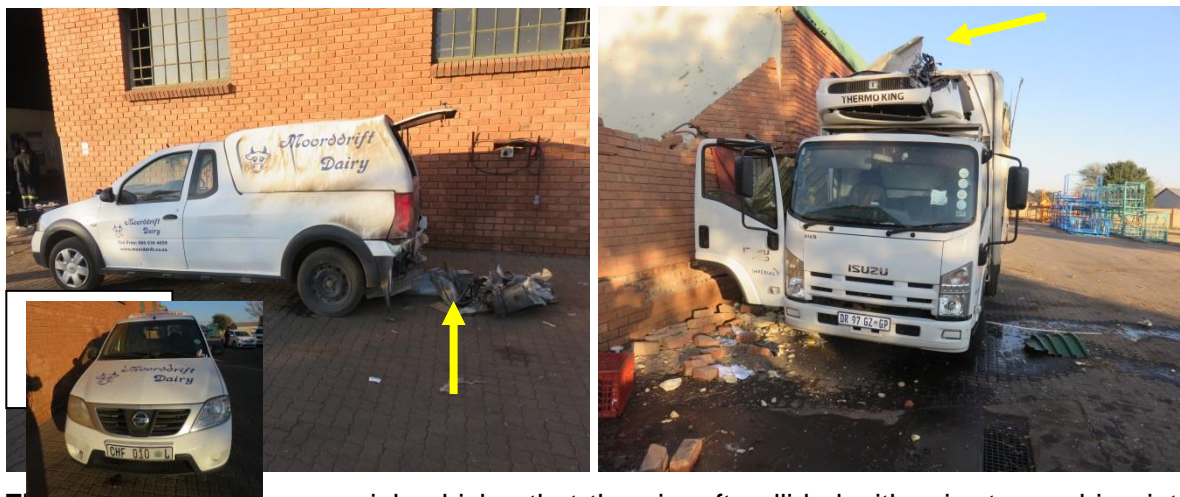
1.4.1 Damage was limited to the power lines that spanned parallel to Sakabuka Street, two commercial vehicles and the factory building. See Figures 6 and 7.

Figures 6/7: Two commercial vehicles that the aircraft collided with prior to crashing into the warehouse. The left image shows pieces of the left wing. The vehicle on the right sustained substantial damage to the freezer.

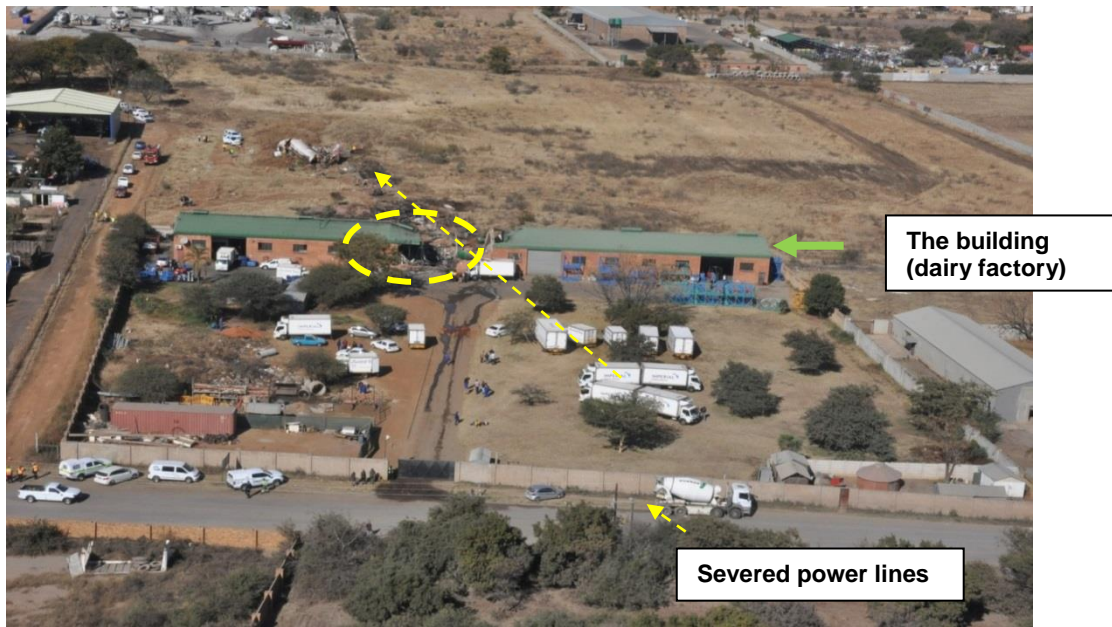
Figure 8: Reconstruction of the aircraft flight path and its final position. The picture shows damage caused to the factory building (circled in **yellow**) during the accident sequence.

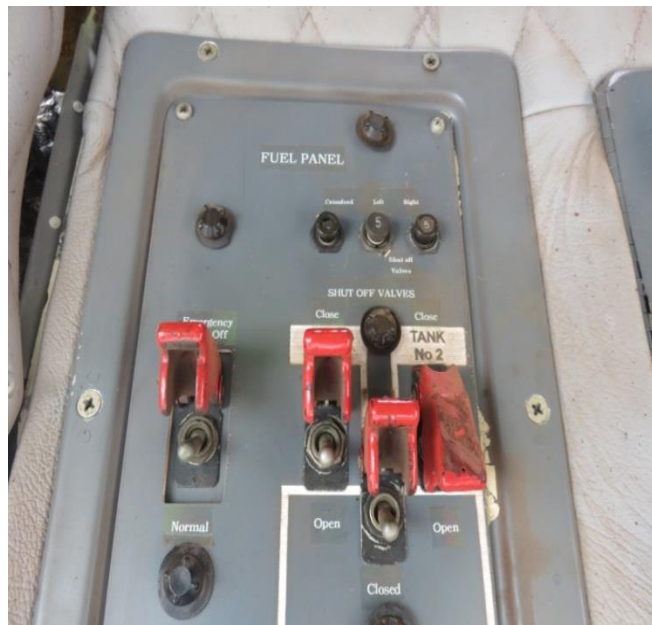
Figure 11: The fuel panel as it was recovered from the accident site.

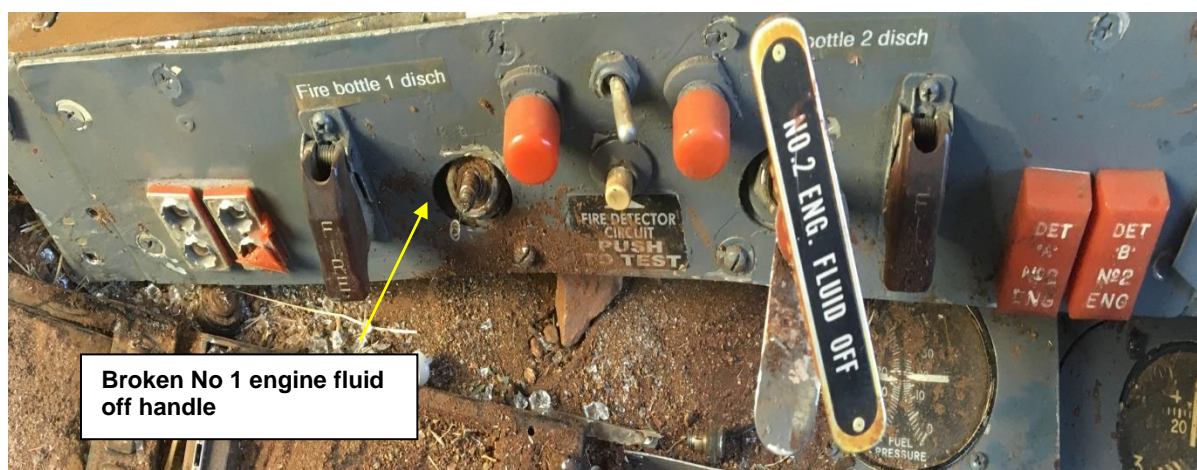
Figure 12: The engine fire extinguisher control panel showing all four unit-detector lights and a broken ‘fluid off’ handle.

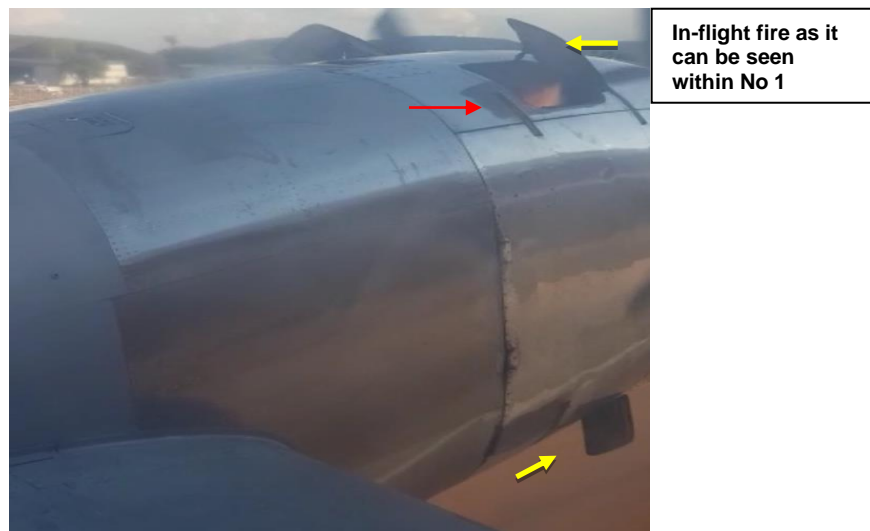
Figure 13: An in-flight captured photo of the No 1 engine cowl flaps in an open position.

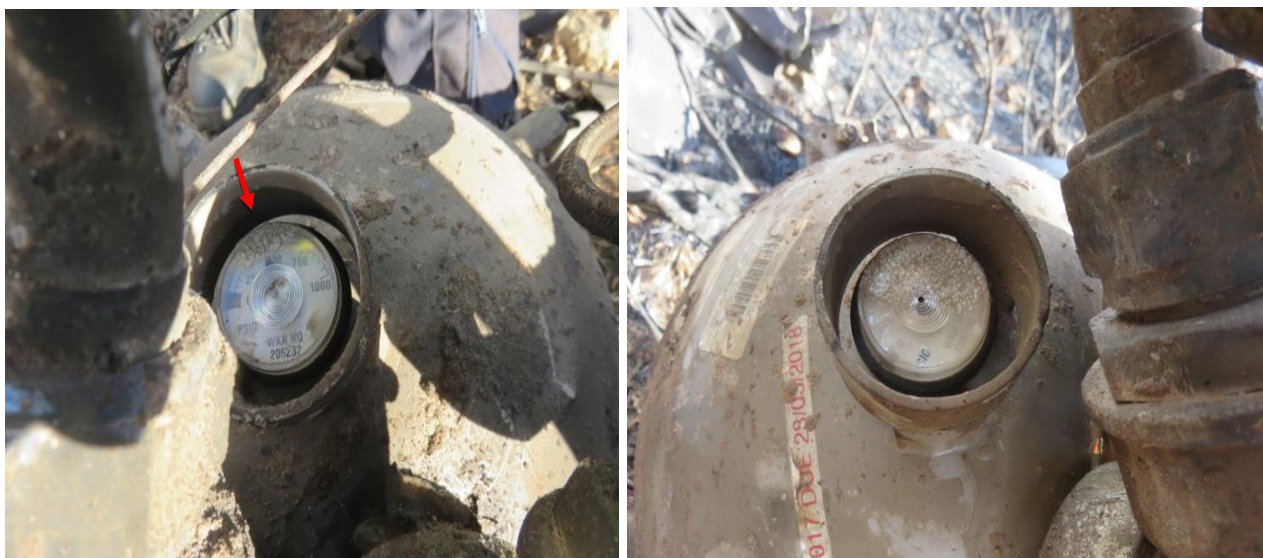
Figure 14: The condition of the fire extinguisher bottles as found at the accident site. The gauge on the left-hand side reads '500psi' and the other gauge was unreadable and heavy, indicating that it contained the fire-extinguishing agent that was never used. This was an indication that both bottles were never discharged. In addition, two fire-extinguishing system discharge switches were in the 'off' and guarded position (refer to Figure 12 above), confirming that the crew neither activated nor discharged either of the fire-extinguishing systems.

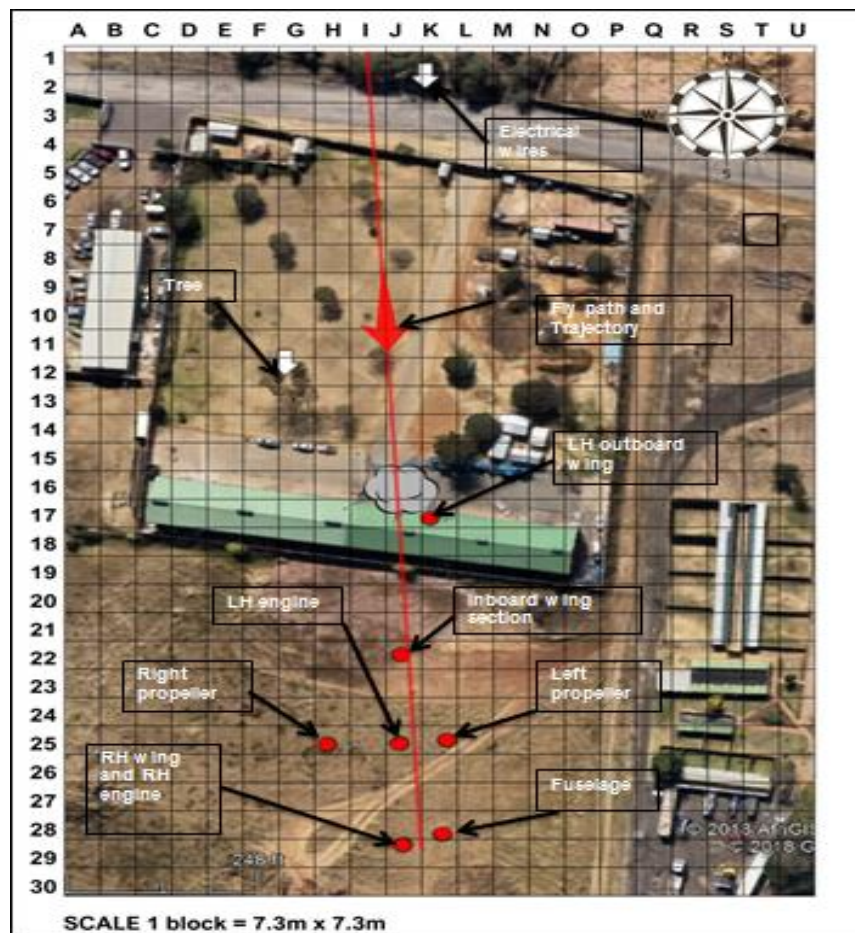
- 1.12.4 Figures 18, 19 and 20 illustrate the aircraft wreckage mapping and damage caused to the dairy farm building.

Figure 18: The aircraft wreckage mapping.

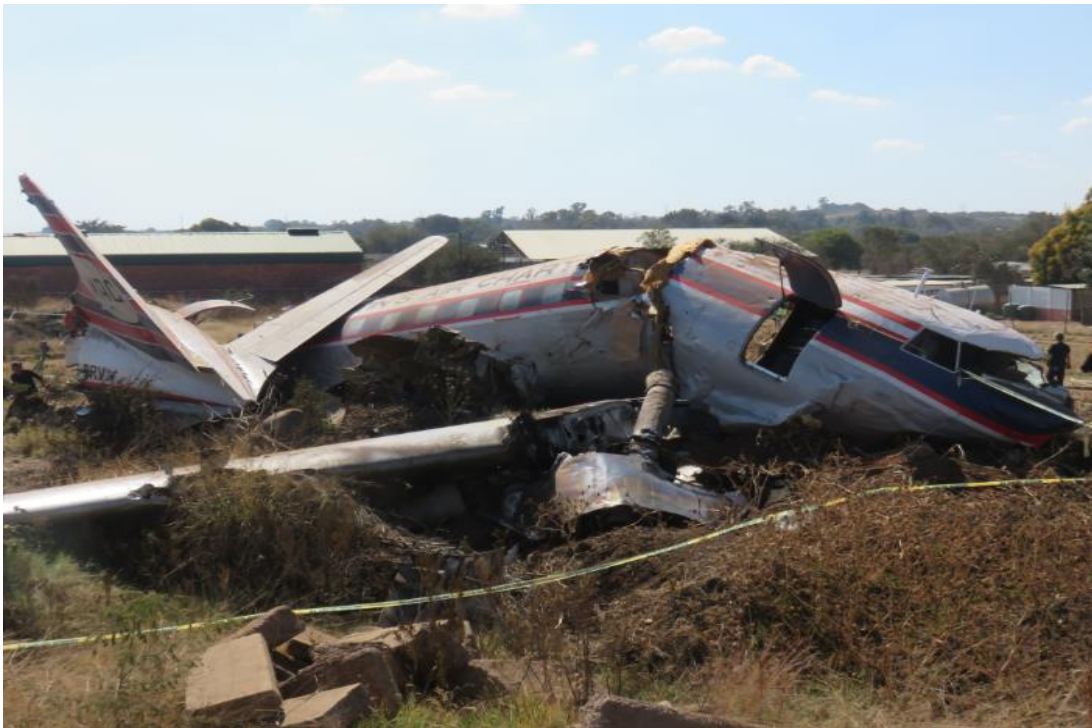
Figure 19: The nose, centre and aft section of the aircraft.

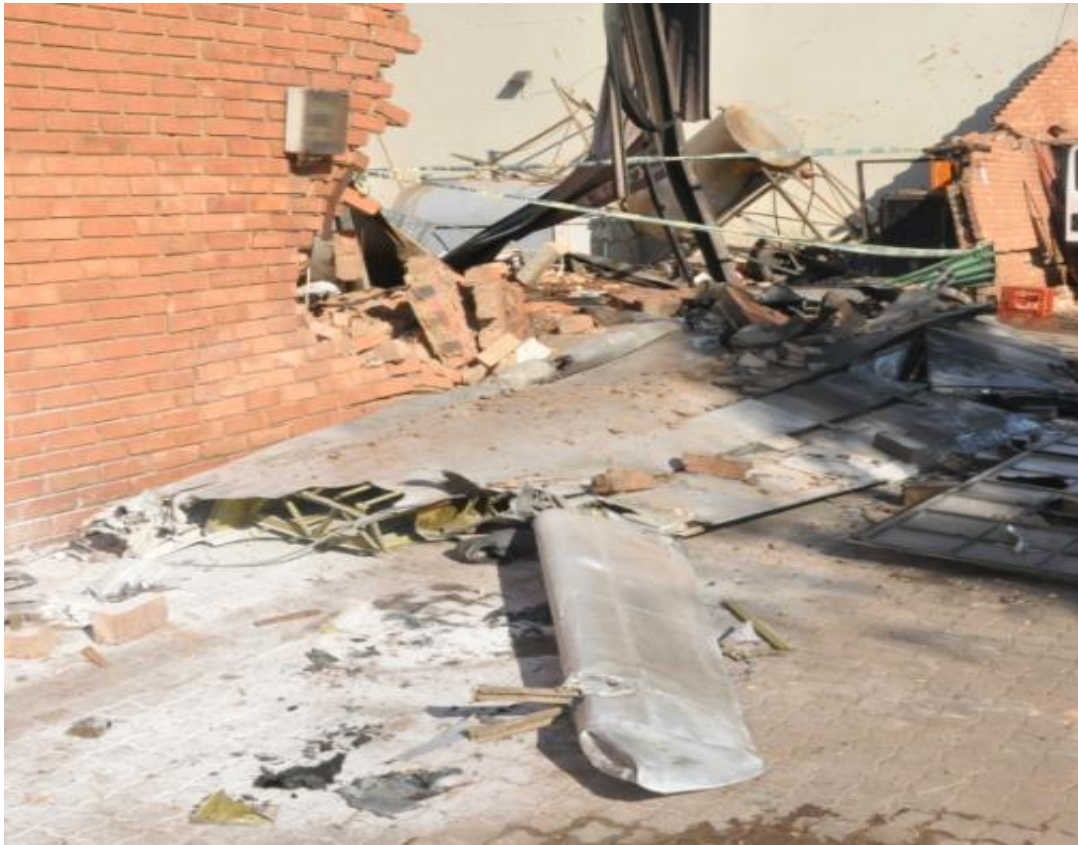
- 1.12.2 This resulted in the left wing out-board section separating from the fuselage and the building severely damaged during the accident sequence.
- 1.12.3 The left wing in-board section caught fire during the accident sequence and continued burning until the fire was extinguished by emergency and fire personnel who arrived at the scene of the accident immediately after the crash. The fire-extinguishing bottles, the left propeller and left engine were found on the left side of the wreckage path at 156 metres, 160 metres and 172 metres, respectively. The right propeller was found to the right of the flight path at 168 metres. The left main gear assembly was located at 230 metres to the left of the flight path, while the main wreckage, right wing and engine were found 250 metres further on, where the wreckage came to rest facing 192 degrees magnetic. See Figures 18 to 26.

Figure 20: The left wing out-board section and part of the building damaged by the aircraft during the accident sequence.

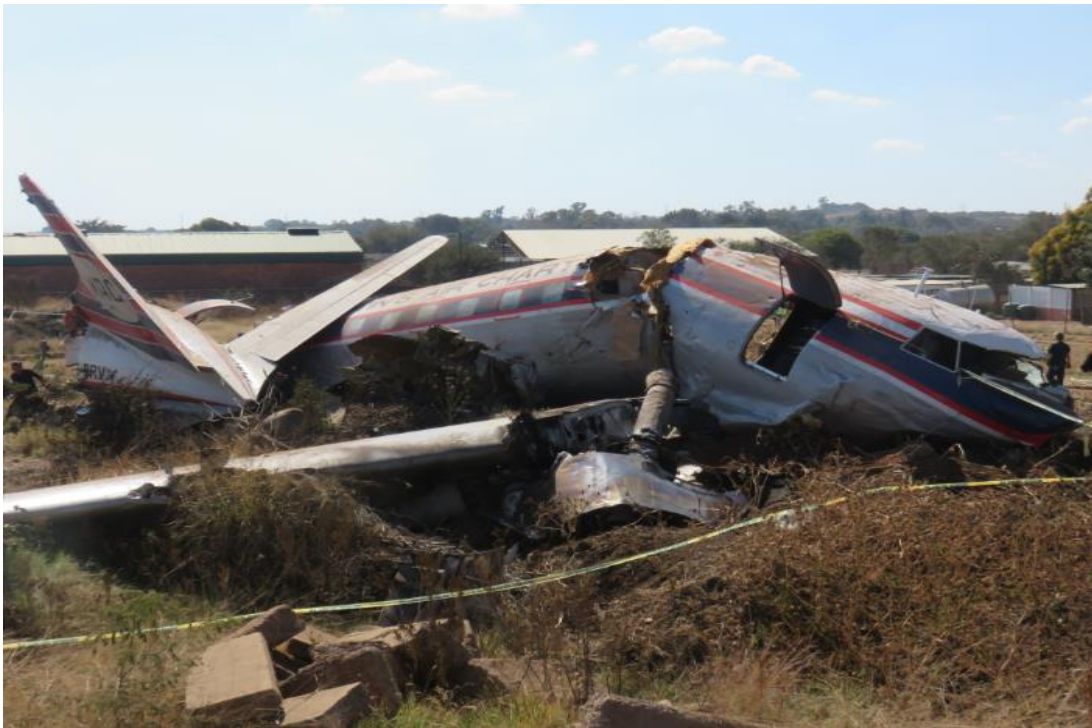
1.12.5 The empennage was separated from the mounts of the centre section. The empennage swung open to an angle of approximately 110° to the right and it was detached from the centre section. The vertical stabiliser exhibited damage on the leading edge. The right horizontal stabiliser was still intact. The left horizontal stabiliser separated as a result of impact with the building and was located at grid station L19. The day after the accident while the investigation team was examining the wreckage at the accident site, they heard a beeping sound coming from the aft section of the aircraft. It was later identified as an emergency locator transmitter (ELT) and it was switched off.

Figure 21: The aft section of the aircraft had separated from the fuselage.

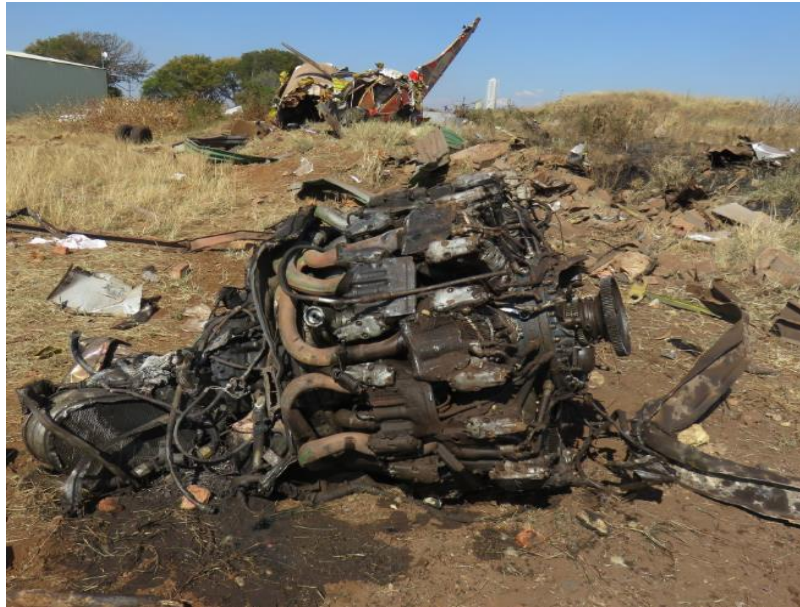
1.12.6 The left-hand engine was located just behind the fuselage at grid station J25. The engine exhibited fire damage signatures near the carburettor. The accessory gearbox had broken off from the housing assembly. The left three-bladed propeller had broken off from the gearbox and was located at grid station K25. The first blade was missing, the second blade had disintegrated from the mid-section, while the third blade was fairly intact. The damage observed on the propeller blades was indicative of damage caused during the running of a low-powered engine. The exhaust tubes were still secured on the centre section of the wing. The exhaust exhibited damage caused by an in-flight fire and had signatures of overheating and discolouration.

Figure 22: The left-hand engine as it came to rest.

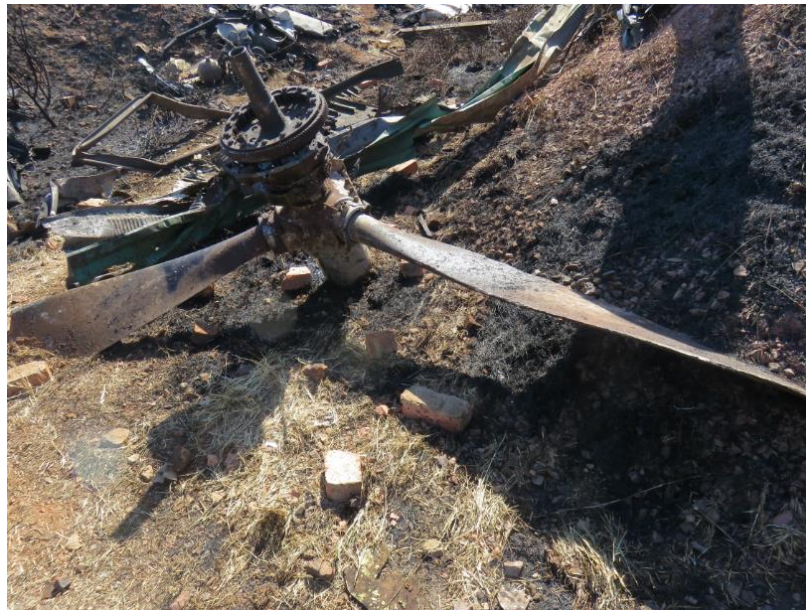
Figure 23: The left-hand propeller.

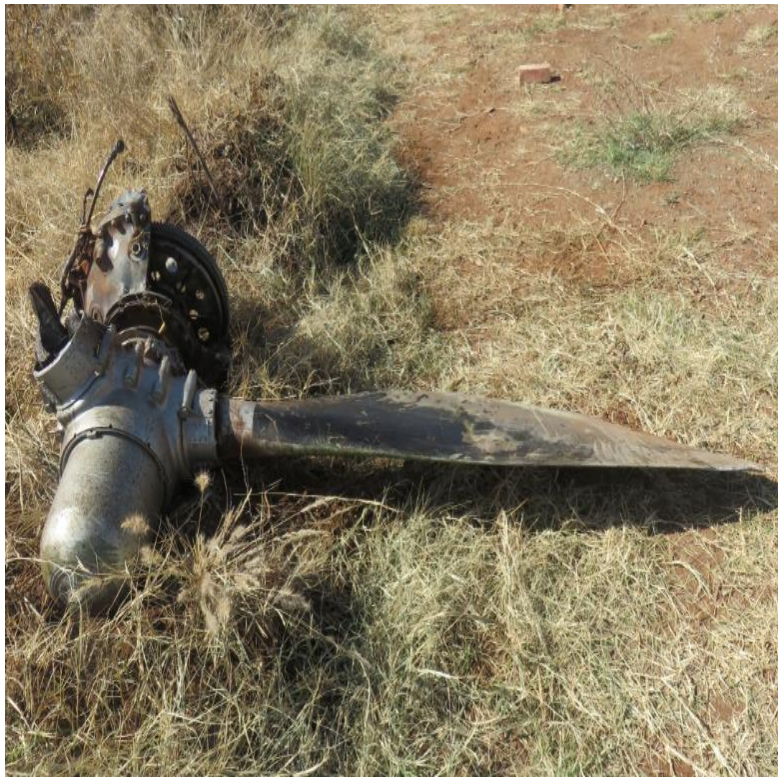
Figure 24: The right-hand propeller as it came to rest.

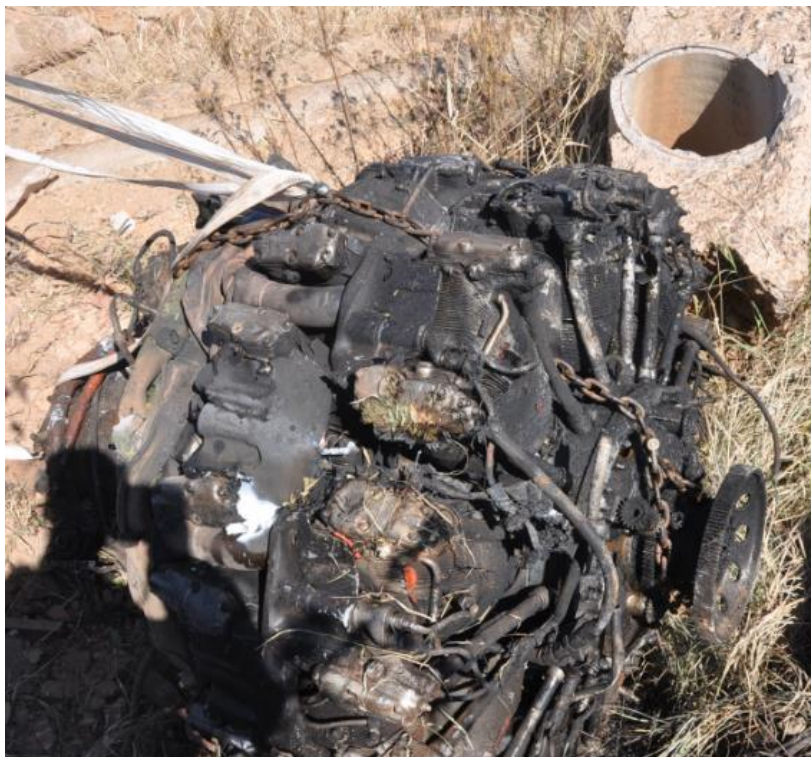
1.12.7 The right-hand engine was located near the leading edge towards the tip of the right wing. The engine exhibited signs of post-impact fire as observed on the scene. The right-hand propeller had broken off from the gearbox housing and was located at grid station H25. The propeller exhibited signs of damage caused when a rotating object struck an obstacle while at full power. The propeller only had one blade attached to it. The other two blades had broken off from the root. One of the propeller blades was located in the same grid station across grid station L24. The exhaust ducts were located near the right wing.

Figure 25: The right-hand engine as it came to rest with black soot indicating exposure to fire.

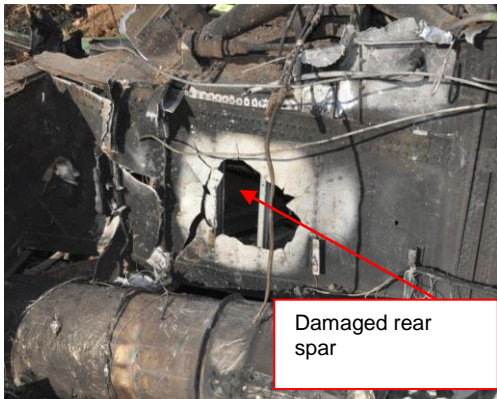
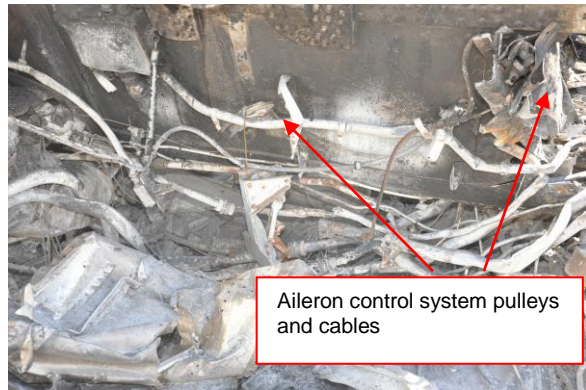
1.12.8 The images below show the damaged rear main spar and the aileron pulley attachment brackets because of the fire that came from the left engine. The pulley attachment brackets were found detached from the spar with slacked cables.

Figure 26/27: Images showing fire damage on the left-wing rear spar and pulley attachment brackets separated from the spar with its pulleys and the cables.

2.5.7 The aircraft made another right turn (base leg) while losing height. It continued in that trajectory and the PF lost aileron control. This occurred due to the weakening of the left-wing rear spar because of fire damage that caused the attachment rivets of the aileron cables to melt, resulting in the cables being slack and, thus, loss of aileron control. The loss of aileron control led to the crew losing control of the aircraft and the aircraft colliding with power lines before impacting the factory building.

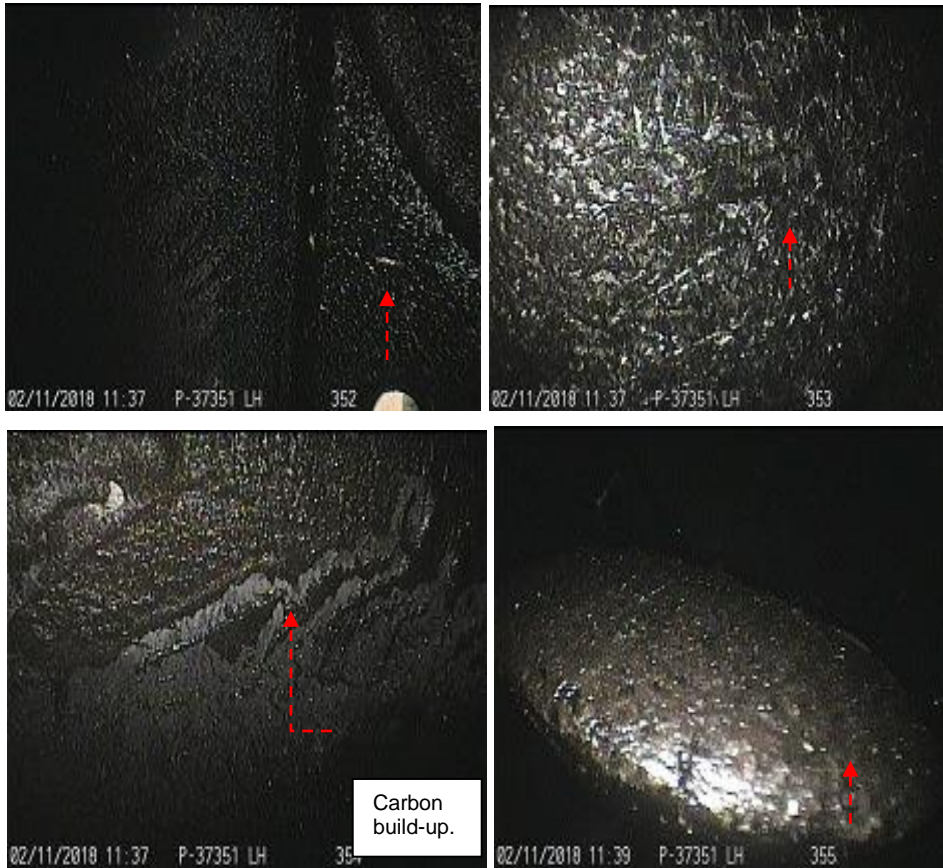
1.16.3 Following the recovery of both engines and propellers from the accident site, the No 1 engine S/N P-37351 was subjected to a borescope inspection procedure. The borescope inspection found that cylinder No 13 had piston damage and carbon build-up on the valves. See images of the piston crown – Figures 29-32.

Figures 29/30/31/32 Show the piston crown of cylinder No 13 taken during the borescope inspection.

1.16.10 The engine No 1 manifold pressure drop, as reported by the crew during the take-off roll, was the result of the No 13 cylinder damaged piston crown, piston rings and fractured No 7 cylinder exhaust valve head which subsequently caused backfiring.

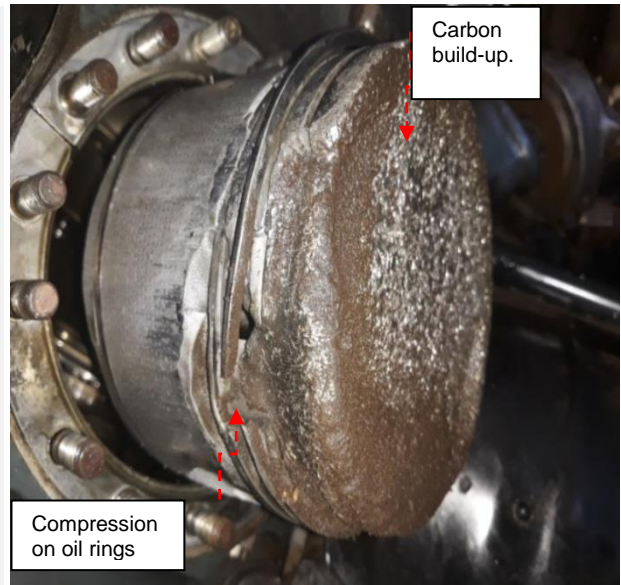
Figures 33/34: A sketch of components and terminology of engine operation and an image of the No 1 engine's cylinder No 13 piston displaying damaged compression and oil control ring packs and hard carbon on the piston crown.

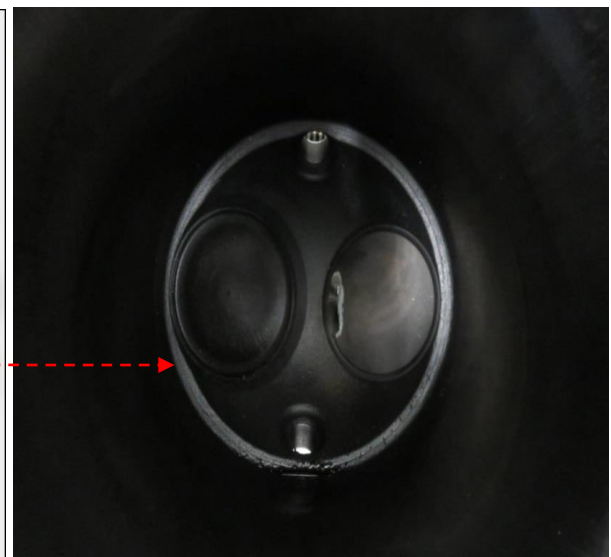
1.16.8 After the removal of the No 7 cylinder, the exhaust valve (P/N: 331107) head was found to be fractured. Further examination indicated that the inlet and the exhaust valves return springs and rocker arms were intact and in good condition. The No 7 cylinder cooling fins/plate (valve housing) had damage on the side wall.

Figures 35/36: On the left is the 18 double-row, air-cooled Pratt and Whitney R-2800 radial engine and on the right is an image of the No 7 cylinder combustion chamber, showing a fractured exhaust valve head.

- 2.5.3 The engine No 1 manifold pressure drop, as reported by the crew during the take-off roll, was the result of a fractured No 7 cylinder exhaust valve head which subsequently caused backfiring. This explains the flames by the engine cowl flaps above the cowling.

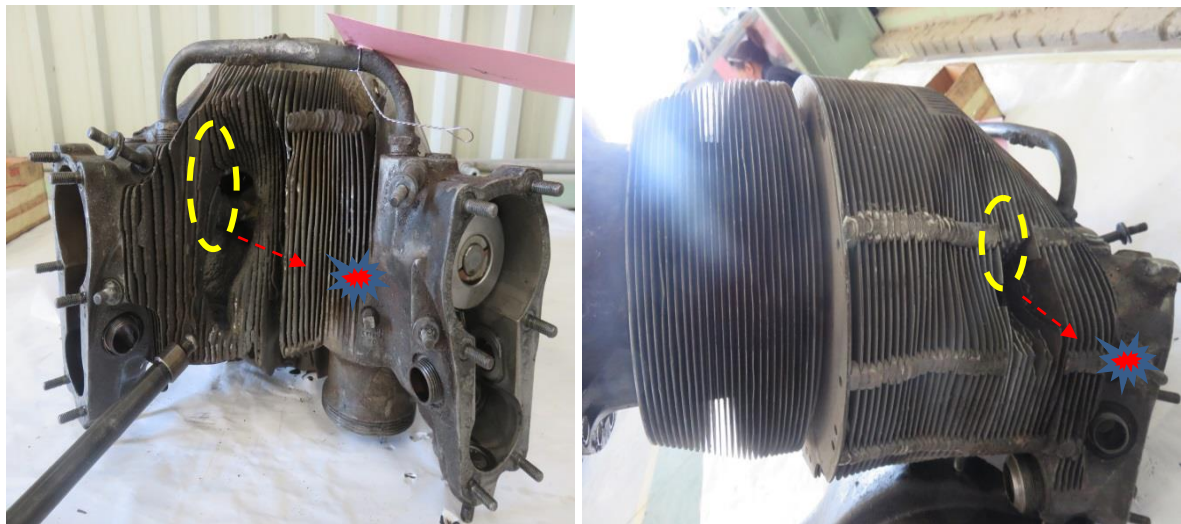
Figures 37/38: Cylinder No 7 showing the hole where the fire escaped.

- 2.5.11 The failure of the No. 7 cylinder exhaust valve led to the cylinder cooling fins overheating, thus, causing the failure of the cylinder housing.

- 2.5.13 The fire started in the left engine and evidence showed that the No 7 cylinder was the one with the most damage and was the source of the left engine fire. The fire continued burning through a hole on the No 7 cylinder, causing damage to the front wing spar and the left aileron pulley attachment point, melting the attachment rivets. As a result, the left aileron control cables slacked and the aileron deflected slightly up. With the left engine operating at partial power due to damage and failure of cylinder number 7, the aircraft started rolling to the left. The opening of the left engine cowl flaps in-flight increased the intensity of the engine fire and the left roll.

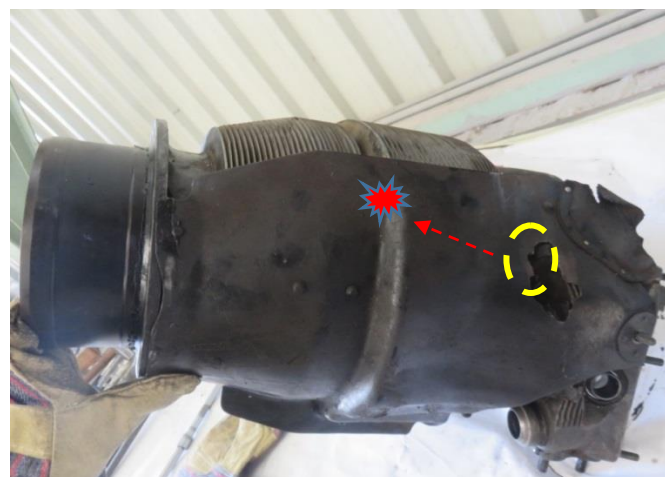
Figure 39: An image of the No 7 cylinder showing the fire damage on the exterior through the cooling fins and the plate.
