<b>AIRCRAFT ACCIDENT SHORT REPORT</b>
---------------------------------------

**CA18/2/3/9724** : Incorrect approach resulting in a hard landing

**Aircraft registration** : ZS-PYG

**Aircraft manufacturer and model** : Robinson Helicopter Company, Raven II R44

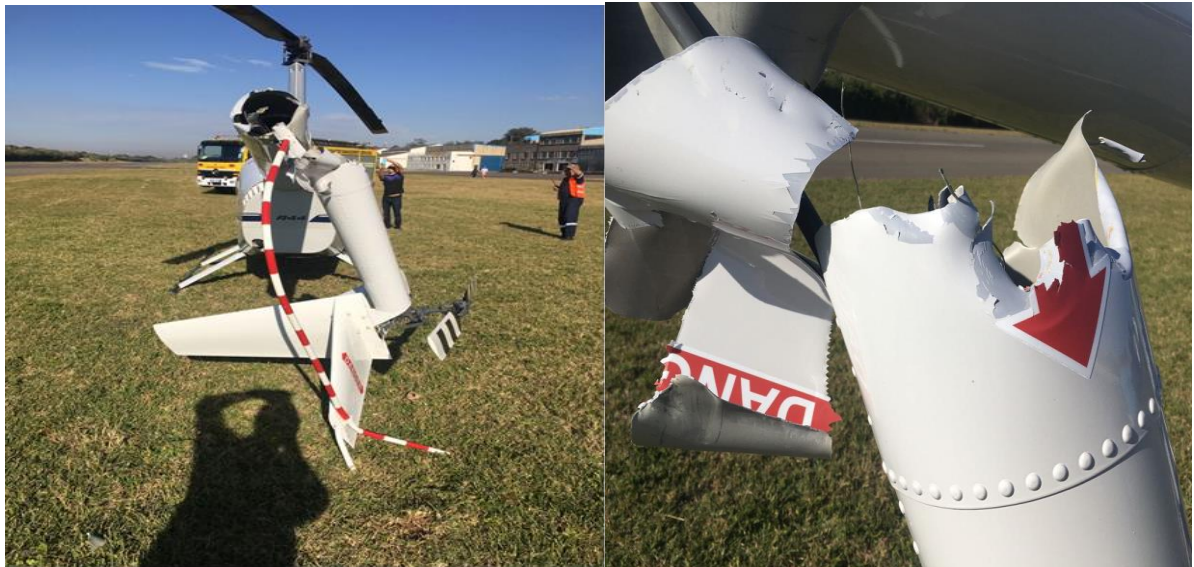
1.2 The investigation revealed that the pilot was unable to arrest the rate of descent due to the power available being at maximum resulting on hard impact with the ground.

2.3 The helicopter sustained damage to the main rotor blades and the tail boom. None of the four occupants sustained injuries.

**Figures 1 & 2: Damage to the tail boom**

- 4.3 The helicopter's mandatory periodic inspection (MPI) was last carried out on 2 June 2018 at 3350.5 hours. The aircraft had a total of 3385.3 hours at the time of the incident and had flown a total of 34.8 hours since the last MPI.
- 4.4 The weather conditions were fine at the time of the occurrence.
- 4.5 The helicopter's weight and balance were within limits.
- 4.6 The helicopter landed hard and the main rotor blades severed the tail boom.

- 5.1 Incorrect approach resulting in a hard landing

*The pilot has been briefed on a possibly better approach as well as limited power landings. We have advised a proficiency check of the following in order to familiarise herself and gain confidence before commencing her next commercial flight.*
