AIRCRAFT ACCIDENT SHORT REPORT

CA18/2/3/9725: ZS-RCY, Hard landing following a transition from a hover

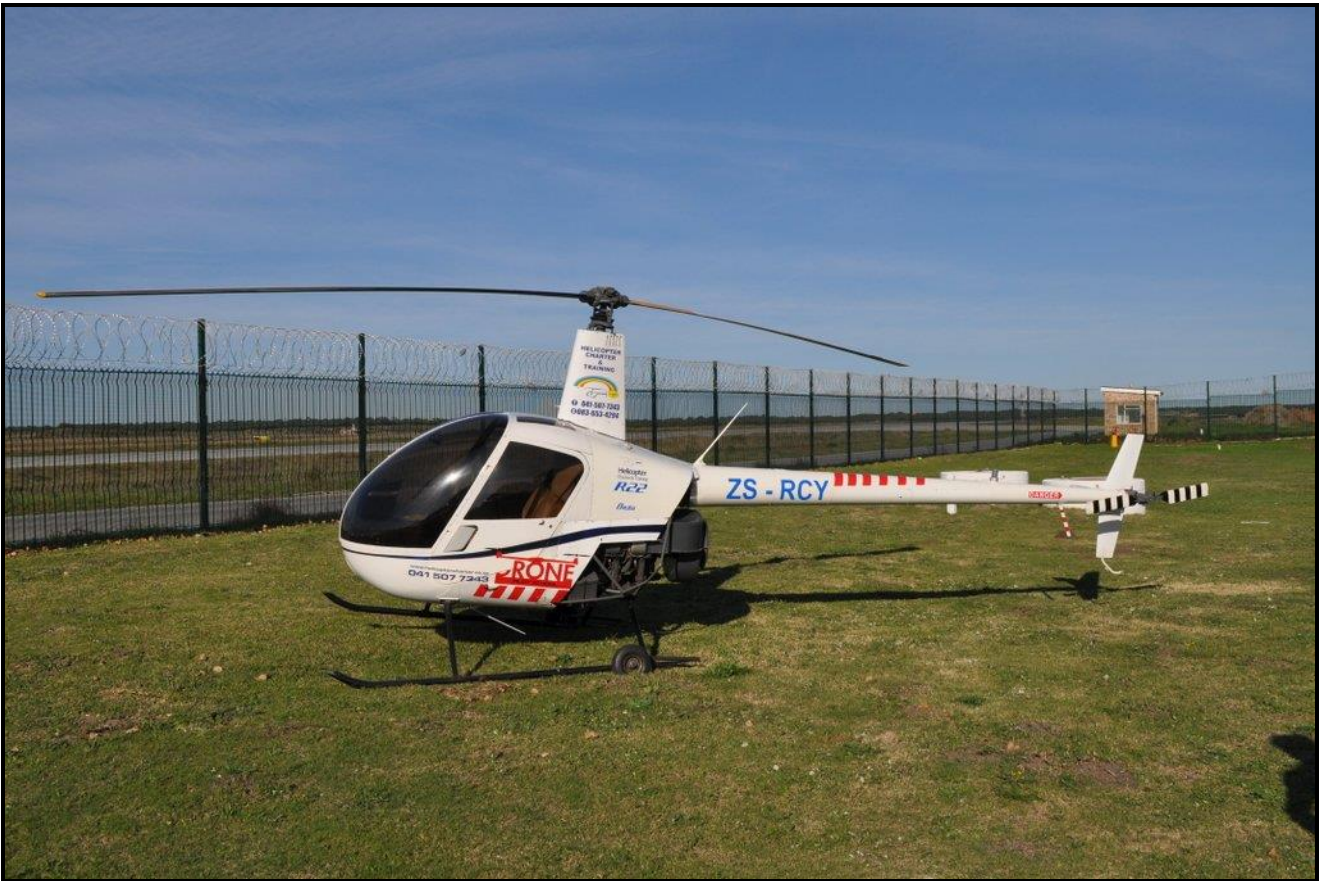
- 2.3 The helicopter sustained damage to lower left frame. The student pilot sustained no injuries.
- 2.4 The accident occurred during daylight conditions at a geographical position that was determined to be 33°59'14.51” South 025°36'26.38” East at an elevation of 220ft above mean sea level (AMSL).

Figure 1: Helicopter as it came to rest showing damage to the rear frame

- 5.1 The helicopter landed hard following a transition from a hover with insufficient left pedal input.

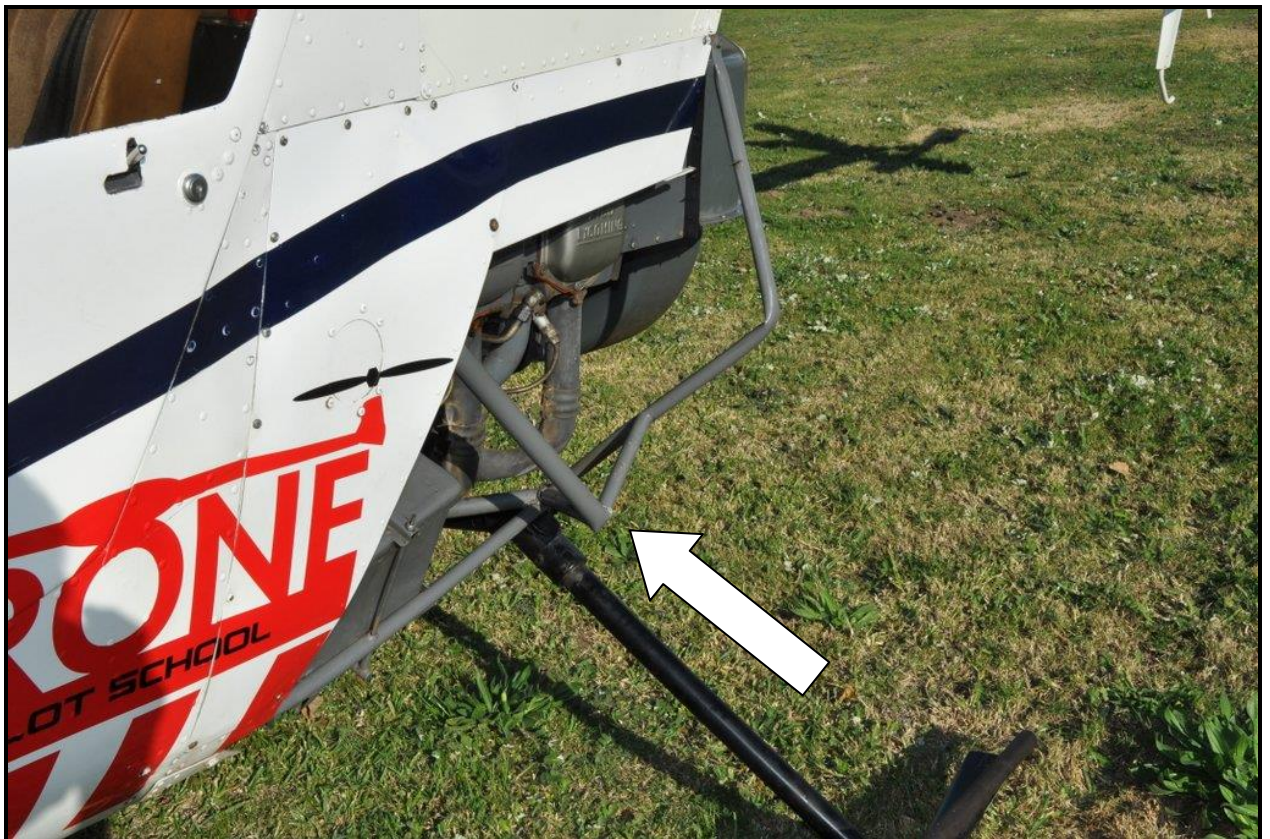
- 2.2 The student pilot lifted off into a hover to conduct solo transitions training. As he entered into transition from hover the helicopter yawed to the right and the rear part of the left skid impacted the ground hard. The student pilot immediately lowered the collective to put both skids on the ground.

Figure 2: Damage to the rear left frame
