### AIRCRAFT ACCIDENT SHORT REPORT

CA18/3/2/9728: ZS-OHN, Runway excursion (Overrun) during a touch and go

Aircraft registration : ZS-OHN

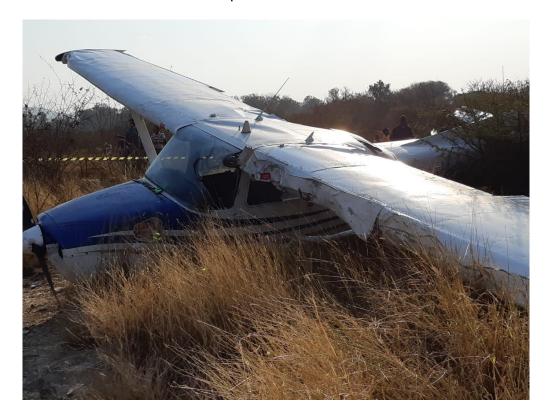
2.7 The aircraft sustained substantial damage to both wings, the propeller, the fuselage and the nose gear. The three occupants on-board sustained minor injuries. The aircraft flattened the aerodrome perimeter fence.

Figure 2: Damage sustained to the aircraft after the runway excursion

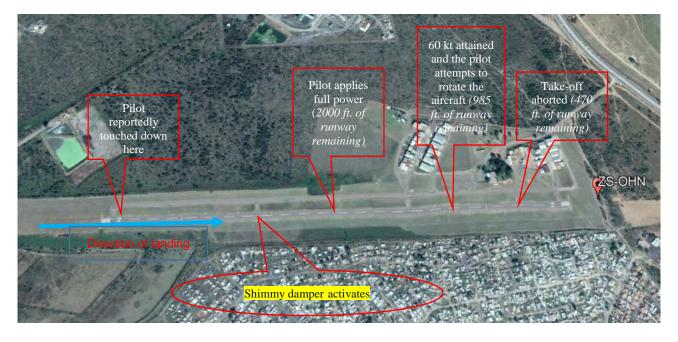
- 2.6 The stopping distance was insufficient and the aircraft burst through the aerodrome perimeter fence, which was approximately 80 m past the threshold of runway 16. The aircraft came to rest on a pile of domestic and building rubble that had been dumped there.

**Figure 3:** Direction of landing and final resting position of ZS-OHN. The above distances are approximates as supplied by the PIC

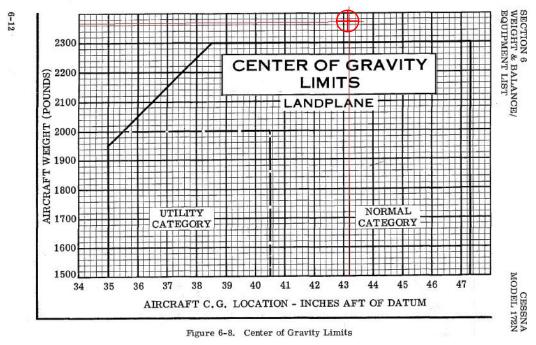
- 4.4 The corrected aircraft zero fuel weight was 2 122 lb. Therefore, the fuel uplift should not have exceeded 178 lb.
- 4.5 The aircraft departed FAWB with the maximum take-off weight, as stipulated in the POH of the C172N, exceeded. (Estimated take-off weight was ±2 352 lb.)

Investigation	Weight	Arm	Moment
	(lb)	(inches)	(in-lb)
Aircraft Empty Weight	1 517	39.98	60 649.66
Front Seats 1 & 2	368	37.00	13 616.00
Fuel (40 US gallons)	240	47.90	11 496.00
Rear Seats 1 & 2	227	73.00	16 571.00
Baggage Area 1	10	95.00	950.00
Gross Weight	2 362		103 283.00
Loaded Centre of Gravity		43.73

Figure 5: Actual Centre of Gravity position

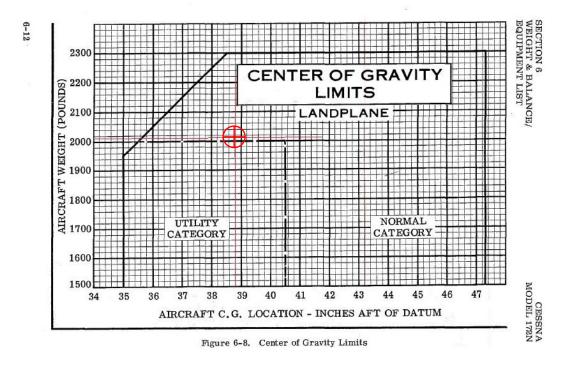
- 4.2 The pilot did not make use of the correct empty weight of the aircraft for his weight and balance calculation.
- 4.3 The passengers' mass used by the pilot in his weight and balance calculation was 136 kg (300 lb) in total. The actual weight of the two passengers was 188 kg (414 lb).

Pilot	Weight	Arm	Moment
	(lb)	(inches)	(in-lb)
Aircraft Empty Weight	1 460	37.40	54 604
Front Seats 1 & 2	300	37.00	11 100
Fuel (40 US gallons)	240	47.90	11 496
Rear Seats 1 & 2	0	73.00	16 571
Baggage Area 1	10	95.00	950
Gross Weight	2 010		78 150
Loaded Centre of Gravity		38.88

Figure 6: Centre of Gravity position estimated by the pilot

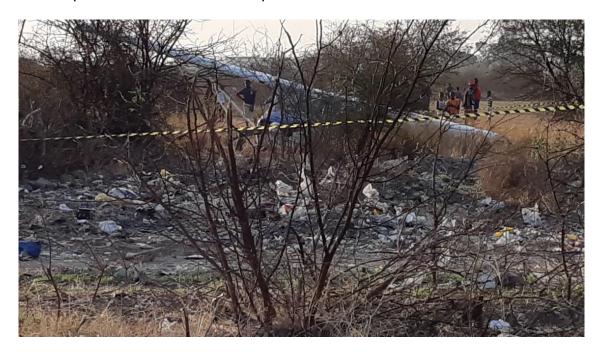
- 5.3 The aerodrome is licensed by the South African Civil Aviation Authority (SACAA), licence number 117.
- 5.4 After inspection of the pictures of where ZS-OHN came to rest, it was determined that a dumpsite exists on the outside perimeter of the aerodrome.

Figure 6: Dumpsite near the aerodrome

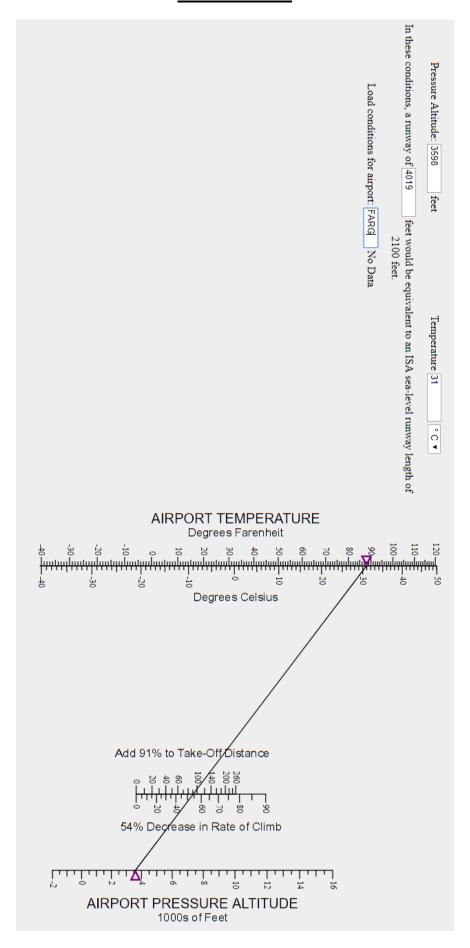
# **APPENDIX B**

3.13 The density altitude at the time of the accident was 6 210 ft. According to the Koch Chart, an increase of 91% of take-off distance was required in order to compensate for the higher density altitude. The take-off distance required was 385 m (1 265 ft.). With the density altitude correction, the take-off distance required would have increased to 736 m (2 417 ft.). (See Appendix B)

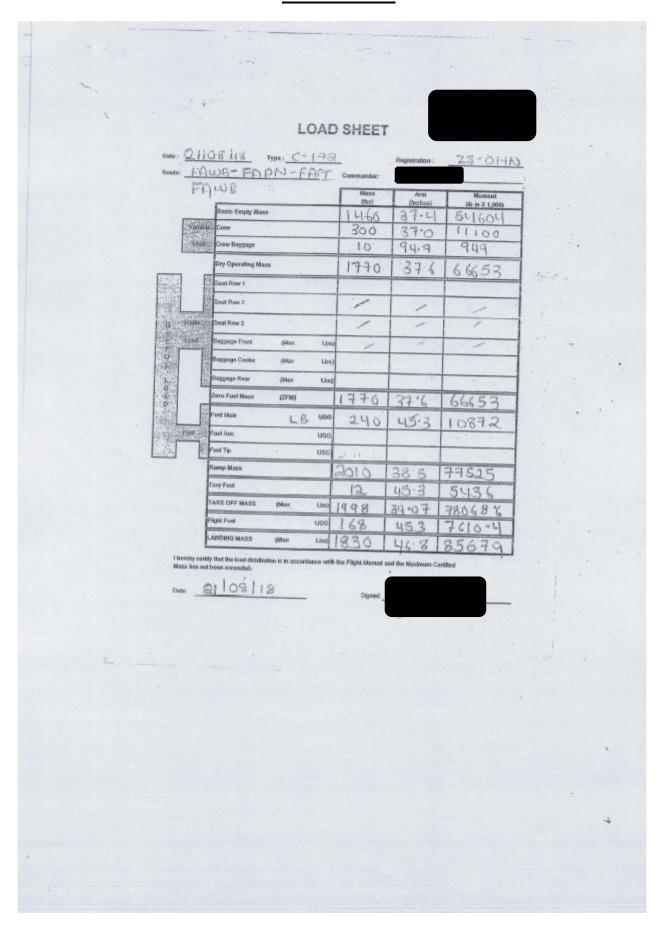
# **APPENDIX E**

- 4.1 The weight and balance calculation on the aircraft was carried out using a chart that was not approved by the ATO from which the aircraft was hired. (see Appendix E)

- 7.1 Aircraft overweight:
- 7.1.1 The aircraft was overweight at the time of landing at FARG. Following this, the pilot attempted an overweight take-off from FARG. The pilot had used the incorrect load sheet (See appendix E). If the pilot had used the electronic authorisation sheet (See appendix D), the pilot would have been notified that the operating limits of the aircraft were being exceeded.

12.1 The importance of doing an accurate weight and balance calculation prior to departure is imperative to the safe operation of the aircraft. Using figures, which are not accurate, or an assumption can place the aircraft outside it safe operating limitations.
