AIRCRAFT ACCIDENT SHORT REPORT

CA18/2/3/9731: ZT-RBF, Loss of power during a crop spraying operation

Aircraft registration : ZT-RBF

Aircraft manufacturer and model : Bell Helicopter Textron, Bell 206B

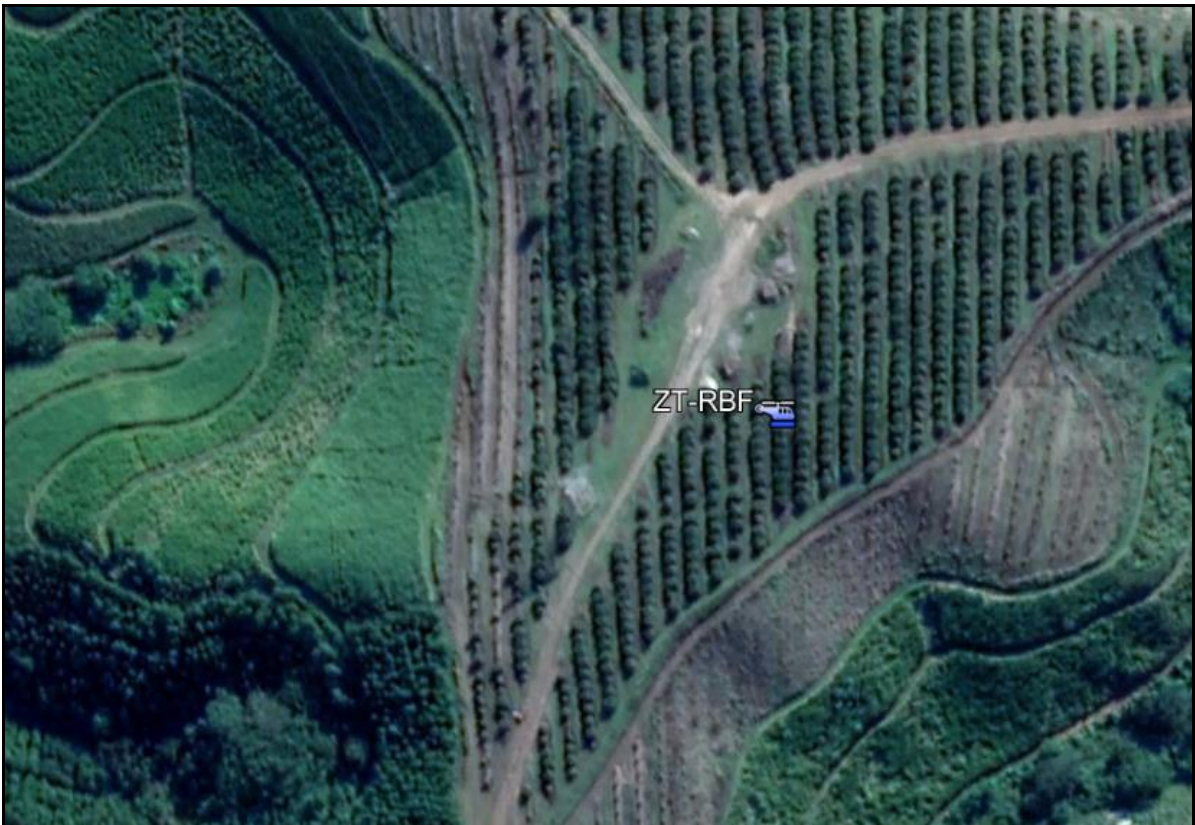
- 2.3 The helicopter sustained substantial damage. The pilot was not injured.
- 2.4 The accident occurred during daylight conditions at a geographical position that was determined to be 28°39'52.00" South 031°24'43.00" East at an elevation of 2 500ft above mean sea level (AMSL).

Figure 1: Helicopter accident site

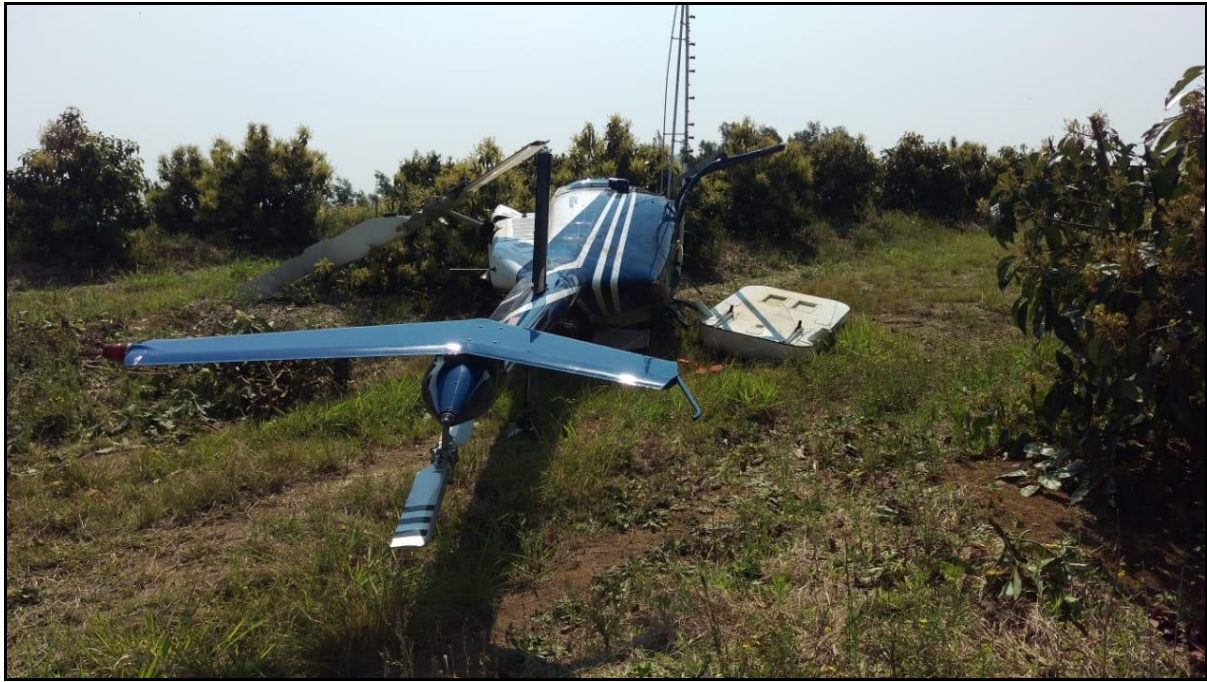
- 1.2 The helicopter sustained damage to the main rotor, skids, the transmission system, and the crop spraying system. The pilot was not injured.
- 1.3 Investigation revealed that during take-off, the collective was raised rapidly which increased the main rotor blades pitch angles at a rate which caused the main rotor RPM to decay and subsequently the helicopter to descend which resulted in a hard landing.

an avocado tree. The helicopter then rolled onto its left side and came to rest in that position. The pilot switched off the battery, closed the throttle and disembarked from the helicopter unassisted.

Figure 2: The helicopter as it came to rest

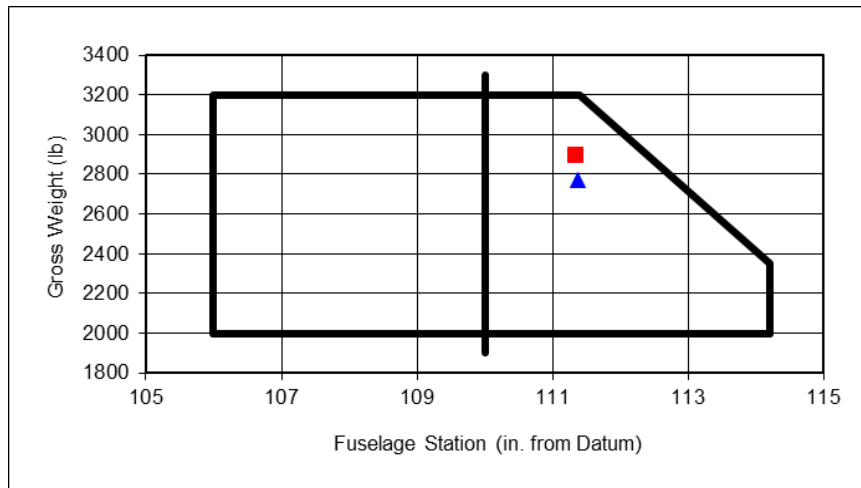
3.1 On the day of the accident, 20L of fuel was in the helicopter and 350L of pesticide was loaded into the Isolair system before take-off. According to the computed weight and balance, the helicopter weighed 3 022lbs prior to take-off, however the pilot stated that the actual maximum weight was 3 185lbs. Both values were below the maximum take-off weight (MTOW) of the helicopter, which is 3 200lbs but were very close to the MTOW.

Figure 3: Weight and Balance calculation

- 4.11 The pilot stated that the wind came from the south at approximately 3kts, CAVOK and the temperature was 16°C.
- 4.12 The weight of the helicopter according to the computed weight and balance sheet on take-off was 3 022lbs which was 178lbs below the MTOW of 3 200lbs. The pilot also stated that the actual weight before the accident was 3 185lbs.

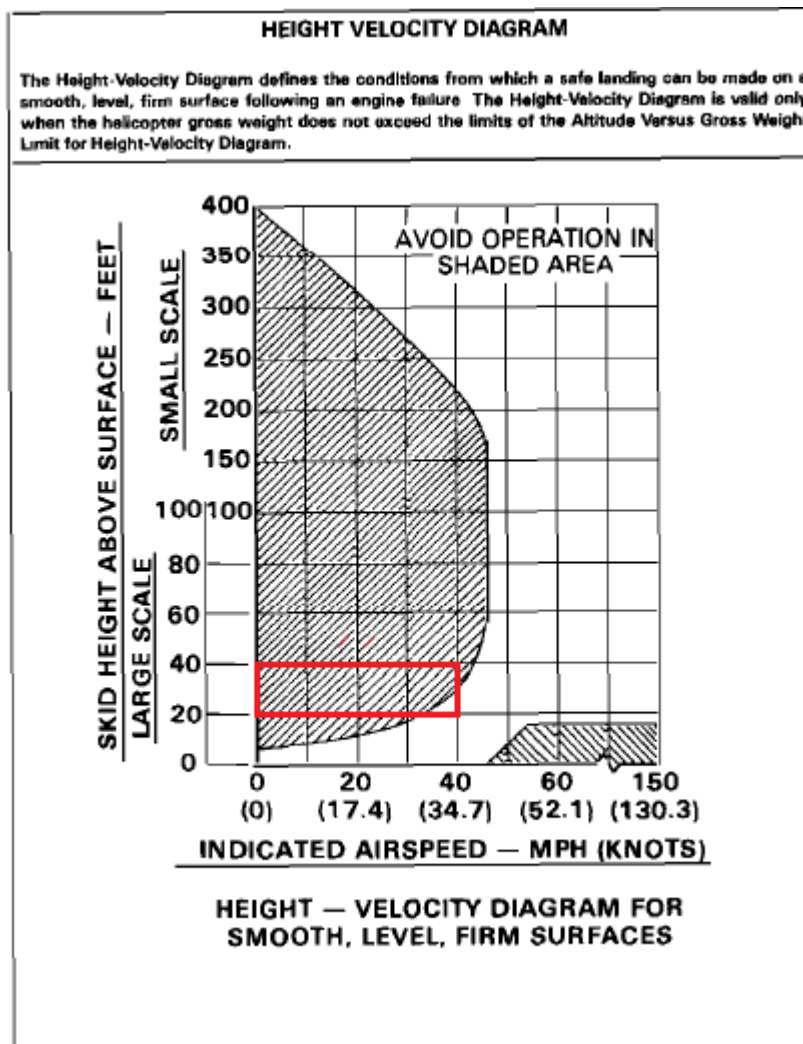
3.2 The pilot stated that he was at a height of 5-10m (16-33ft) AGL and his speed was below 40kts. This means according to the height velocity diagram that he was in the dead man's curve, low speed and close to the ground.

Figure 4: Helicopter's take-off profile

- 4.13 The investigation revealed that the pilot likely pulled the collective rapidly which increased the main rotor blades pitch angles at a rate that caused a sudden loss of rotor RPM. Added to that he was within the shaded region of the height velocity diagram which is dangerous to operate because it may be impossible for the pilot to complete an emergency landing should he need to.
