AIRCRAFT ACCIDENT REPORT AND EXECUTIVE SUMMARY

Reference:	CA18/2/3/9732	
Aircraft registration	ZU-EVW	Date of accident	18 September 2018		Time of accident	0820Z
Type of aircraft	Ikarus C42B (Micro-light)		Type of operation		Commercial (Part 96)	
Pilot-in-command licence type	Commercial		Age	24	Licence valid	Yes
Pilot-in-command flying experience	Total flying hours		294.2		Hours on type	47.7
Last point of departure	Bethlehem Aerodrome (FABM), Free-State Province					
Next point of intended landing	Bethlehem Aerodrome (FABM), Free-State Province					
Location of the accident site with reference to easily defined geographical points (GPS readings if possible)						
Bethlehem Aerodrome (GPS position; 28°14'52.25" South 028°20'08.33" East) elevation 5 536 feet AMSL						
Meteorological information	Surface wind; 328°/7.4kt gusting 10.7kt, temperature; 24.5°C, CAVOK					
Number of people on board	1 + 1	No. of people injured	0	No. of people killed	2

Synopsis	<p>On Wednesday morning, 19 September 2018, the pilot accompanied by a passenger departed from Kroonstad Aerodrome (FAKS) on an agricultural survey flight and landed at Bethlehem Aerodrome (FABM) after being airborne for three hours

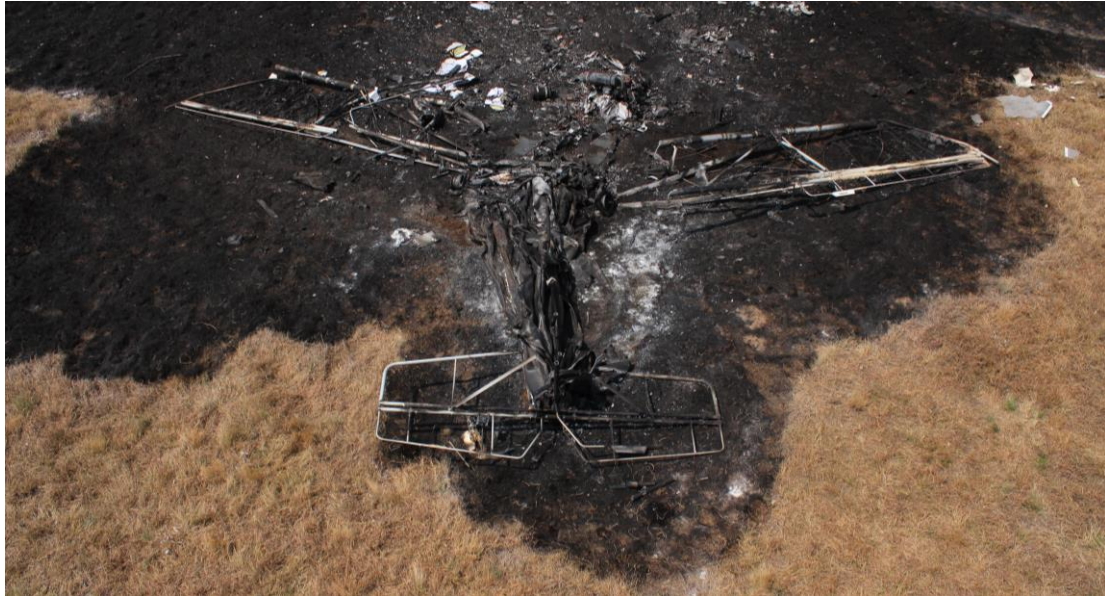
1.3.1 The micro-light aircraft was consumed by the post impact fuel fed fire that erupted.

Figure 1: The wreckage was consumed by the post impact fire

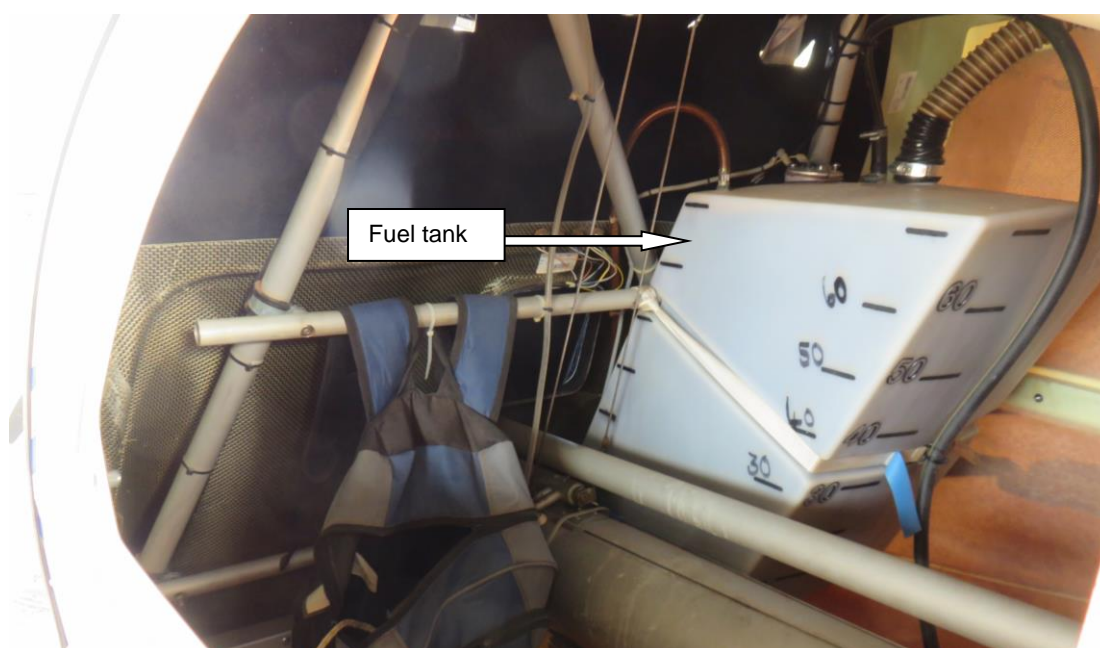
According to information received from Ikarus Flight Center South Africa, the fuel tanks in these aircraft are fabricated from high-density polyethylene (HDPE) as can be seen in Figure 3.

Figure 3: The fuel tank that was installed in the aircraft, ZU-FTO

- 1.15.3 The fact that the two fuel tanks, which were manufactured of the non-crashworthy type of material, were located directly behind the cockpit/cabin area contributed significantly to the intensity of the post impact fire and the burn wounds that were sustained by the two occupants.

- 4.1 It is recommended that the aircraft manufacturer (OEM) review the design and location of the fuel tank to the one such as bladder type fuel tank.

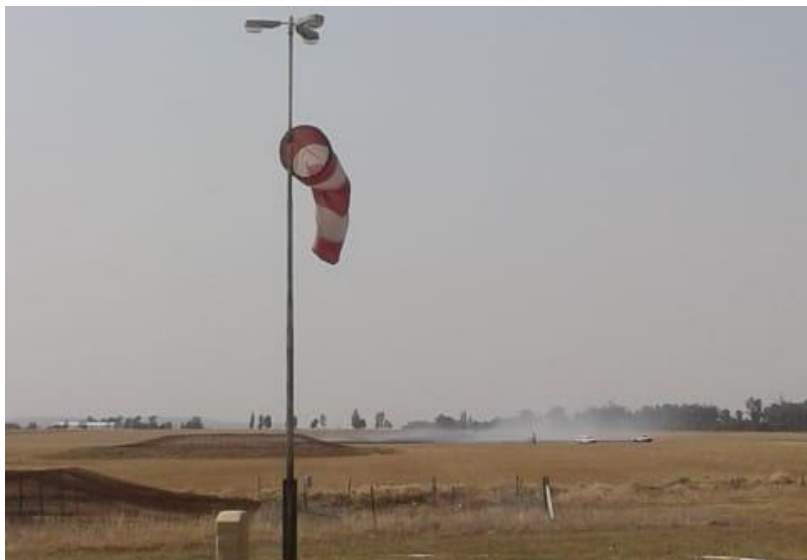
The photograph in Figure 5 was obtained courtesy of a person that was at the aerodrome when the accident occurred and made it available to the investigator. Some smoke from the veld fire, which was as a result of the accident was still visible in the background.

Figure 5: Windsock at FABM, with the smoke from the veld fire (post-accident) still visible

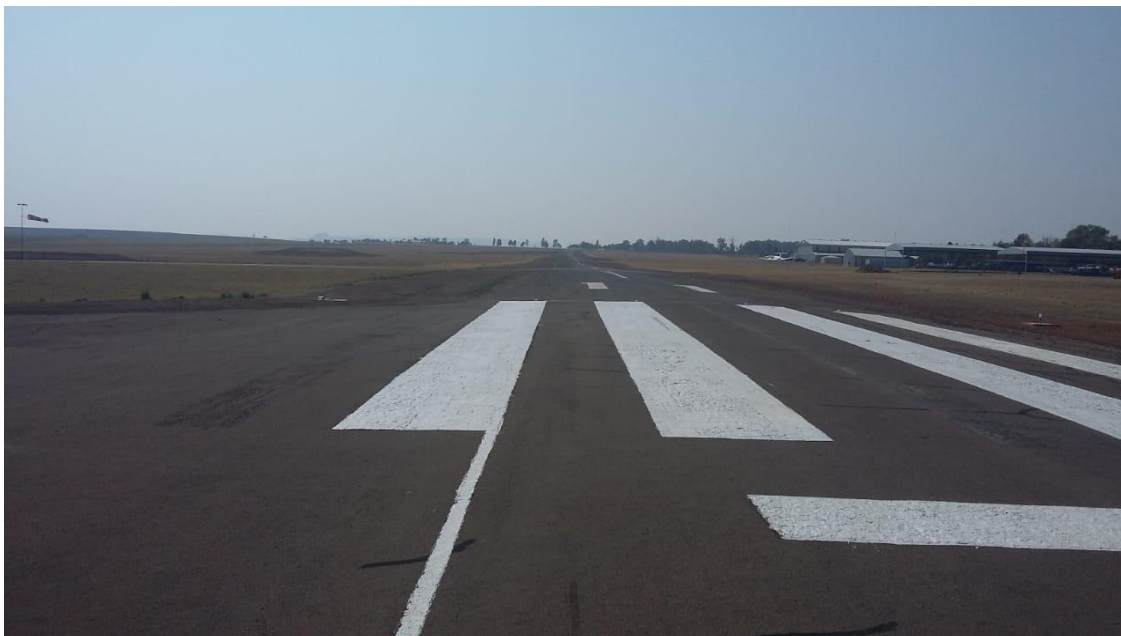
Figure 7: Runway 11, which had an up slope (photograph was taken by the Investigator)

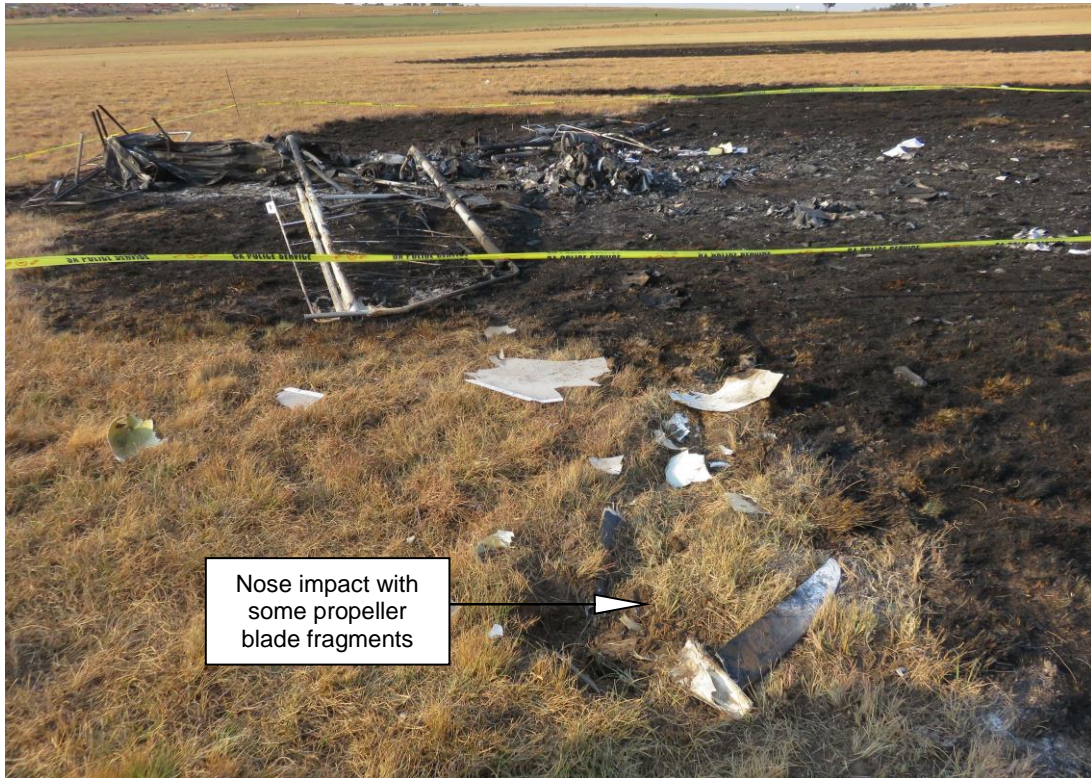
- 1.12.1 The aircraft impacted with grass covered terrain within the aerodrome parameter 67m to the left of the centreline of runway 11. It was noted that the composite blades from the propeller broke off at the hub assembly (see Figure 9) when the nose section impacted with the ground. The airspeed indicator as can be seen in Figure 13 was the only instrument that was located on the site, from which a reading could be obtained. It had a dual speed indication with miles per hour (mph) displayed on the outer circumference and knots on the inner circumference. The needle evidence mark indicated a speed of just above 100 kts / 54 mph. The wreckage came to rest in the direction of take-off approximately 180m from the point where the aircraft was observed to rotate and basically in line with the position where two eyewitnesses (first responders) were standing when the accident occurred. The distance from where the eyewitnesses (first responders) were standing to the accident site was approximately 170m.

Figure 9: Nose impact markings with propeller blade fragments visible

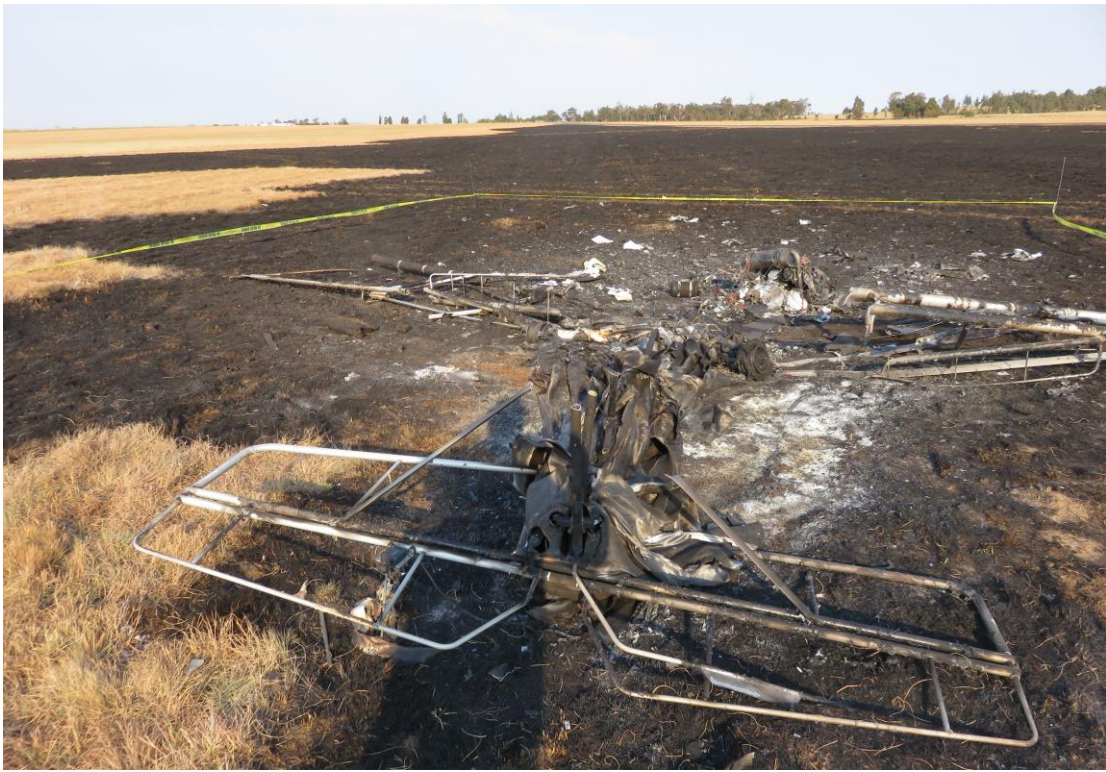
Figure 10 below shows the direction which the aircraft was facing post-accident and the runway is positioned behind the wreckage. Figure 11 and 12 shows the position of the engine with a missing propeller assembly within the wreckage area.

Figure 10: The burnt-out wreckage [photograph was taken in the direction of take-off (110°)]

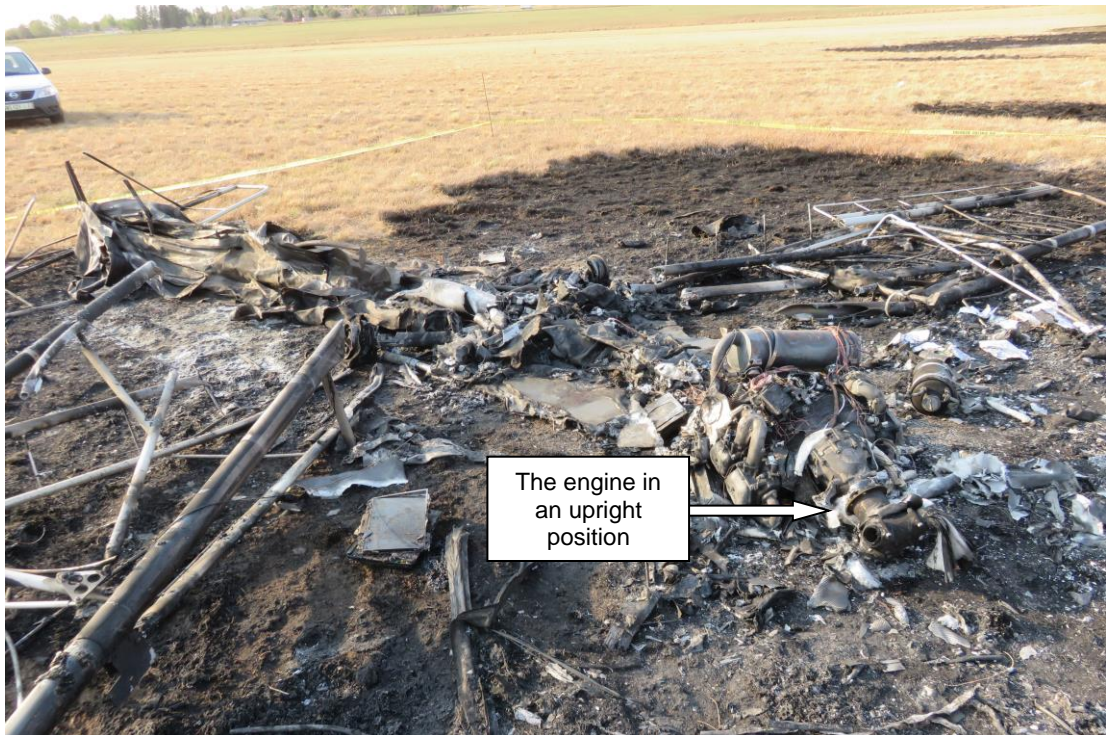
Figure 11: The engine was found in an upright position

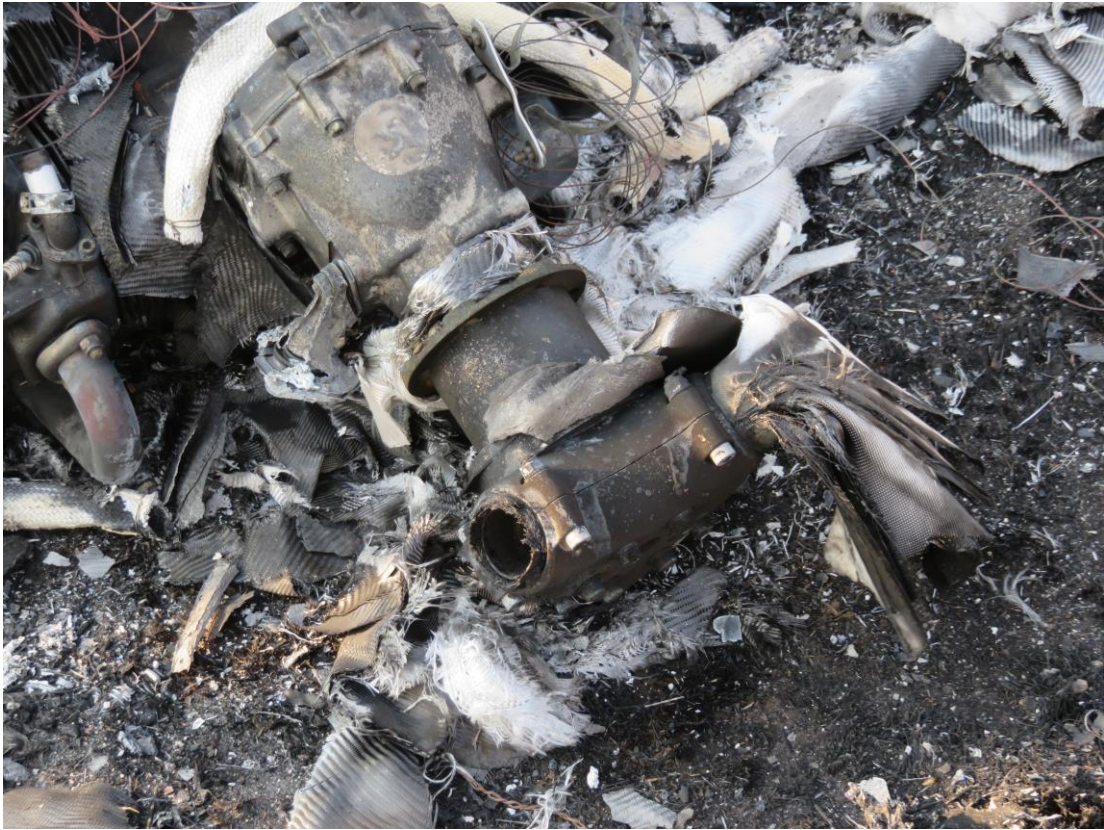
Figure 12: A closer view of the engine gearbox and the propeller flange assembly

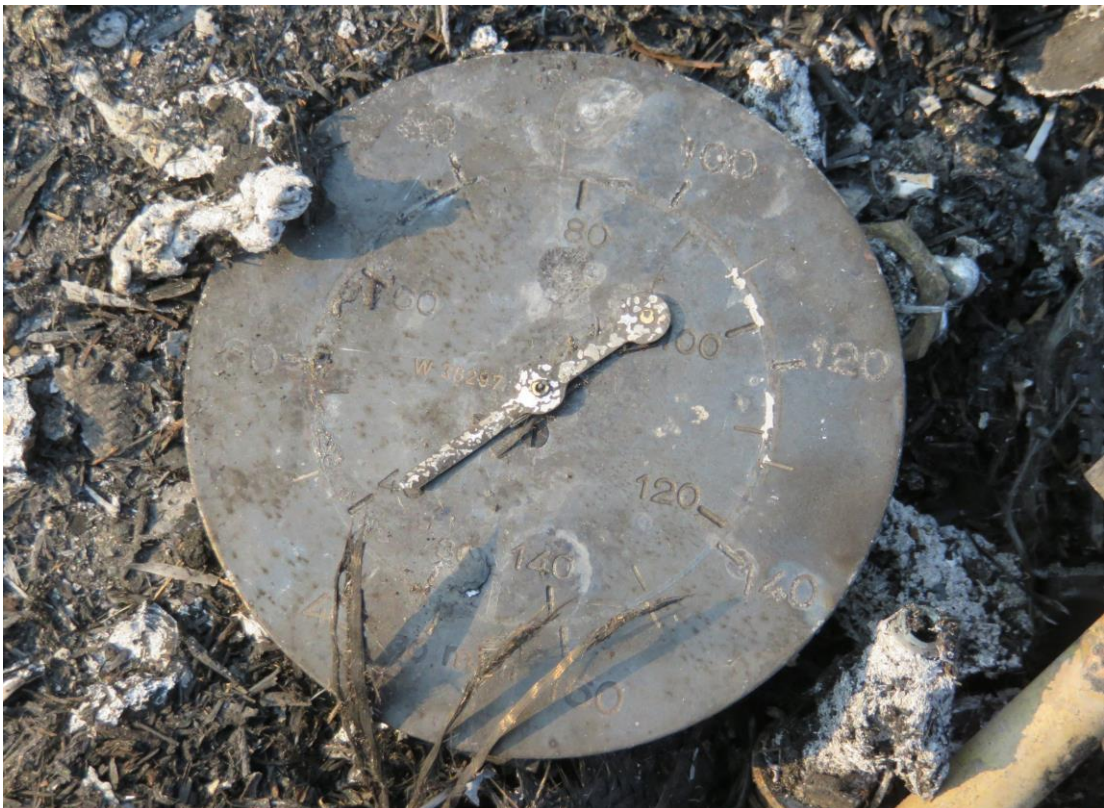
Figure 13: The airspeed indicator as it was found on site, indicating a speed of approximately 100 kt / 54 mph

In the calculations to determine the WCA a true airspeed of 40 knots was used, which equated to a ground speed of 48 knots if the wind correction was taken into account. This speed was 2 kt above the value as captured on the airspeed indicator that was found on the accident site as displayed in Figure 13 of this report.

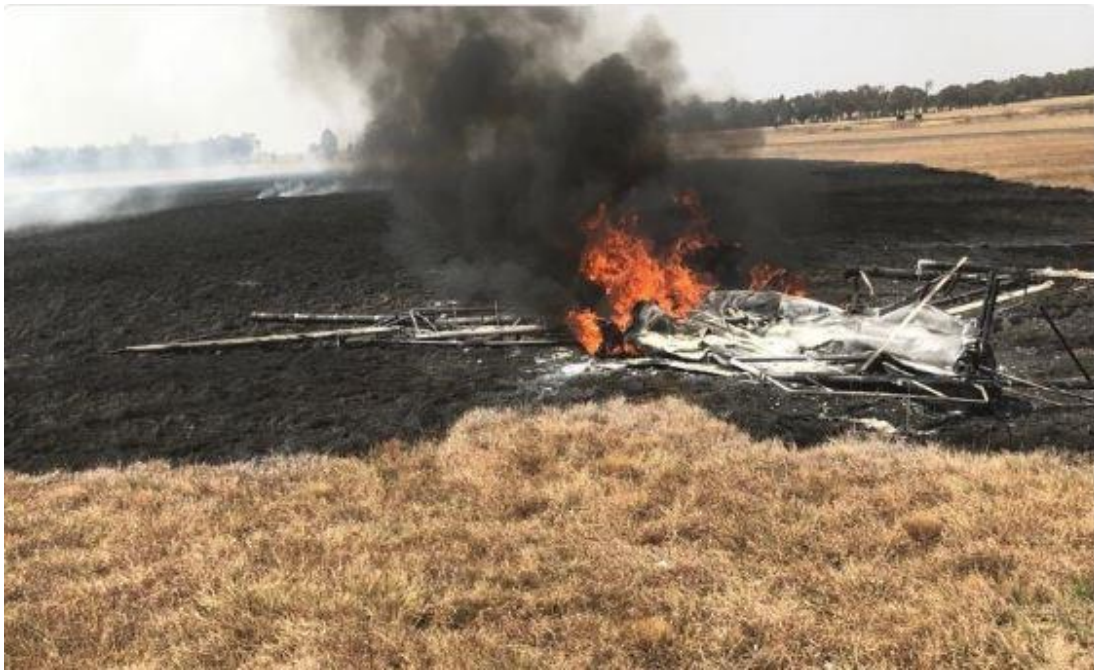
1.14.4 The black smoke could have been attributed to the petroleum-based material that was burning, which would have included the tyres of the aircraft and the fabric/composite materials used during the manufacturing process.

1.14.5 The fire and smoke direction in figure 14 below provide an indication of what the prevailing wind conditions were like at the time of the accident.

Figure 14: Part of the wreckage still on fire, with the smoke blowing in the direction of take-off

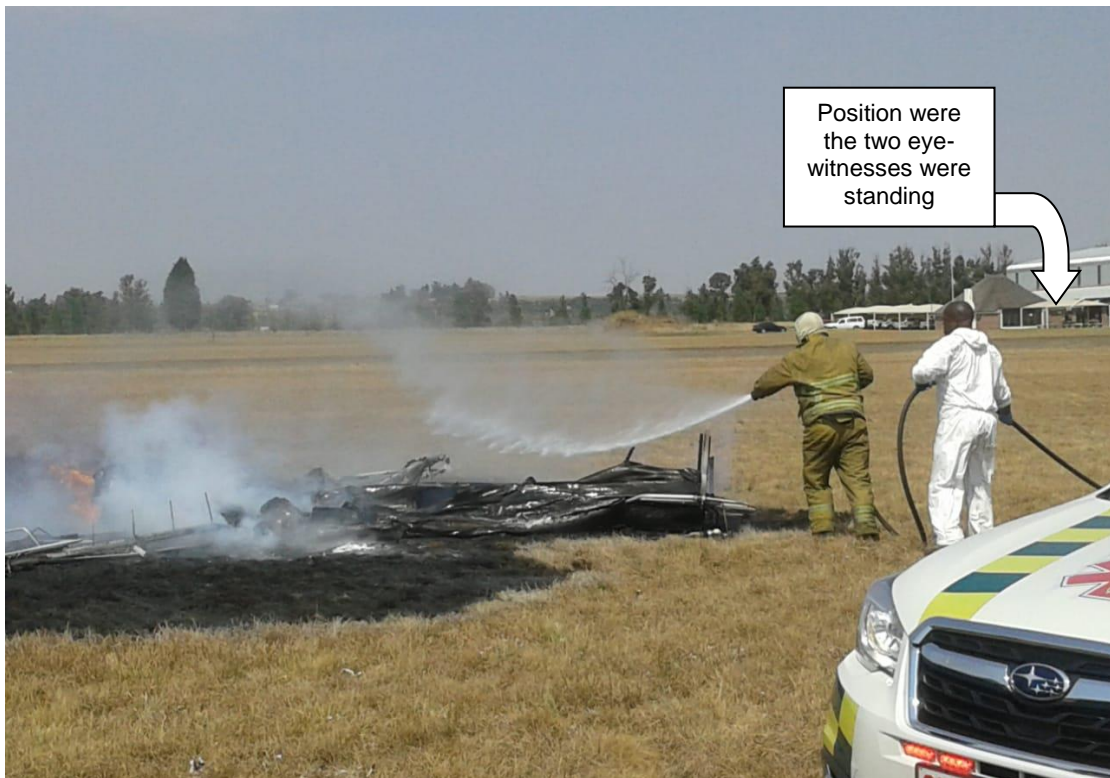
Figure 15: Fire services personnel from the local municipality extinguishing the fire

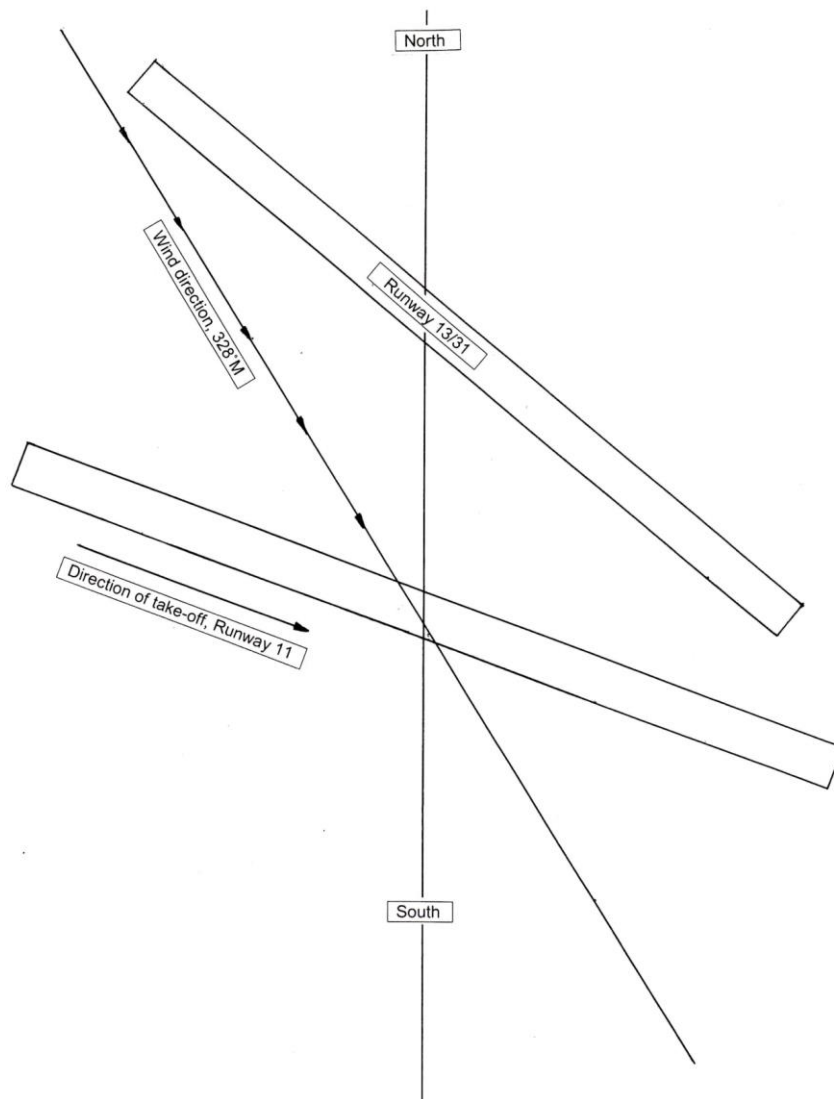
Figure 15 provide a schematic of the direction of the prevailing wind when ZU-EVW took-off from runway 11. A tailwind component was present, which was blowing from the left aft position at an angle of approximately 42° onto the aircraft fuselage during the take-off roll and subsequent rotation according to the wind data received.

With the wind as assessed at the time, it was 18° from the right front (into wind) when runway 31 would have been used, yet the pilot of ZU-EVW opted to take-off from runway 11.

Figure 17: Schematic indicating the prevailing wind at the time in relation with the two runways at FABM

Taking into consideration the information that is depicted in Figure 16 on page 27 of this report, which provides the orientation of the two runways at FABM and the prevailing wind conditions at the time. From this illustration it could be seen that if the pilot had planned the flight better, he would have most probably opted to make use of runway 31, which would have allowed for an into wind take off. The pilot that was flying ZS-LUW, which was the first aircraft that took-off from FABM following the accident in question, did opt to use runway 31 due to the prevailing wind conditions, which was still from the northwest (unchanged) at the time. Taking off into wind increases lift, and also assist the aircraft in becoming airborne at a lower ground speed and a shorter take-off roll is required.

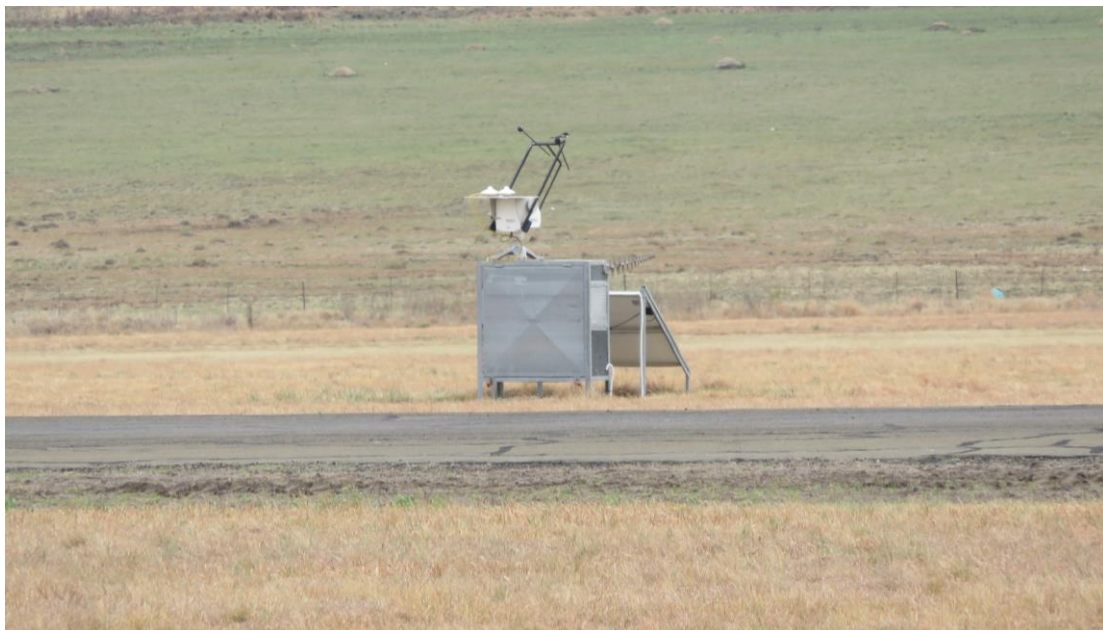
It should be noted that there was a weather station on FABM as can be seen in Figure 24. Accurate weather data was available to the pilot should he have opted to contact the local weather office, but he most probably trusted on the visual clues / observations that was available to him, seeing they were going to return to FABM.

Figure 24: The weather station at FABM (Photograph was taken by the Investigator)

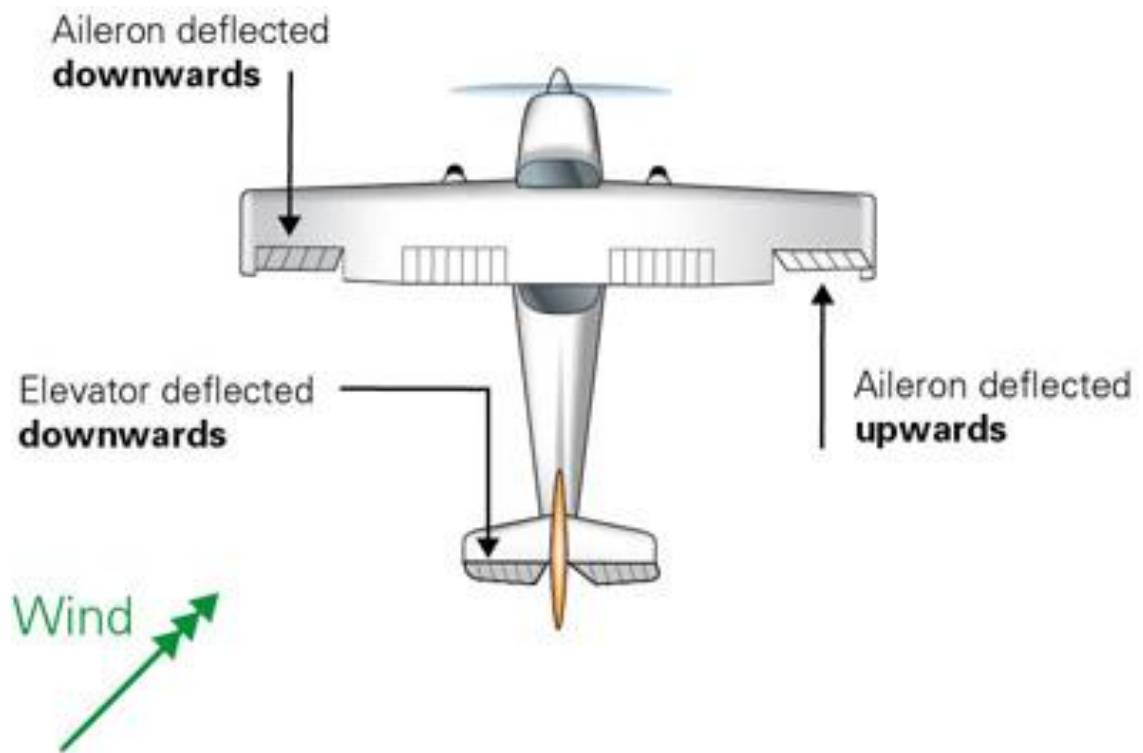
The aircraft encountered a tailwind component from the left aft position as depicted in the illustration in Figure 25 on page 41. This would also explain the observation that was made from the video footage, where the aircraft was observed to yaw to the left after rotation, which was a classic weathercock / weathervane effect.

With the tail wind component the ground speed was substantially higher than the true airspeed, the speed could have felt to the pilot adequate to rotate the aircraft, which he did, however once the aircraft exited ground effect, which was at a height of approximately 20 to 30ft above the runway surface the induced lift that supported the aircraft to sustain flight dissipated and was no longer available. The flight characteristics of the aircraft changed rapidly and the left wing, stalled before the right wing. It could be that the pilot then used aileron control to attempt to 'pick up' the left wing, which would have increased the angle of attack (AoA) and further stalled the wing, which rendered recovery impossible due to insufficient altitude being available.

Figure 25: Illustrates the position of the wind on the aircraft during take off
