| AIRCRAFT ACCIDENT SHORT REPORT |

CA18/2/3/9734: ZU-FYZ, Aeroprakt A-22LS Loss of control due to wind shear.

Aircraft registration : ZU-FYZ

Aircraft manufacturer and model : Aeroprakt A-22LS Foxbat

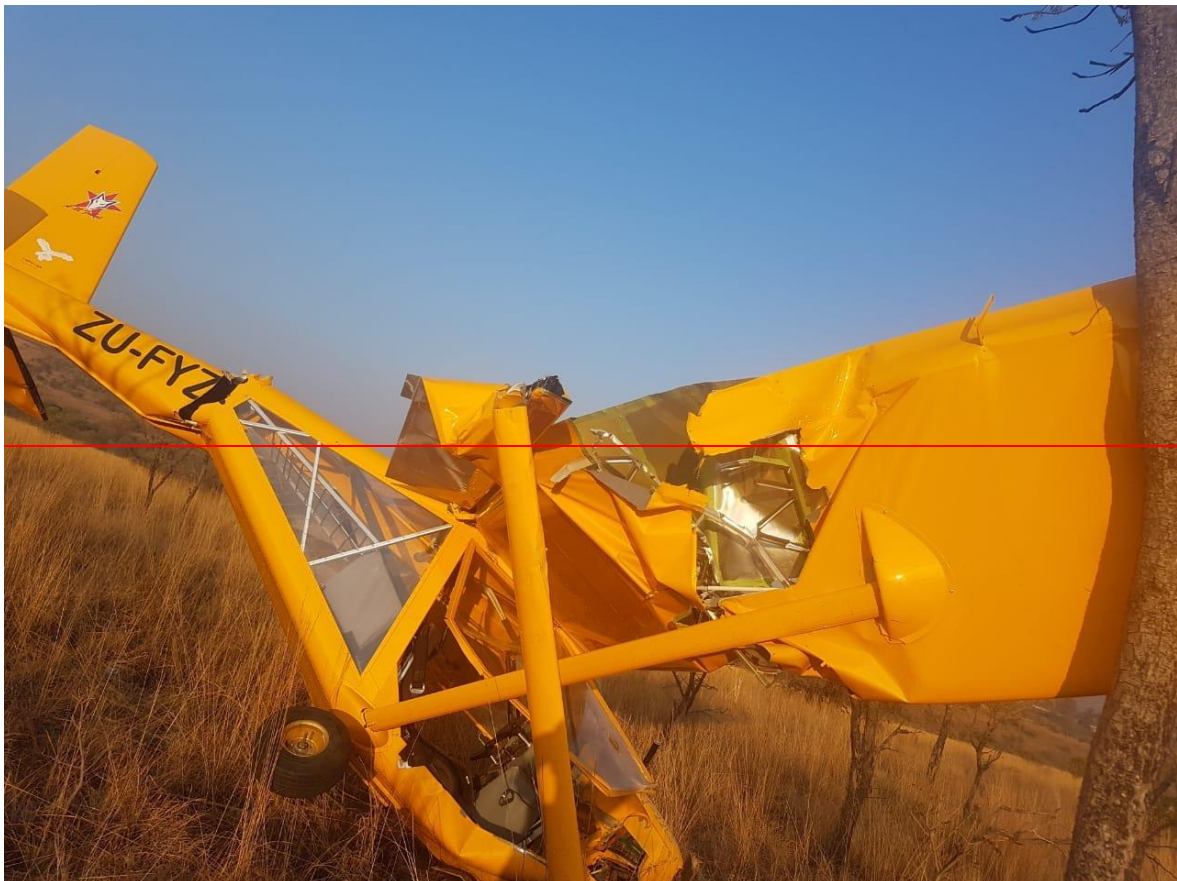
- 2.1.4 The dust devils made the landing difficult as the aircraft's tail kicked out to the left and the right wing dropped. The pilot attempted to correct this but the left wing hit a tree, which spun the nose into the ground 6 meters away from the runway.

Figure 2: shows the aircraft as it came to rest at the accident site.

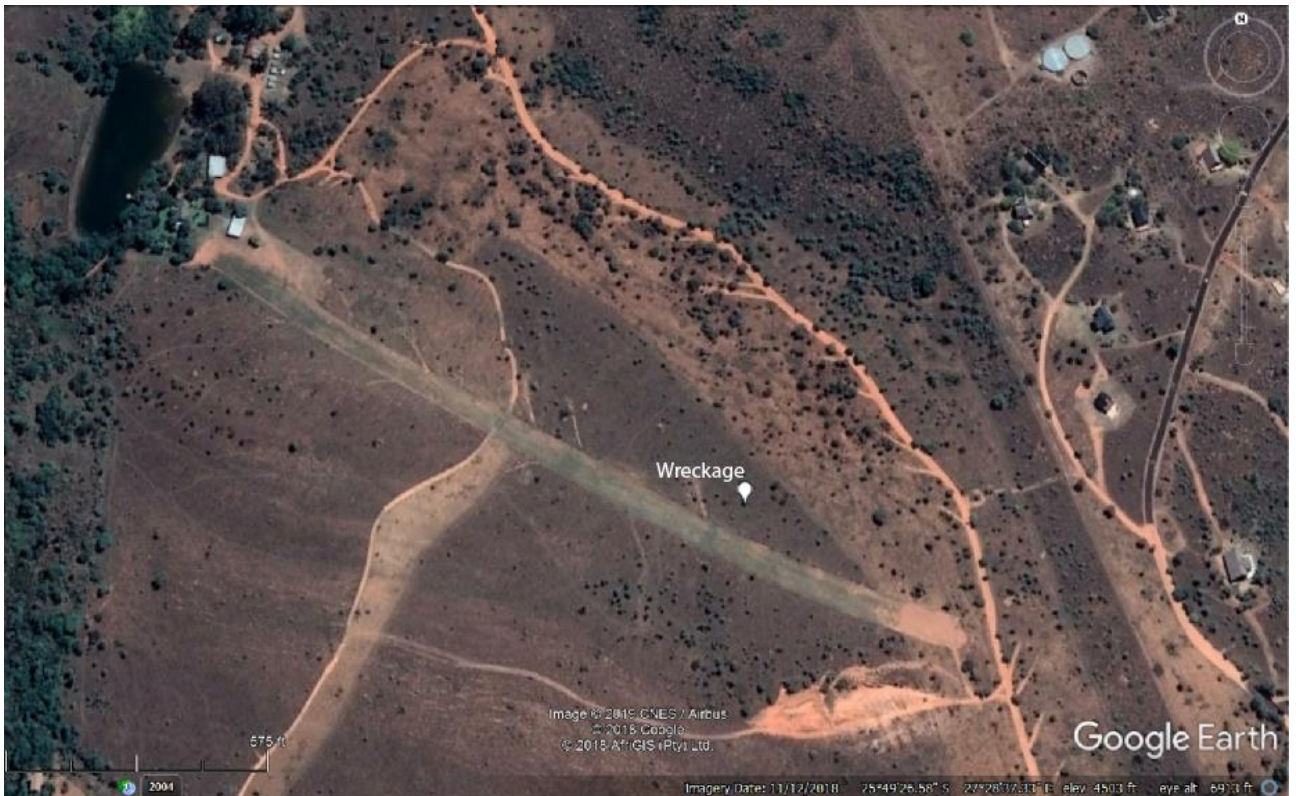
2.1.7 Figure 3 below shows the Google Earth image of the airfield and the wreckage location.

Figure 3: Runway at Mountain Sanctuary Park Private Airfield.
