Accident and Incident Investigations Division

<b>AIRCRAFT ACCIDENT REPORT AND EXECUTIVE SUMMARY</b>
---

Reference:		CA18/2/3/9735		
<b>Aircraft Registration</b>	ZU-CBR	<b>Date of Accident</b>	6 October 2018	<b>Time of Accident</b>	0645Z	
<b>Type of Aircraft</b>	Windlass Aquilla		<b>Type of Operation</b>	Private (Part 94)		
<b>Pilot-in-command Licence Type</b>	NPL (National Pilot Licence)		<b>Age</b>	32	<b>Licence Valid</b>	Yes
<b>Pilot-in-command Flying Experience</b>	Total Flying Hours		60	<b>Hours on Type</b>	60	
<b>Last Point of Departure</b>	Mlala Game Farm Private Airstrip in Limpopo Province					
<b>Next Point of Intended Landing</b>	Mlala Game Farm Private Airstrip in Limpopo Province					
<b>Location of the accident site with reference to easily defined geographical points (GPS readings if possible)</b>						
Mlala Game Farm is 5.4nm north-east of Marble Hall at GPS co-ordinates S24°54'56,8" E029°21'34,2", at an field elevation of 2 815ft						
<b>Meteorological Information</b>	Wind: 135° at 05kt; Visibility: 9999m; Temperature: 17°C

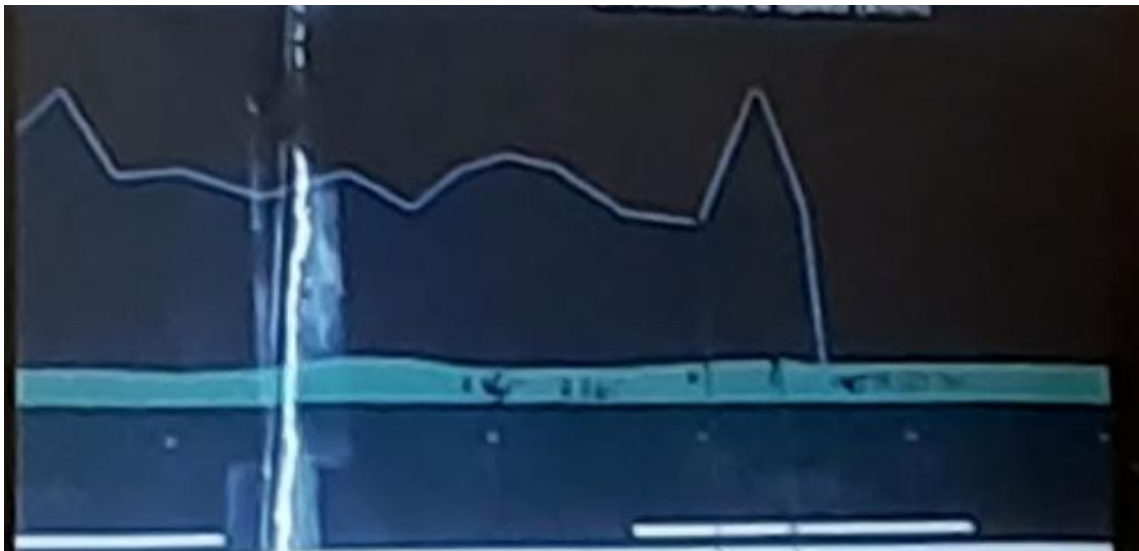
- 1.6.4 The pilot had worn a Garmin watch which was downloaded after the accident (see Figure 1 and Test and Research 1.16).

**Figure 1:** The downloaded graph from the Garmin watch which the pilot was wearing.

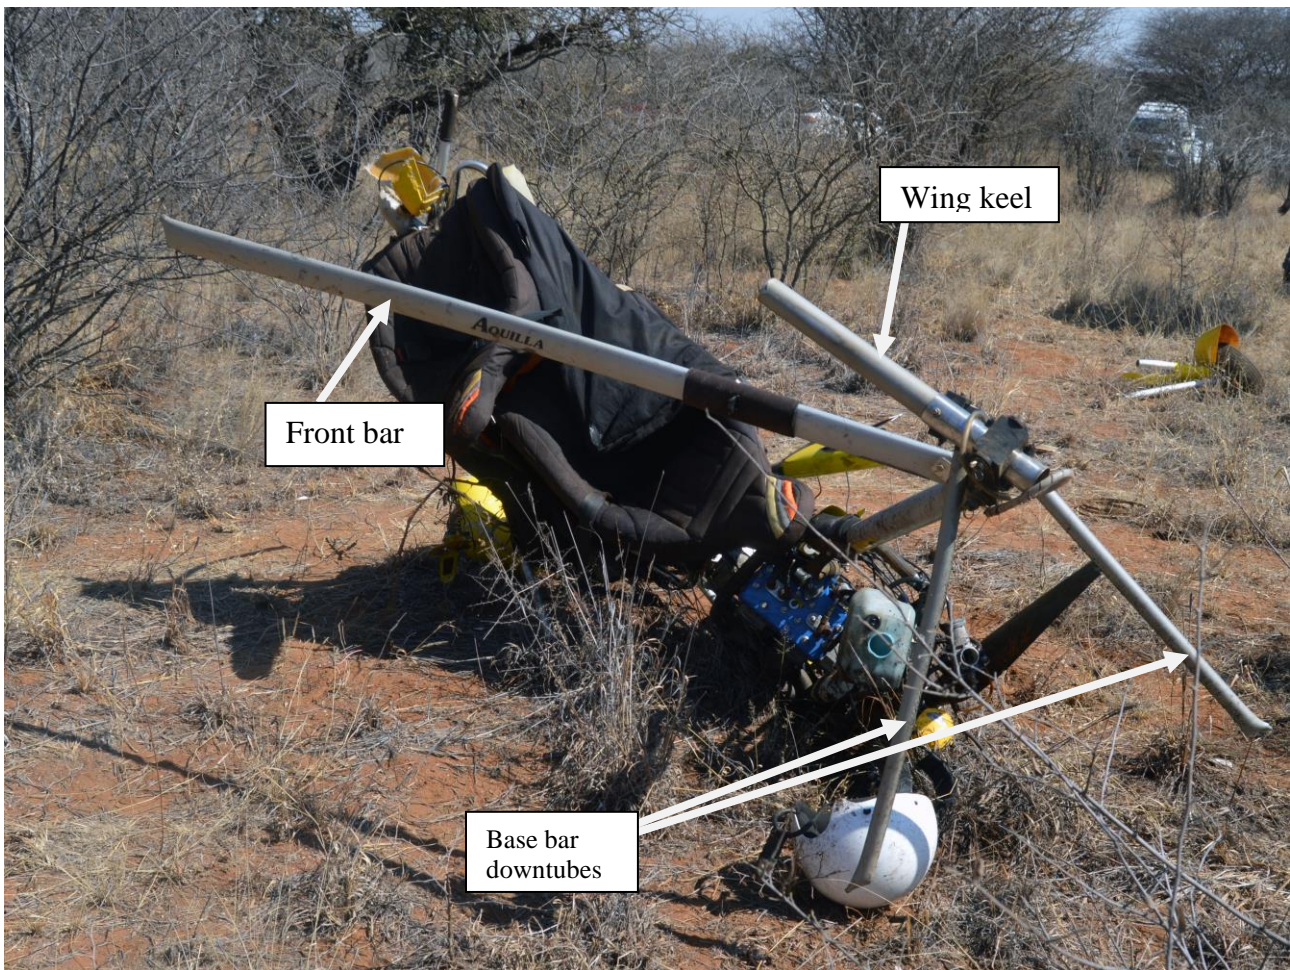
#### 1.3.1 The microlight was destroyed.

**Figure 3:** The damaged body of the microlight after the accident.

1.12.3 The fuselage, the engine and the propeller were significantly damaged during the impact sequence.

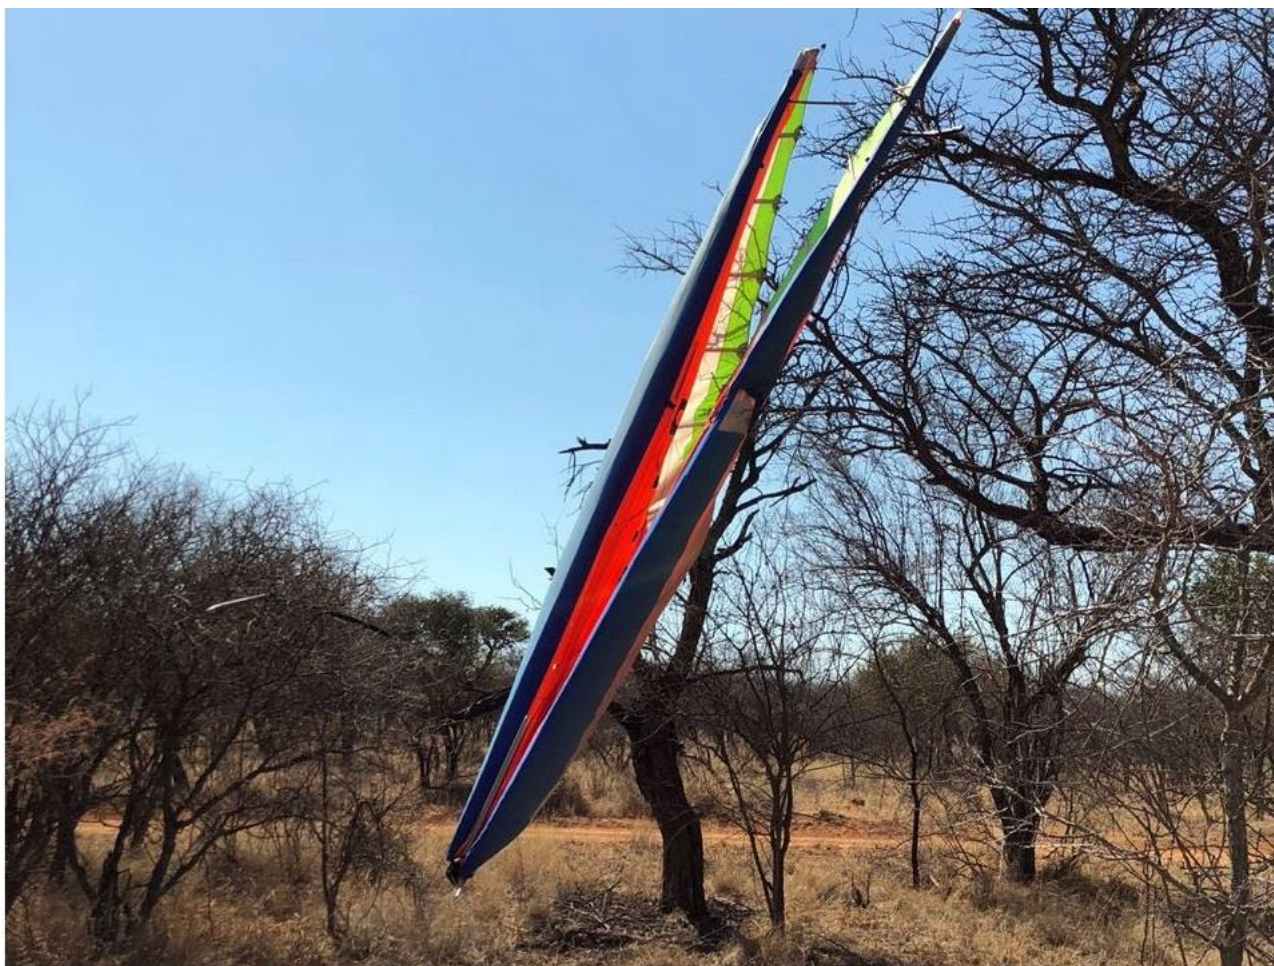
- 1.6.3 According to the eyewitness, a strange noise attracted his attention to the microlight. He then saw the microlight's wing separate from its body. The microlight's body rotated three times before impacting the ground while the wing settled on a tree 75 metres (m) from the fuselage. The pilot and the passenger were thrown off the microlight during the accident sequence and were fatally injured. The safety harnesses that they had worn failed during the accident sequence. Medical personnel removed the pilot and the passenger from the accident site.

**Figure 4:** The wing came to rest on a tree after separating from the body of the microlight.

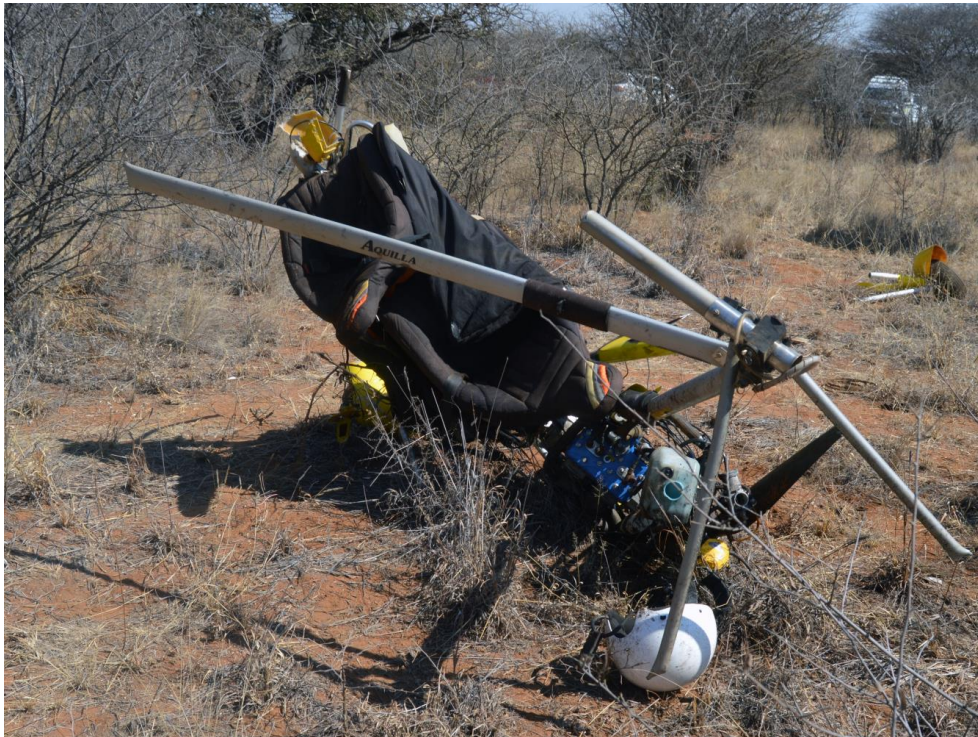
**Figure 7:** The airframe and its components at the accident site.

1.12.4 The passenger was positioned 6m from the airframe and the pilot's position was 5m from the body. They were both ejected from the body of the microlight during the accident sequence.

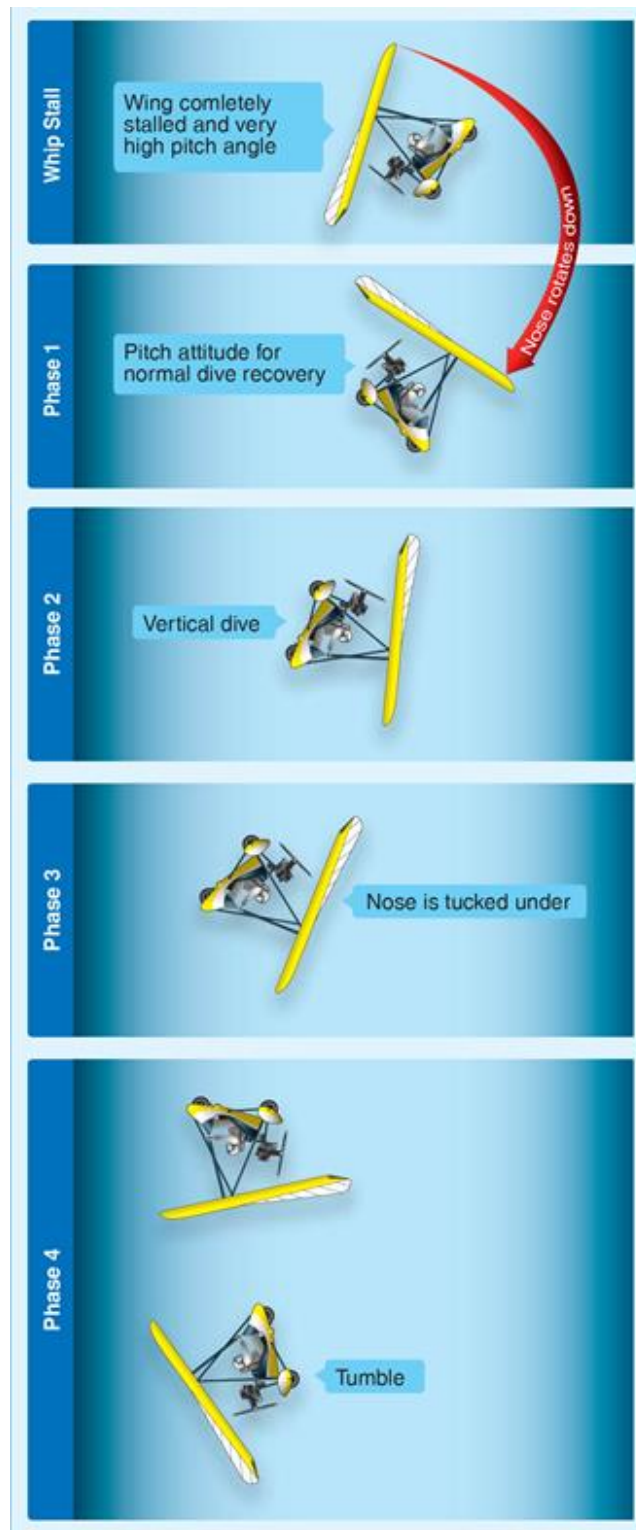
*“A WSC aircraft can get to a high pitch attitude by flying outside its limitations or flying in extreme/severe turbulence. If the wing gets to such a high pitch attitude and the angle of attack (AOA) is high enough that the tips stall, a whip stall occurs. In a WSC wing, most of the area of the wing is behind the centre of gravity (CG) (about three-quarters). With the tips and aft part of the wing having the greatest drag, and the weight being forward, an immediate and strong nose-down moment is created and the WSC nose starts to drop. Since both the relative wind and the 2-20 wing is rapidly changing direction, there is no opportunity to re-establish laminar airflow across the wing. This rotational momentum can pull the nose down into several increasingly worse situations, depending on the severity of the whip stall. Figure 10 shows a whip stall and the phases that can result, depending on the severity.*

Phase 4 - The rotational momentum is severe enough to continue rotation, bringing the WSC wing into a tumble from which there is no recovery to normal flight, and structural damage is probable.

**Figure 9:** Demonstration of a whip stall.

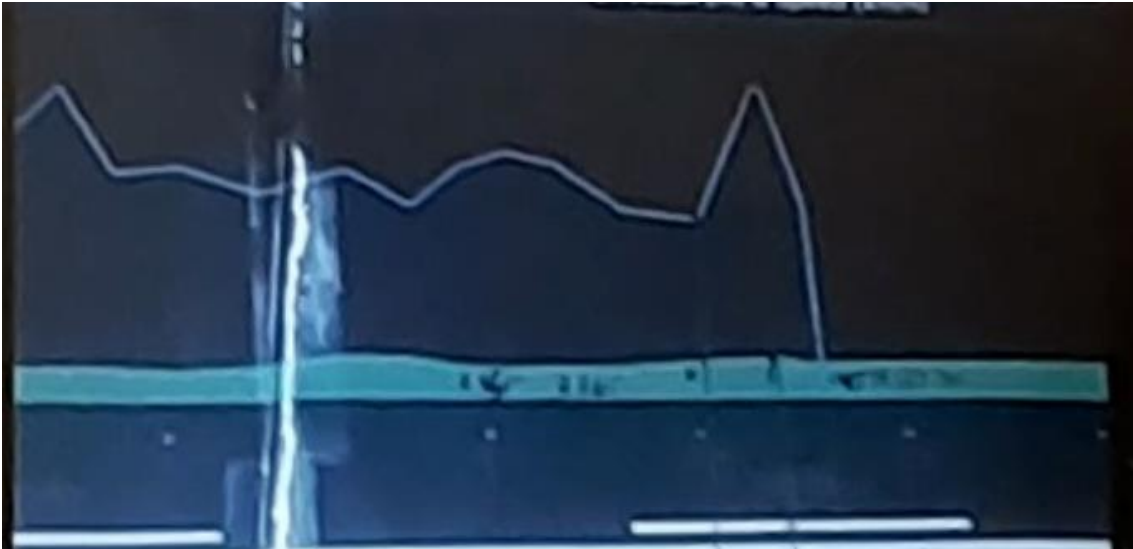
**Figure 10:** The graphical representation of the downloaded data from the pilot's Garmin watch.

- 1.16.3.1 The graph reveals a classic build up to a whip stall. On the far left, the pilot performs a moderate stall. By the sudden drop there was no recovery with power. This is followed by a loss of height and a gain in speed, which then results in a levelling off with a bit of a rollercoaster effect. This is a perfectly normal and safe exercise. In the middle of the graph, the pilot then applies power which shows a climb and he then increases the speed by pulling hard back on the bar, initially losing some height. The graph then shows a rapid steep increase in height showing that the pilot pushed the base bar forward. The result is an unsafe and very steep climb where the angle of attack is exceeded too far, resulting in a fatal whip stall. The graph shows an almost vertical trajectory to the ground.

2.1.2 It seemed that during the flight, the pilot was doing stall exercises as indicated by the analysis of his Garmin watch. The first stall exercise was completed without any incident and, on the second stall exercise, the pilot exceeded his angle of attack (AOA) which resulted in the aircraft entering a whip stall. The way in which the microlight stalled resulted in it becoming inverted, damaging itself before the wing separated. The pilot was unable to recover the microlight from the stall.
