AIRCRAFT ACCIDENT REPORT AND EXECUTIVE SUMMARY

Reference:	CA18/2/3/9736	
Aircraft Registration	ZS-PZT	Date of Accident	8 October 2018		Time of Accident	0920Z
Type of Aircraft	Cessna C172L		Type of Operation	Training (Part 141)		
Pilot-in-command Licence Type	Student Pilot		Age	21	Licence Valid	Yes
Pilot-in-command Flying Experience	Total Flying Hours		37.7		Hours on Type	37.7
Last Point of Departure	Grand Central Aerodrome (FAGC), Gauteng					
Next Point of Intended Landing	Grand Central Aerodrome (FAGC), Gauteng					
Location of the accident site with reference to easily defined geographical points (GPS readings) if possible						
Residential property, Vorna Valley (S26°00'02" E028°06'25")						
Meteorological Information	FAGC 080900Z; Temperature: 17°C; Dew Point: 02°C; Wind: 300°/6 kts; CAVOK QNH: 1028 hPa					
Number of People On Board	1 + 0	No. of People Injured	0	No. of People Killed	1 (On board) and 1 (On ground)	
Synopsis	<p>On Monday 8 October 2018 at 0833Z, the pilot departed Grand Central Aerodrome (FAGC) on a solo training flight with the intention of remaining in the circuit to practise touch-and-go landings.</p> <p>Following the pilot's fifth touch-and-go, while the

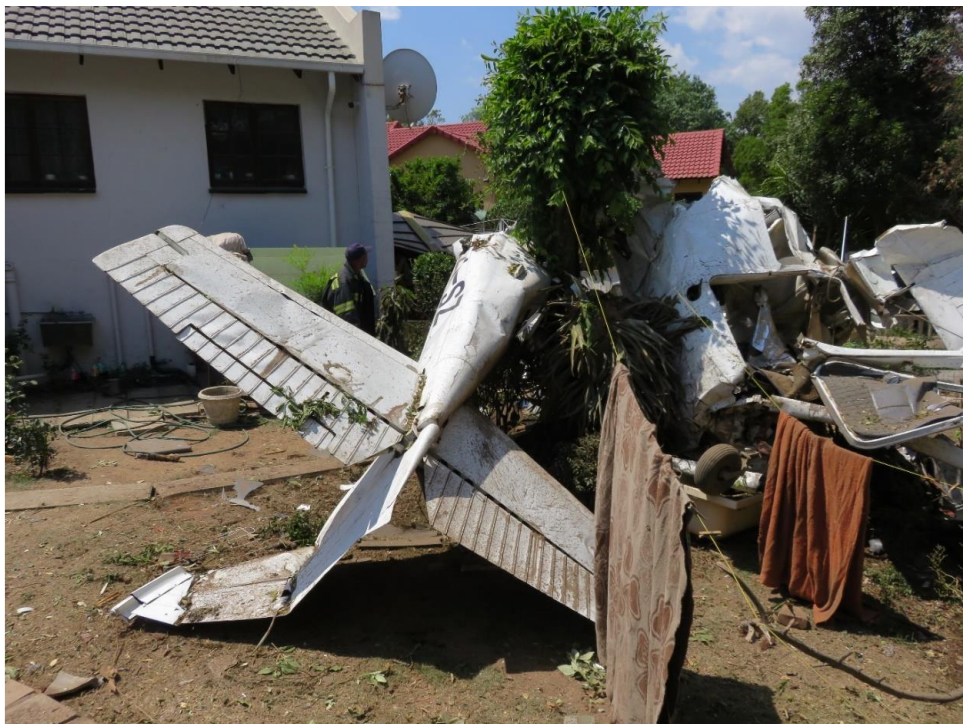
- 1.1.9 The aircraft wreckage was located in the back yard of a residential property in Vorna Valley. The aircraft came to rest in an inverted position; the fuselage was broken in half after impacting a tree.

Figure 5: The Accident aircraft at the Accident site

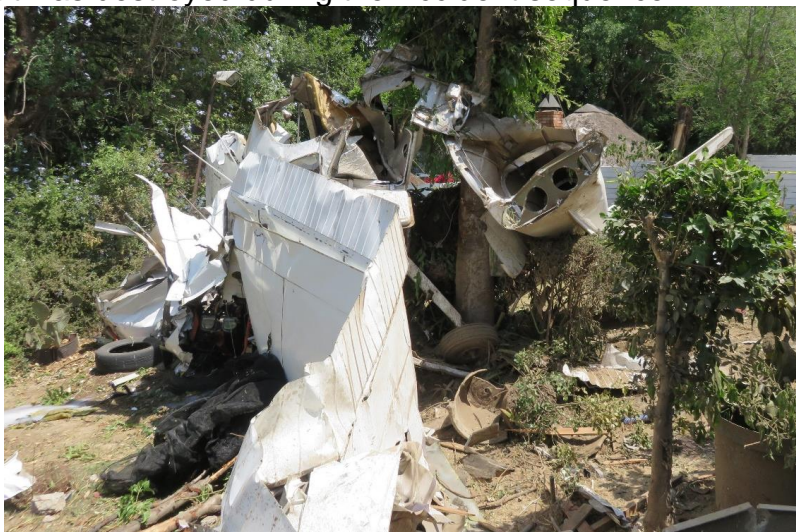
1.3.1 The aircraft was destroyed during the Accident sequence.

Figure 6: The aircraft as it came to rest

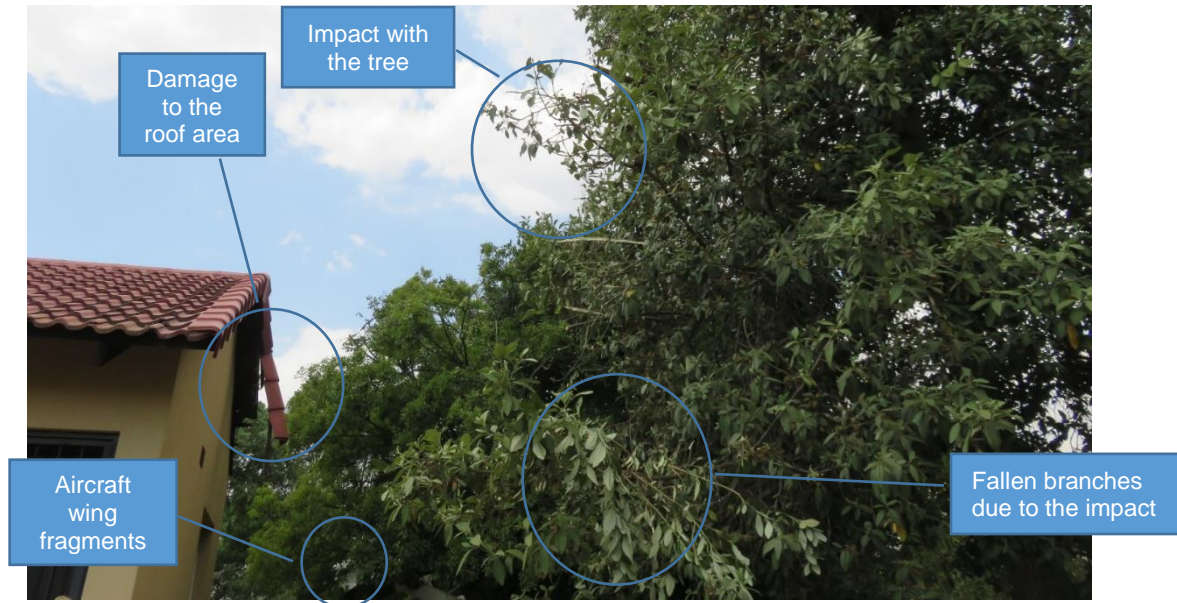
1.12.2 The first impact occurred when the aircraft struck the roof and a tree of a neighbouring

Figure 9: The first impact during the Accident sequence

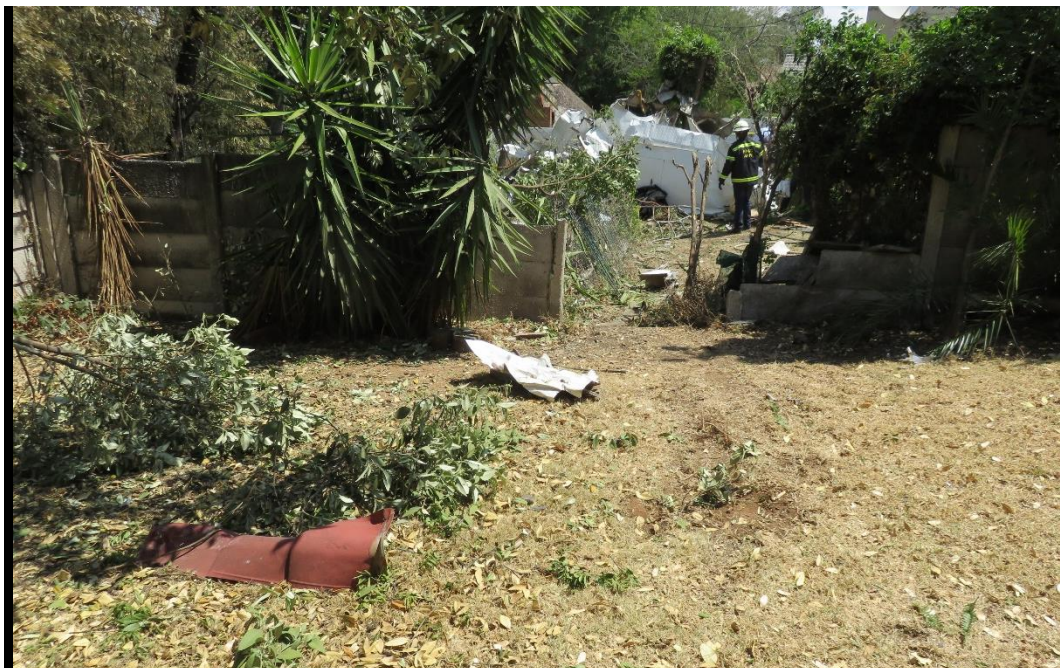
- 1.4.1 The neighbouring house sustained minor damage to its roof and some vegetation.
- 1.4.2 The house of the final impact location sustained damage to its perimeter wall, a shed and some vegetation. (See Figure 9 and 10)

Figure 10: Damage to the precast wall and a piece from the damaged roof

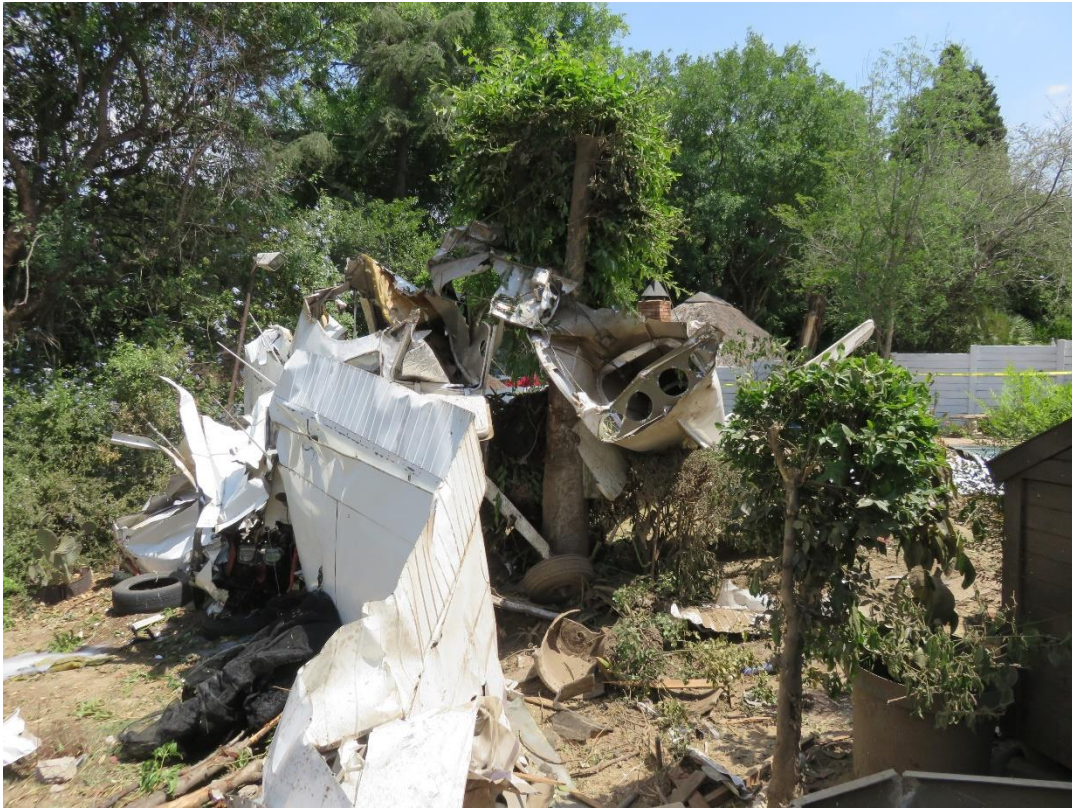
- 1.12.3 The aircraft came to rest against a tree in the backyard of a residential property. The distance from the first point of impact to the final resting point was 23m. Considering the damage sustained, the aircraft impacted the precast wall in a right wing low attitude with most of the impact forces affecting the right wing. The aircraft then skidded and impacted the tree on the right side of the fuselage.

Figure 11: The aircraft fuselage broke in half after impacting a tree

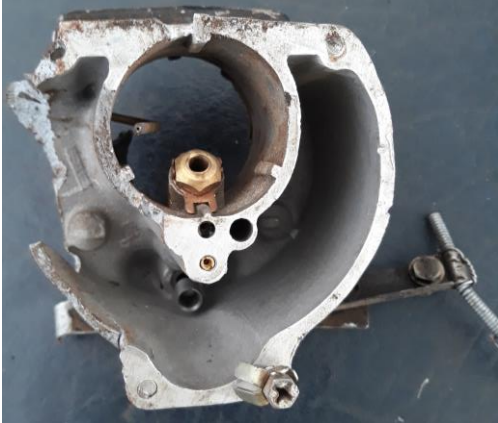
Carburettor (Marvel-Schebler Aircraft Carburetors)

Part Number	10-5009
Serial Number	MS659403
Description	The carburettor had broken off the engine during the impact sequence and sustained substantial damage.

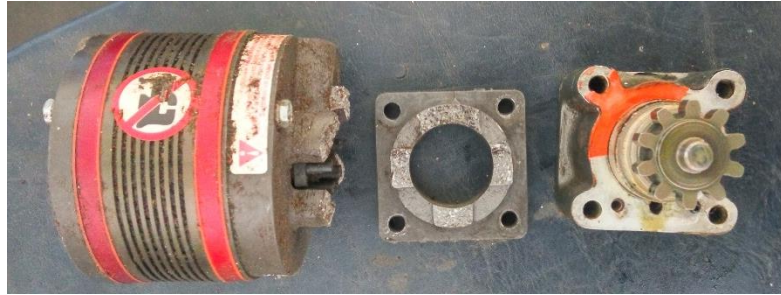
Vacuum Pump (RAPCO)

Part Number	RAP215CC
Serial Number	A66530
Description	The vacuum pump had broken off at its mount during the impact sequence. The adapter shaft remained in a relatively good condition.

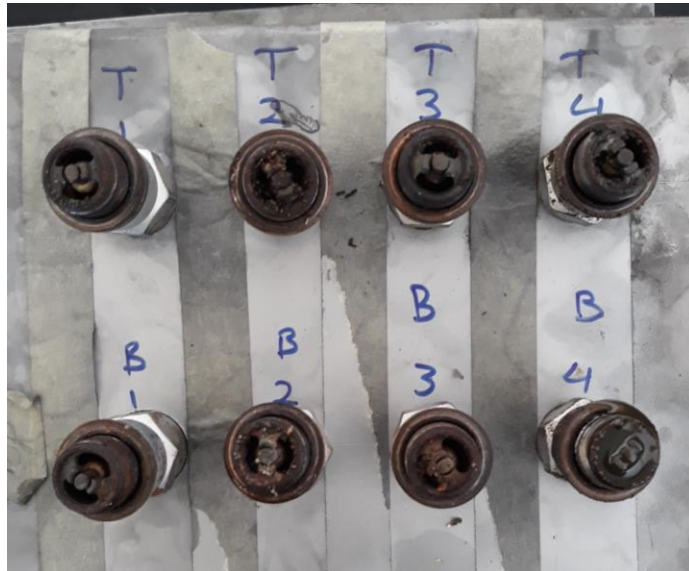
Spark Plugs (Champion)

Part Number	REM40-EF
Description	All the spark plugs were removed for inspection purposes. All the spark plugs displayed a brown tint synonymous with normal operation and had the correct electrode gaps.

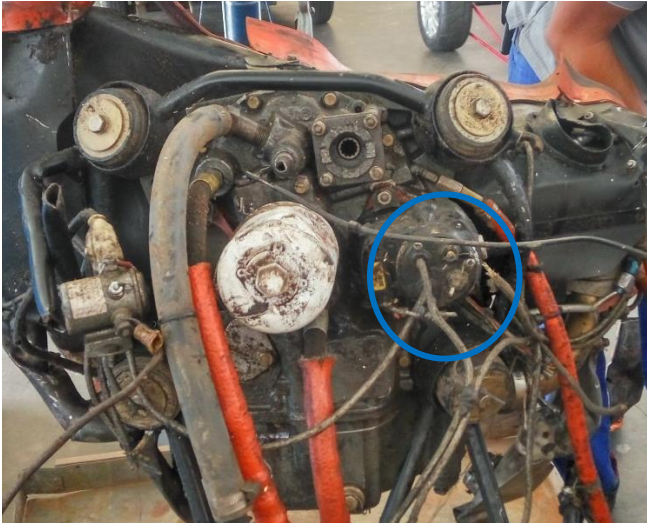
Magnetos (Slick)

Description	<p>The right-hand magneto remained attached to the engine. The left-hand magneto had broken off the engine at the mount. The units sustained serious damage and it was not possible to bench-test the units.</p>

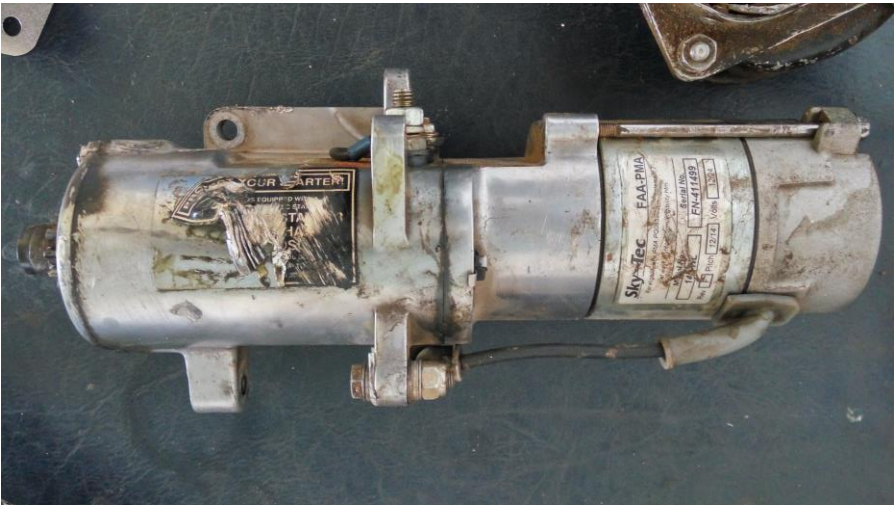
Starter (Skytec)

Part Number	147-NL
Serial Number	FN-411499
Description	<p>The starter remained attached to the aircraft. It suffered minor external damage. The adapter shaft remained in a relatively good condition.</p>

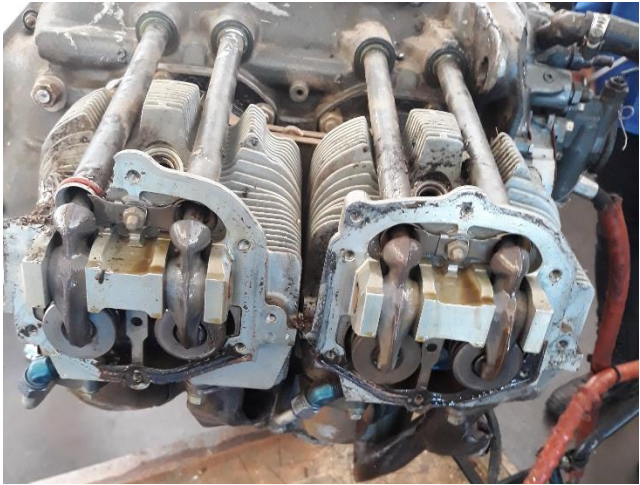
Cylinder head and valves

Description	<p>All the rocker covers were distorted due to the impact forces during the accident sequence. Once removed, all the valves and valve springs were found to be in good condition.</p>

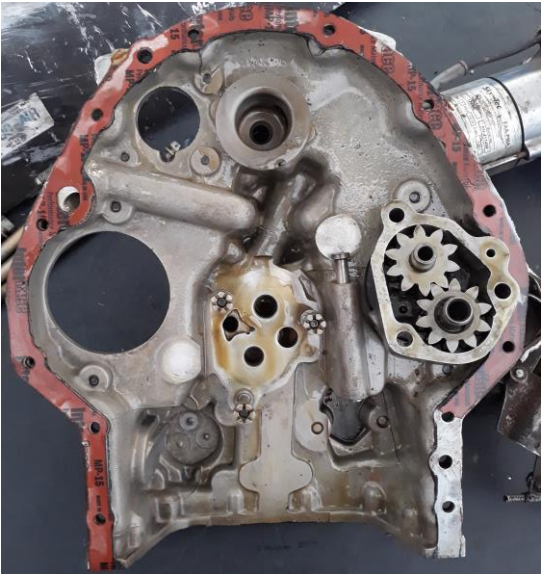
Oil Pump

Description	<p>The oil pump remained in a good condition.</p>

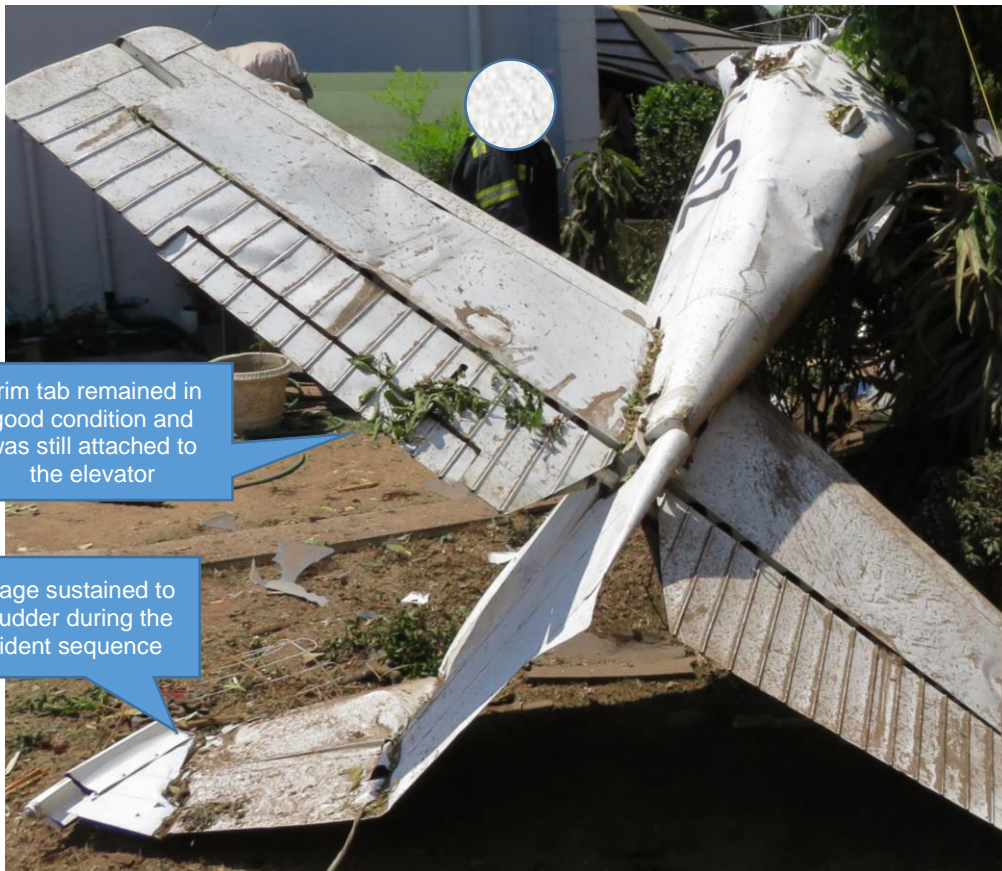
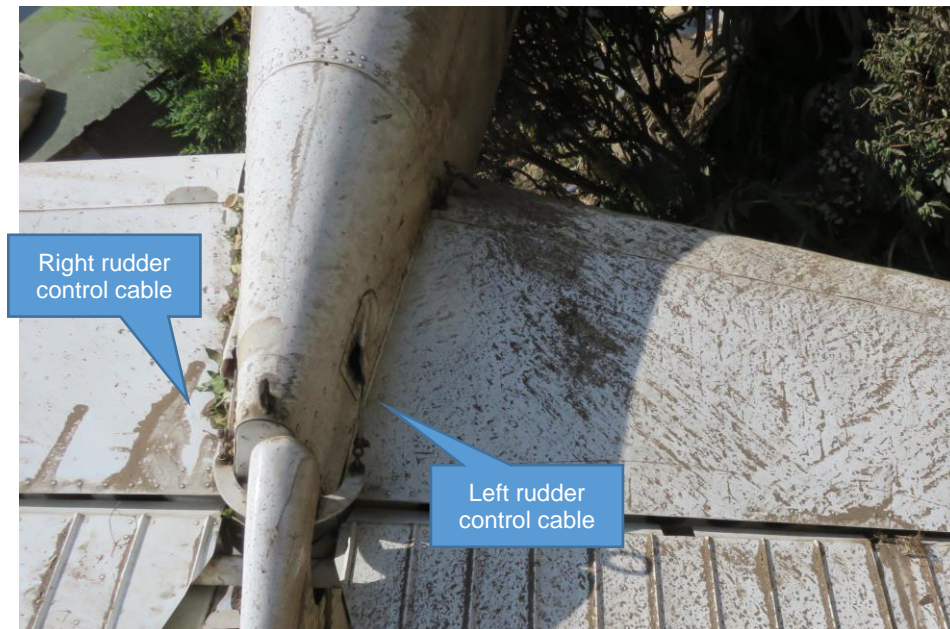
Empennage

The airframe had broken in half behind the baggage compartment after impacting a tree. The operation of the flight control cables to the elevator and rudder could not be determined. The flight control surfaces were inspected for condition and integrity. The rudder had bent due to the empennage area coming to rest in an inverted position. The rudder control cable attachments remained attached to the rudder. The elevator trim tab was visually inspected and was found to be in satisfactory condition. Both elevators remained attached to their horizontal stabilisers and had denting due to the accident sequence. The damage sustained to the empennage area was due to the accident sequence and no pre-impact faults could be identified.

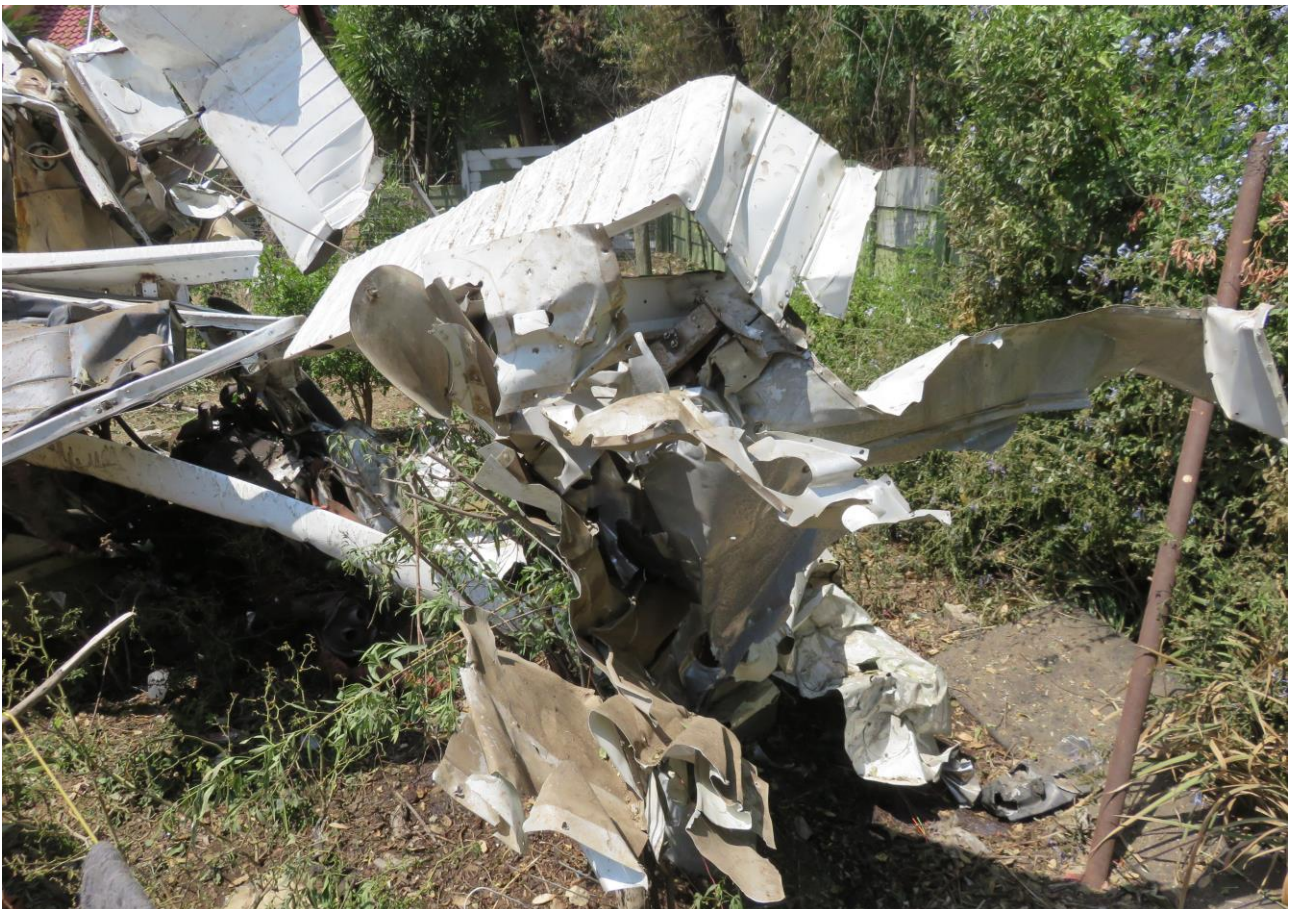
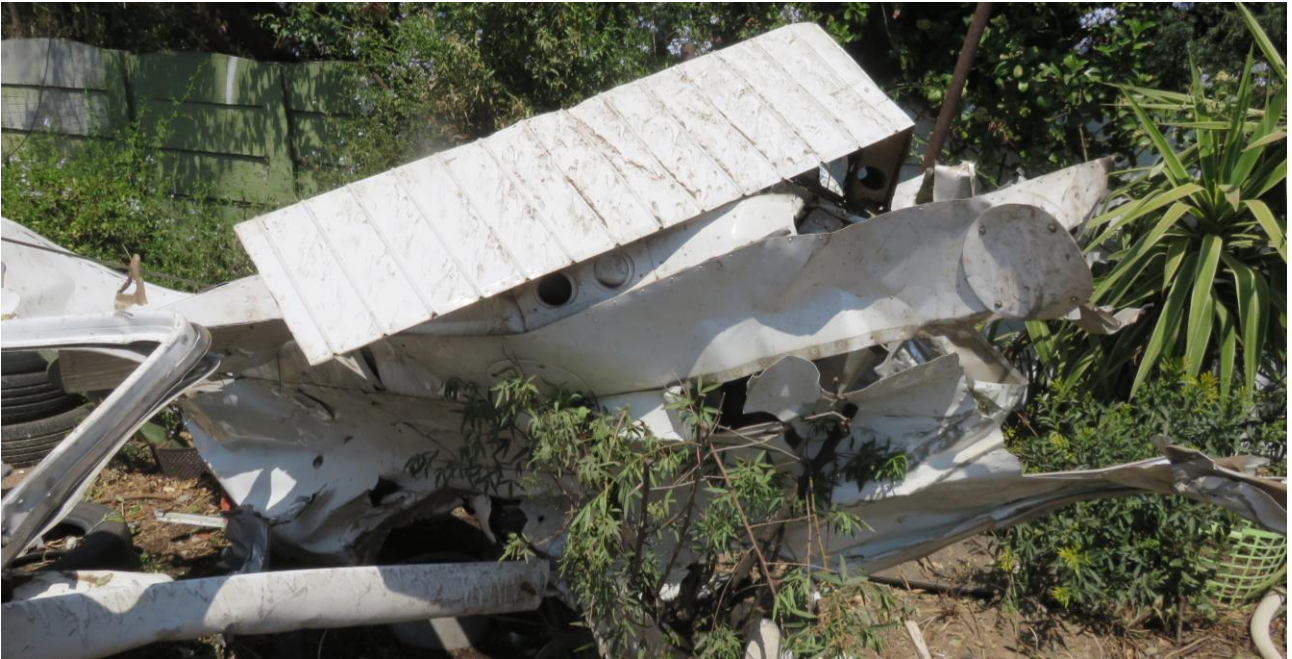
Right Wing

The right wing was completely destroyed during the accident sequence. The right strut had collapsed. The aileron had broken off and was located near the wreckage. The wing attached mounts had broken at their attach points. Based on the extensive damage sustained to the wing, it was determined that the damage was caused due to the accident sequence.

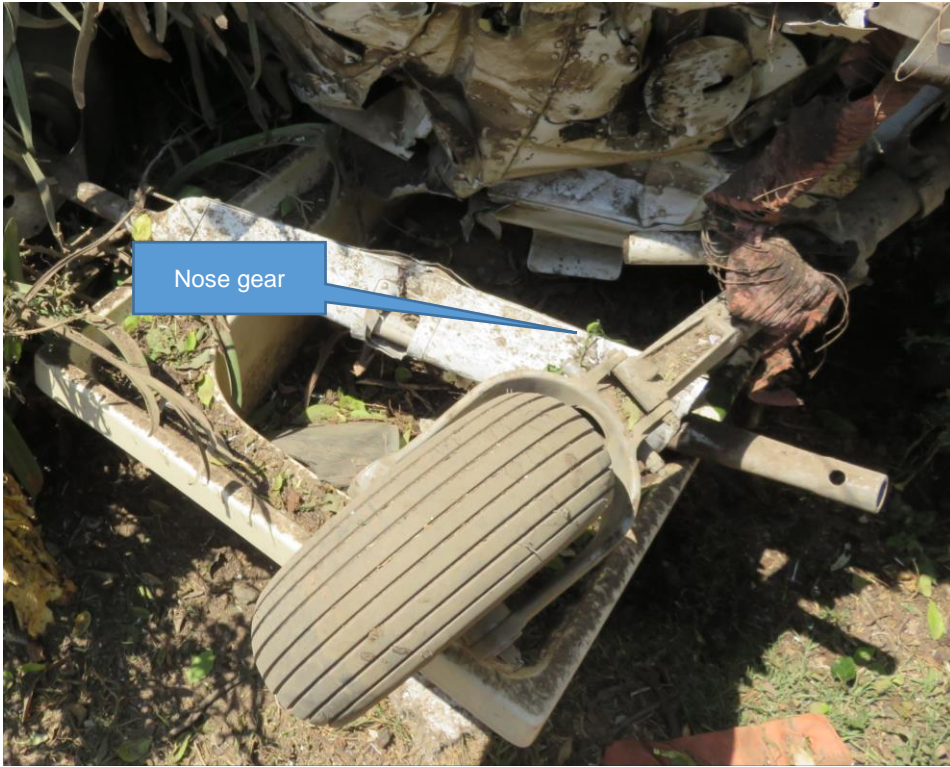
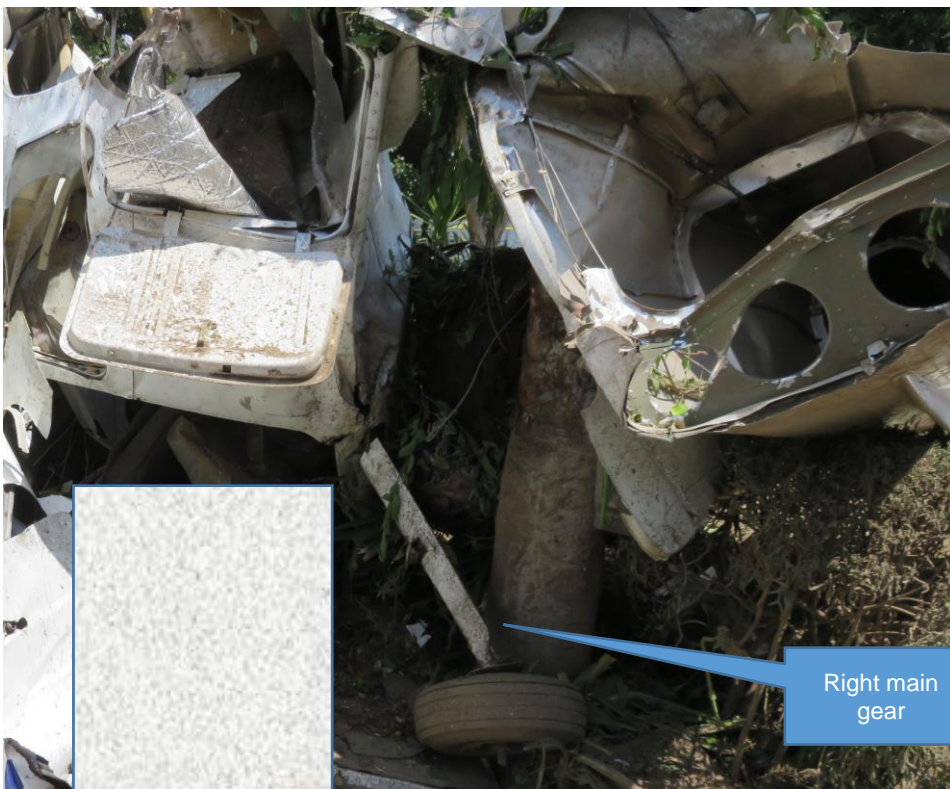
Landing Gear

The nose gear remained attached to the aircraft. The tyre and hub remained in satisfactory condition. The left main landing spring strut remained in place despite its mount breaking. The right main gear had broken off and was found near the wreckage. Based on the inspection carried out, it was ascertained that all damage to the landing gear occurred during the accident sequence and no prior defects could be identified.

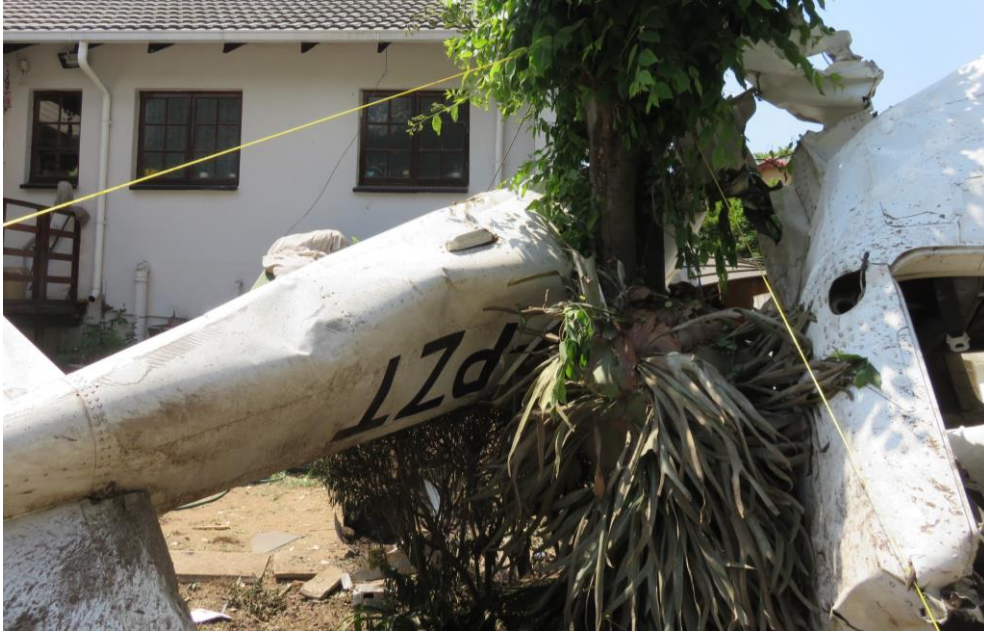
Fuselage and Cabin Area

The fuselage had broken into half behind the baggage compartment after impacting a tree during the accident sequence. The rear half of the fuselage remained largely intact although denting of the skin was prevalent.

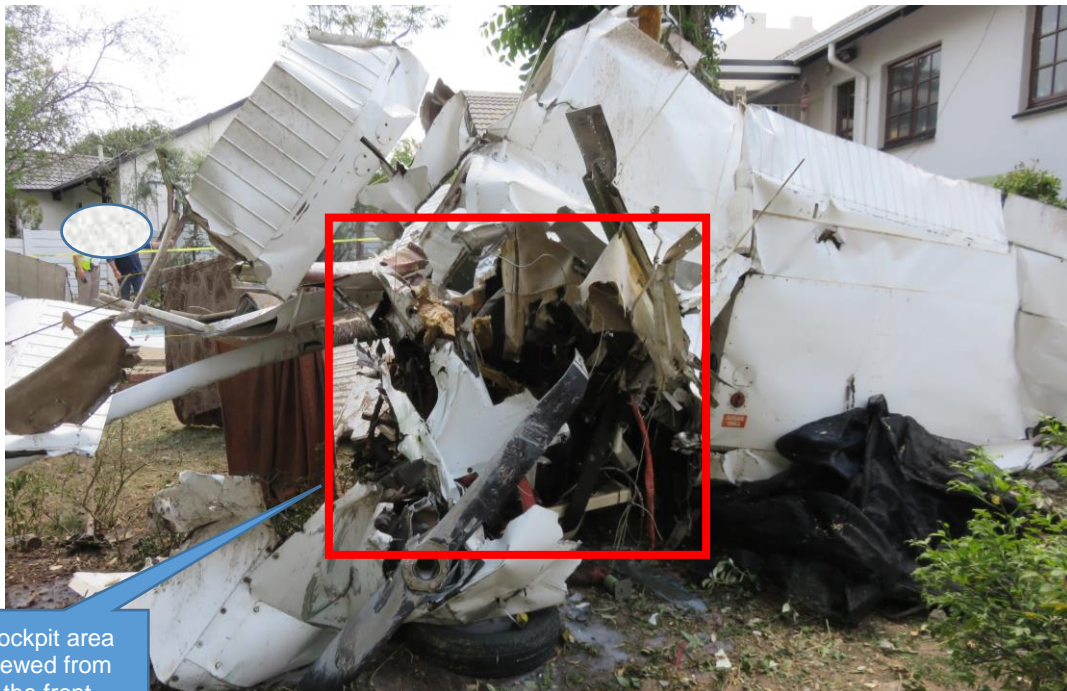
Cockpit area
viewed from
the front

The cabin area had partially collapsed due to the aircraft coming to rest in a nose down attitude. Both cabin doors had failed at the hinge points and all the Perspex windows had shattered. The engine had broken from its mounts and pushed through the firewall into the cockpit. The instrument panel mounts had broken, causing the panel to detach. The forward portion of the cockpit was crushed.
