AIRCRAFT ACCIDENT SHORT REPORT

CA18/2/3/9743, ZS-RHY, Unsuccessful forced landing on mountainous terrain following a decay in main rotor RPM.

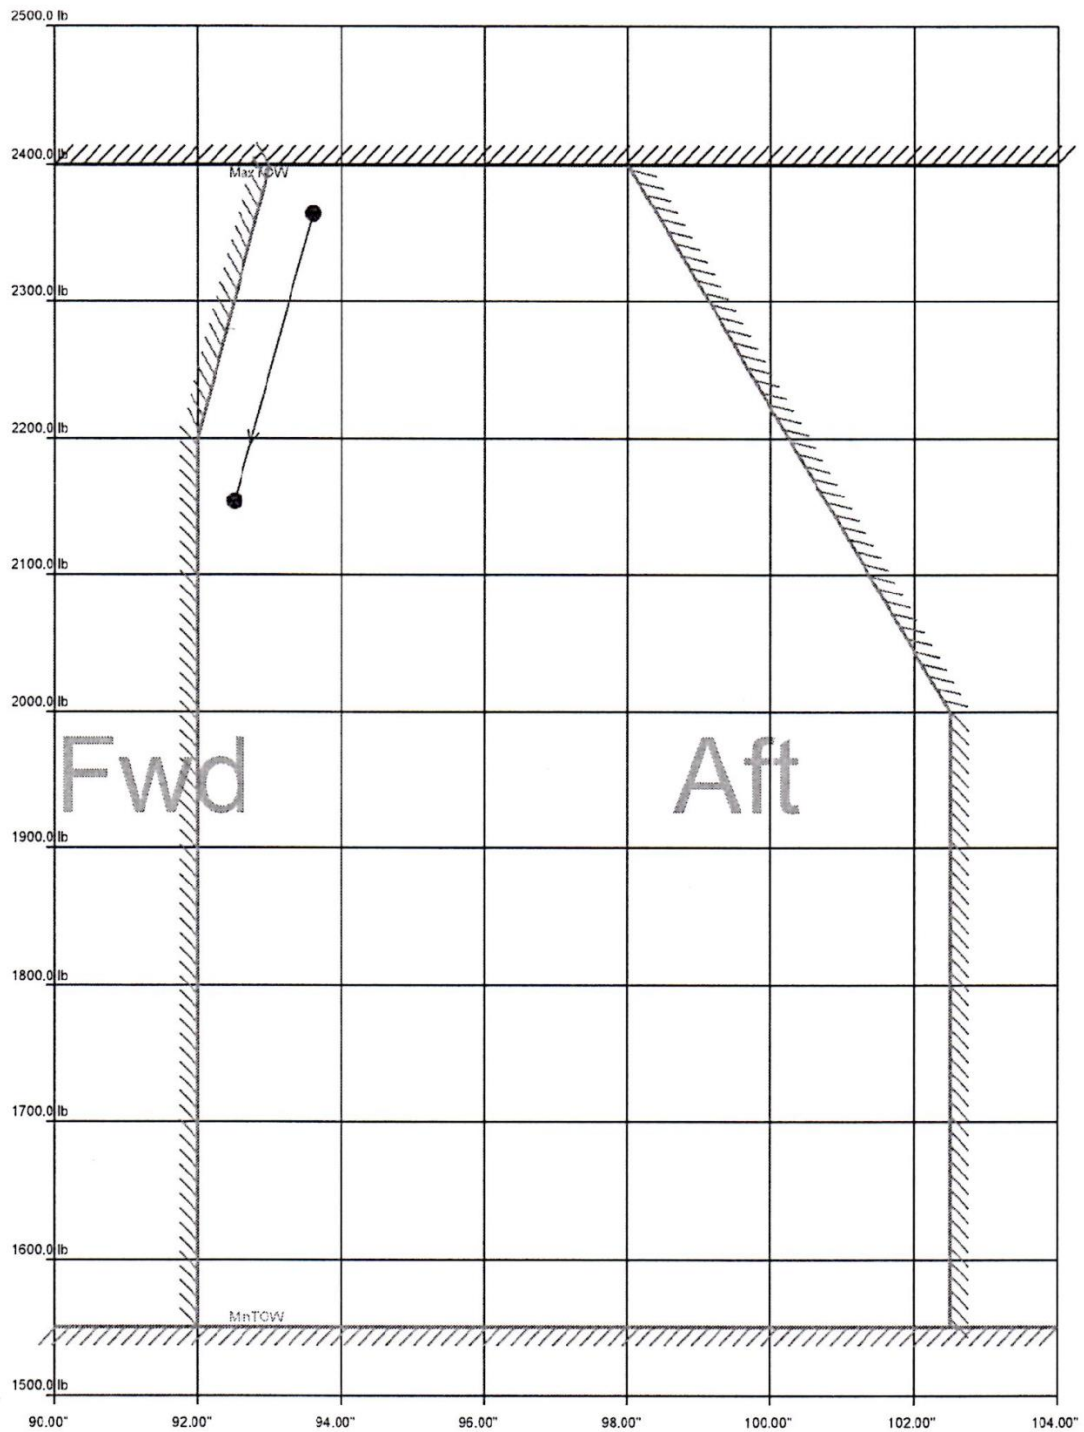
Figure 1: WB calculation

2.1.6 The pilot was requested to submit a detailed weight and balance (WB) calculation for the accident flight. The information in Figures 1 to 3 was obtained from the pilot. The maximum take-off weight for this helicopter, according to the pilot's operating handbook (POH), section 2, was not allowed to exceed 2 400 lb (1 089 kg). According to the WB calculation, the helicopter was operated at 36 lb (16 kg) below its maximum gross weight.

- 3.5 The helicopter was 36 lb (16 kg) below its maximum take-off weight of 2 400 lb (1 089 kg) during take-off on the accident flight.
- 3.6 According to the CG graphs in Figures 2 and 3 of this report, the helicopter was loaded within the allowable limits as per the POH.

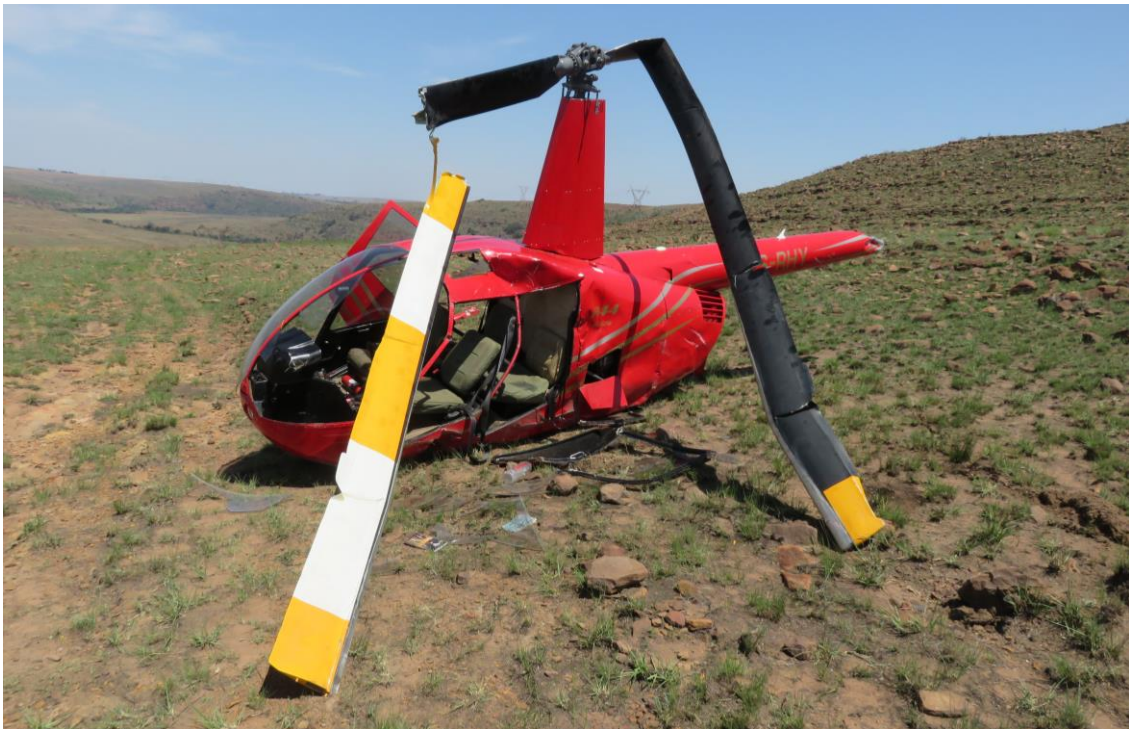
The pilot opted to execute a skid-on landing on open rocky terrain. The aircraft touched down on a heading of 110°M. Evidence from the impact sequence was that the skids touched down on the rocks and due to the excessive forces associated with hard ground contact, the skid gear broke off (Figure 4). The helicopter then remained in an upright position and skidded for a distance of approximately 6 m on its lower fuselage before it turned to the right and rolled over to the left after the main rotor blades had severed the tail boom. The tail boom assembly and the tail rotor drive system (comprising the tail rotor hub assembly, which was still attached to the tail rotor gearbox, and some deformed sections of both tail rotor blades) were found lying on the right-hand side of the fuselage. The collective pitch lever was found to be in the full-up position and the fuel shut-off valve was found to be in the closed position. The pilot stated that he and the other two adult passengers turned the fuselage upright after disembarking from it. The main fuel tank was approximately $\frac{3}{4}$ full and the auxiliary tank approximately $\frac{1}{2}$ full. The fuel levels of the two fuel tanks were measured using the dipstick method, with the helicopter in the attitude as seen in Figures 4 to 6.

Figure 4: The helicopter as it came to rest and after it was picked up and placed in an upright position

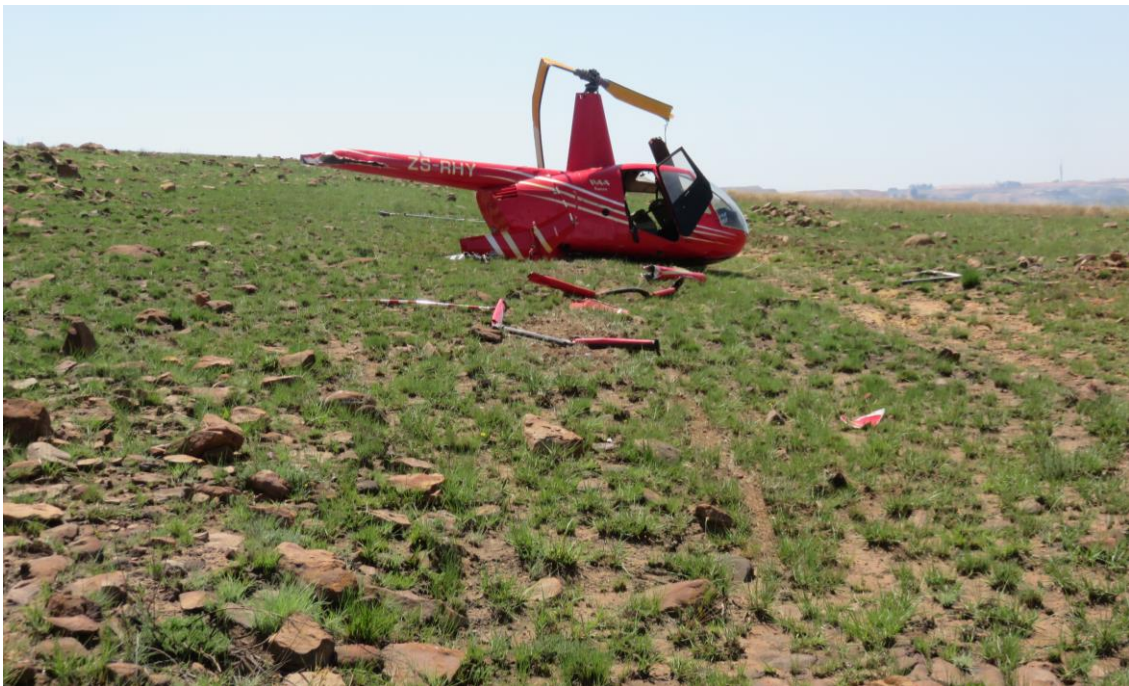
Figure 5: Showing the forward and aft skid gear cross tube assemblies

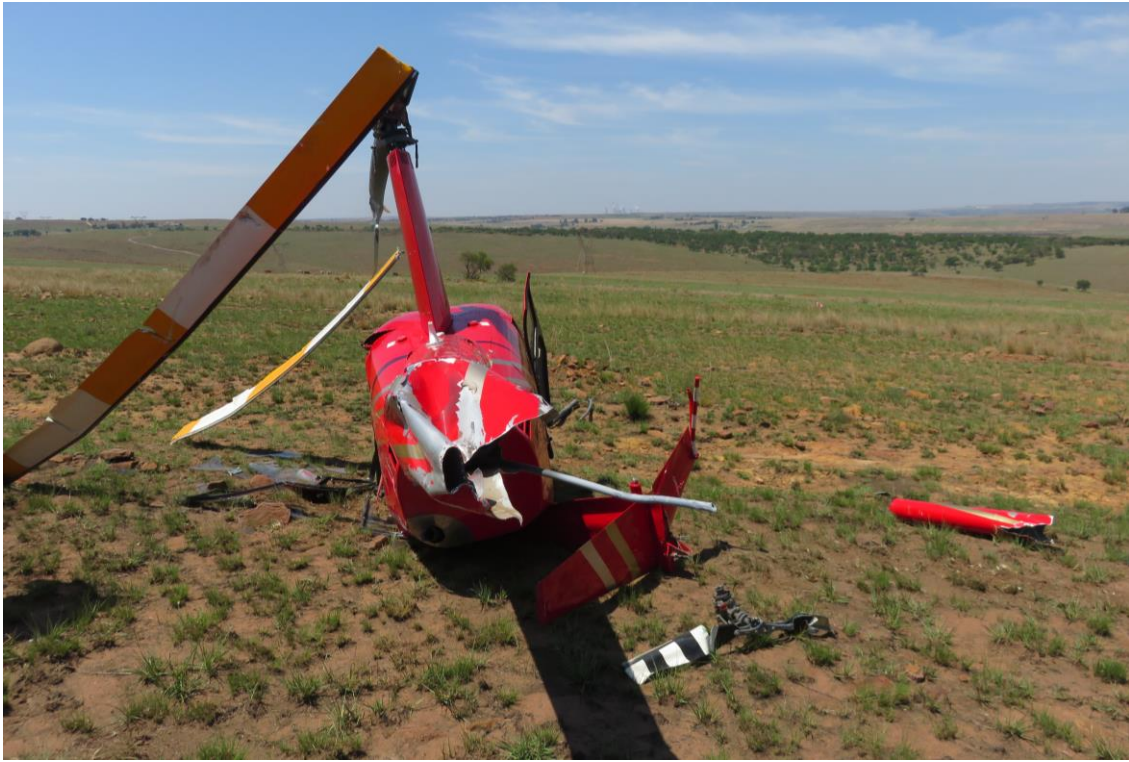
Figure 6: An aft view of the main wreckage, facing in a southerly direction

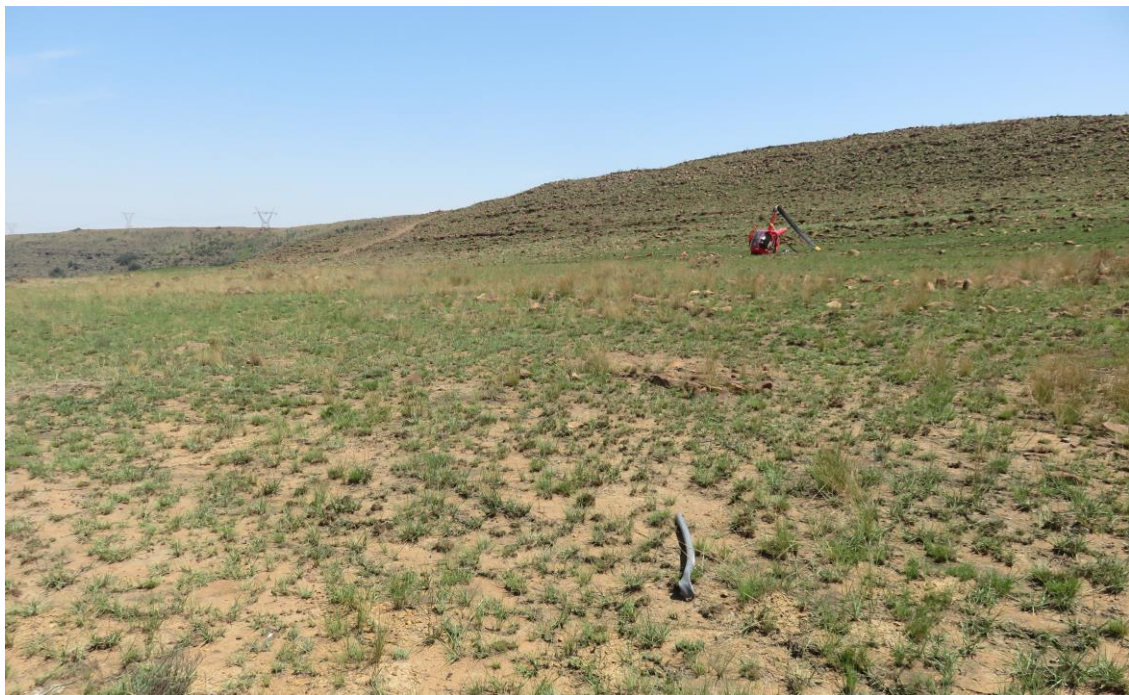
Figure 7: A view of the terrain (high ground)

- 5.2 The prevailing wind conditions and flying on the leeward side of the high ground had a direct effect on the flight characteristics of the helicopter, as a down-draught was encountered.
