AIRCRAFT ACCIDENT REPORT AND EXECUTIVE SUMMARY

Reference:	CA18/2/3/9748	
Aircraft Registration	ZS-PBR	Date of Accident	9 November 2018		Time of Accident	1620Z	
Type of Aircraft	Partenavia P68C-TC		Type of Operation		Test flight (Part 43)		
Pilot-in-command Licence Type	Commercial Licence		Age	34		Licence Valid	Yes
Pilot-in-command Flying Experience	Total Flying Hours		1514.7		Hours on Type	4.9	
Last point of departure	Lanseria Aerodrome (FALA) Gauteng Province						
Next point of intended landing	Lanseria Aerodrome (FALA) Gauteng Province						
Location of the accident site with reference to easily defined geographical points (GPS readings if possible)							
Hartebeesfontein Road at GPS 25°51'14.15" South 027°37'25.41" East, at an elevation of 4 206 feet							
Meteorological Information	Wind: Variable at 5kt, Temp 26°C, Dew point 6°C, Visibility 10km.						
Number of people on board	1+0	No. of people injured	0	No. of people killed	0		
Synopsis	<p>On 9 November 2018 at 1320Z, a pilot took off from Lanseria International Airport (FALA) following a mandatory periodical inspection (MPI), the flight was conducted as a maintenance check flight with the intention to land back at FALA.

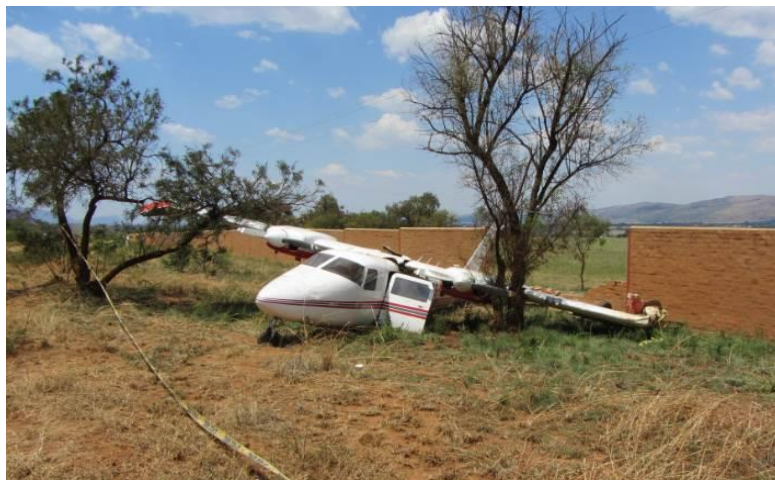
Figure 1: Aircraft as it came to rest.

1.4.1 Limited to a section of a perimeter wall as can be seen on Figure 1.

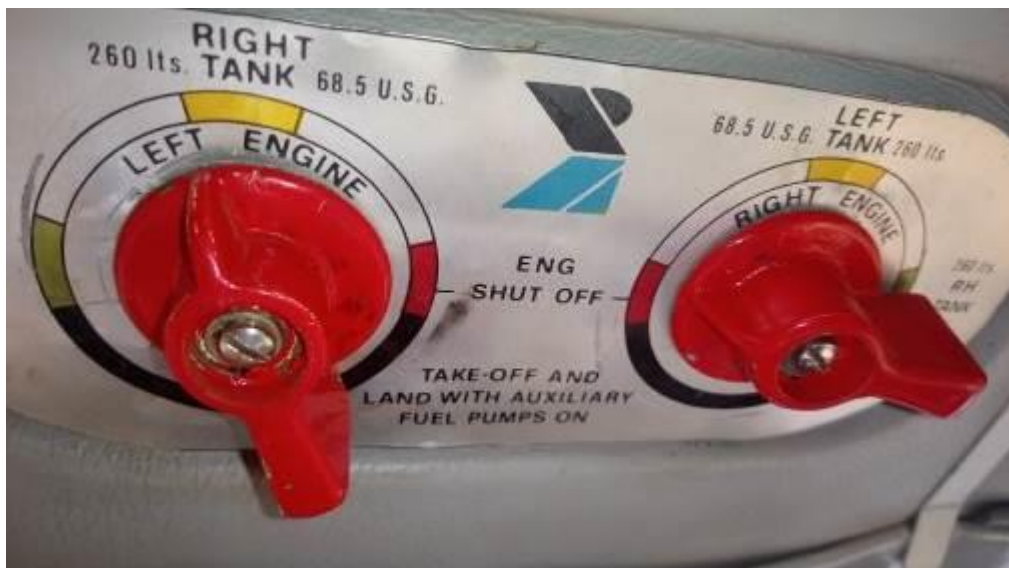
Figure 4: Positon of the fuel valve selectors as found at the accident site.

position of the engine fuel supply valve selectors as found on the scene were as follows: the left engine fuel selector control knob was pointing intermediate between the left- and the right-hand tank position; the right-hand engine fuel selector control knob was pointing to the shutdown position, the left-hand engine fuel selector control knob was stuck in the intermediate position between the left- and the right-hand tank position and could not be rotated, the right-hand engine fuel selector control knob was moving freely. All switches for the fuel pumps were in the off position. All circuit breakers were pushed in, except those that were intentionally pulled out and secured with cable ties.

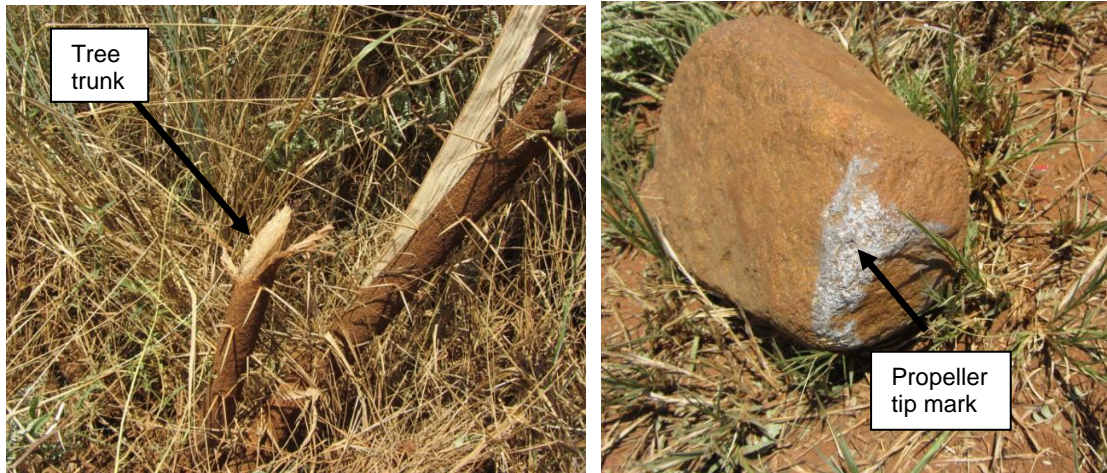
At approximately 54.8m from the tree that was severed, a rock was found with metal imprints and shavings, indicative of impact with the rotating left-hand propeller as seen in Figure 7. Small rocks on the left-hand side of the road also showed metal shavings and impact marks.

Figure 6 & 7: A small tree trunk severed by the left-hand propeller and a small rock with propeller tip marks.

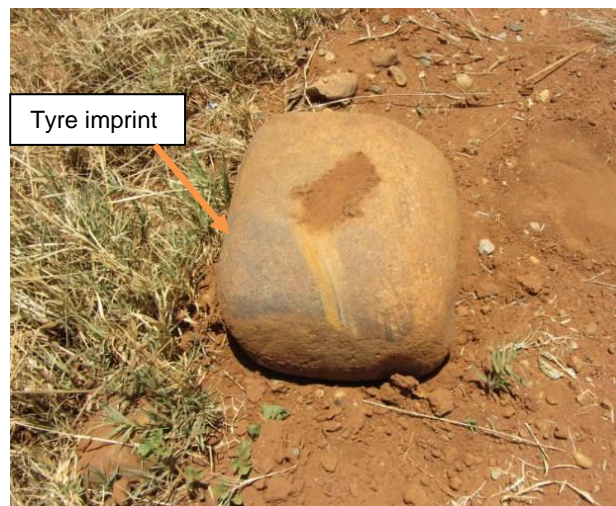
Figure 8: Tyre imprint on the rock surface.

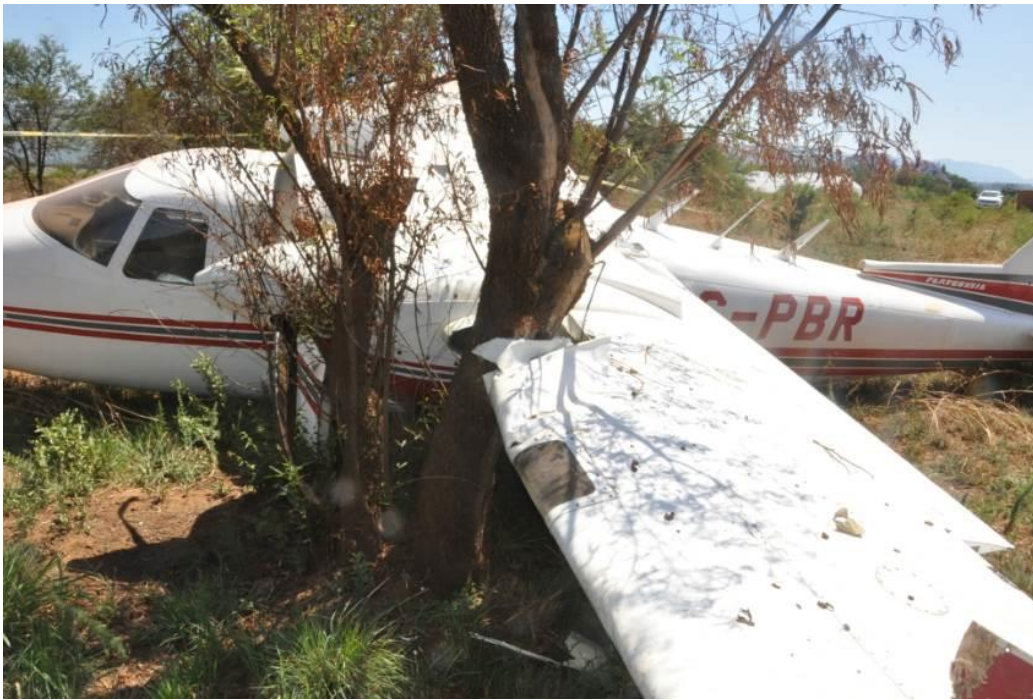
1.12.2 The aircraft left a trail of skid marks on the left side of the road, indicating heavy braking covering 97.6m from the first point of touchdown. It was noted that rocks on the left edge of the road had tyre imprint marks as shown in Figure 8. At approximately 112m, from touchdown, the left landing gear strut assembly impacted an embankment and separated from the fuselage. It was noted that according to the ground marks, the aircraft veered to the left of the road after the left strut separated. The aircraft skidded on its belly and right wheel before the leading edge of the right wing impacted a tree. This caused the aircraft to ground loop to the right. The left-wing tip impacted the perimeter wall first before the leading edge collided with another tree, which stopped the ground loop. The aircraft came to rest facing north north-west. The distance from the first point of impact and where the aircraft came to rest was 280m.

Figure 9: Aircraft after it came to rest.

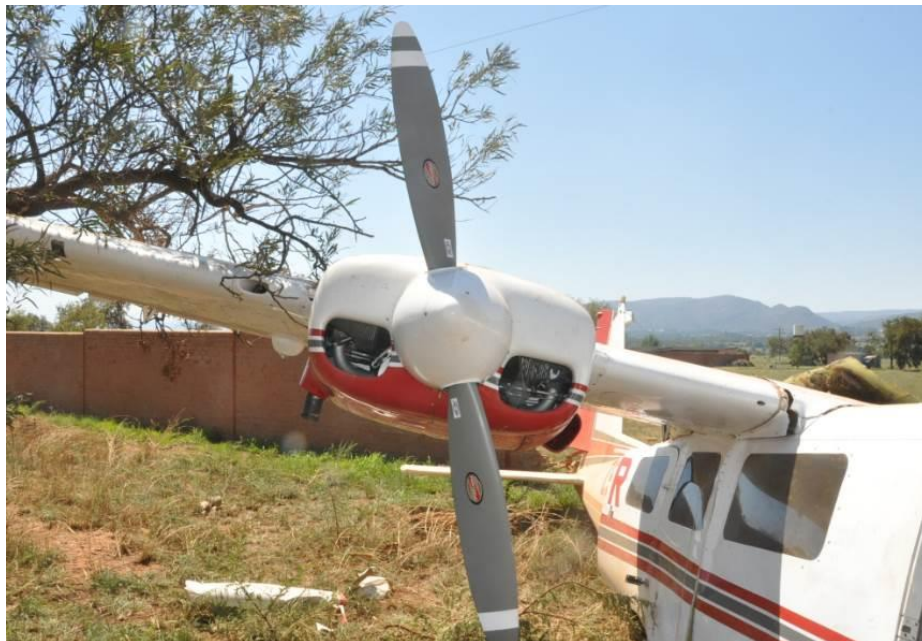
1.12.3 Investigation of the right-hand propeller revealed that the propeller was still intact, and the blades were at fine pitch. The right-hand engine was rotated, and it turned freely when the propeller was turned in the direction of rotation. The right-hand tank was drained from the purge valve and there was no fuel seeping out. The right-hand wing had substantial damage on the leading edge as well as at attachment point to the fuselage. The right-wing tip was also damaged during collision with the trees. The flaps were found selected in the up position and were still intact. Ailerons were checked for free movement by moving the yoke to the left and right, and the movement of the ailerons was found to be normal.

Figure 10: The right-hand propeller.

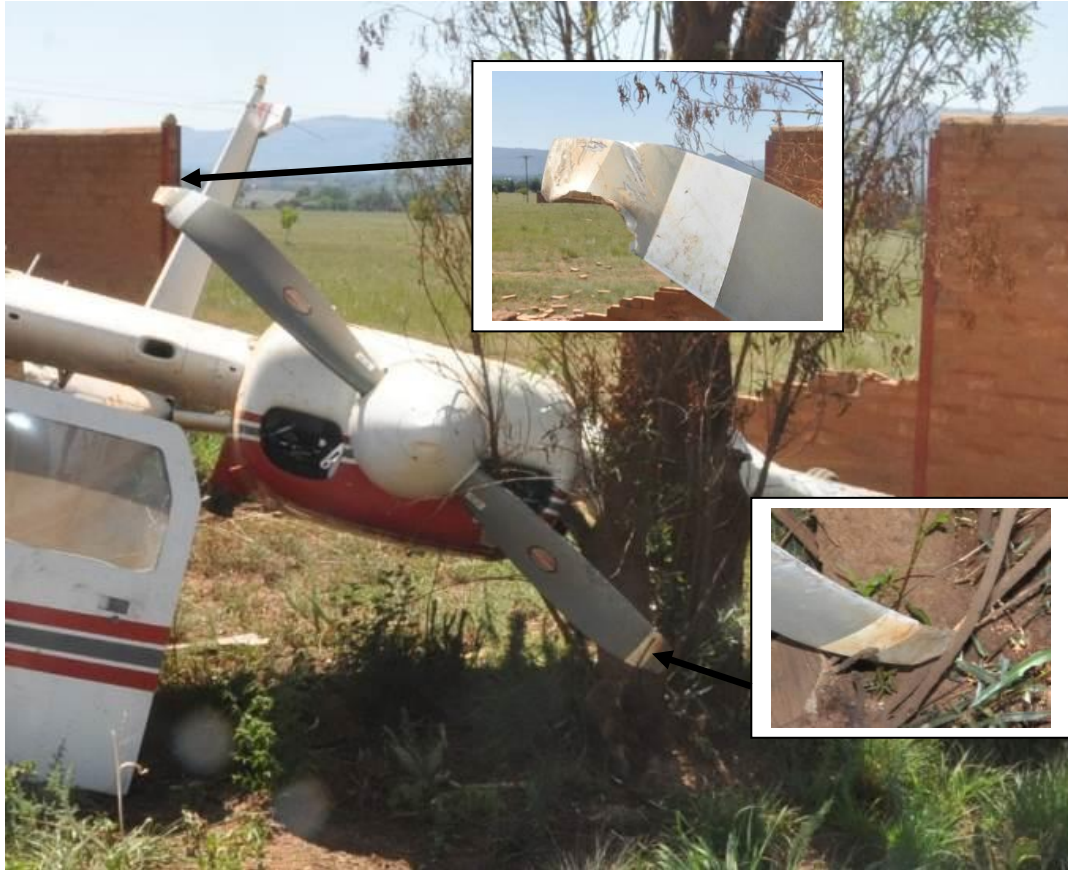
1.12.4 It was noted that the left-hand propeller had significant impact damage on both tips, which were bent backwards with the blades at fine pitch. The propeller blades had deep score marks across the face from the leading edge to the trailing ledge at a 45° angle. The propeller was turned by hand in the direction of rotation, and the engine was turning freely. The left wing had impact damage on the leading edge and the wing tip was substantially damaged. On-site inspection of the outside condition of both engines did not reveal any malfunctions.

Figure 11: The left-hand propeller.

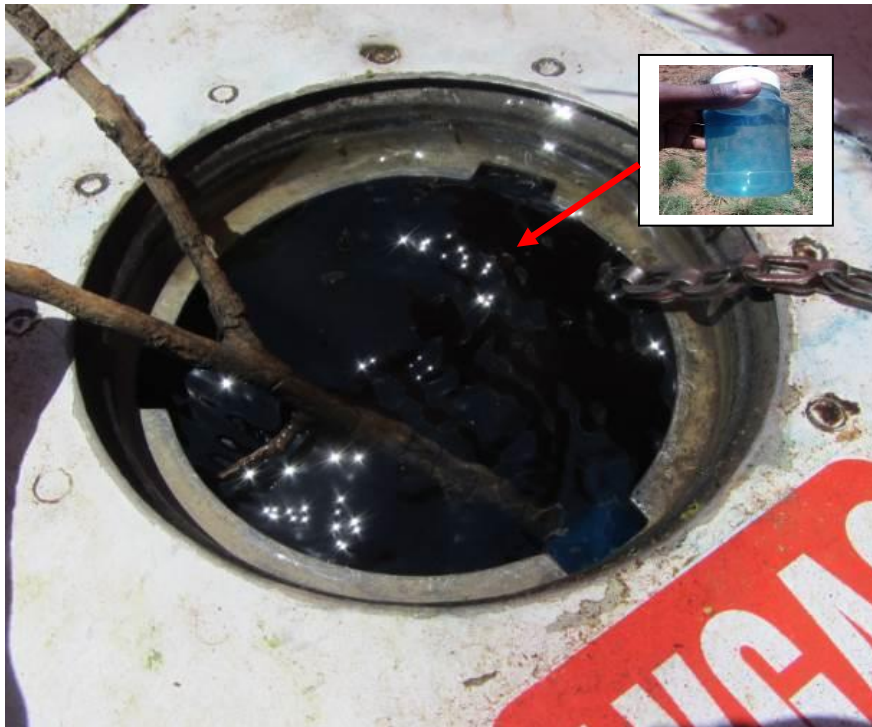
Figure 12: Fuel in the left tank.

1.16.4 According to the technical report by the approved AMO who recovered the aircraft, ample fuel was drained from the left tank during the recovery of the aircraft. The right-hand tank was empty. The external conditions of the engines were inspected in accordance with maintenance manual and were found to be satisfactory according to the AMO. This was confirmed by the on-site investigation.

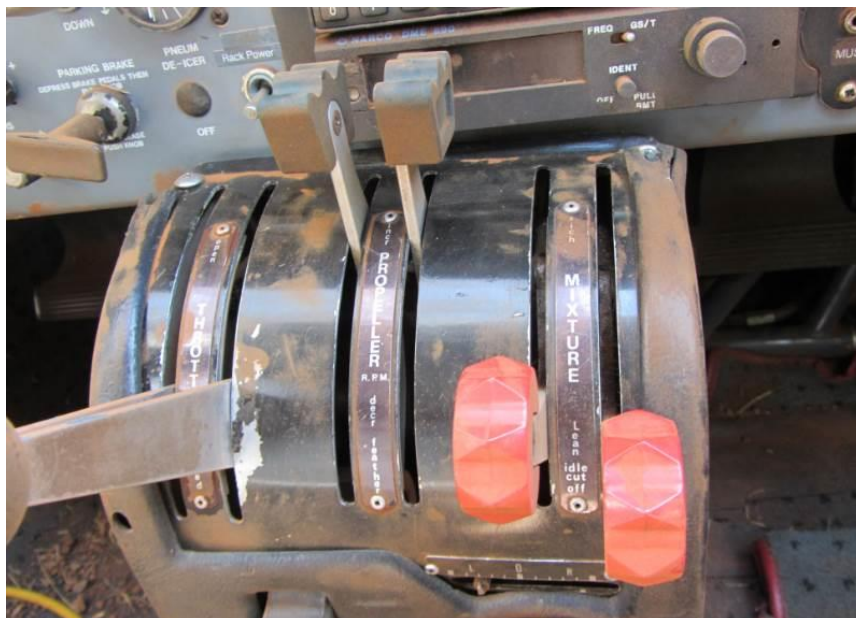
Figure 13: Engine and propeller controls (as found on the accident site).

1.12.6 The instrument panel inside the cockpit was still intact and all instruments were in their correct positions. The positions of the engine control levers as found on the scene of the accident were as follows: the mixture levers were in the idle cut-off position, the propeller pitch control levers were in the fine pitch position, and the throttle control levers were in the off position. The upper console was still intact. The

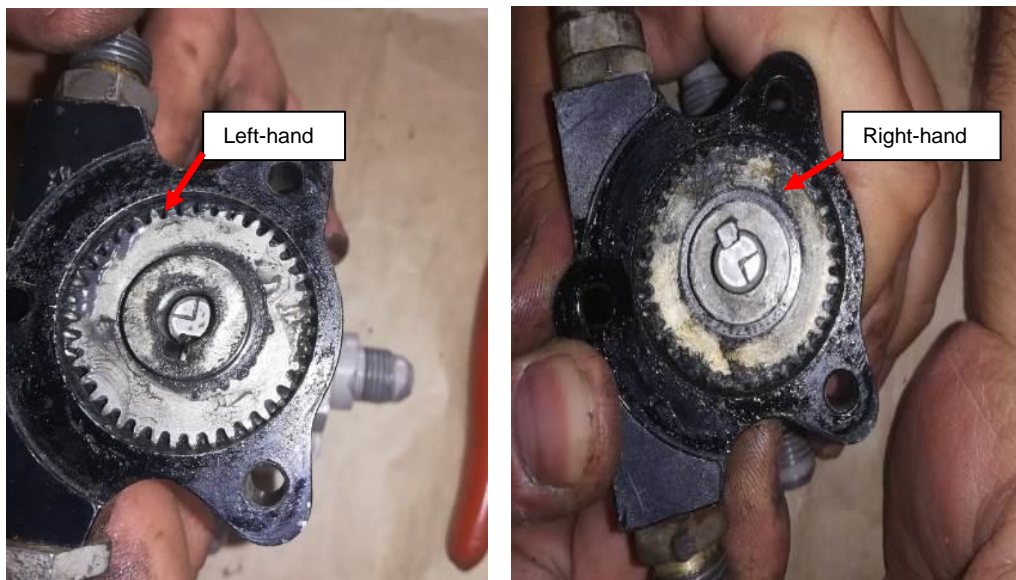
1.16.1 Both the left- and the right-hand engine fuel selector valves were recovered and subjected to teardown examination at an approved AMO during the presence of the investigators. The right-hand fuel valve outside condition was not in a good condition as compared to the left-hand one as shown in Figure 14 and 15.

Figure 14 & 15: The worm wheel for left-hand and right-hand selector valve.

1.16.2 Figures 14 and 15 show the left- and right-hand selector valve worm wheel which was recovered and subjected to an inspection. The flex cable for the left-hand selector valve exhibited a kink 23mm from the beginning of the retainer nut for the conduit when the Teleflex cable was at minimum position stop. This kink was affecting freedom of movement of the Teleflex cable as it was binding inside the conduit and worm wheel casing during the selection, which was consistent with the selector valve in the cockpit. The selector valve was stuck in position to feed from the right-hand tank. During the teardown of the left-hand selector valve, it was noted that the conduit was out of its position and not retained by the nut. The conduit was not flared at the end as compared to the right-hand side one. During operation of the cable via the control knob, it was noted that the cable moved with the conduit during operation. During test, it was noted that the conduit was not flared as compared to the right-hand side as depicted in the Figures 16 and 17. Both valves exhibited good operation and inside conditions were good. The left-hand worm wheel revealed signs of insufficient lubrication whereas the right-hand worm wheel showed signs of enough lubrication inside it. The rest of the inspection report is appended in this report as Appendix A.

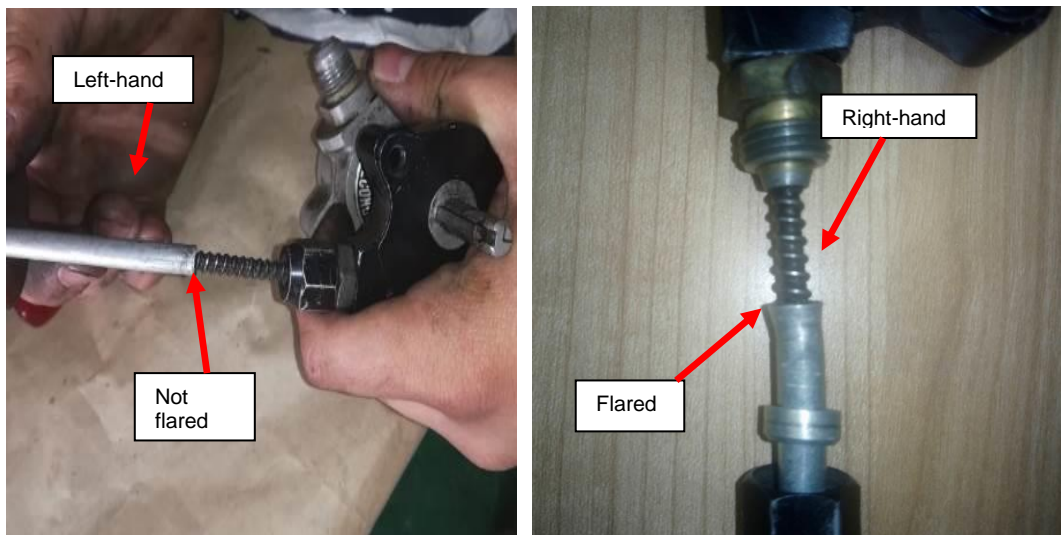
Figure 16 & 17: The left-hand and right-hand conduit.

- 2.2.6 The left Teleflex cable conduit, which is a link between fuel selector in the cockpit and the fuel selector valve in the fuel system, had failed on its attachment bolt. This resulted in the cable which ran inside the conduit forming a kink and causing the left tank selector valve to have a partial movement when opened, closed or selected to cross-feed. The manufacturer issued a service bulletin (SB) 113 which mandated fuel selector control system detailed inspection at 100 hours intervals. Although the AMO indicated that they had incorporated SB 113 as part of the MPI, there was no evidence of the incorporation of SB 113, which could have prevented the failure of the Teleflex cable.

The L/H flexible cable was stuck, and no amount of pressure could move the cable. When we removed the selector off the mount assembly, we found that the cable guide tube was able to pull out of the lock nut attaching the cable guide tube to the fuel control receiver. The fuel control cable was kinked inside the guide tube, thus binding the cable to the guide tube. We also found that there was no lubrication visible on the cable and the gear mechanism inside the fuel control receiver. Once we had straightened the cable the movement was easy and could be pushed in by hand.

The lack of lubrication and the kinked cable was the cause of the non-movement. The kinked cable was caused by the Cable Guide Tube not having the end flared to stop the guide from pulling out of the attachment nut. The mechanism inside the selector mechanism was stuck in a partial opening for cross feed operation but restricted due to the valve not moving all the way to the open the valve to have complete flow. The valve was stuck in a partial fuel shut off position thus restricting the flow to the L/H engine.

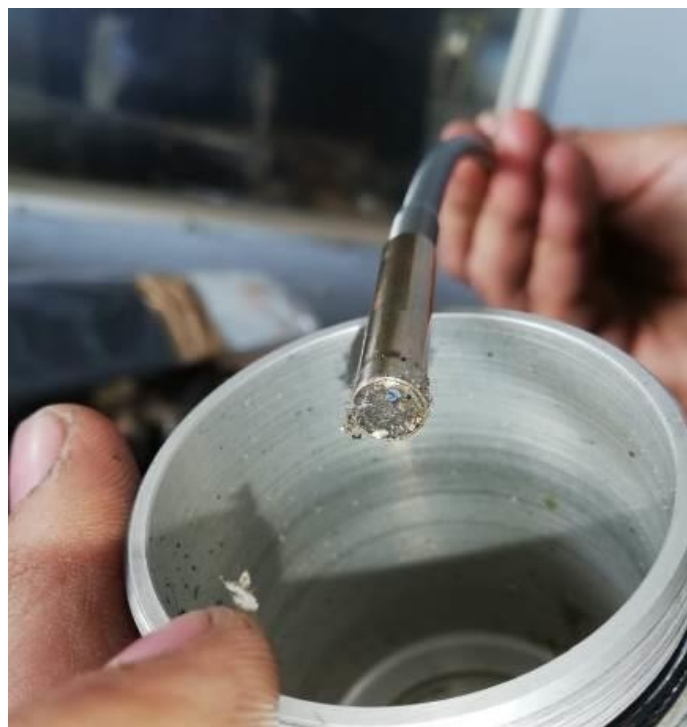
1.16.3 Both fuel filters were recovered and subjected to teardown inspection by an approved AMO. Both filters were opened and checked. There were metal filings and sand as seen in the Figure 18 below. The creases of the micron filter had metal fillings and had sand stuck to it. The teardown inspection report is attached as Appendix A.

Figure 18: Debris and metal filings.

When disassembling the Gascolators, we found it very difficult to unscrew, loosen, the bowl from the head. Once the assembly was apart, we found the bowls to have debris in them. The debris consisted mostly of metal filings and sand, silica. The creases of the micron filter had debris stuck in the folds. It is in our opinion that the filter had not been cleaned in a while or that the aircraft was refueled by means of Jerry cans or drums.
