AIRCRAFT ACCIDENT SHORT REPORT

CA18/2/3/9751: The aircraft's engine experienced a power loss during a climb.

Date and time	: 18 November 2018, 0743Z
Aircraft registration	: ZS-BUA
Aircraft manufacturer and model	: DE Havilland Aircraft Company, DH-82a Tigermoth
Last point of departure	: Krugersdorp Aerodrome (FAKR), Gauteng Province
Next point of intended landing	: Krugersdorp Aerodrome (FAKR), Gauteng Province
Location of accident site with reference to easily defined geographical points (GPS readings)	: GPS coordinates: 26°5'24.5" South, 027°42'37.89" East
Meteorological Information	: Surface wind: 330° at 11kts; temperature: 29°C; dew point: 9°C; QNH: 1023
Type of operation	: Private (Part 91)
Persons on board	: 1 + 0
Injuries	: Nil
Damage to aircraft	: Substantial

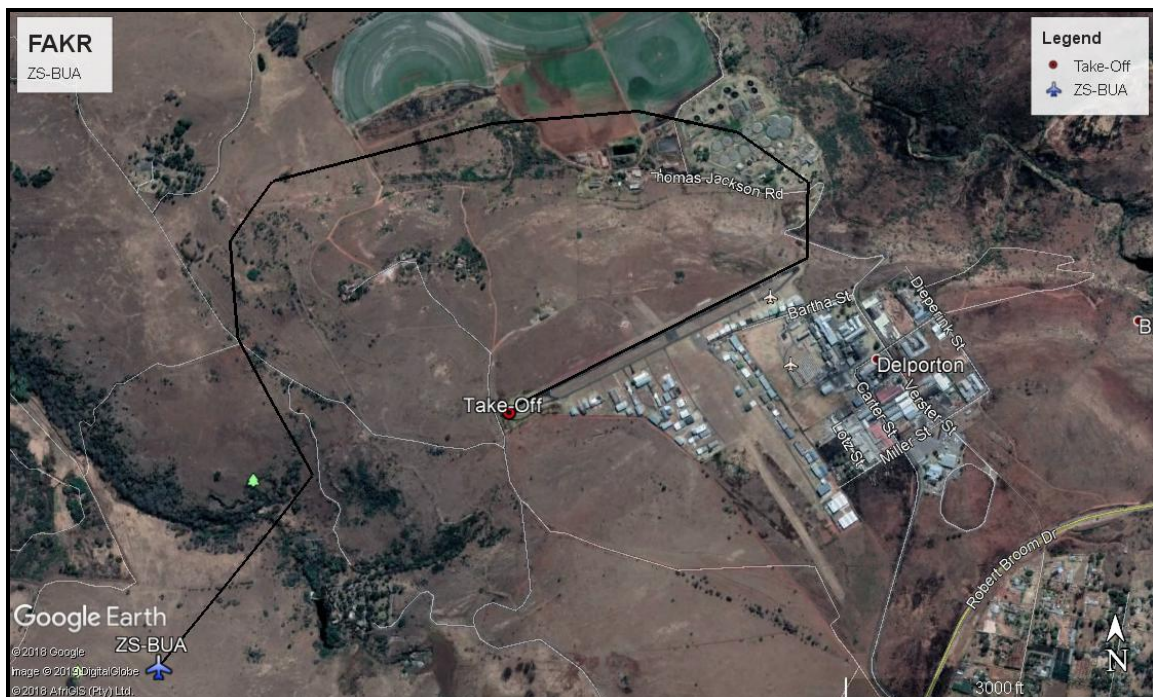
Figure 1: Flight path from take-off to accident site

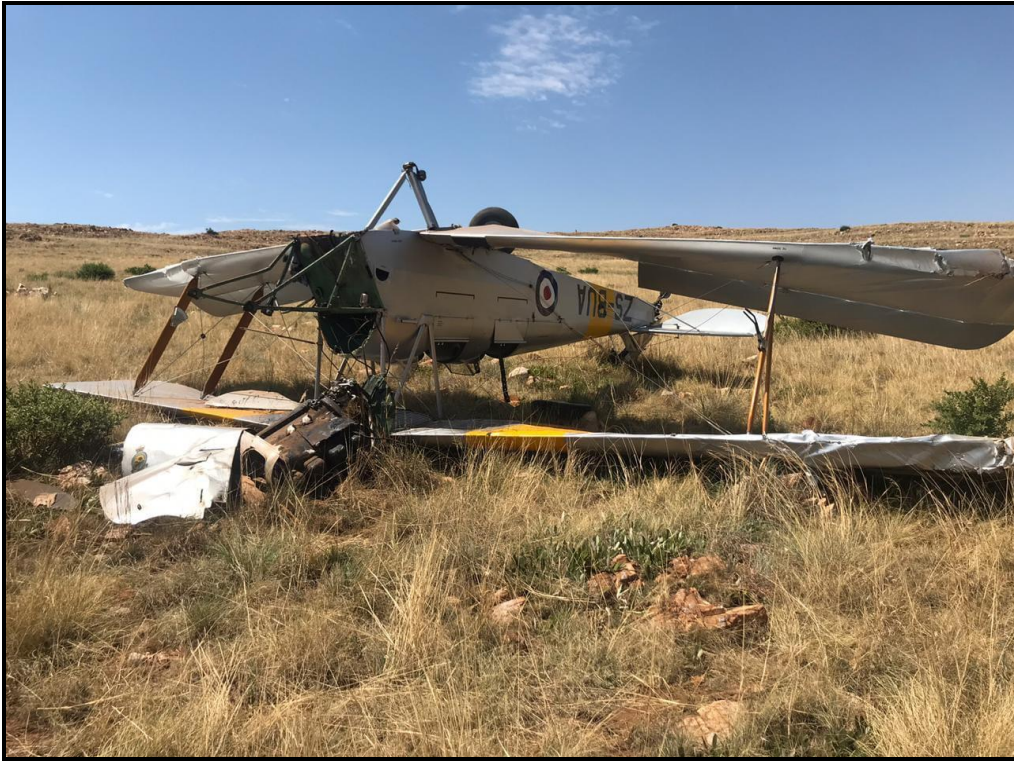
- 1.2 At this point, the pilot broadcasted an emergency. After realising that he could not land on the terrain ahead, he decided to turn onto downwind leg for Runway 08. He further stated that he suspected carburettor icing as a cause of the engine power loss. He decided to move the throttle backwards to clear the ice in the carburettor. He then opened the throttle to maximum again in order to climb so as to reach Runway 08 and the RPM gauge reading rose to a maximum of 2000. On the base leg, the engine RPM dropped to 1400rpm. The aircraft was continuously losing height as the pilot was attempting to restore the engine power and during the three turns to the left in an attempt to reach Runway 08. After realising that the aircraft will not reach Runway 08, the pilot decided to turn the aircraft to a south-westerly direction and cut off the fuel, switched off the magnetos and closed the throttle for an emergency landing. The aircraft landed on a rocky terrain and rolled for approximately 75 metres (m) before colliding with a rocky ridge. It rolled again for a further 10m before nosing over and coming to rest in an inverted position.

Figure 2: The aircraft as it came to rest

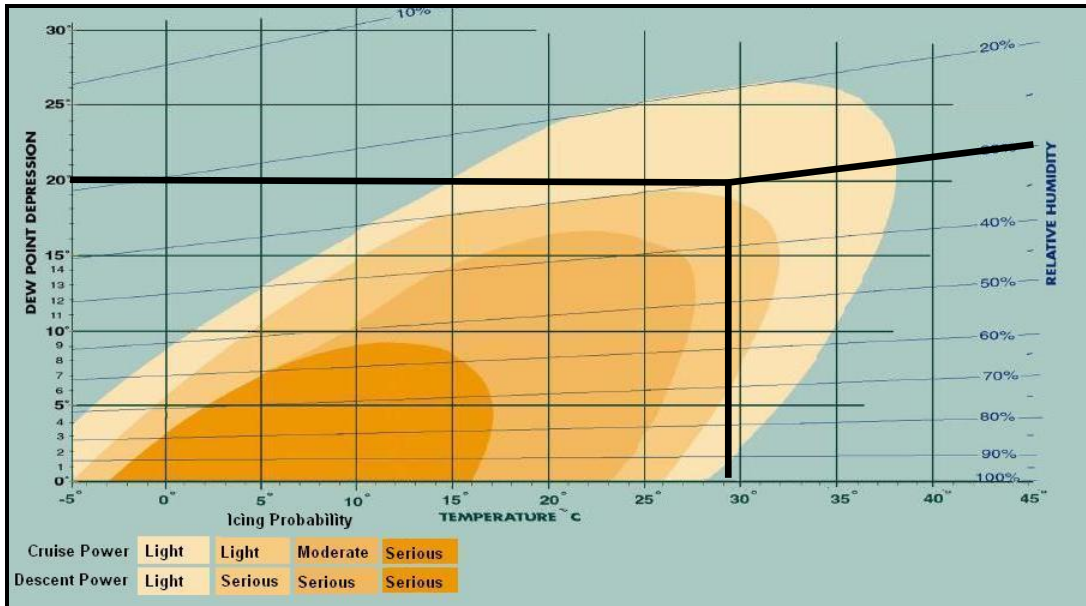
2.4 The temperature at the time of accident was 29°C and dew point was 9°C which equates to a dew point depression of 20°C. The probability of icing would have been light at cruise and descent power and the relative humidity would be 29%.

Figure 3: Carb icing probability chart

- 3.7 The weather at the time of the accident was as follows: wind 330°11KT; temperature 29°C; dew point 9°C; QNH: 1023.
- 3.8 The pilot had suspected that the cause of the engine losing power could have been carburetor icing, but after considering the weather conditions at the time of the accident, the investigation team concluded that there was a small probability of carburetor icing. The pilots operating handbook (POH) does not have warning of carburetor icing and, considering the temperature at that time and altitude of the aerodrome, there was no reason for the pilot to suspect carburetor icing.
