<b>AIRCRAFT ACCIDENT SHORT REPORT</b>
---------------------------------------

**CA18/2/3/9752: ZS-RPV, The helicopter landed hard due to turbulence at the peak of the mountain.**

<b>Date and time</b>	:19 November 2018, 0732Z
<b>Occurrence type</b>	:Accident
<b>Aircraft registration</b>	:ZS-RPV
<b>Aircraft manufacturer and model</b>	:Robinson Helicopter Company, R44
<b>Last point of departure</b>	:Witfontein, Western Cape Province
<b>Next point of intended landing</b>	:Geelhoutboom Mountain, Western Cape Province
<b>Location of accident site with reference to easily defined geographical points (GPS readings if possible)</b>	:GPS coordinates: 33°53'54.4" South, 022°22'18.3" East
<b>Meteorological Information</b>	:Surface wind: 140° 6kts variable from 080° to 190°, visibility: 9999, temperature: 20°C, dew point:14°C, cloud cover: FEW, cloud base: 1500ft, QNH: 1012
<b>Type of operation</b>	:Commercial (Part 127)
<b>Persons on board</b>	:1 + 1
<b>Injuries</b>	:Nil
<b>Damage to aircraft</b>	:Substantial

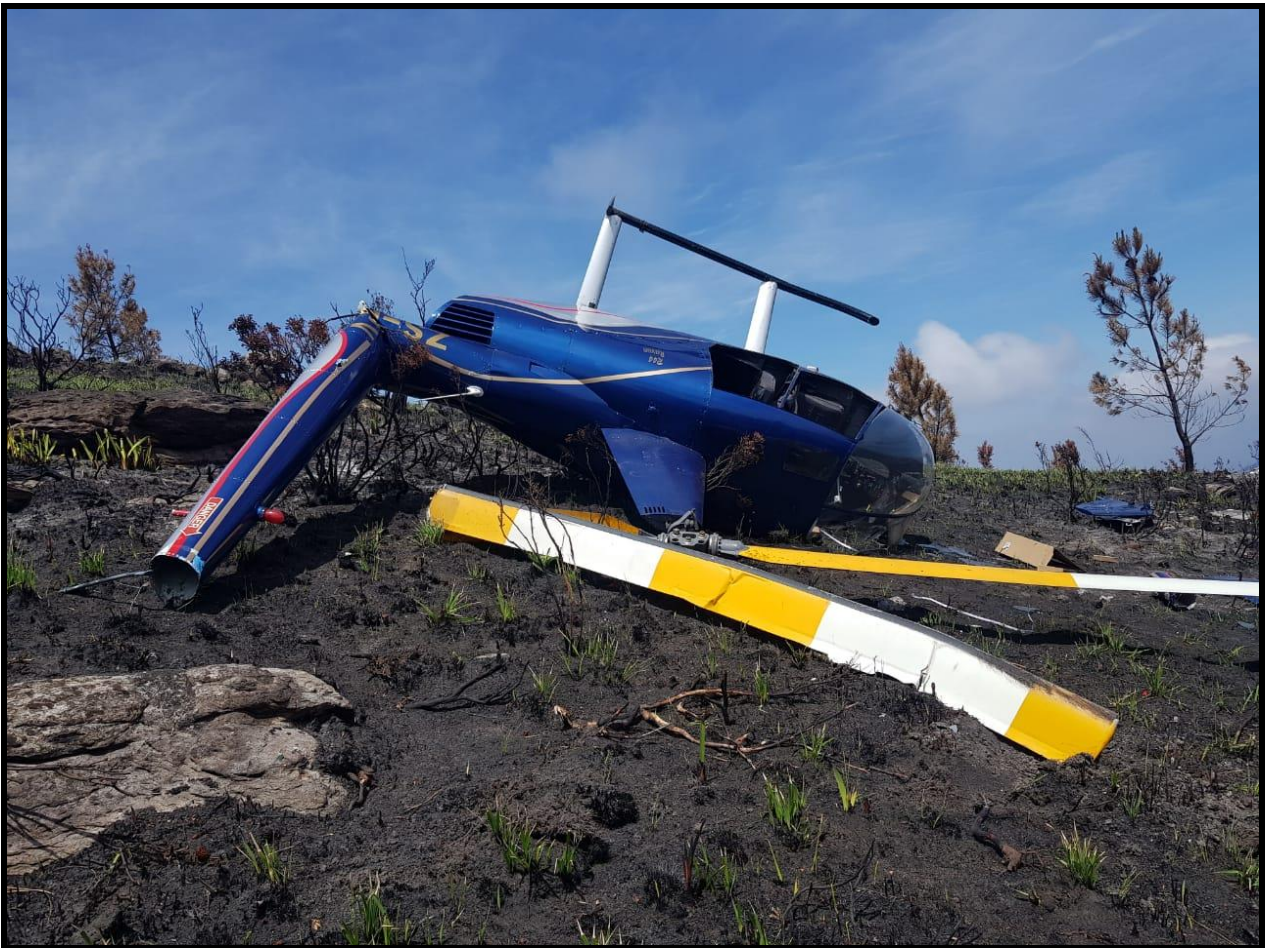
Figure 2: The helicopter as it came to rest

- 2.3 The helicopter sustained damage to the main rotor blades, swashplate, main rotor gearbox, fuel tanks, tail boom, tail rotor, cabin and skids. The pilot and passenger were not injured.
- 2.4 The accident occurred during daylight conditions at a geographical position that was determined to be 33°53'54.4" South 022°22'18.3" East at an elevation of 3 900ft above mean sea level (AMSL).

- 4.10 The investigation concluded that at low level the helicopter experienced a sudden downdraft and lost translational lift during landing and impacted with a protruding rock on the top of the mountain. Contributory factor is due to the helicopter being too close to the ground for a safe recovery.

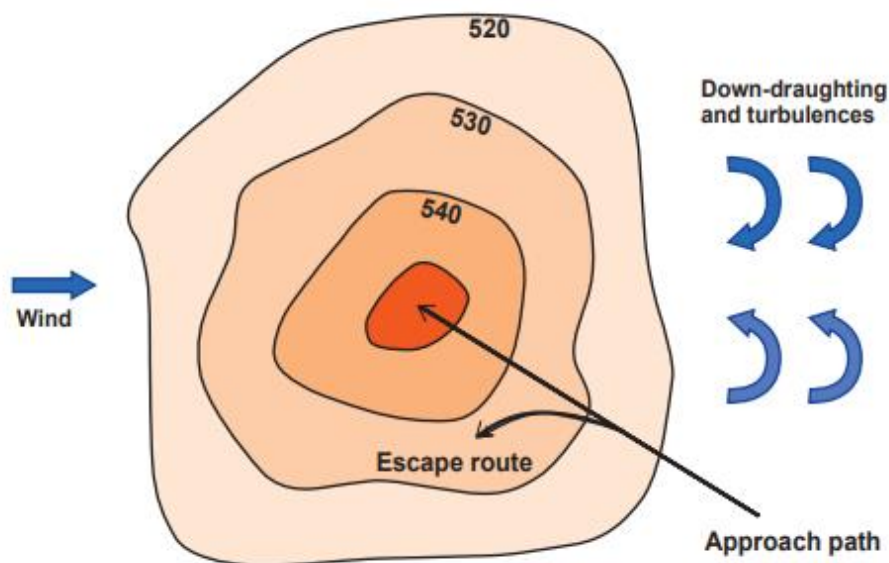
Figure 3: Demarcation Line

*The absence of obstacles and the opportunities for an 'escape route' make ridges and pinnacles a good choice for a landing site. However, as previously described, these sites are often affected by a turbulent rising and descending airflow over the top, the demarcation line has to be identified. A normal circuit should be flown above the elevation of a LS (landing site). For the final approach, if possible, rather than flying directly into wind towards the feature, the final approach may be flown at an offset angle (up to 45°) and out of wind to keep the aircraft out of the descending air and allow an escape route away from the feature. If there is little or no wind, the approach angle can be normal, however, it is essential to avoid reducing the speed too early and lose translational lift before gaining ground effect. If the wind is moderate or strong, an approach with a normal to steep angle can be flown as the wind will*

maintain translational lift until entering in ground effect (avoiding flight through turbulent areas upwind of the LS).
