AIRCRAFT ACCIDENT REPORT AND EXECUTIVE SUMMARY

Reference:	CA18/2/3/9753	
Aircraft Registration	ZS-GBK	Date of Accident	19 November 2018		Time of Accident	0956Z
Type of Aircraft	Glider Sailplane- JS1C 21		Type of Operation		Private (Part 91)	
Pilot-in-command Licence Type		Sailplane Pilot Licence	Age	60	Licence Valid	Yes
Pilot-in-command Flying Experience		Total Flying Hours	4768.02		Hours on Type	87.13
Last Point of Departure		Gariiep Dam Airfield, FAHV, Free State Province				
Next Point of Intended Landing		Gariiep Dam Airfield, FAHV, Free State Province				
Location of the accident site with reference to easily defined geographical points (GPS readings if possible)						
The accident occurred at a ridge 1.3 NM north of FAHV at GPS co-ordinates: S30° 33.73'E025°31.79' with an elevation of 4176 ft AMSL						
Meteorological Information		Wind: 018°Gusting 30kts, Visibility: CAVOK, Temperature: 35°C, Dew point: 04°C and Query nautical height: 1013ft

Reference Number : CA18/2/3/9753
Name of Owner/Operator : JS-VW Partnership
Manufacturer : Jonker Sailplanes
Model : JS1C 18/21
Nationality : South African
Registration Marks : ZS-GBK
Place : Gariep Dam, FAHV, Free State Province
Date :

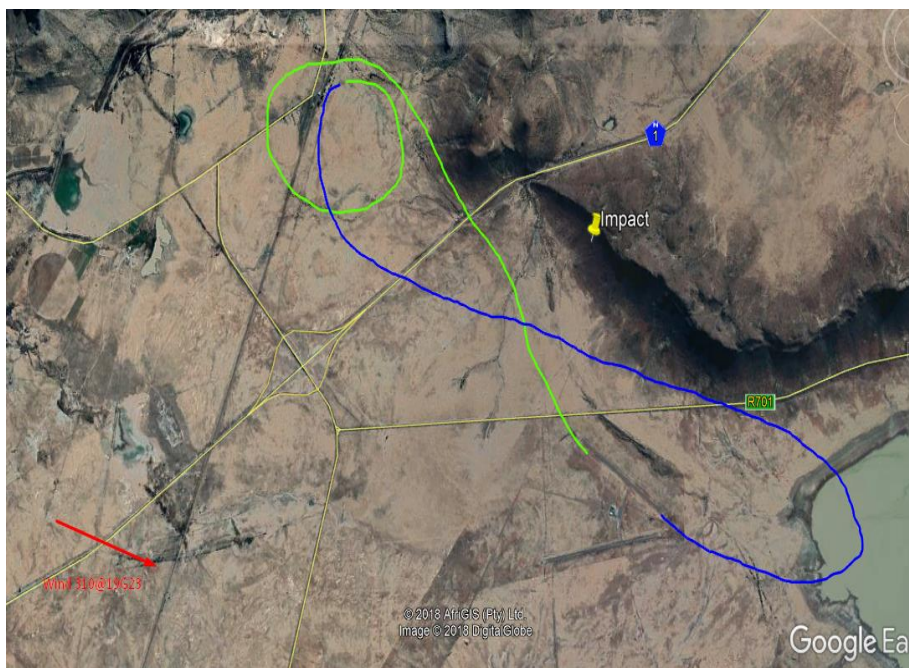
Figure 1: A rough sketch made by the tow pilot of an approximate track of the tow aircraft and glider climb out (green line) and the tow aircraft descent and landing after releasing the glider (blue line).

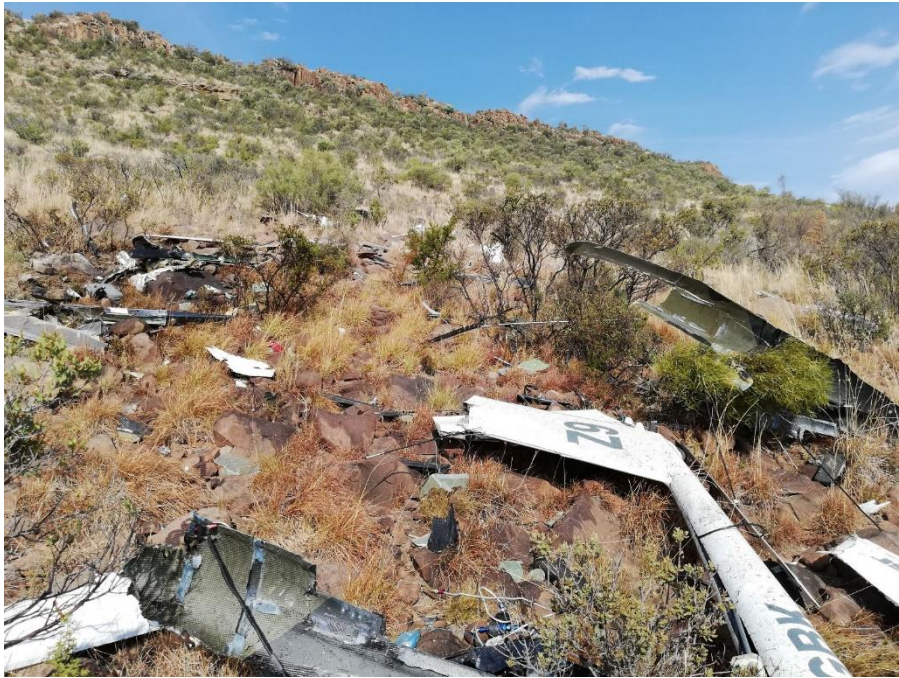
1.3.1 The aircraft was destroyed on impact.

Figure 2: The wreckage after impact with terrain.

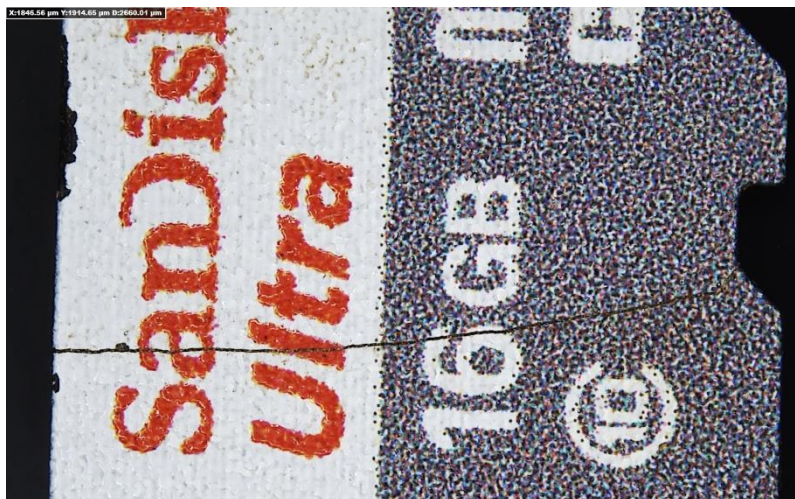
1.11.2 The aircraft was equipped with an LX9000 flight data logger but was destroyed on impact. A damaged micro SD card was recovered from the logger and sent to the United Kingdom Air Accidents Investigation Branch (UK AAIB) laboratory for analysis, however, it was discovered that it got damaged during the accident (see Figure 5).

Figure 4: The damaged micro SD card with a crack in the middle.

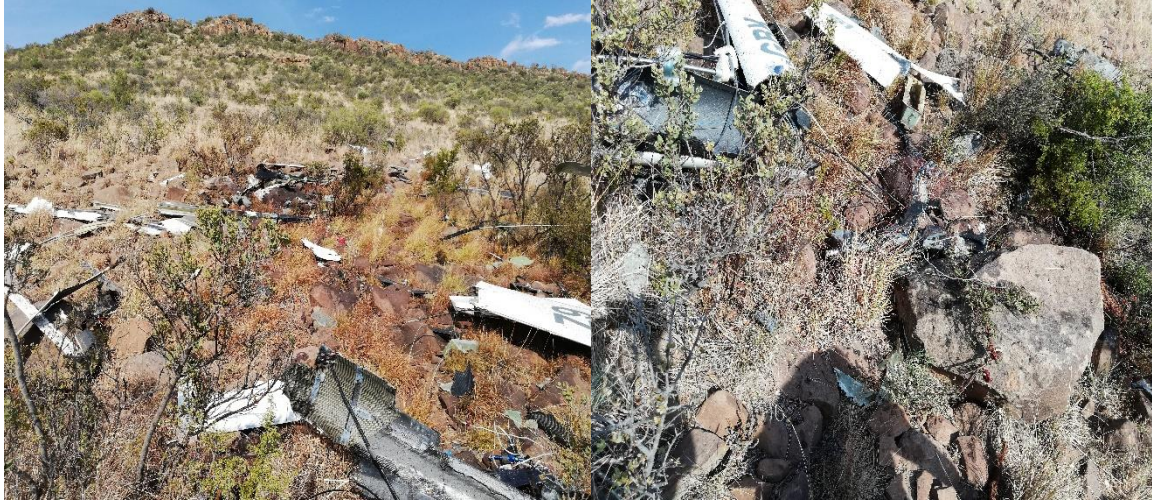
1.12.2 The investigation was unable to check the continuity of all the flight controls of the glider as they were destroyed by post-impact forces. The SSSA expert who dispatched to the accident site reported that the rudder cable connection was still intact. The damage sustained was a result of post-impact forces and there were no signs of an in-flight break-up. The control stick, the ailerons, the elevators, the rudder pedals, the cockpit and both spoilers were destroyed (see Figures 5 and 6).

Figure 5 and 6: The glider wreckage.

1.12.3 The glider impacted the mountainous terrain and the entire glider wreckage was located in the immediate vicinity of the accident. A linear ground scar, consistent with wing impact, was observed with the left wing of the glider directly over the ground scar and the right wing located a few feet from the ground scar. The glider's aft was broken and the tail was bent upward and to the left, relative to the fuselage. The wreckage was scattered around the accident site.
