AIRCRAFT ACCIDENT SHORT REPORT

CA18/2/3/9754: The aircraft failed to climb during take-off and impacted with the ground.

Date and time : 25 November 2018, 0635Z
Location : Marble Hall Aerodrome, Limpopo
Aircraft registration : ZS-NRX
Aircraft manufacturer and model : Cessna Aircraft Company and Cessna 150L
Last point of departure : Marble Hall Aerodrome, Limpopo Province
Next point of intended landing : Rand Aerodrome (FAGM), Gauteng Province
Location of incident site with reference to easily defined geographical points (GPS readings if possible) : S24°59'47.5" E29°16'37.3" at an elevation of 2 979ft
Meteorological information : Surface wind: 040°/4kts; temperature: 22 °C; dew point: 16 °C; visibility: 10km
CAVOK QNH: 1020h Pa
Type of operation : Air Transport Operations – Carriage of less than 20 passengers or cargo (Part 135)
Persons on board : 1 + 1
Injuries : No injuries were sustained
Damage to aircraft : Substantial damage

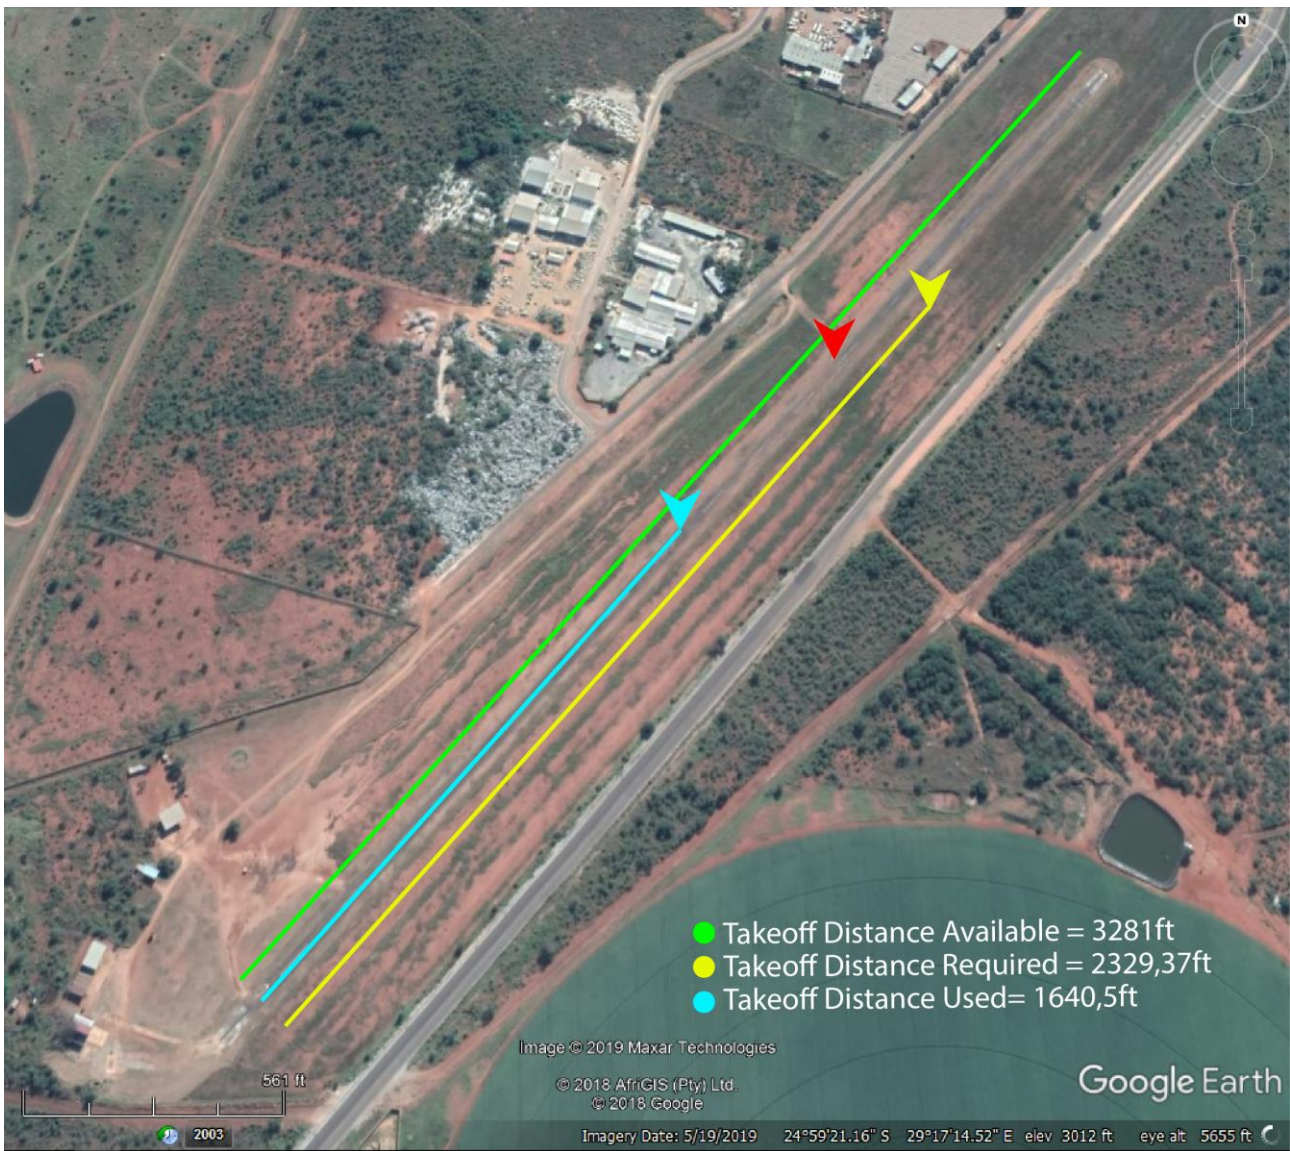
Figure 2: Google Earth image of the take-off distance available (green), take-off distance required (yellow) and take-off distance used (blue) by the pilot at Marble Hall Aerodrome

- 2.1.3. Considering the departure, the pilot had a take-off distance available of 3 281ft (green line) – Appendix B. The required take-off distance was 2 329.37ft (yellow line) – Appendix A. The pilot only used 1 640.5ft to conduct the take-off after joining the active runway from the taxiway (red arrow).
- 2.1.4. The aircraft was destroyed by the impact sequence and both occupants sustained no injuries. The pilot and passenger were attended to by paramedics on site and they both decided it was not necessary to be hospitalised. No mechanical malfunctions with the aircraft were reported by the pilot.

- 2.2.3. The runway at Marble Hall Aerodrome is 1000m X 10m (3 281ft X 33ft). The take-off roll started at midpoint of the runway (1 640.5ft) and the aircraft was rotated below 60kts. The runway distance used was 688.87ft less than what was required for this take-off to avoid colliding with terrain (tree) after take-off. The amount of runway needed to clear a 50ft obstacle was 2 329.37ft.

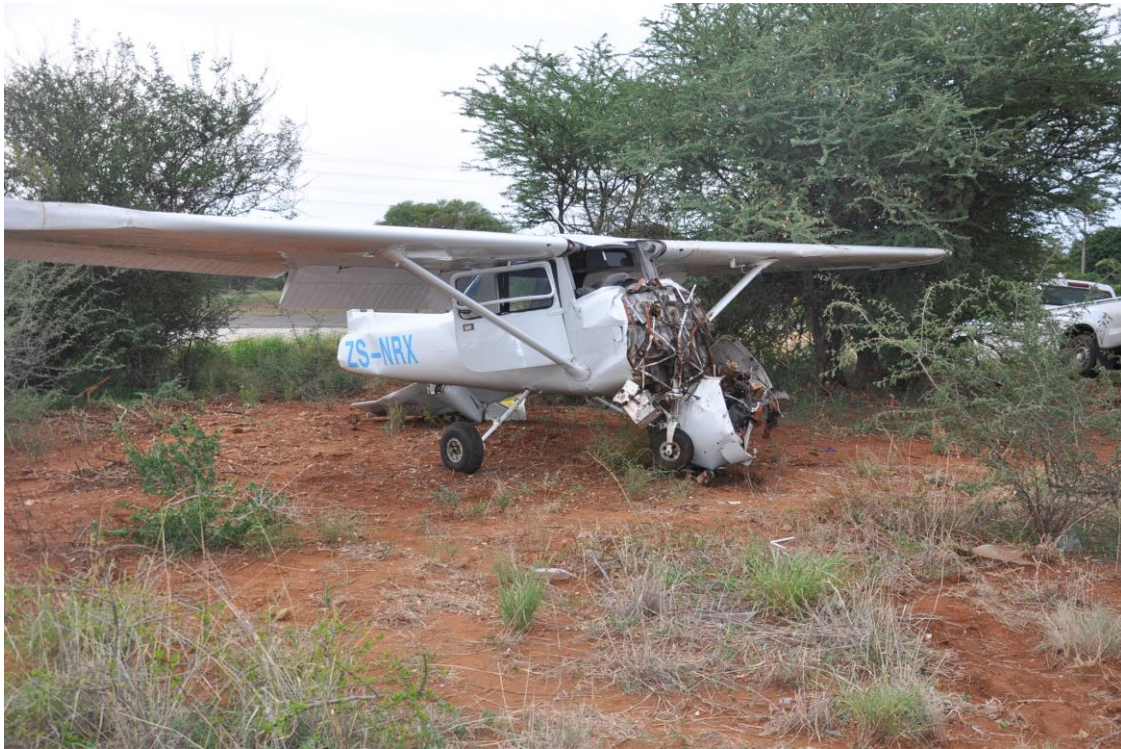
Figure 3: Damage to the aircraft

- 2.2.1. The right wing hit a tree top 490m south of threshold 04 before impacting the ground. The aircraft came to rest facing 260° magnetic in an upright position. The distance between the tree and the first point of impact with the ground was 36.6m and the distance between this point and the location of the wreckage was 12m.
