AIRCRAFT ACCIDENT SHORT REPORT

CA18/2/3/9760: During an out landing, the glider collided with a perimeter fence, seriously injuring the pilot.

Date and time : 4 January 2019 at 1119Z
Aircraft registration : ZS-GXX
Aircraft manufacturer and model : Alexander Schleicher GmBh & Co, ASH 25 Glider
Last point of departure : New Tempe Aerodrome (FATP), Free State Province
Next point of intended landing : New Tempe Aerodrome (FATP), Free State Province
Location of accident site with reference to easily defined geographical points (GPS readings if possible) : S29°1'36" E026°9'34" elevation 4 500ft
Meteorological information : Surface wind: 330°/12kts; temperature: 31°C; visibility: good
Type of operation : Hire and fly (Part 94)
Persons on board : 1+1
Injuries : 1+1 (pilot - seriously injured; passenger - minor injuries)
Damage to the glider : Substantial

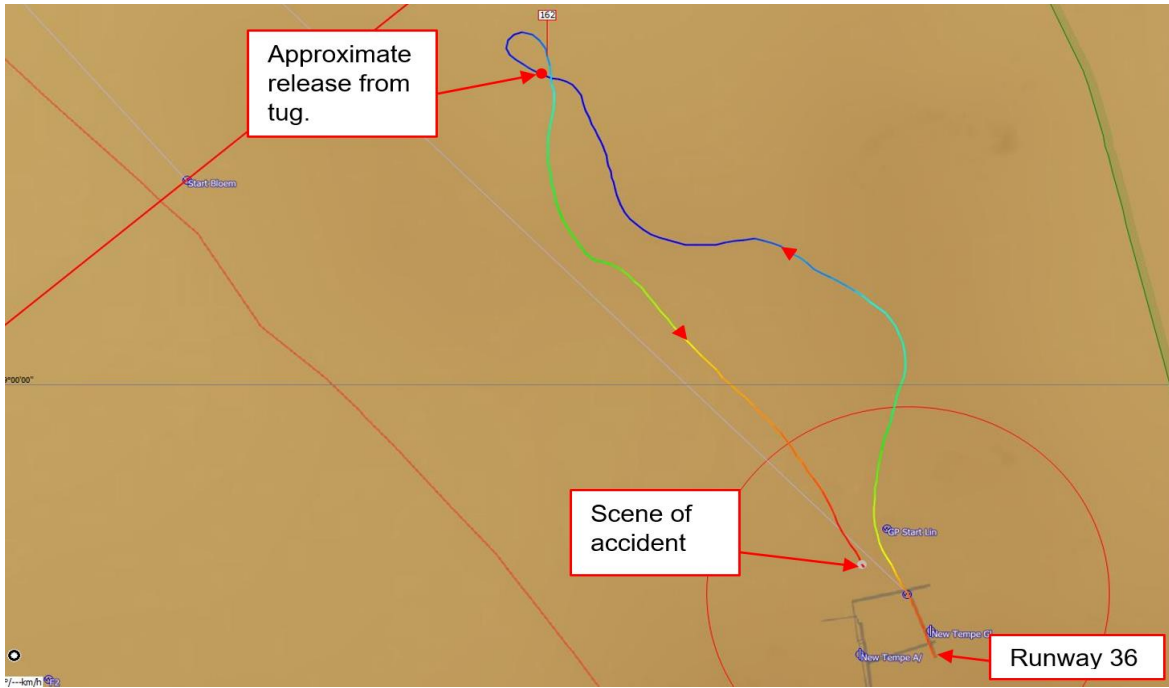
2.1.3. The glider was equipped with Cambridge Aero Instrumentation, which included a digital variometer with integral Global Positioning System (GPS) and a flight logger. Data downloaded from the flight logger in the presence of the investigator-in-charge revealed that the glider continued to fly in a northerly direction for approximately one minute after the pilot released the tow rope from the tug aircraft and then turned back towards FATP. The owner of the glider reported that the pilot made radio contact with the Soaring Safaris ground station indicating that they were flying back to FATP for a full stop landing on Runway 18. After turning back towards the aerodrome, the glider continued on its course in a southerly direction in an attempt to reach the aerodrome, but it was unable to reach the runway and the pilot opted to perform an out landing on an open flat field of a small holding, which was approximately 900m from the threshold of Runway 18. During the landing, the glider collided with a 1.8m (6ft) high perimeter fence before coming to rest in an upright position.

Figure 2: The flight path of the glider from take-off to ground impact, (data was downloaded from the flight logger, courtesy of the owner of the glider)

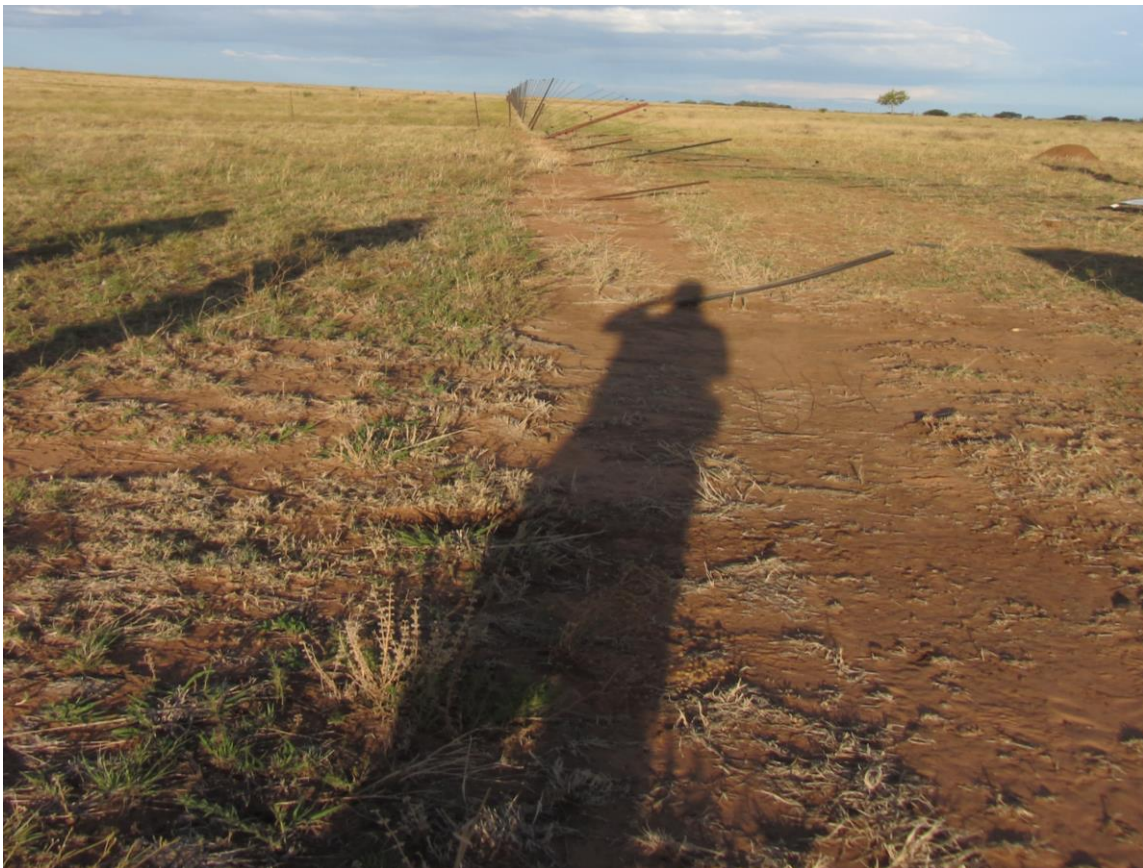
Figure 3: Flattened perimeter fence

- 3.8. The pilot executed an out landing in an open field close to FATP. During the out landing, the glider impacted with a perimeter fence. The barbed wire fence penetrated the canopy and cockpit area, causing serious injuries to the pilot. The fence and supporting poles caused damage to the wings. The surface wind was north-westerly at 12kts. The glider was executing an out landing with a tail wind component.

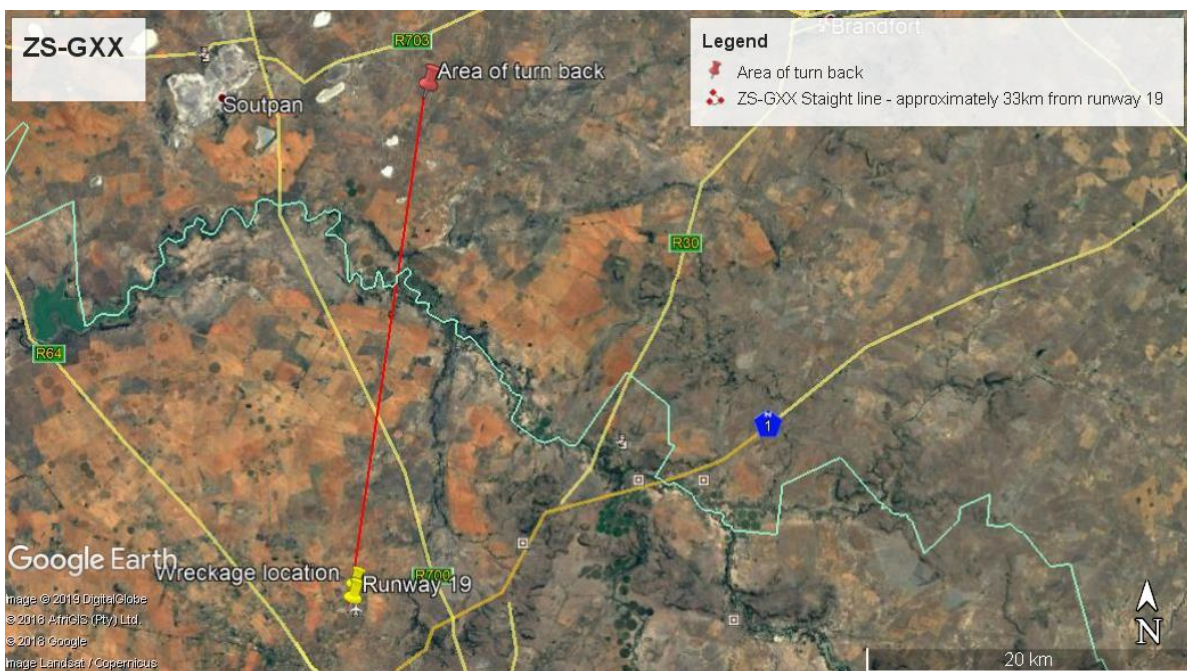
2.1.5. Data from the Cambridge Aero Instrumentation that was on-board the glider, which includes the direct digital variometer with Integral GPS and the flight logger, showed that the glider climbed to a height of 6 050ft AMSL under tow. The glider pilot then released the tow rope at 1112Z and, immediately, the glider gradually started to descend in the direction of FATP. The last height parameter captured before the accident was at 4 490ft at 1119Z. Data from the flight logger and the flight profile revealed that the glider turned back to FATP at a distance of approximately 33km. According to the Alexander Schleicher ASH-25 technical data sheet, the glider had a best glide ratio of 60:1. For the mentioned glide ratio, the glider required 93 600ft (28.5km) to reach Runway 19 at the New Tempe Aerodrome with the recorded height of 1 560ft above ground level (AGL) where the glider turned back to the aerodrome. The glider approached the aerodrome from a northerly direction with a north-westerly wind of 12kts prevailing at the time of the accident. With the prevailing wind conditions, it was likely that the glider did not have enough height to reach the runway at FATP.

Figure 3: Google Earth overlay showing the approximate straight-line distance from the area of turn back to the aerodrome

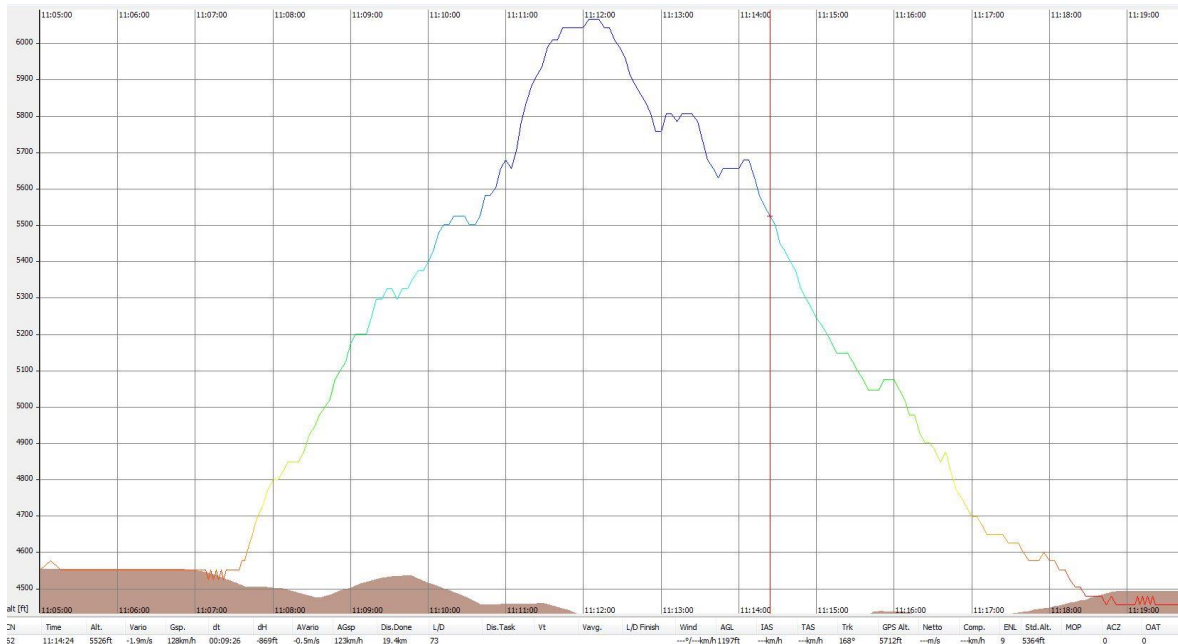
Figure 4: Graph downloaded from the flight logger (courtesy of the glider owner)

- 5.1. At the time of landing, the surface wind was from the north-west at 12kts, which accounted to a tailwind component.
- 5.2. The rate of descent (ROD) was approximately 240ft/min from the time the glider pilot released the tow rope until the glider was on the ground.
- 5.3. Absence of thermal activity at the time or the pilot releasing too soon from the tug aircraft to benefit from thermal activity in the area resulted in an immediate descent profile of the glider as captured in Figure 4.

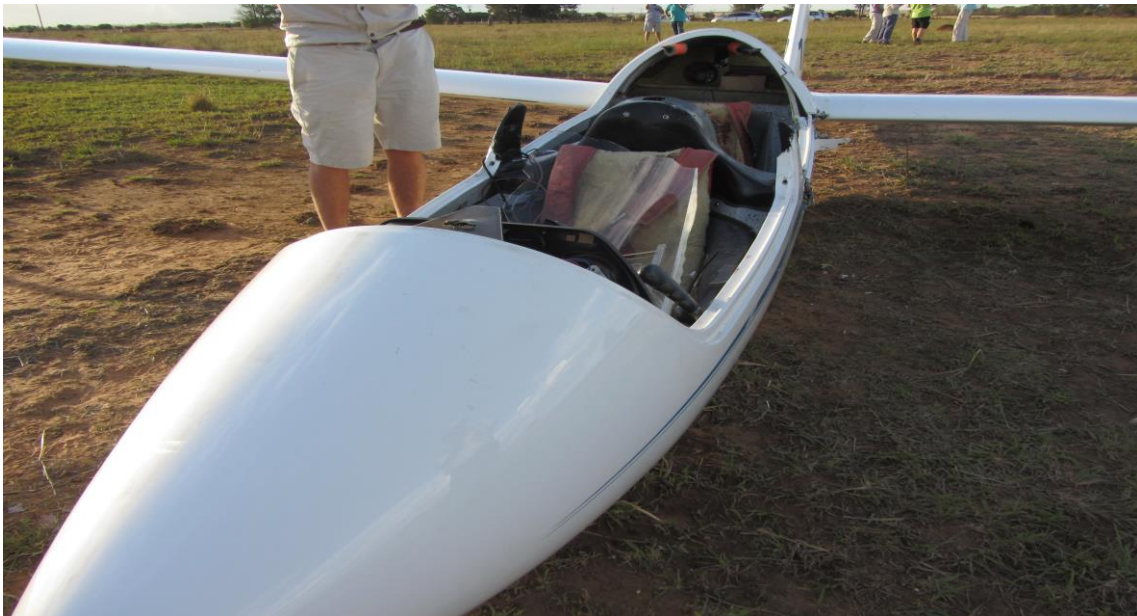
2.1.6. According to the ASH 25 Flight Manual, the glider must be trimmed between 90 to 100km/h (IAS) during approach. Data retrieved from the flight logger revealed that the glider had a ground speed of 123km/h (Global Positioning System [GPS] speed) just before it impacted with the parameter fence. The glider sustained substantial damage to the canopy, cockpit area and both wings during the impact or accident sequence.

Figure 5: The canopy was destroyed

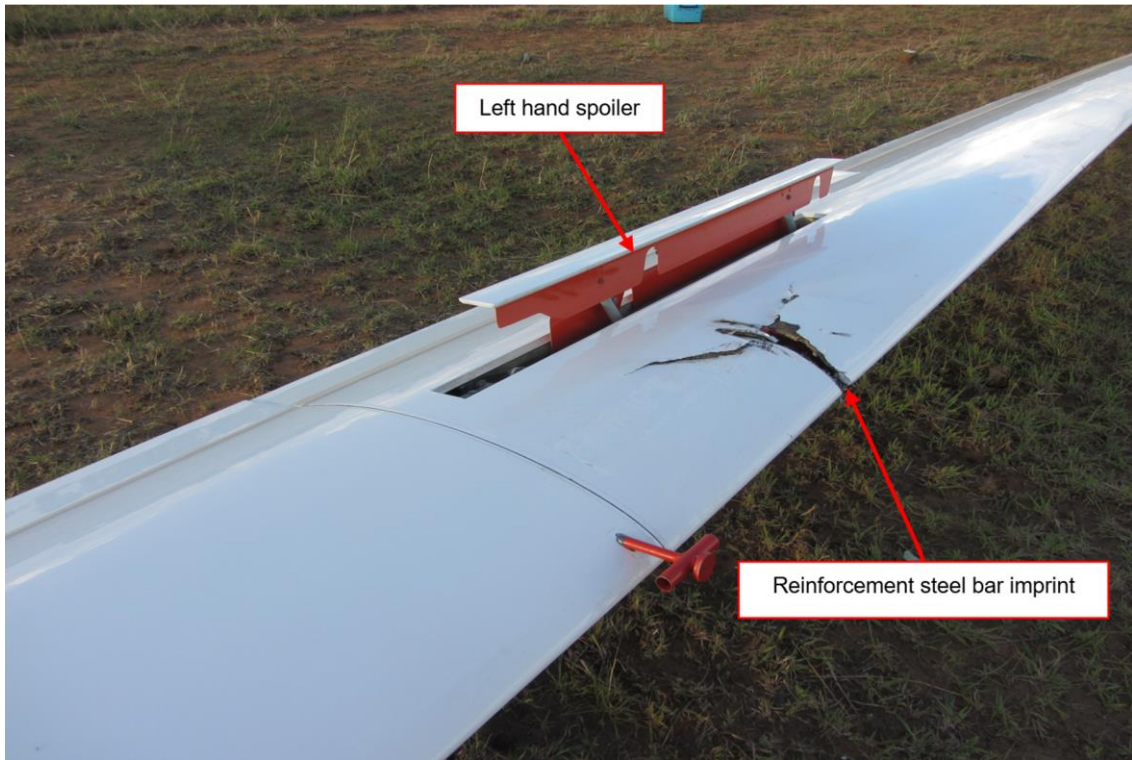
Figure 6: Damage to the left wing

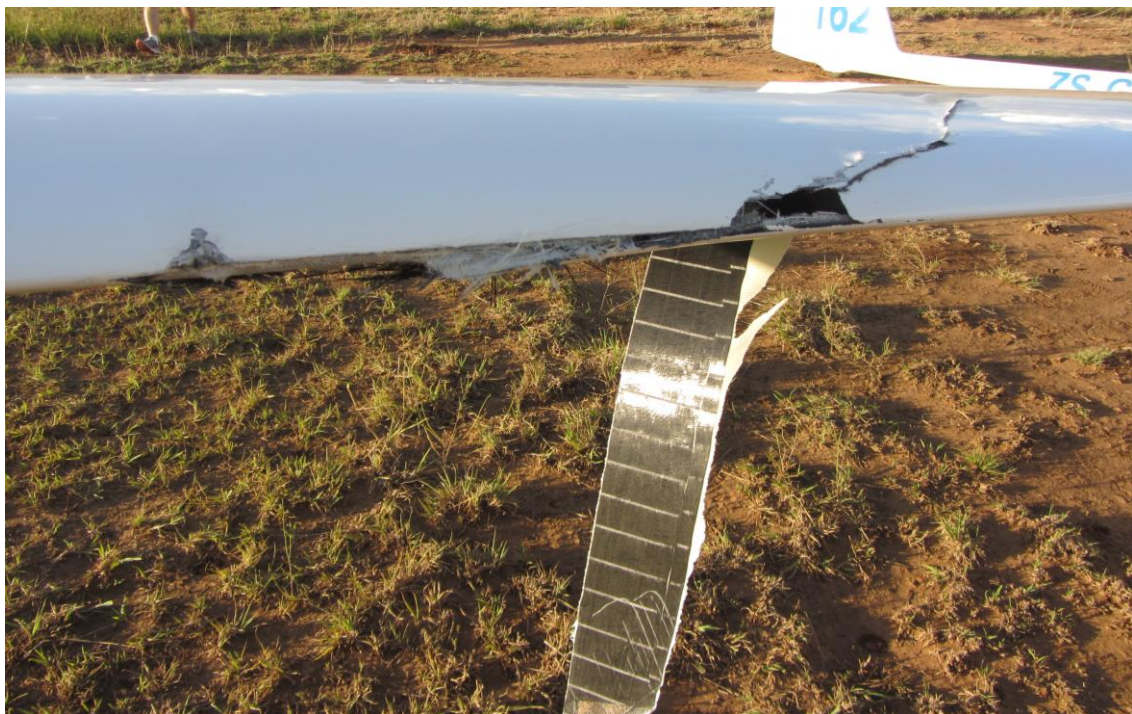
Figure 7: Damage to the right wing
