## AIRCRAFT ACCIDENT SHORT REPORT

**CA18/2/3/9768:** ZU-INH: During a low-level aerial flight in the Kruger National Park the engine stopped, and the pilot executed a forced landing.

**Aircraft registration** : ZU-INH

**Aircraft manufacturer and model** : Aeroprakt Ltd, A22-LS

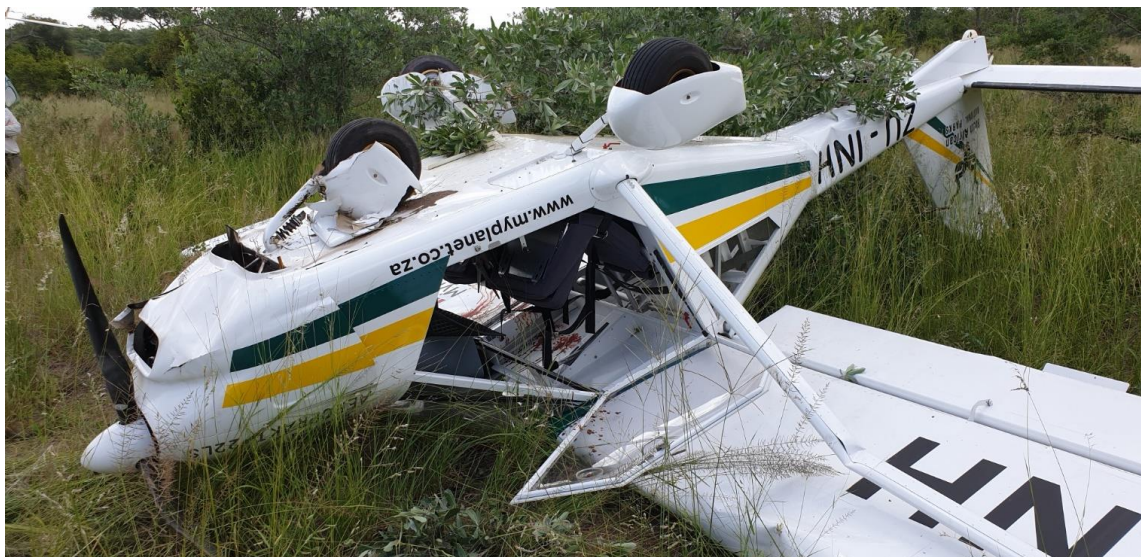
**Figure 1:** The aircraft as it came to rest in an inverted position.

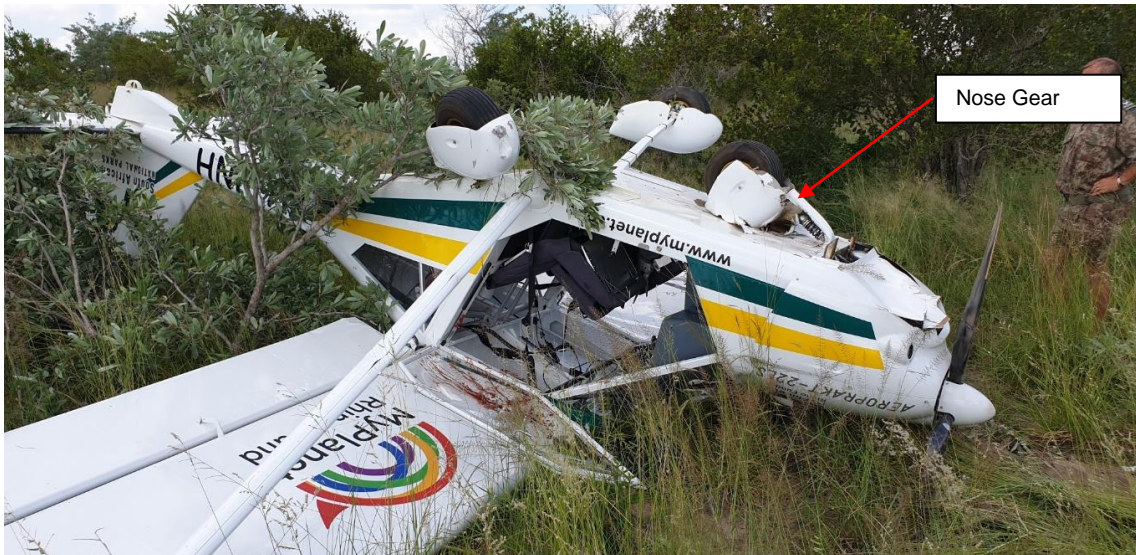
**Figure 2:** The nose gear could be seen bent backwards

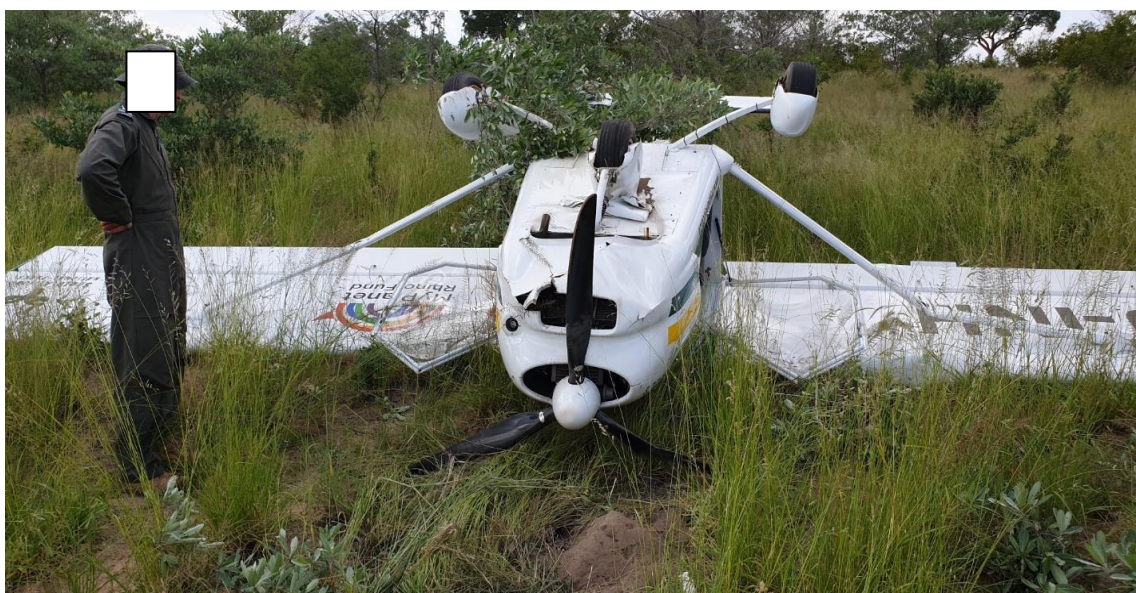
**Figure 3:** Front view of the aircraft

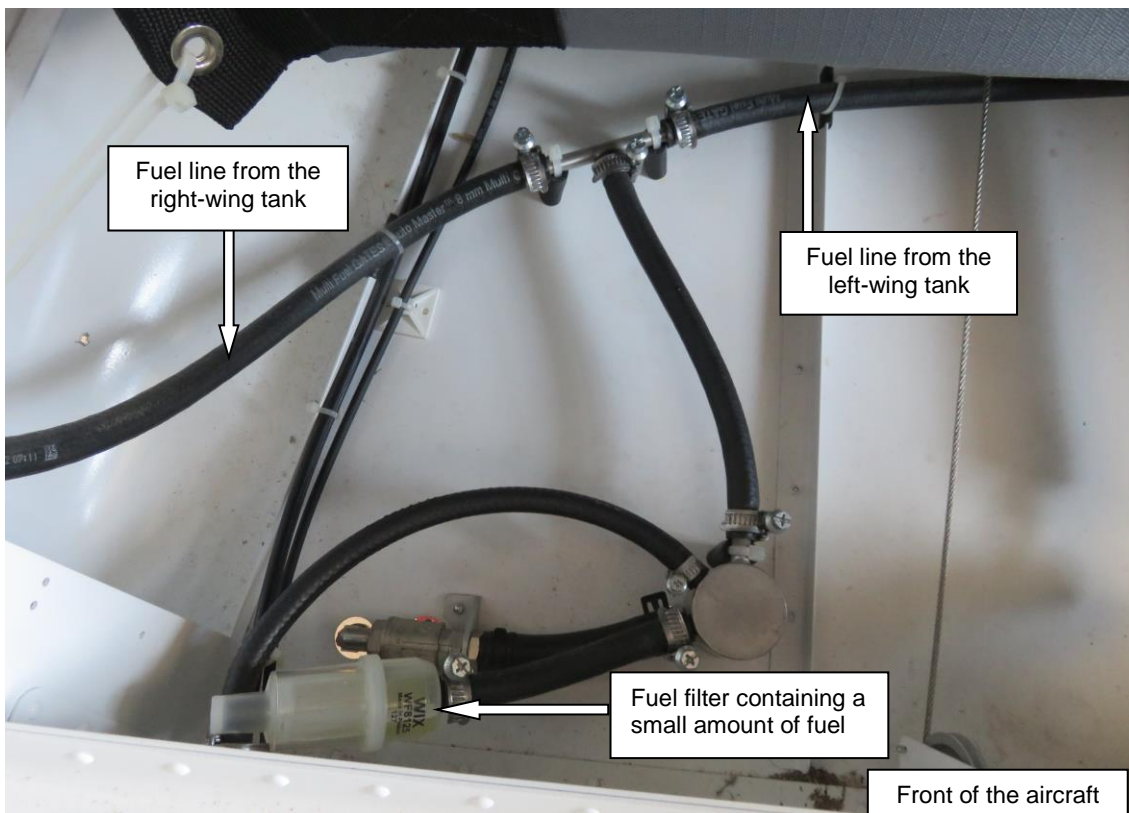
**Figure 4:** Fuel lines from the left- and right-wing tanks feeding under gravity into a T-fitting (this fuel plumbing is installed behind the two seats)

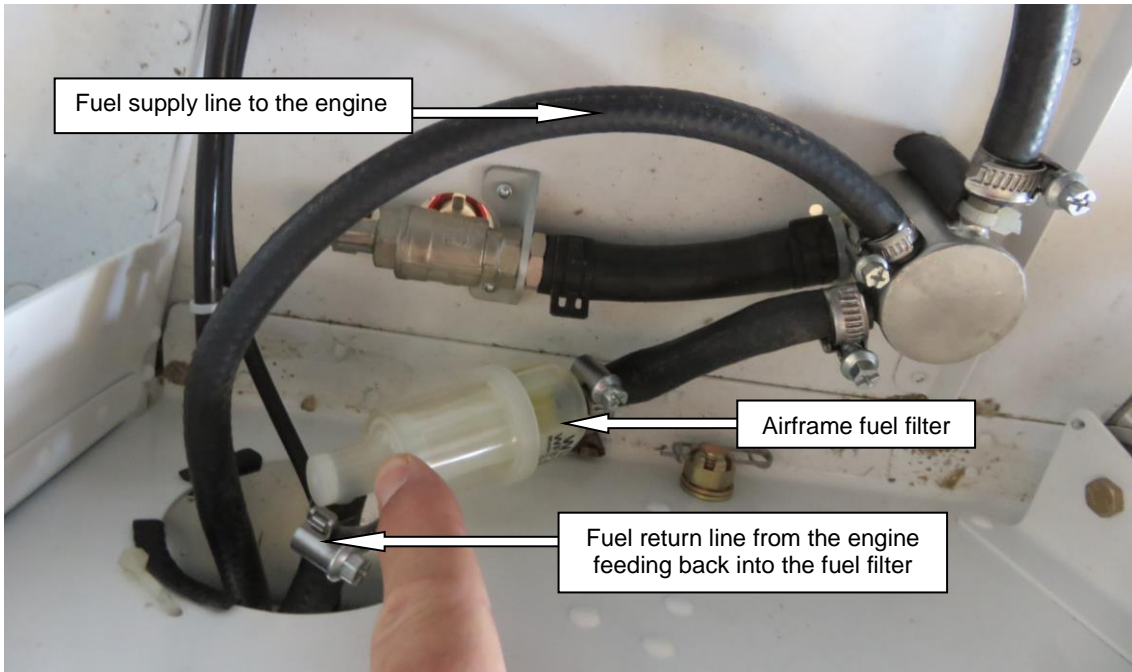
**Figure 5:** The airframe fuel filter located behind the right seat

- 3.15 The fuel return line (airframe fuel system) was installed on the accident aircraft but did not route back to the fuel tank (suction side of the fuel system) as discussed in sub-paragraph 2.1.14 of this report and also as per the official Rotax fuel system as contained in the Installation Manual (Annexure B). Instead, it was connected to the airframe fuel filter as depicted in Figure 5.

The airframe fuel system, specifically the plumbing, with regards to the fuel return line on this aircraft was found to differ from the guidance provided by the engine manufacturer as contained in the Rotax 912 Series Installation Manual, Edition 2. The fuel return line should feed back to the fuel tank suction side of the airframe fuel system, which was not the case.

- 7.1 It is recommended to the Director of Civil Aviation that the Director review that all Aeroprakt A22LS aircraft registered in South Africa are equipped with a (i) fuel pressure gauge as well as (ii) an electrical auxiliary fuel pump as standard equipment. The Rotax Installation Manual extract attached as Annexure B emphasise that these requirements should be met.

This will allow the pilot(s) with a cockpit indication whereby he or she can monitor the fuel pressure during flight and, should it decay or start fluctuating, the electrical auxiliary fuel pump can be switched on to ensure a positive fuel flow is restored to the engine-driven fuel pump. The fuel return line from the engine to the airframe should meet the prescribed guidelines as called for by the Rotax Information Safety Notice: 912 Series Fuel Return Line (Mandatory) whereby the fuel return line should root back to the fuel tank(s), which would include the fuel suction system.

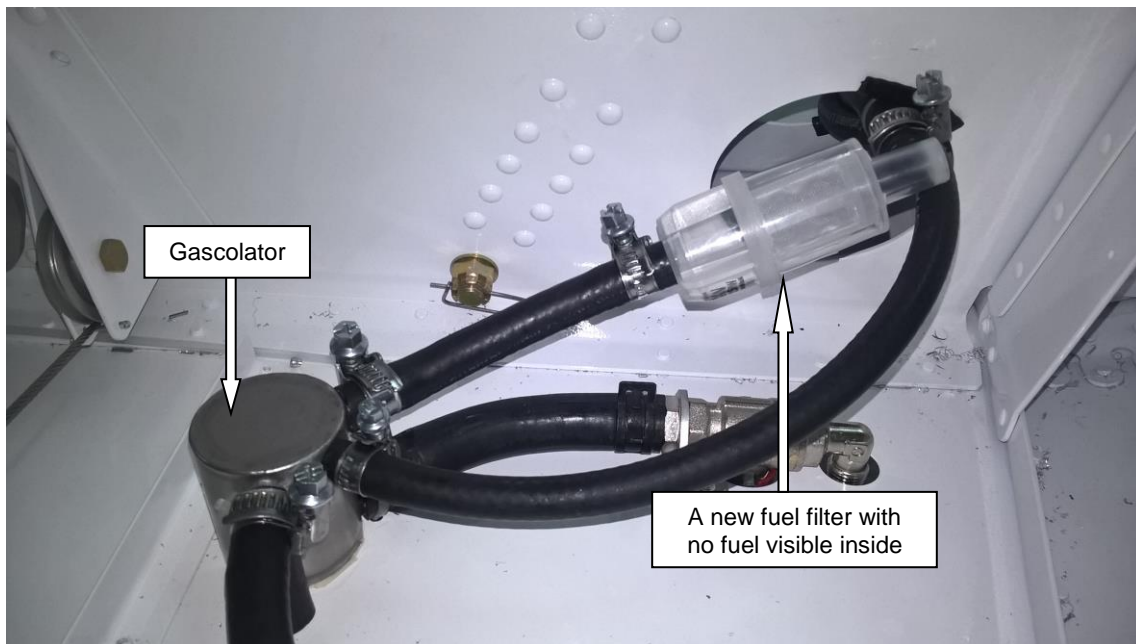
**Figure 6:** Fuel plumbing installation behind the right seat (photograph courtesy of Aeroprakt Ltd)

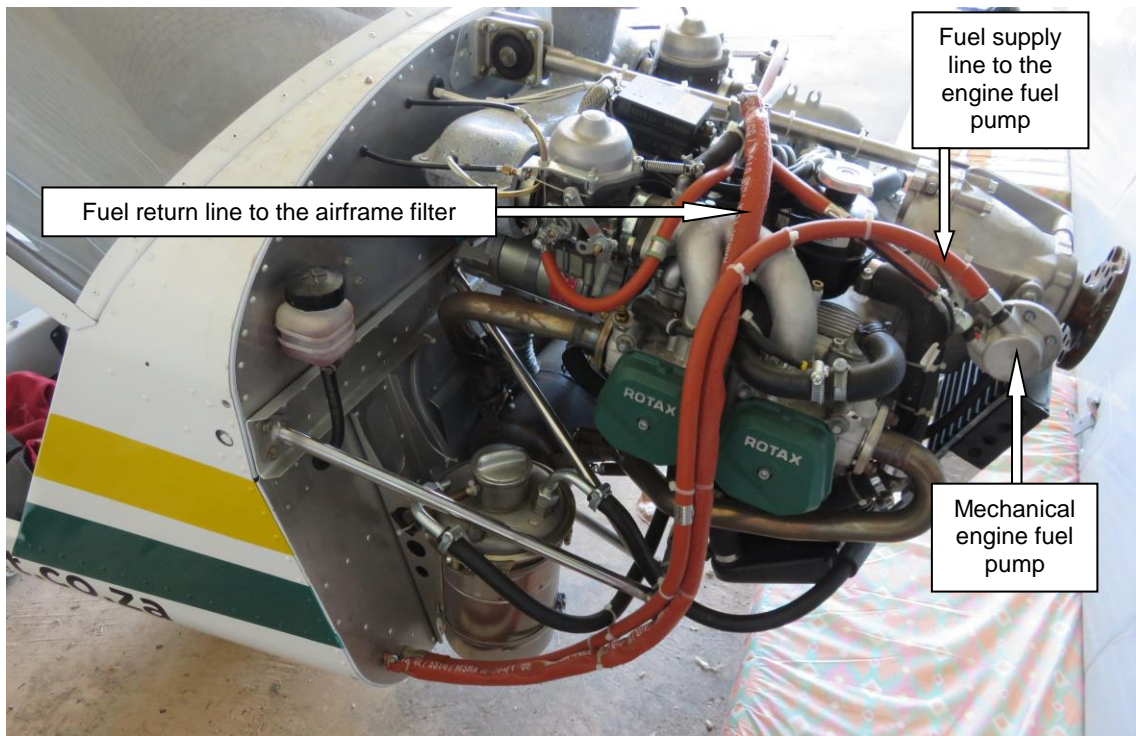
**Figure 7:** A view of the right side of the engine still within the airframe of ZU-INH

- 3.18 In Figures 7, 10 and 11 in this report, the same type of engine was installed in the same type of aircraft but different airframes. Neither of these three engine installations were consistent with one another, especially with regards to the fuel return line.

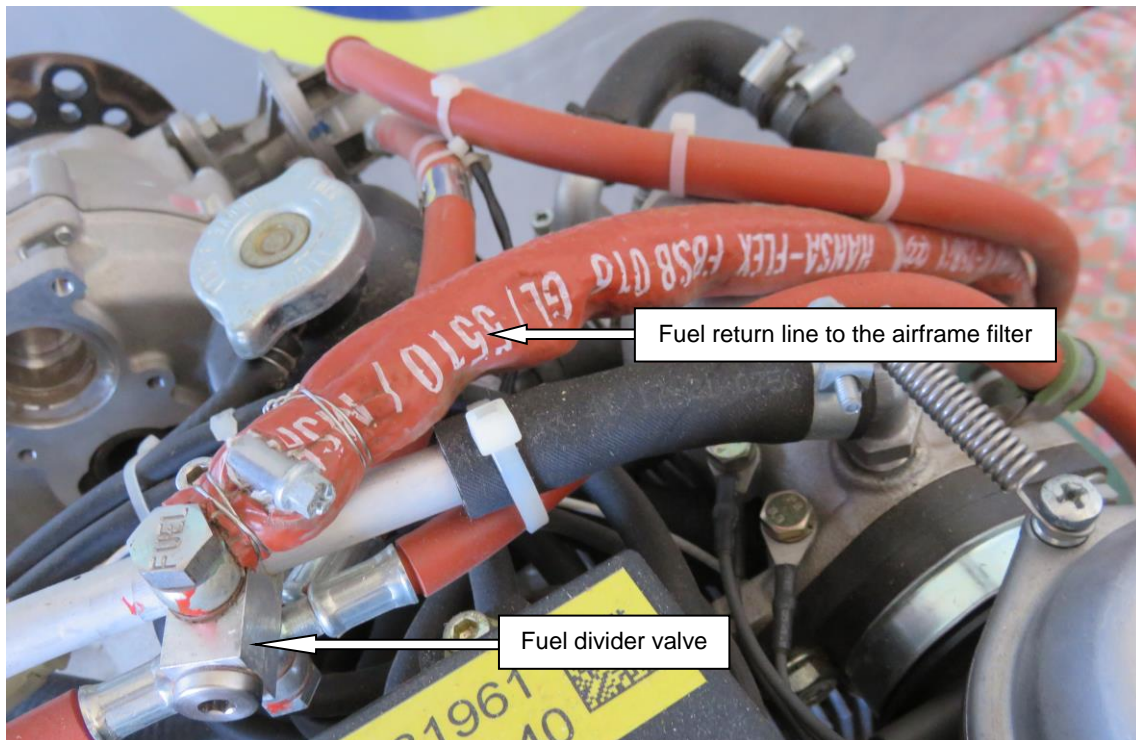
**Figure 8:** The fuel divider valve (spider valve) located on top of the engine (ZU-INH)

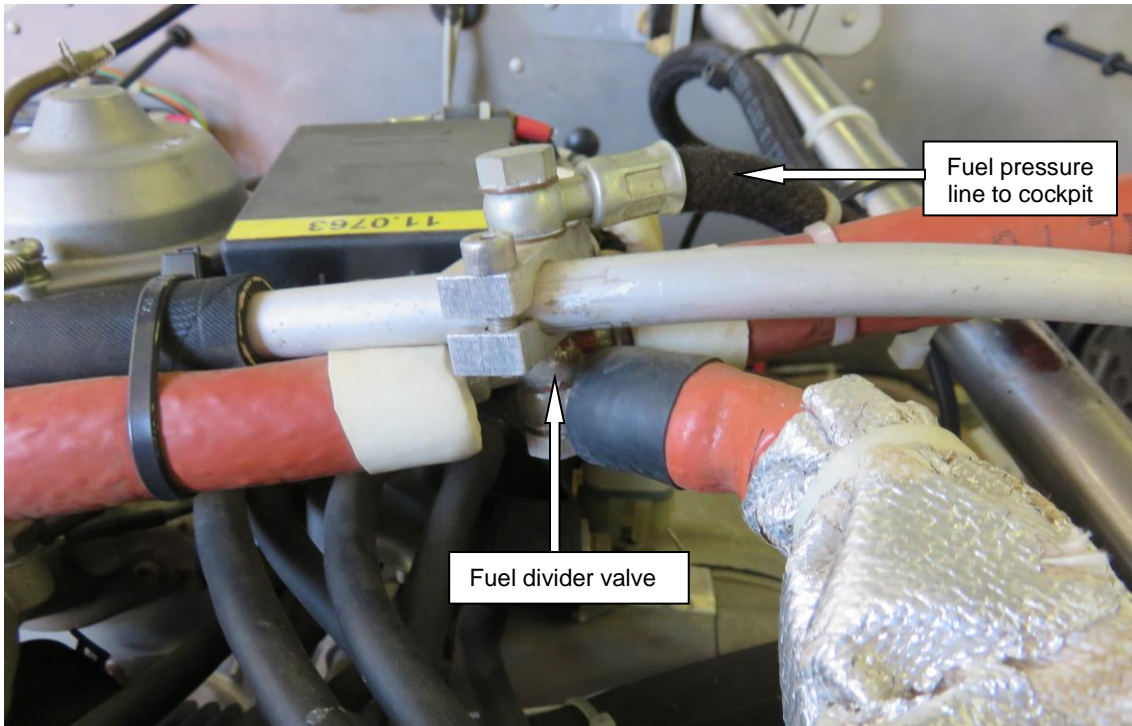
**Figure 9:** The fuel divider valve from another similar type of aircraft, with a fuel pressure line to the cockpit

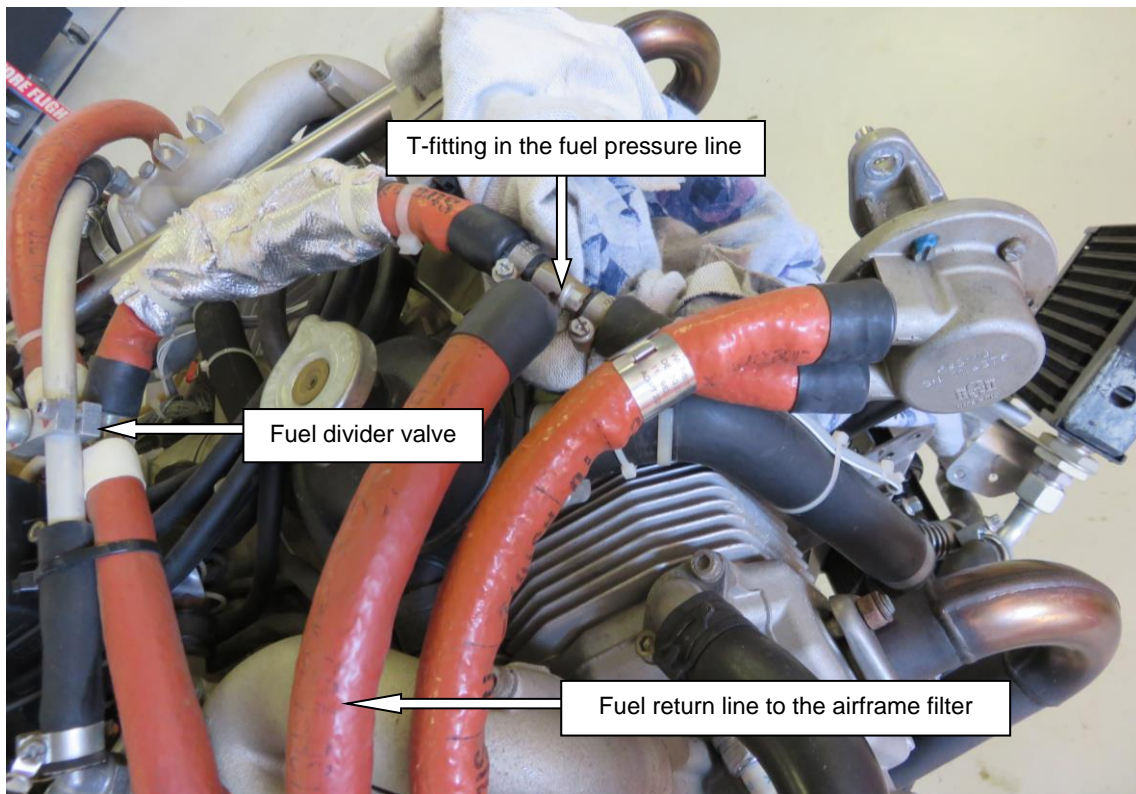
**Figure 10:** The fuel return line bleeding off from a T-fitting located within the fuel supply line from the engine-driven fuel pump to the fuel divider valve (From a similar type of engine and aircraft)

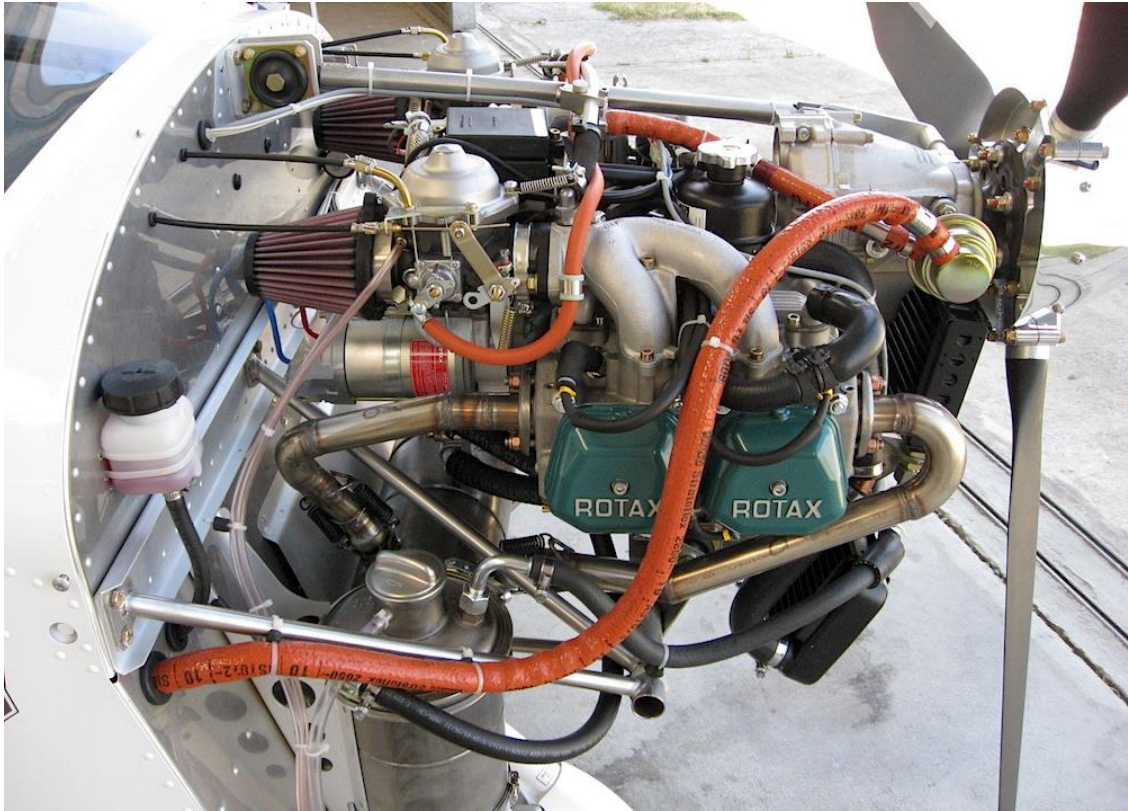
**Figure 11:** The same engine installed in the same aircraft type with no fuel return line (Courtesy of Foxbat Australia)
