<b>AIRCRAFT ACCIDENT SHORT REPORT</b>
---------------------------------------

**CA18/2/3/9769**, Unsuccessful forced landing after an engine failure while turning crosswind for Runway 17 at Hoedspruit Aerodrome (FAHT).

<b>Date and time</b>	: 8 February 2019 at 0530Z
<b>Location</b>	: Zandspruit River, near Hoedspruit
<b>Aircraft registration</b>	: ZU-DOG
<b>Aircraft manufacturer and model</b>	: Micro Aviation New Zealand Ltd, Bantam B22J
<b>Last point of departure</b>	: Hoedspruit Aerodrome (FAHT)
<b>Next point of intended landing</b>	: Hoedspruit Aerodrome (FAHT)
<b>Location of accident site with reference to easily defined geographical points (GPS readings if possible)</b>	: Zandspruit River, 24°37'20.47" South 030°59'31.87" East
<b>Meteorological information</b>	: Surface wind: 170°/5kt, temperature: 25°C, CAVOK
<b>Type of operation</b>	: Training (Part 141)
<b>Persons on board</b>	: 1 + 1
<b>Injuries</b>	: None
<b>Damage to aircraft</b>	: Substantial

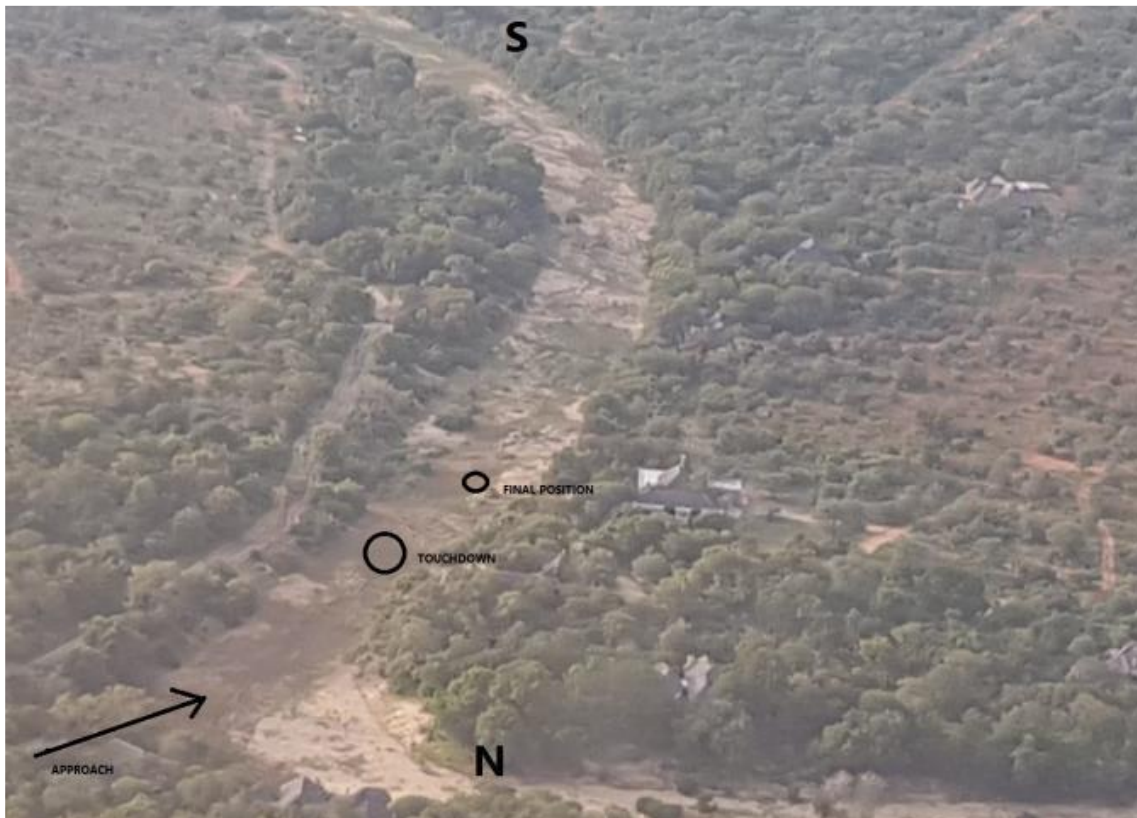
**Figure 1:** Aerial photograph of the approach and the terrain (Photograph courtesy of the ATO)

2.1.4 The aircraft touched down in a southerly direction in a dry riverbed (Figure 1). During the landing roll, the right main wheel collided with a rock and the aircraft nosed over, coming to rest in an inverted attitude (Figures 2 and 3). The nose gear bent backwards, but the cockpit/cabin area remained intact.

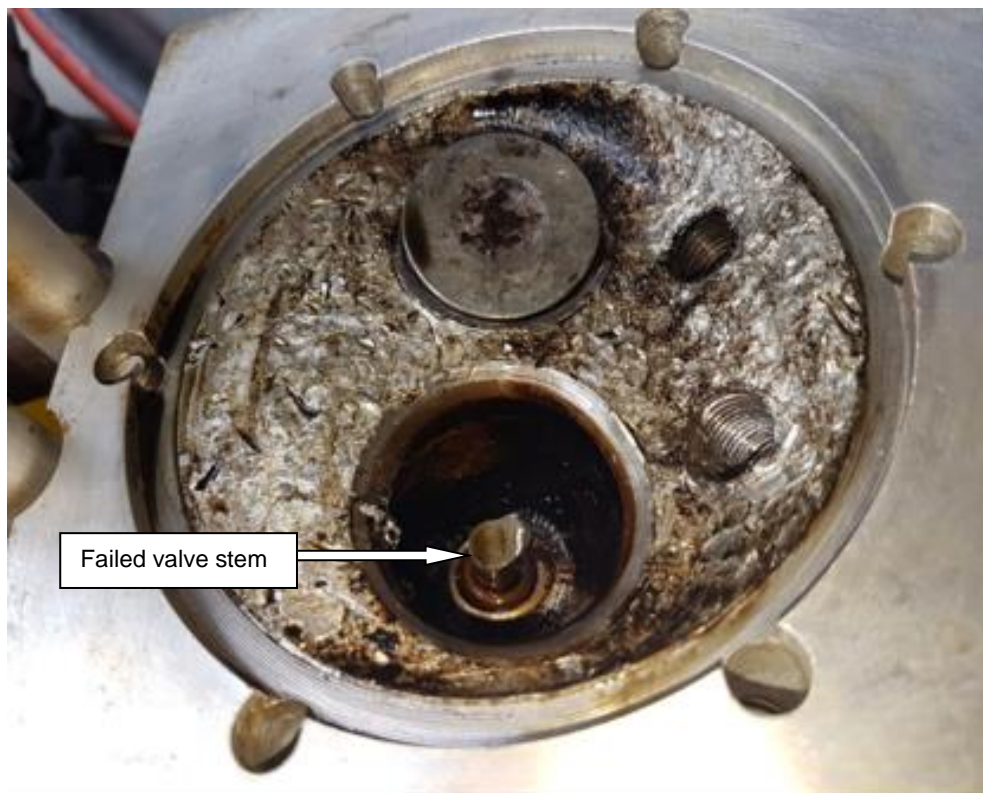
**Figure 4:** The failed valve stem on number 4 cylinder (Photograph courtesy of AMO)

The engine, a Jabiru 2200A with serial number 22A1878 was removed from the wreckage after it was recovered and was subjected to an engine teardown inspection at an approved aircraft maintenance organisation (AMO). It was found that the inlet valve on the number 4 cylinder had failed, which resulted in extensive internal engine damage. The engine had been in operation for 898.0 hours since new.

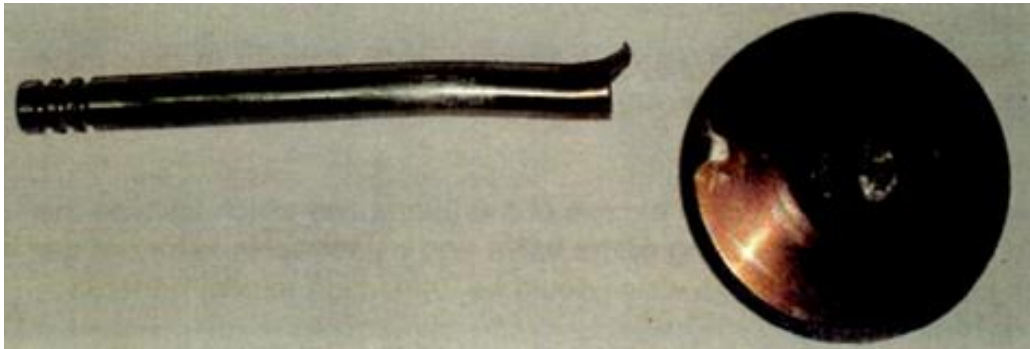
**Figure 5:** Showing the failed valve on number 4 cylinder

1. The failed inlet valve separated from the stem and the nature of the failure was metal fatigue. The stem of the valve shows two distinct areas of wear, indicating that the valve was moving side-to-side in the valve guide. See Figure 5 and 6 below.

2. The report concludes that, the valve guide for the failed valve was worn in excess of its tolerance/limits. That allowed the valve to operate at unusual angles, which led to the valve failing due to fatigue. Other valves, which were also inspected, had signs of scuffing which is attributed to the lack of lubrication or overheating or dirt in the oil. See Annexure A.

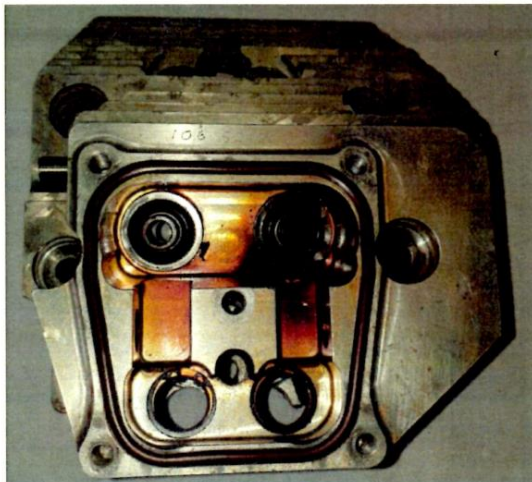
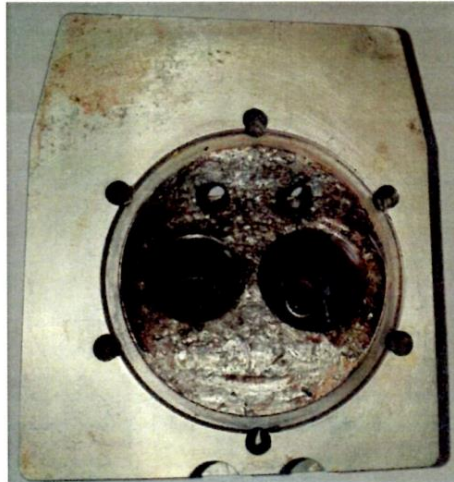
The head condition prior to valve failing is in good condition, with no signs of recession, cylinder head leak. Inlet and exhaust ports show no evidence of leaks in the system

Above pictures show state of cylinder head

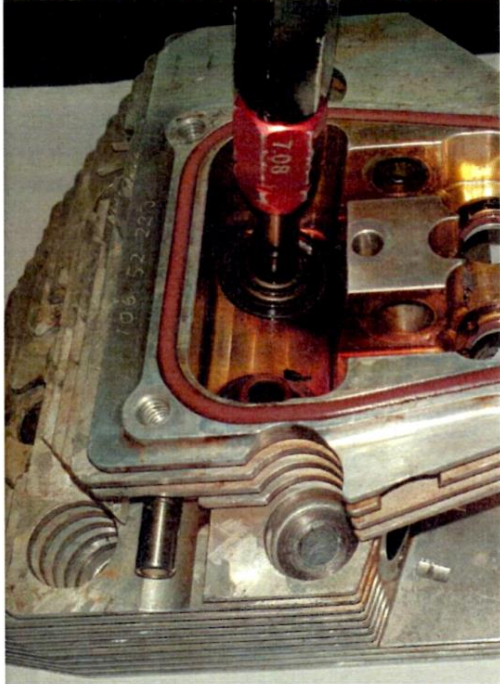
Above Picture Exhaust Valve Guide size

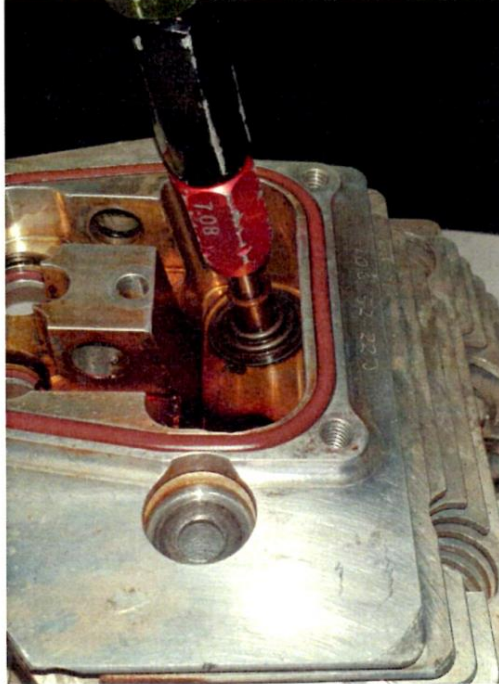
Inspection of the valve guides using a go-no-go gauge, go being 7.04mm and no being 7.08mm

Above Picture Inlet Valve Guide Size

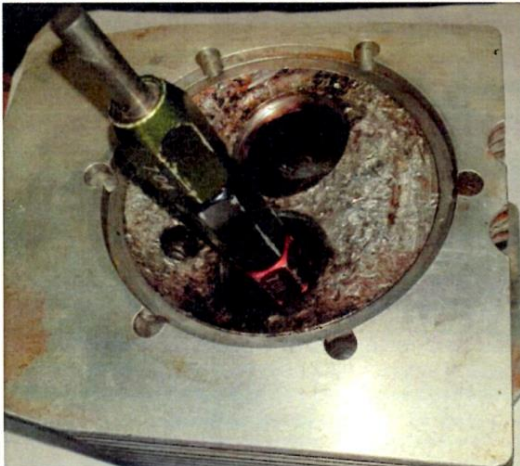
Above Picture  
The No go gauge showing same size on the  
Other side of the Exhaust valve

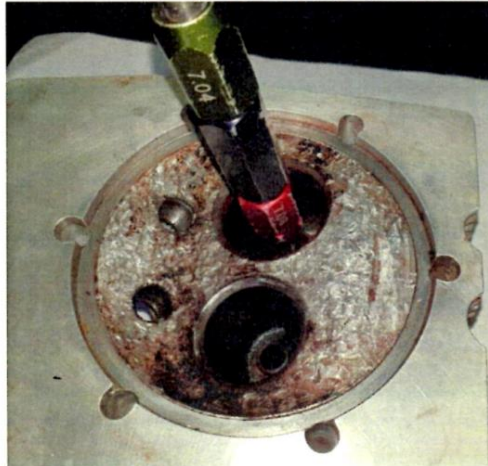
Above Picture  
The No go gauge showing same size on the  
other side of the inlet valve

The evidence lends to the fact that the valve guide was worn in excess of the tolerances which allowed the valve to operate at unusual angles, which leads to the fatiguing of the valve and catastrophic failure of the valve was the end result. All valve stems show scuffing marks which could be lubrication failure, either lack of oil or overheated oil or dirt in the oil.

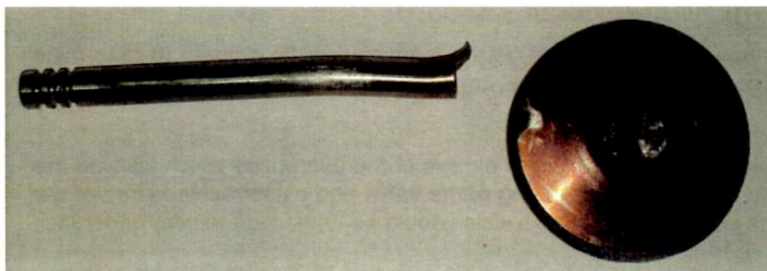
The valve that broke was an inlet valve. The head of the valve separated from the stem of the valve. The nature of the break was consistent to signs of metal fatigue and not thermal stress. The stem of the valve shows two distinct areas of wear, indicating that the valve was wobbling in the valve guide.

Above Picture of Broken intake Valve

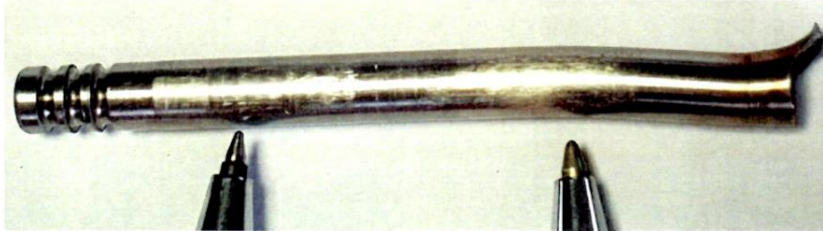
Above picture showing the wear areas

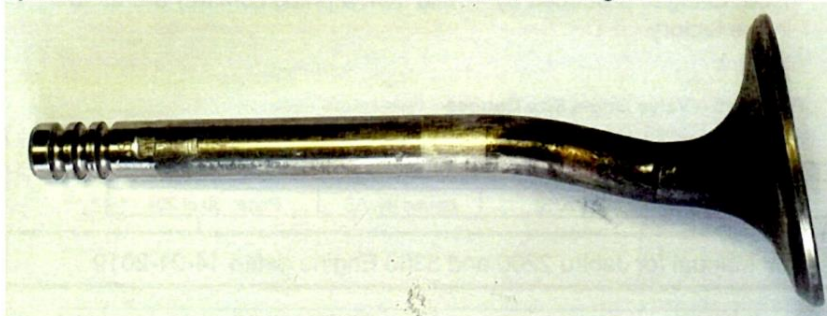
One exhaust valve was bent. This is likely to have happened after the inlet valve broke and the debris in the cylinder collided with the heated exhaust valve causing the deformation.

Above picture of the bent exhaust valve

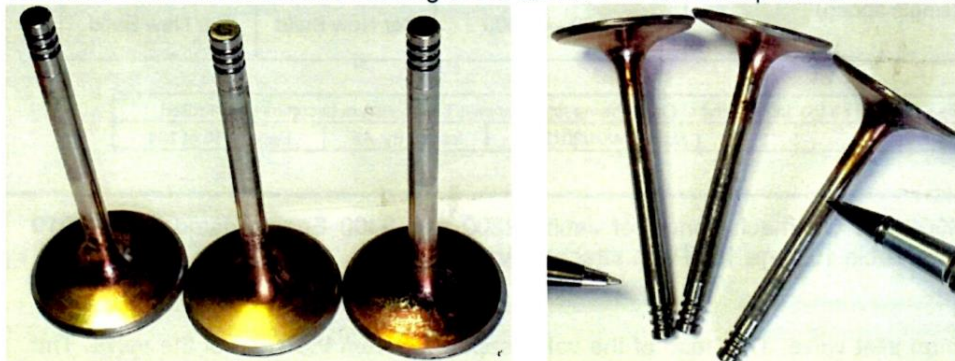
The other valve stems showed scuffing of the stems. The valve keep collets were of the correct shape

Above pictures showing the condition of the other valves and on the right showing the wear markings on the valves
