AIRCRAFT ACCIDENT REPORT AND EXECUTIVE SUMMARY

Reference:	CA18/2/3/9785	
Aircraft Registration	ZU-FUO	Date of Accident	10 May 2019		Time of Accident	1105Z
Type of Aircraft	RT13B		Type of Operation	Private (Part 94)		
Pilot-in-command Licence Type	Private Pilot Licence		Age	75	Licence Valid	No
Pilot-in-command Flying Experience	Total Flying Hours		3092.98		Hours on Type	354.6
Last point of departure	Volksrust Aerodrome (FAVU), Mpumalanga Province					
Next point of intended landing	Mountain View Lodge, Mookgopong, Limpopo Province					
Location of the accident site with reference to easily defined geographical points (GPS readings if possible)						
Mountain View Lodge at GPS co-ordinates S24°26'36.82" E028°26'26.10" at an elevation of 4 835 feet (ft) above mean sea level (AMSL)						
Meteorological Information	Temperature: 25°C; Dew Point: 13°C; Wind: 040° at 05 knots; QNH: 1021 hPa					
Number of people on board	1+1	No. of people injured	0	No. of people killed	2

Reference Number : CA18/2/3/9785
Name of Owner/Operator : Kemp J.M
Manufacturer : Kemp J.M
Model : RT13B
Nationality : South African
Registration Marks : ZU-FUO
Place : Mountain View Lodge, Mookgopong, Limpopo Province
D

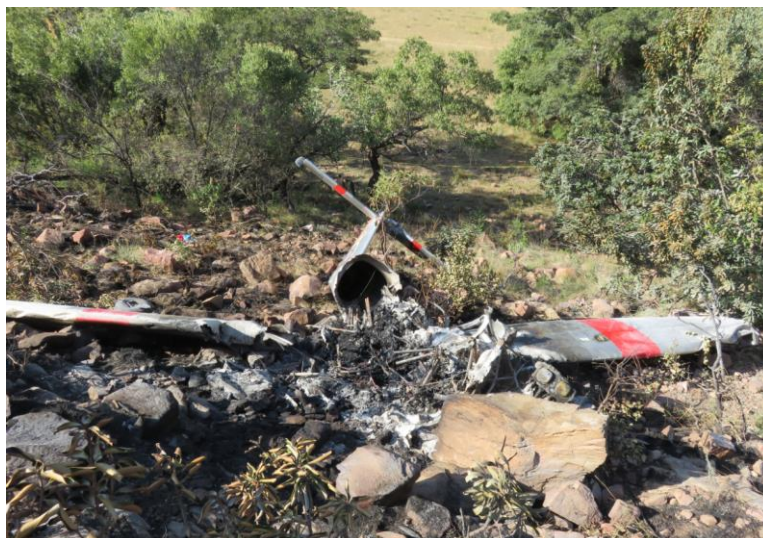
- 1.1.3 The aircraft impacted a rocky hill (terrain) located north of the runway and was destroyed on impact as well as by a post-impact fire which erupted thereafter. The fire consumed the cabin area and the in-board section of the wings of the aircraft. The wreckage was contained within a 13-metre radius.

1.3.1 The aircraft was destroyed.

Figure 2: Aircraft as it came to rest.

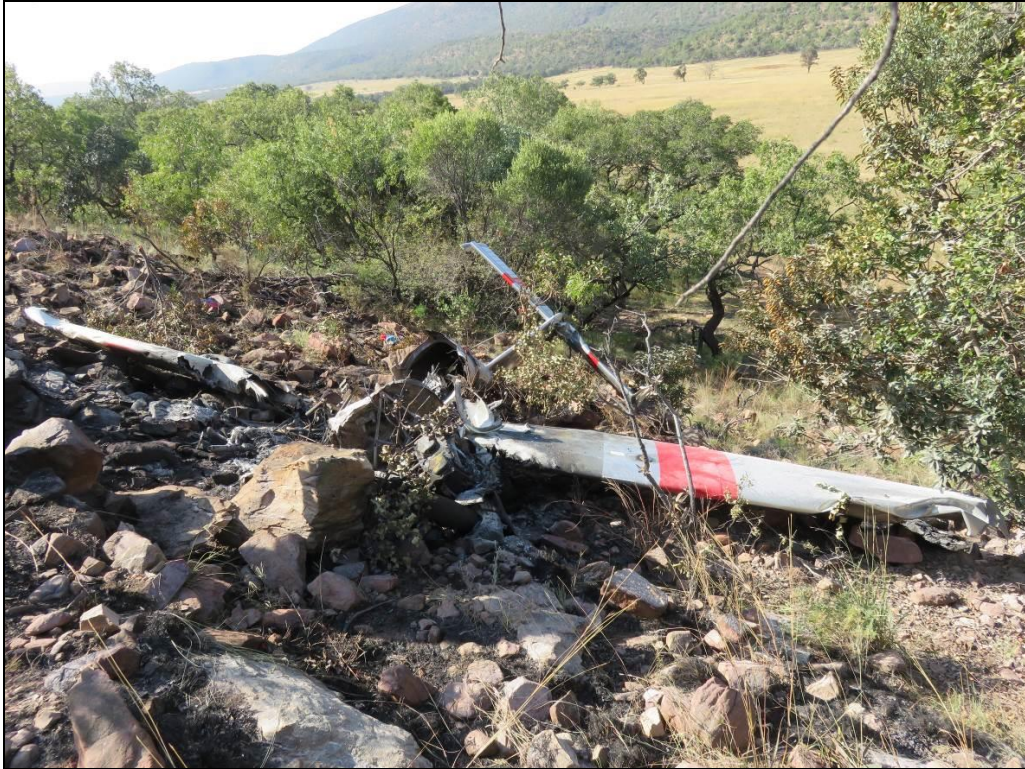
1.12.1 It was determined that the aircraft approached the accident site from an easterly direction in a slightly left-wing low attitude. Marks on the face of the rocks indicated that the right-hand (R/H) wing tip impacted the rocks on the ridge first. The aircraft continued on the same path for approximately 6m before impacting a tree and uprooting it with its left-hand horizontal stabiliser. The aircraft spun around its vertical axis and came to a halt facing a north-westerly direction after impacting hard on the large rocks with its nose section; the engine was pushed to the left. The left-hand main landing gear wheel assembly and nose landing gear separated from the aircraft during the impact sequence.

Figure 4: A view of the wreckage taken from the front.

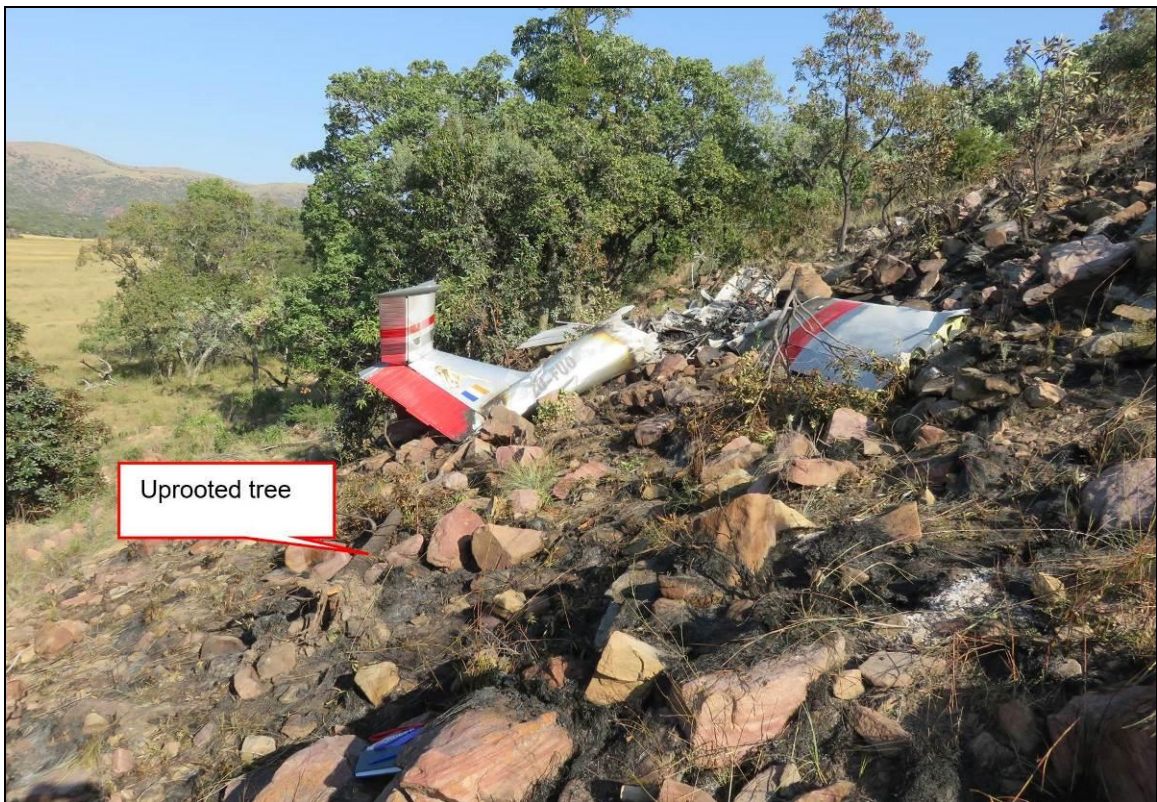
Figure 5: A view of the wreckage taken from the right-hand side showing the uprooted tree.

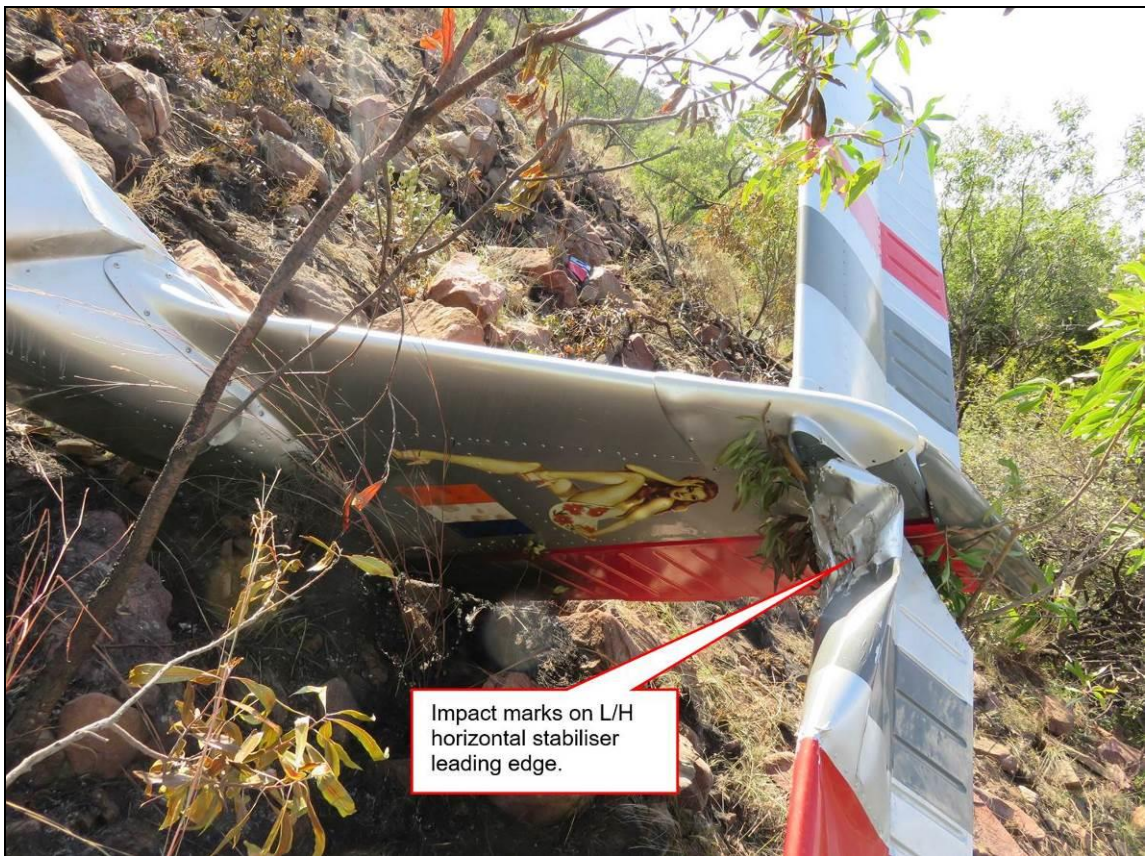
Figure 6: A view of the tail section taken from the left-hand side showing the impact marks on the leading edge.

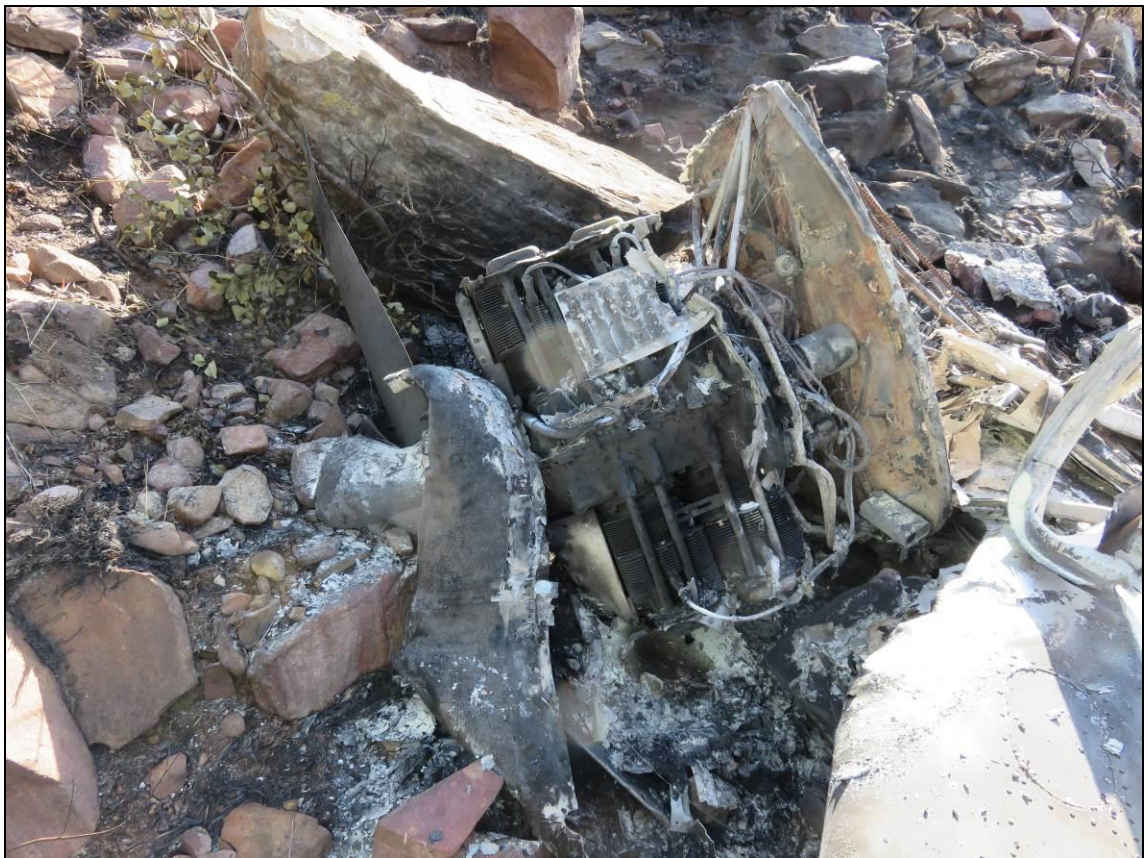
1.12.2 It was noted that the tip of one of the propeller blades broke off, while the other tip was still intact with no signs of rotational damage, which would be consistent with the engine not operating at impact. Both wings were damaged during the impact sequence.

Figure 7: A view of the engine and propeller.

A post-accident inspection revealed that the engine could turn freely by hand. An engine tear-down inspection was considered for this investigation, but due to the extensive heat damage to the engine components, a decision was made not to do a tear-down inspection to confirm if any internal parts had failed as this was considered unlikely.

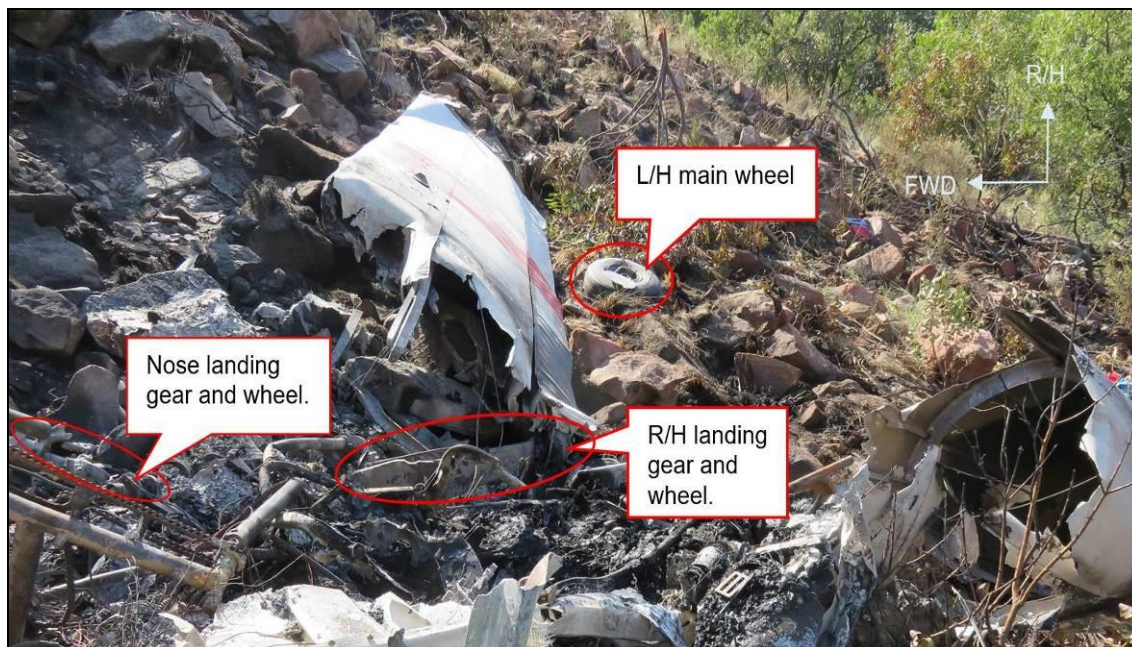
Figure 8: A view of the landing gears and wheels.

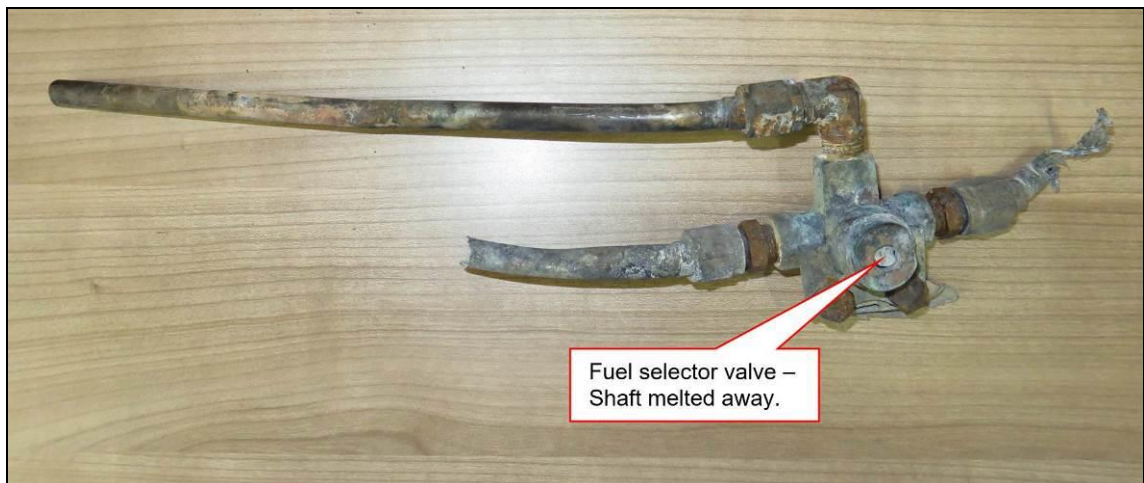
The fuel selector valve was recovered from the wreckage during the follow-up inspection of the wreckage. The valve sustained severe fire damage, and the fuel selector valve shaft had melted. The fuel selector valve was stripped down by an approved AMO to determine the position and internal condition. However, the position and internal condition of the valve were undetermined due to the significant heat damage sustained during the post-impact fire.

Figure 9: A fuel selector valve after it was recovered from the wreckage.

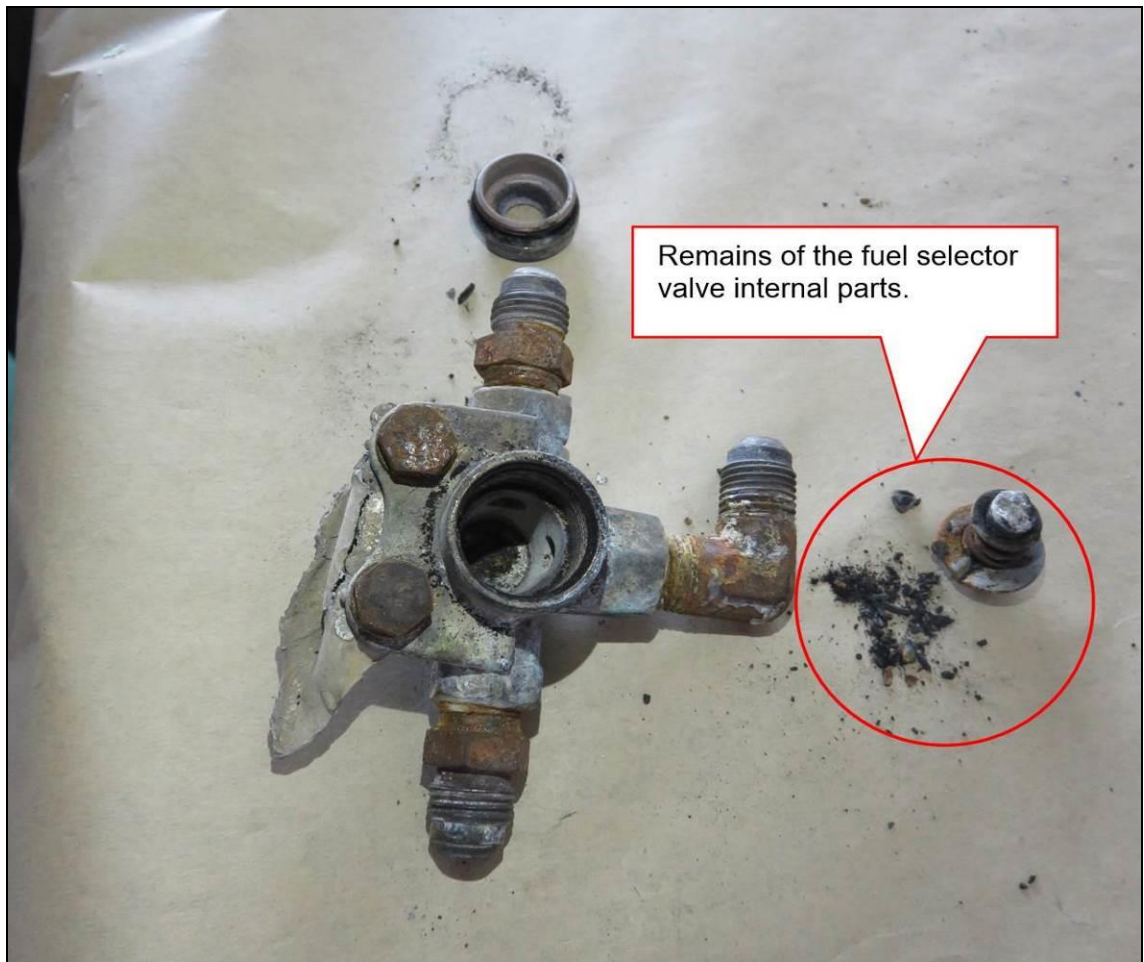
It was further noted during the investigation that the fuel selector valve, which was the original Piper PA-38-112 Tomahawk part, was subject to inspection and lubrication every 400 hours, according to the Piper Aircraft Corporation PA-38-112 Tomahawk Maintenance Manual and Service Letter No. 944. There was no evidence in the aircraft's logbook or in the built history file that the valve was inspected and lubricated since it was introduced in the NTCA category. Copies of the required maintenance action are attached (see Appendix 1).

Figure 10: A fuel selector valve after it was disassembled at an approved AMO.

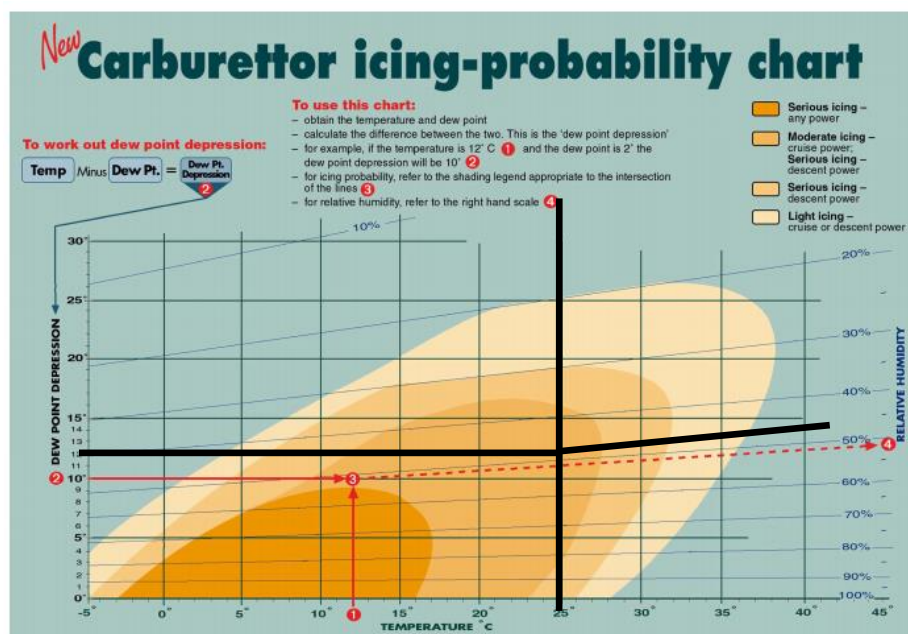
Figure 12: Carburettor icing probability graph. (Source: Google)

1.18.2 The reported weather conditions for FAER (temperature 25°C and dew point 13°C) placed the aircraft in the serious icing conditions section of the carburettor icing probability graph for the glide power phase of the flight. The reported weather conditions indicated that the relative humidity in the area was between 45% at the time of the accident.

- 2.2.10 The weather was CAVOK with a calculated precipitation of 48% and serious icing conditions during approach. The aircraft had just conducted a fly past on the runway and was on a left turn; thus, icing was ruled out as a cause or contributory factor to the engine failure.
