Accident and Incident Investigations Division

<b>AIRCRAFT ACCIDENT REPORT AND EXECUTIVE SUMMARY</b>
---

Reference:	CA18/2/3/9786	
<b>Aircraft Registration</b>	ZU-DVO	<b>Date of Accident</b>	1 May 2019		<b>Time of Accident</b>	0902Z
<b>Type of Aircraft</b>	Glasair II-S FT		<b>Type of Operation</b>	Private (Part 94)		
<b>Pilot-in-command Licence Type</b>	PPL	<b>Age</b>	41	<b>Licence Valid</b>	Yes	
<b>Pilot-in-command Flying Experience</b>	Total Flying Hours	583.16		Hours on Type	10.6	
<b>Last point of Departure</b>	Wings Park Aerodrome, Kwetyana, Eastern Cape					
<b>Next point of Intended landing</b>	East London Aerodrome, East London, Eastern Cape					
<b>Location of the accident site with reference to easily defined geographical points (GPS readings if possible)</b>						
Wings Park Aerodrome to the left of Runway 27 (32°49'46" South 027°49'46" East)						
<b>Meteorological Information</b>	Wind: 220°/5-10 knots, Temperature: 25°C, Dew Point: Unknown, Visibility: 9999m, Clouds: BKN at: 4900ft, QNH: Unknown

**Reference Number** : CA18/2/3/9786  
**Name of Owner** : ZUDVO Syndicate  
**Manufacturer** : Chorosz Gilbert  
**Model** : Glasair Super II-S FT  
**Nationality** : South A

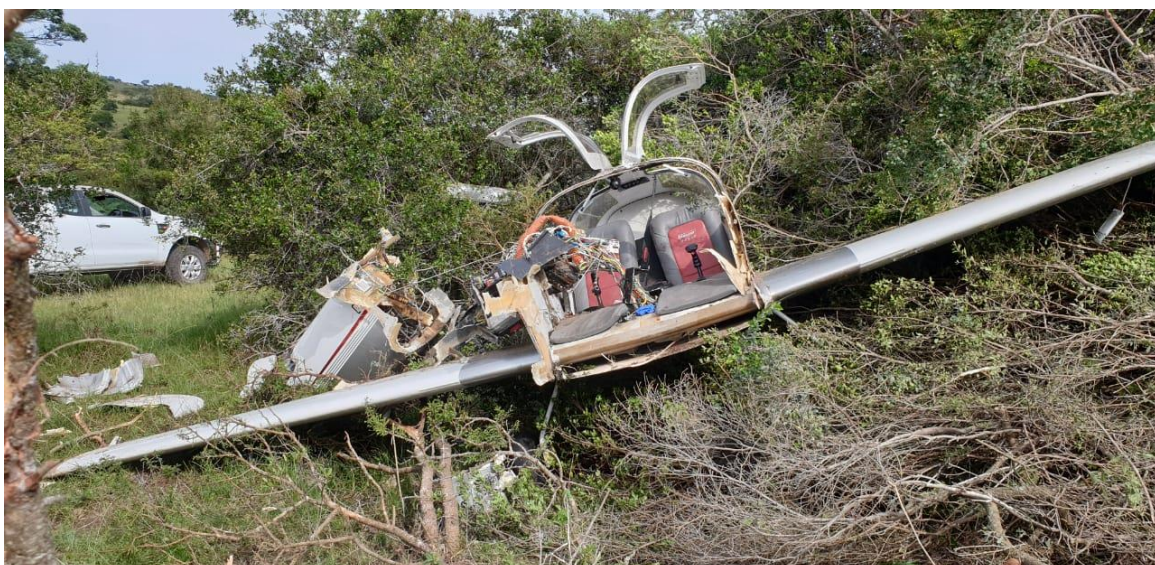
1.3.1 The aircraft was destroyed during the accident sequence.

**Figure 2:** Front view of the damage sustained by the aircraft. (Picture: Rob Williamson)

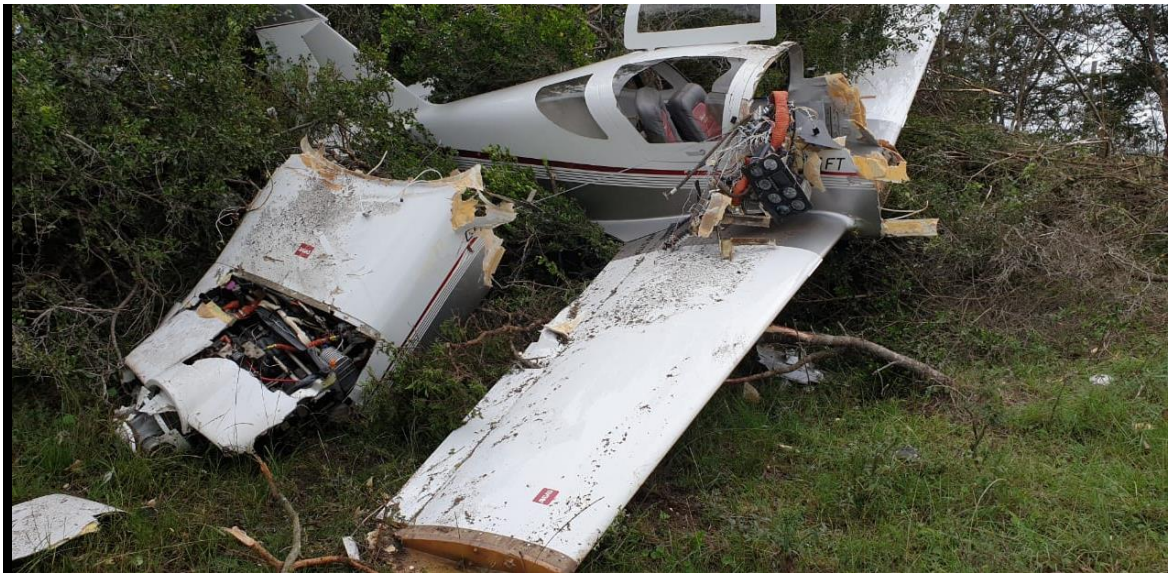
Figure 3: Side view of the damage sustained by the aircraft. (Picture: Rob Williamson)

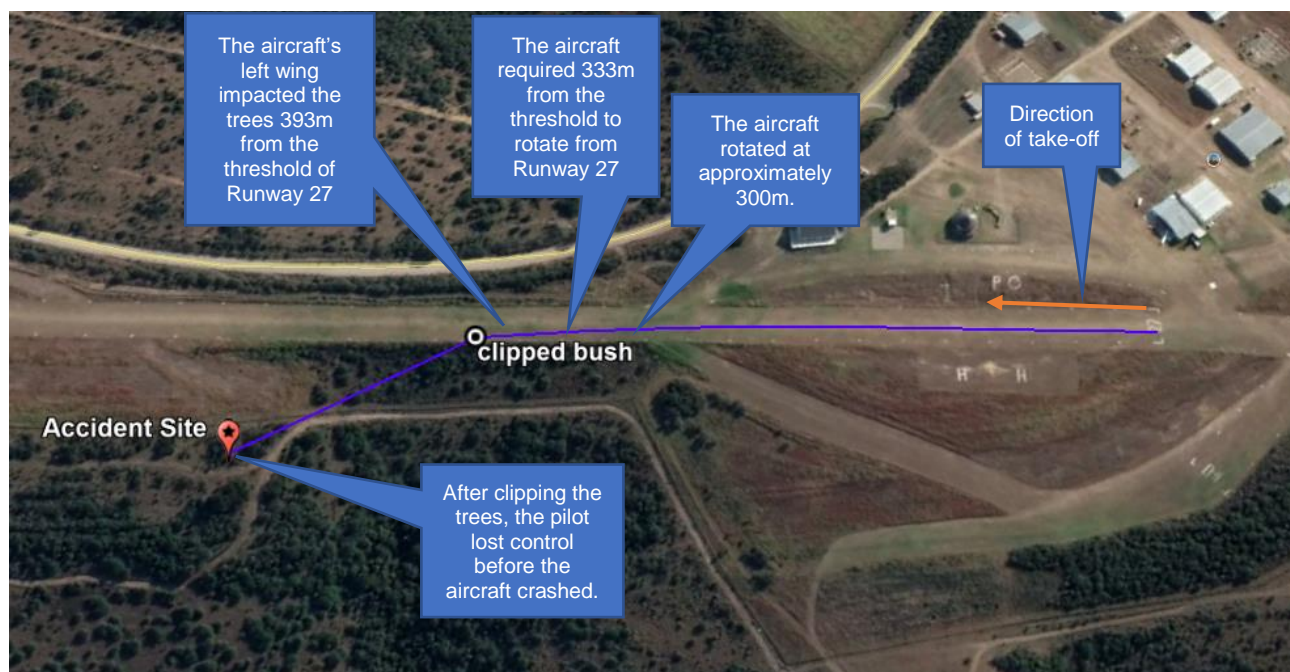
1.12.2 During the take-off roll, the aircraft drifted to the left of the runway centre line. The runway is partially lined by trees on both sides and this deviation in runway heading may limit the clear path ahead of the aircraft during take-off.

1.12.3 As the aircraft rotated, the left wing scraped the ground, causing it (aircraft) to drift further to the left. The aircraft continued with rotation and was able to get airborne before the left wing impacted the trees parallel to the runway.

1.12.4 The aircraft remained airborne for a further 155m from the point of impact with the trees before it lost height and crashed.

1.12.5 The aircraft came to rest facing a northerly direction on a field to the left side of Runway 27, approximately 80m to the left of the runway centre line. The aircraft was destroyed on impact. The accident occurred in the perimeter of the aerodrome.

**Figure 5:** Google Earth map showing the direction of take-off using Runway 27.
