<b>AIRCRAFT ACCIDENT SHORT REPORT</b>
---------------------------------------

**CA18/2/3/9787:** The aircraft pitched the nose up after take-off and crashed due to the rope that was connected on the control stick.

**Aircraft registration** : ZU-FBP

**Aircraft manufacturer and model** : Babst C F, Carl Babst Raven 1

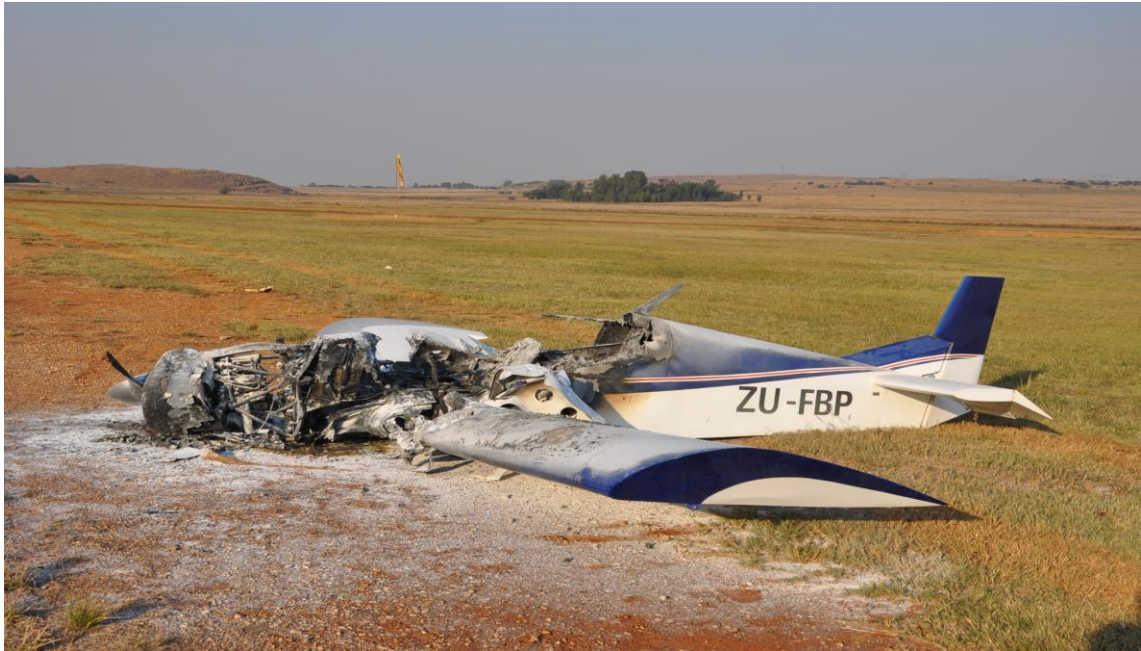
**Figure 2:** The burnt aircraft at the accident site.

2.2.1 The Accident and Incident Investigation Division (AIID) was notified of the accident and an investigator was dispatched to the accident site. On examining the wreckage, it was established that the aircraft's main wheel struts were pushed through the wings and fuel had leaked from the main tank. The front section of the fuselage (cockpit area) was burnt. The flaps and ailerons remained attached to their respective wings. An examination of the flaps showed that they were in a retracted/up position. The rudder and elevator remained attached to the empennage. Control continuity was confirmed from flight control surfaces to the cockpit controls. The engine was still attached to the cradle and airframe. The wooden propeller remained attached to the engine and all blades had rotational damages. The top spark plugs were removed and their electrodes were intact and light grey in colour. The propeller was rotated and the crankshaft rotated freely. The valve train continuity was confirmed and thumb compression was attained on all cylinders.

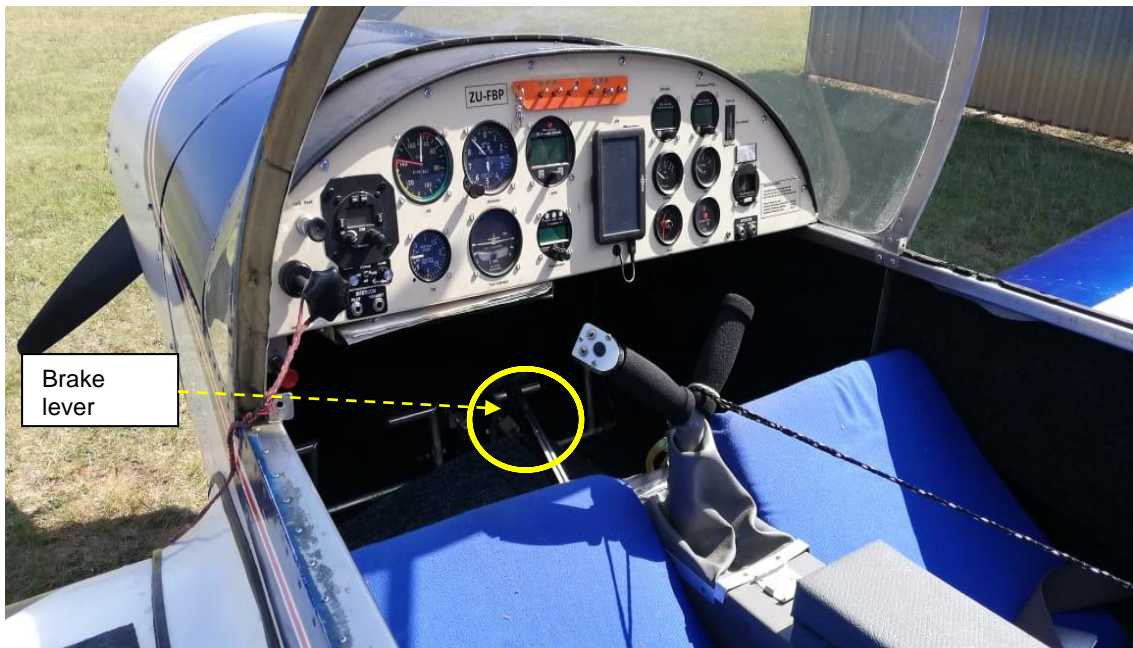
The PF informed the investigator-in-charge (IIC) that the aircraft had a nylon rope fitted to the control stick connecting to the elevator to (i) keep the control stick back to allow the pilot to access the brake lever located on the floor between the two pilots' seats while taxiing; (ii) keep the elevator in a full-up position when parked outside of the hangar to prevent the elevator from flapping up and down. The PF further stated that with the nylon rope holding

back the control stick, pilots are unable to lower the nose. The rope, as shown on Figure 3, does not come fitted with the aircraft and, therefore, does not form part of the pre-take-off checklist. This rope had consequently prohibited the forward movement of the control stick, thus, prohibiting the pilots from effecting changes to the pitch control of the aircraft. See Figure 3.

**Figure 3:** The aircraft's cockpit area with the rope secured from the control stick to the elevator.

**\*NOTE:** The cable was consumed by post-impact fire and no evidence of it was found during the on-site investigation.

4.2 Contributing factor is that the pilot forgot to remove the nylon rope attached to the control stick and that prevented the crew to control the aircraft nose pitch.

5.1 Safety Message: It is recommended that the crew at all times conduct a proper pre-flight including flight controls checkouts prior to the line-up for take-off, this accident could have been avoided should the crew have done proper flight control checkouts prior to take off.
