AIRCRAFT ACCIDENT SHORT REPORT

CA18/2/3/9789: Unsuccessful forced landing following an engine failure in-flight.

Date and time	: 23 May 2019 at 0722Z
Location	: Hans Merensky Golf Course, Phalaborwa
Aircraft registration	: ZU-FFB
Aircraft manufacturer and model	: Micro Aviation New Zealand Ltd, Bantam B22J
Last point of departure	: Phalaborwa Aerodrome (FAPH)
Next point of intended landing	: Skukuza Aerodrome (FASZ)
Location of accident site with reference to easily defined geographical points (GPS readings if possible)	: 18 th Fairway at the Hans Merensky Golf Course, Phalaborwa 23°57'52.47" South 031°10'03.31" East
Meteorological information	: Surface wind: 045°/2 kt, temperature: 15°C, CAVOK
Type of operation	: Private (Part 94)
Persons on board	: 1
Injuries	: None
Damage to aircraft	: Substantial

UNIVERSITEIT VAN PRETORIA UNIVERSITY OF PRETORIA YUNIBESITHI YA PRETORIA	LABORATORY FOR MICROSCOPY & MICROANALYSIS PAGE 2 OF 13
COMPILED FOR: SACAA (AIID)	FAILURE ANALYSIS REPORT: BANTAM B22J ENGINE COMPONENT, AIRCRAFT No ZU-FFB	DOCUMENT NUMBER FA-004-07-19 DATE 2019-07-11 ISSUE 1
<p>(a) INTRODUCTION & BACKGROUND Par. 1 (b) APPLICABLE DOCUMENTS Par. 2 (c) DEFINITIONS Par. 3 (d) INVE

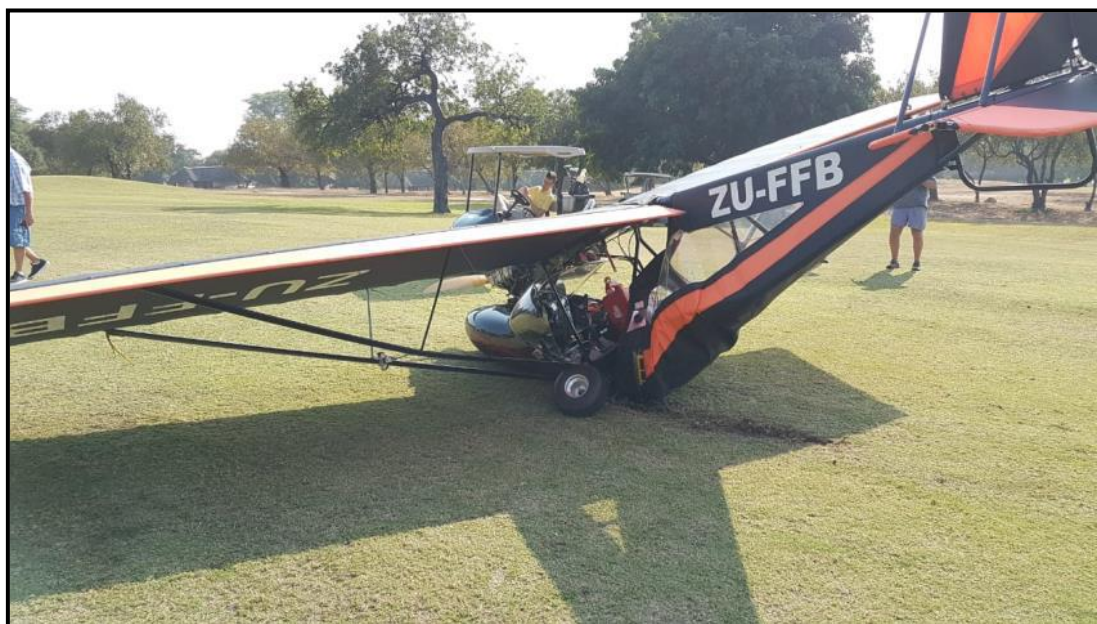
- 2.1.5 The aircraft touched down in a northerly direction on the 18th fairway of the Hans Merensky Golf Course. As can be seen in Figures 1 and 2, the aircraft came to an abrupt stop following the hard landing, which cause the landing gear as well as the engine cradle to collapse onto the canopy.

Figure 1: The microlight aircraft as it came to rest on the fairway

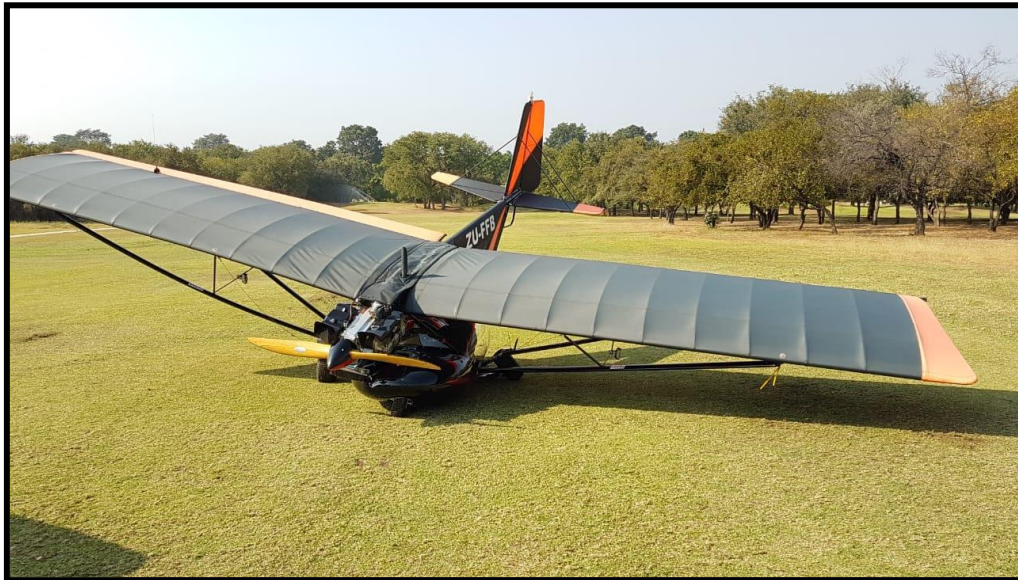
Figure 2: The front view of the microlight aircraft on the fairway

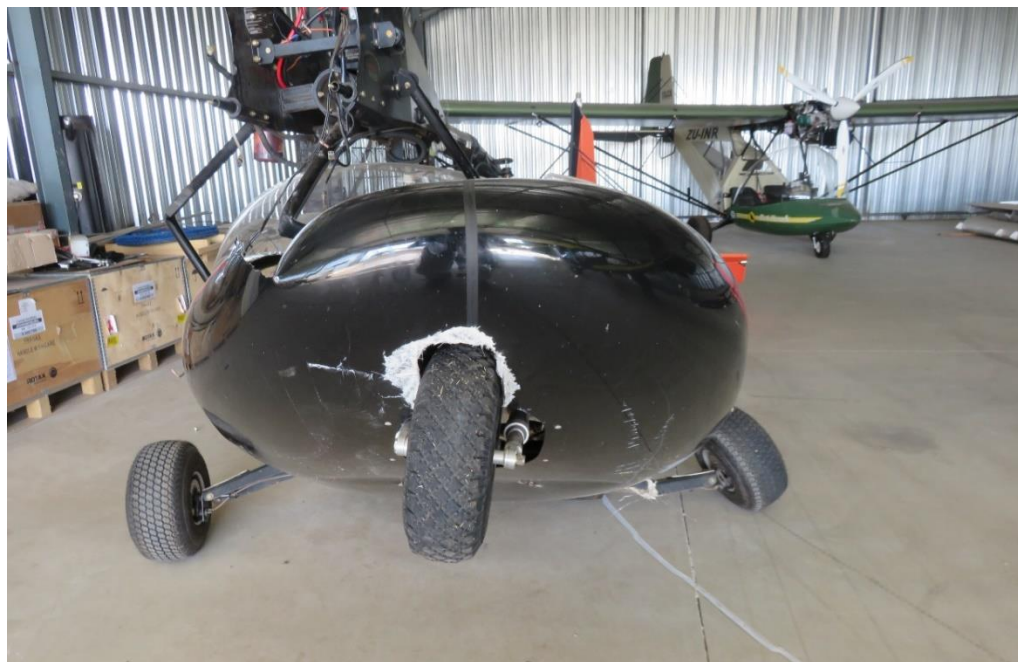
Figure 3: The front view of the aircraft with the boom structure bent to the right (post recovery)

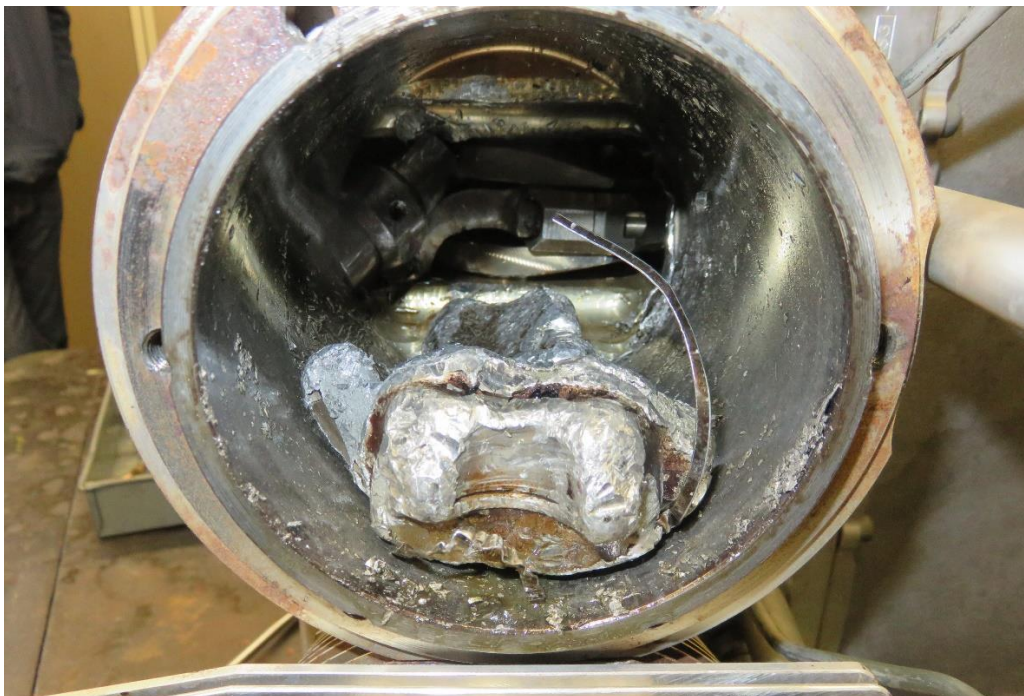
In Figure 5, debris from the piston is visible in the number 4 cylinder after the head assembly was removed.

Figure 5: Visible fragments within the No. 4 cylinder are fragments of the piston and a deformed conrod

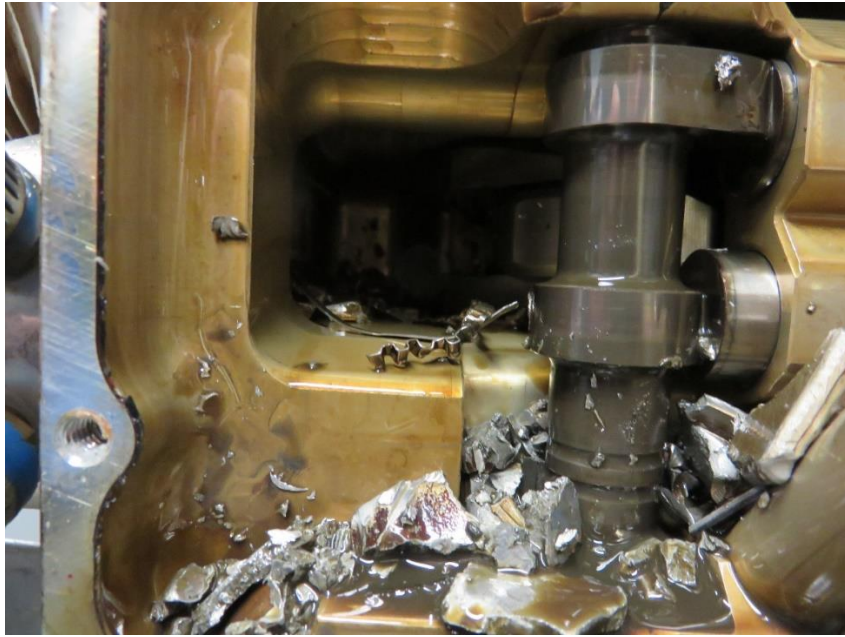
Figure 6: Visible fragments of the piston in the engine after the sump was removed

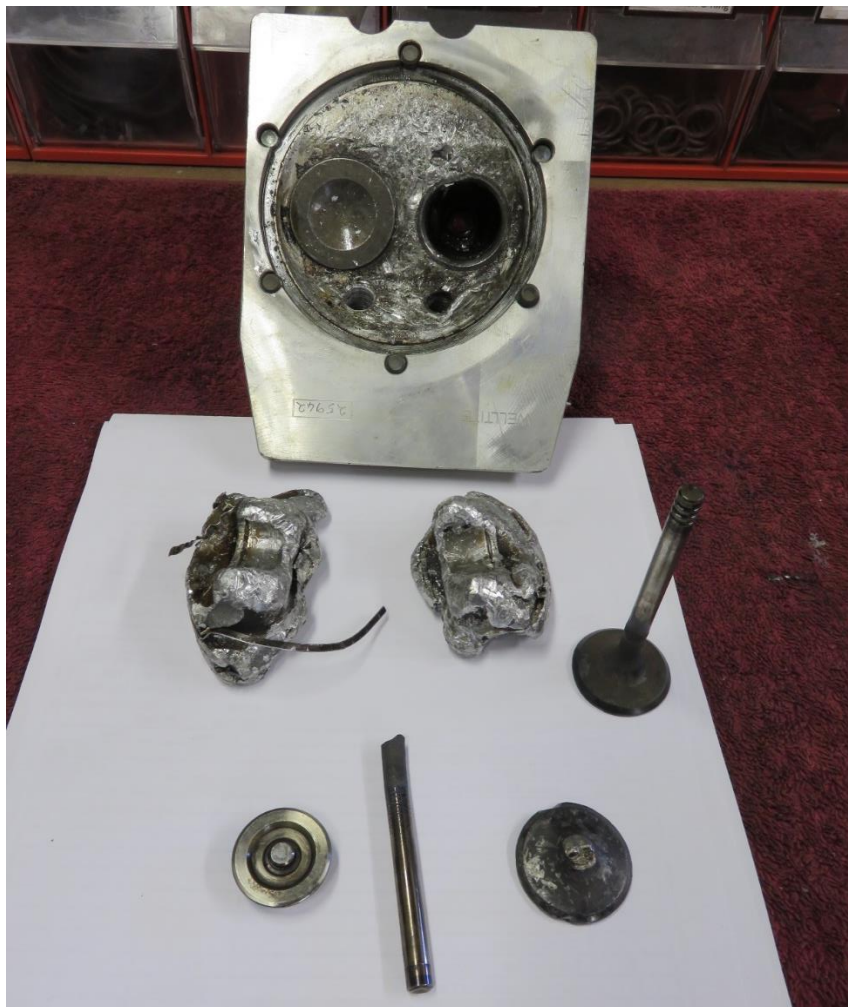
The teardown inspection determined that the catastrophic engine failure was due to a broken exhaust valve on the number 4 cylinder. It was found that the top section of the valve stem, just below the split collet, as well as at the valve neck, had failed as can be seen in Figure 7. The failure mode of the valve is discussed in the laboratory report which can be found attached to this report as Annexure A.

Figure 7: The 3 pieces of the fracture exhaust valve (bottom) and a used valve (right side)

- 3.8 The pilot stated that a strange noise, like clanking metal, came from the engine before it stopped.
- 3.9 The engine was subjected to a teardown examination and it was found that the exhaust valve on the number 4 cylinder had failed due to fatigue, which resulted in a catastrophic engine failure with extensive internal engine damage.

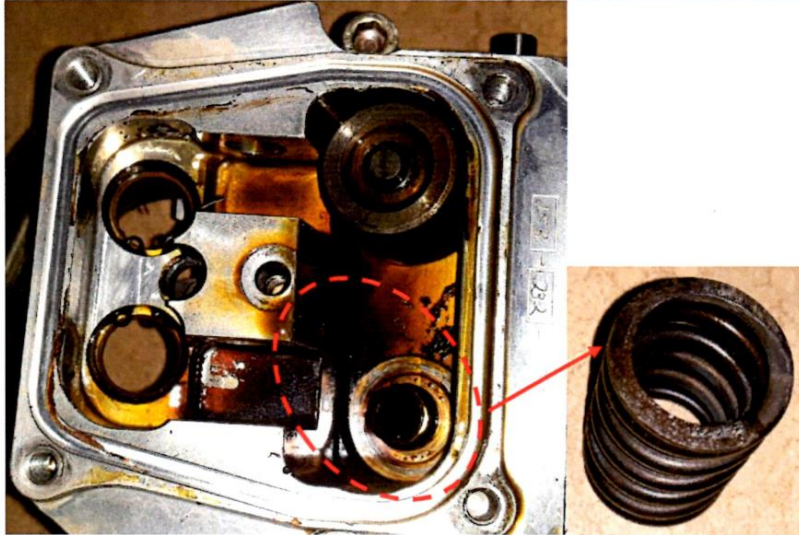
Photo 4: Valve spring seat area, indications of high temperature exposure (digital)

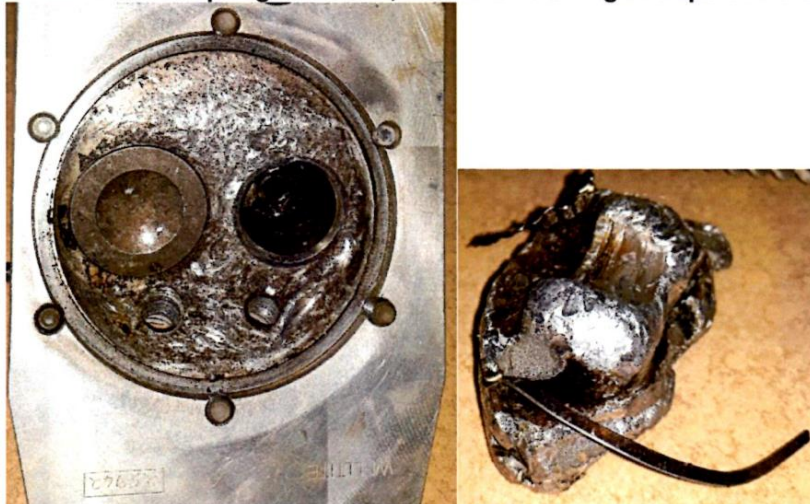
Photo 5: Exhaust valve seat, piston- and head conditions (digital)

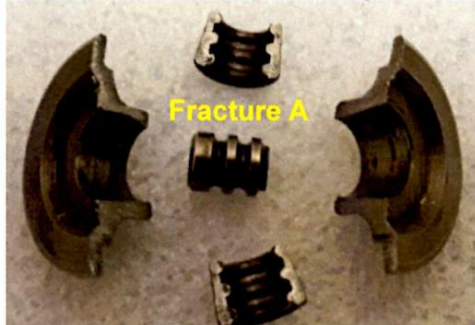
Photo 6: Position of fracture A, top valve spring washer condition (digital)

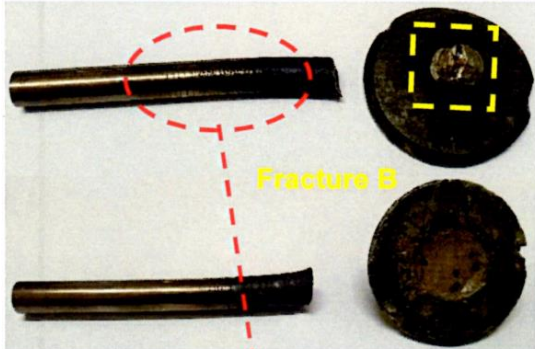
Photo 7: Position of Fracture B, exhaust valve stem condition (digital)

<p>The indications at the position of Fracture B suggest failure due to excessively high operational temperature exposure/s.</p>				
<p>However, due to the extensive post-failure damages, it could not be derived which of Fractures A or B initiated first in the sequence of events, and, whether both conditions for failure was present simultaneously. The only indication that Fracture A <u>most probably</u> initiated first is the presence of the time-dependant fatigue fracture, thus suggesting that Fracture B was imminent.</p>

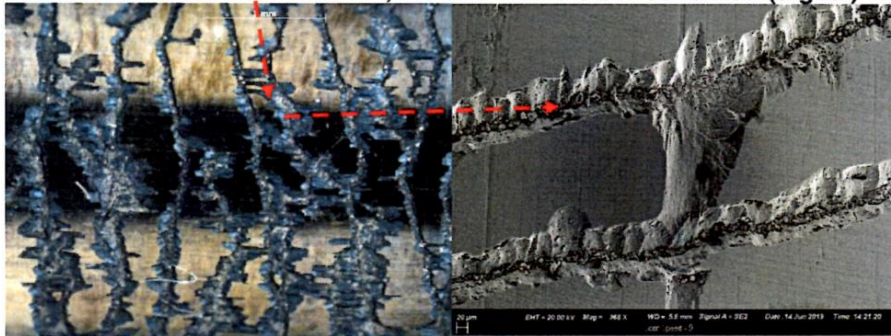
Photo 8: Exhaust valve stem, transverse stress cracking initiations, discoloring (Stereo/FEGSEM)

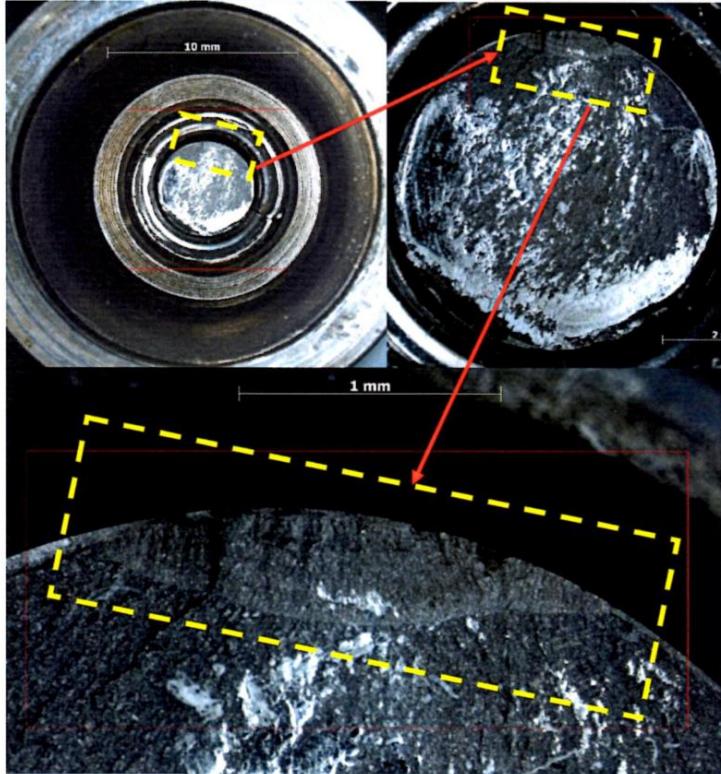
Photo 9: Fracture surface A geometry (Stereo)

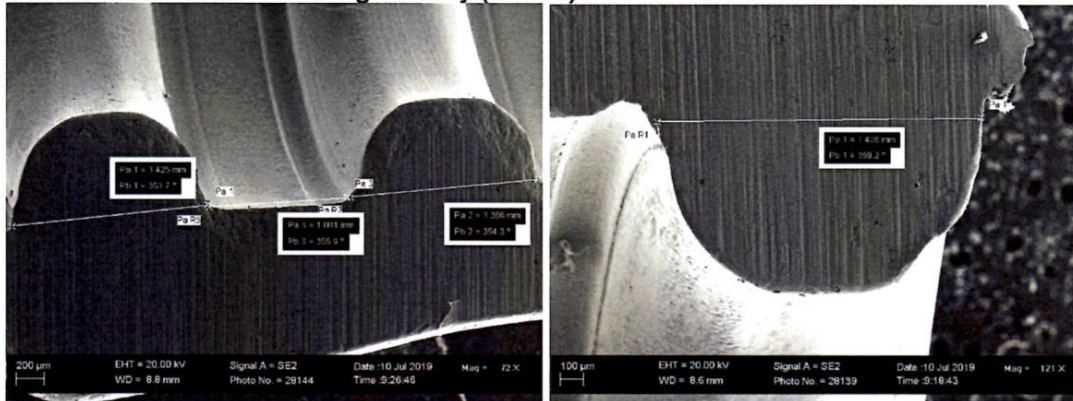
Fractograph 1: Collet dimensions and condition (32-121X, 20kV, SE, FEGSEM)

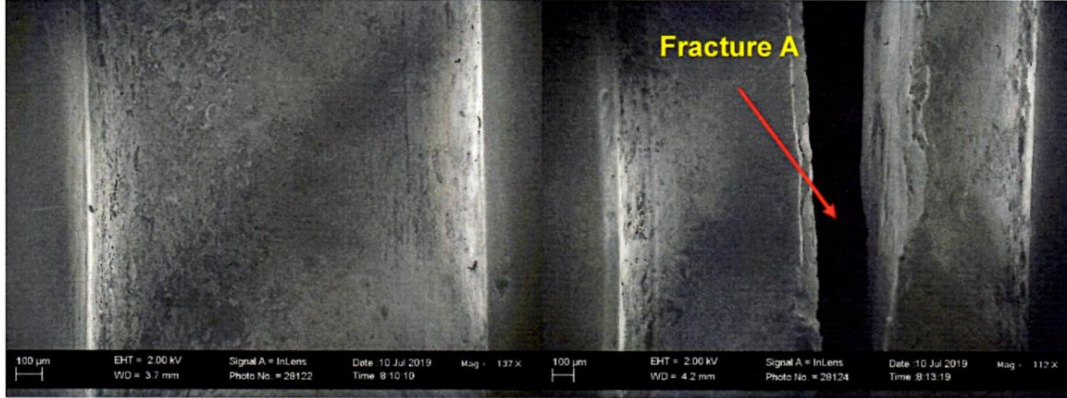
Fractograph 2: Collet/Valve stem interface, position of fracture A (112-137X, 2kV, InLens, FEGSEM)

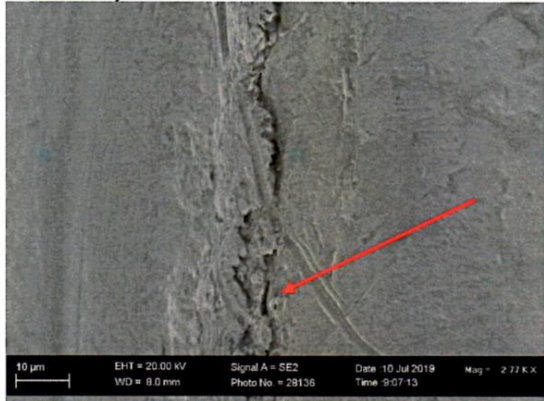
Fractograph 3: Secondary fracture initiation (2770X, 20kV, SE, FEGSEM)

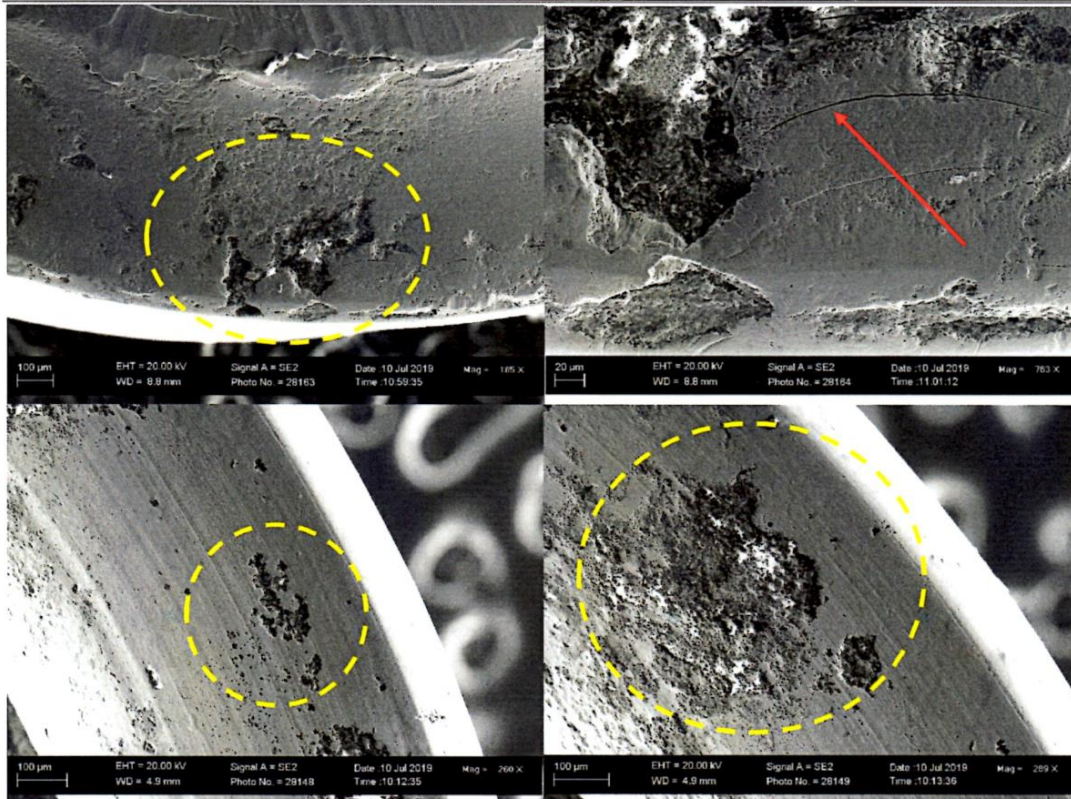
Fractograph 4: Collet/Valve stem interface, wear/corrosion induced pitting damage (185-383X, 20kV, SE, FEGSEM)

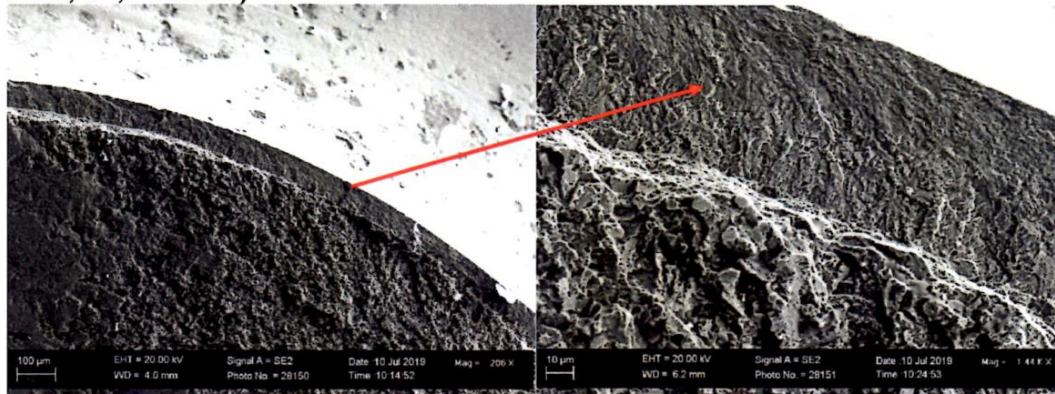
Fractograph 5: Hard surfaced layer geometry, valve stem (206-1440X, 20kV, SE, FEGSEM)

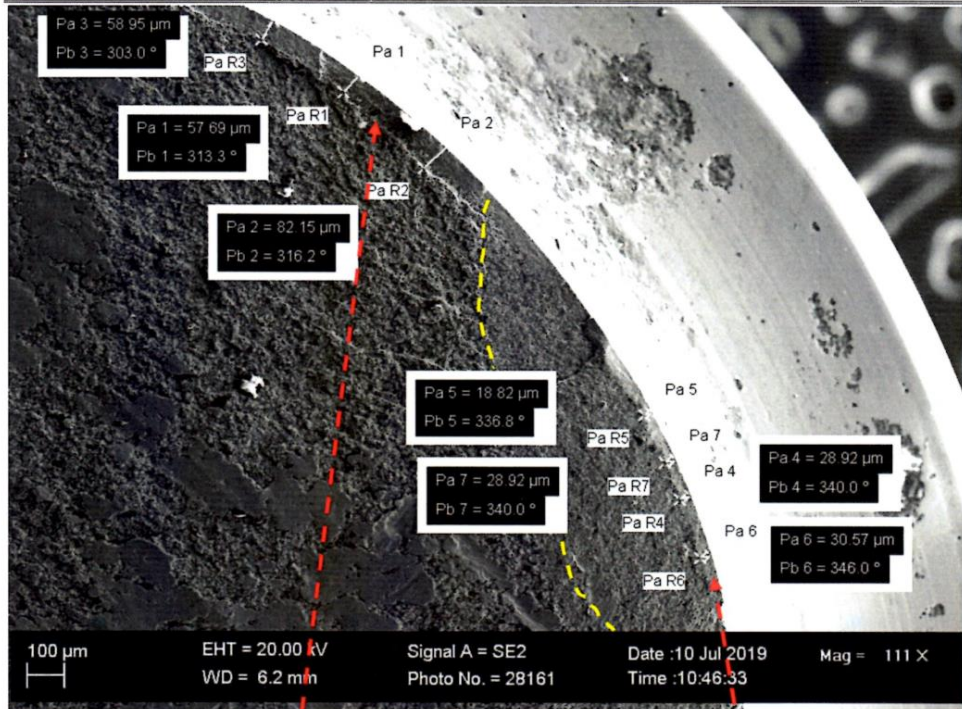
Fractograph 6: Hard surfaced layer thickness variations (111X, 20kV, SE, FEGSEM)

<p>7.2. The high magnification inspection of Fracture A revealed inconsistent hard surface layer thicknesses in the vicinity of the initiation point of the noted fatigue fracture within the serrated area (collet/valve stem interface). This could have contributed to the noted <i>secondary</i> surface cracks and most probably led cause to the initiation of the <i>primary</i> fatigue fracture.</p>				
<p>7.3. The results ascertained from the supplied parts (see Note 3) suggest that both fractures, A and B, had clear cause towards initiation.</p>				
<p>Fracture A due to fatigue fracture initiation/s brought about by hard-surfaced layer inconsistencies and/or operational forces induced as a secondary effect due to the interjected movement of the exhaust valve during operation. The latter possibly due to resistance of movement at the guide/stem interface because of the high temperature induced lubrication failure.</p>

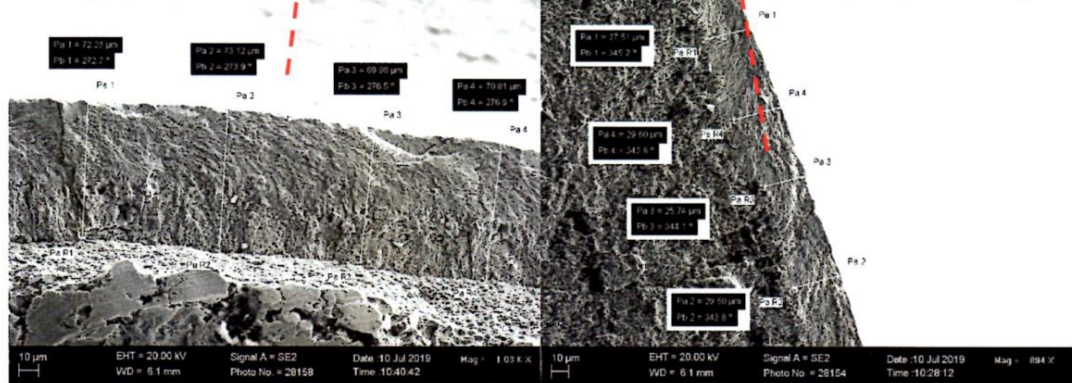
Fractograph 7: Hard surfaced layer thickness variations (894-1030, 20kV, SE, FEGSEM)

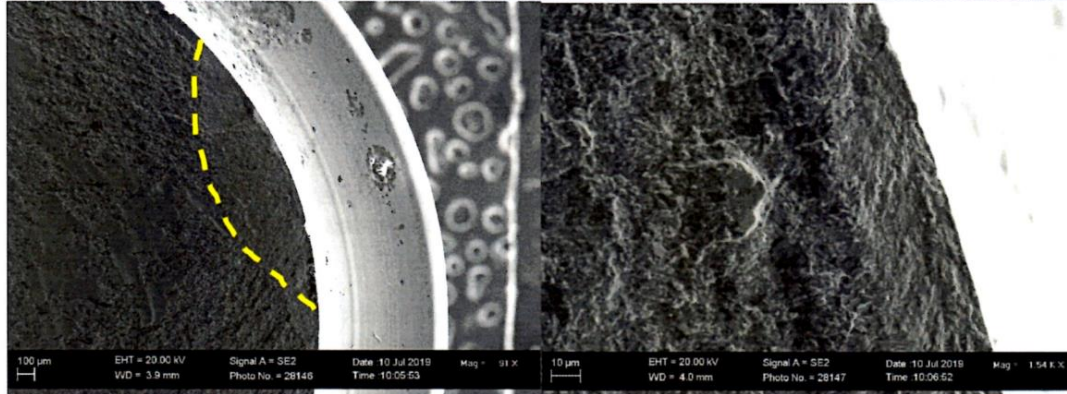
Fractograph 8: Fatigue fracture indications, fracture A (91-1540X, 20kV, SE, FEGSEM)

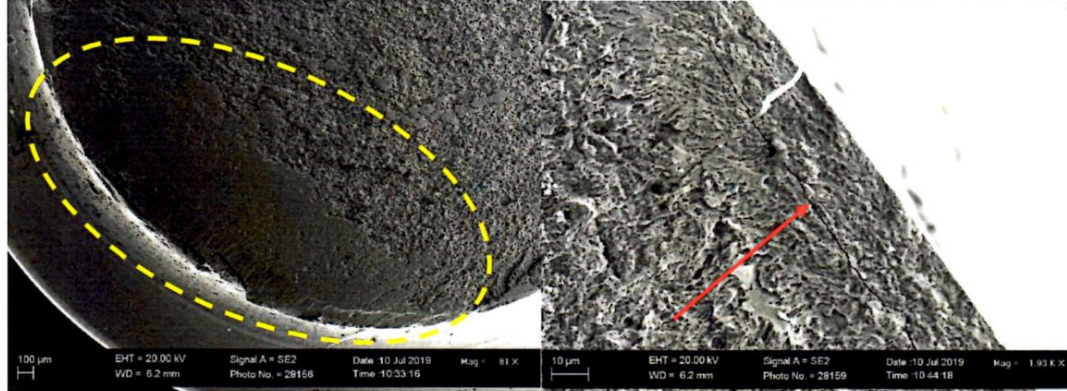
Fractograph 9: Smearing marks and secondary fracture initiation, fracture surface A (81-1930X, 20kV, SE, FEGSEM)

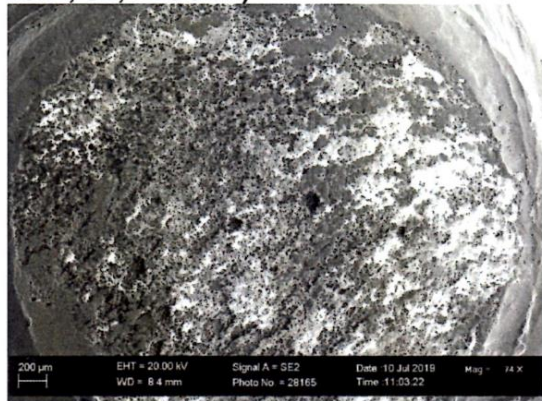
Fractograph 10: Opposing fracture surface damages, valve stem, fracture surface A (74X, 20kV, SE, FEGSEM)

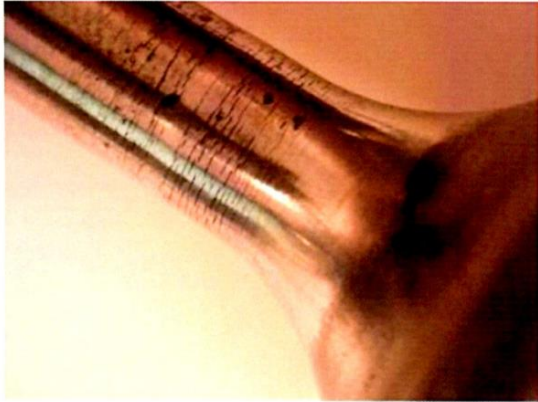
Figure 2: Valve with extensive stress cracks.

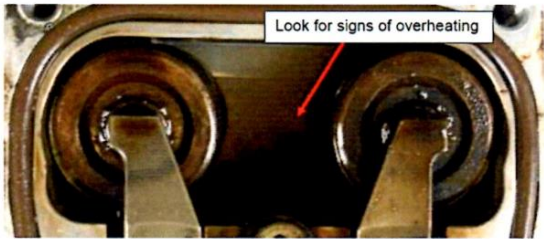
Extract 1: High temperature indications⁴
