AIRCRAFT ACCIDENT SHORT REPORT

CA18/2/3/9796: Engine failure followed by an unsuccessful forced landing.

Date and time : 9 January 2019 at 0558Z
Aircraft registration : ZS-SNU
Aircraft manufacturer and model : Piper Aircraft Corporation, PA-32R-301
Last point of departure : Mahohomal (farm), Northern Cape
Next point of intended landing : Wonderboom Aerodrome (FAWB), Gauteng
Location of incident site with reference to easily defined geographical points (GPS readings if possible) : S26°18'31.67" E023°52'07.82"
Meteorological information : Surface wind: 30°/5 kt; temperature: 25°C; visibility: good
Type of operation : Private (Part 91)
Persons on board : 1 + 0
Injuries : None
Damage to aircraft : Damage to the propeller, landing gear, wings, fuselage and tail section

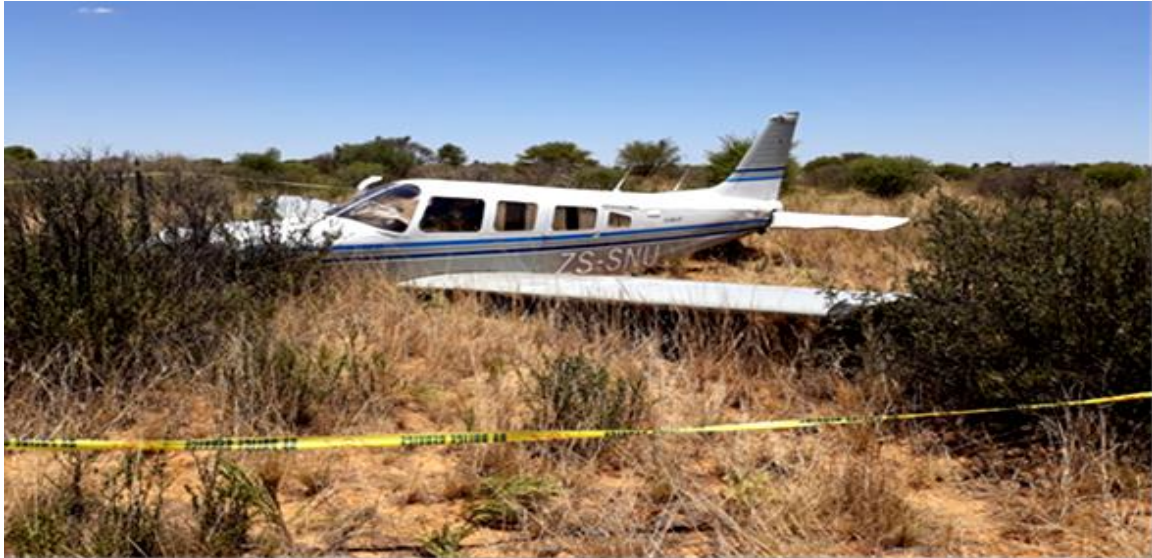
- 2.3. The pilot stated that he had chosen to execute a forced landing on an open field in Phephane farm, close to the town of Morokweng, in the North West Province. The pilot further stated that he had selected the undercarriage down for the forced landing. During the forced landing, the aircraft made contact with several small bushes, which caused dents to the wings, fuselage and tail section. The aircraft continued with the landing roll for approximately 85 metres (m) before all the landing gears broke off in soft sand. The aircraft continued to skid on its underbelly for a further 15m. Two of the three propeller blades were damaged during the forced landing.

Figure 1: The aircraft after it came to rest

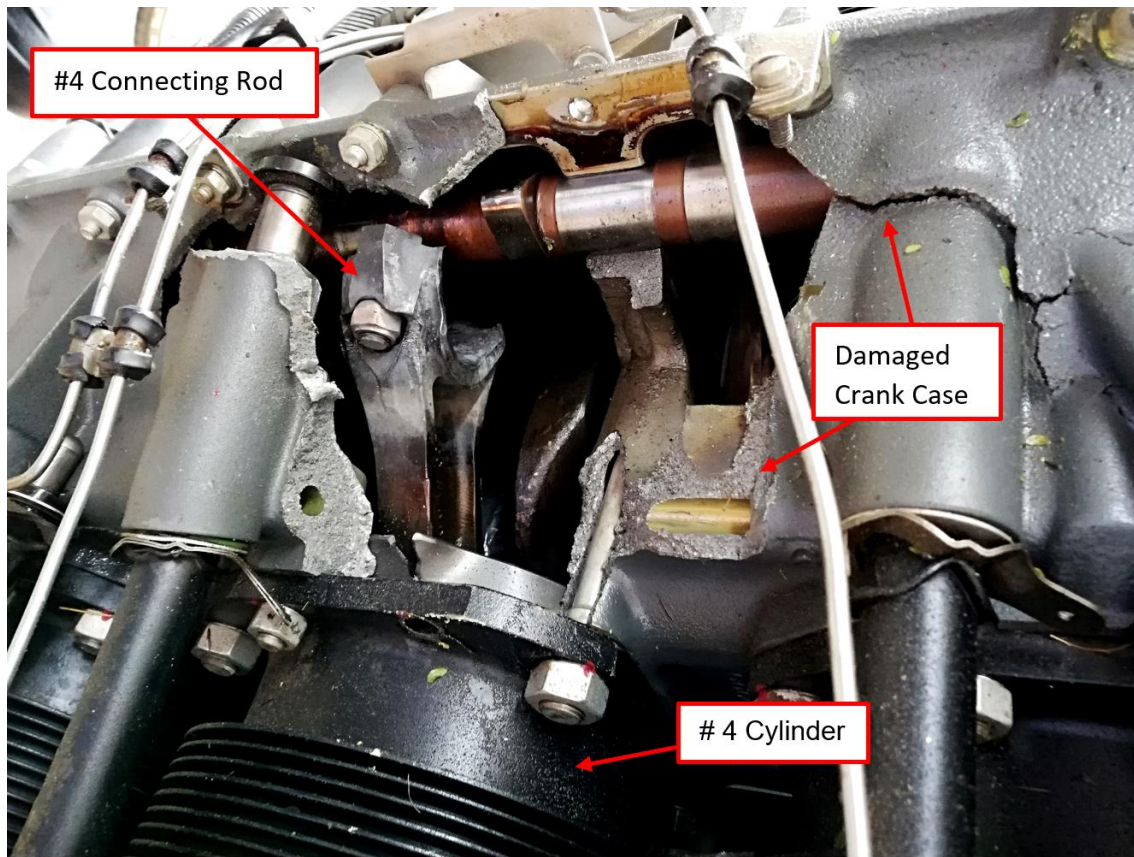
- 3.2. The aircraft maintenance organisation (AMO) which conducted the engine strip-down reported that the #4 and #5 connecting rod bearings had ceased in the crankshaft. They further reported that the main bearings had wear marks indicating that they were beginning to fail. The AMO also reported that the hydraulic plungers were deflated and that, during inspection, no oil was found in the oil coolers or the oil hoses. The AMO further stated that they found some oil in the Constant Speed Unit (CSU). The AMO which removed the engine from the aircraft reported that they did not find any loose, damaged or missing oil system components that could have caused a loss of engine oil, except for the damage on the engine crank case caused during the engine failure.

Figure 3: Some of the engine damage

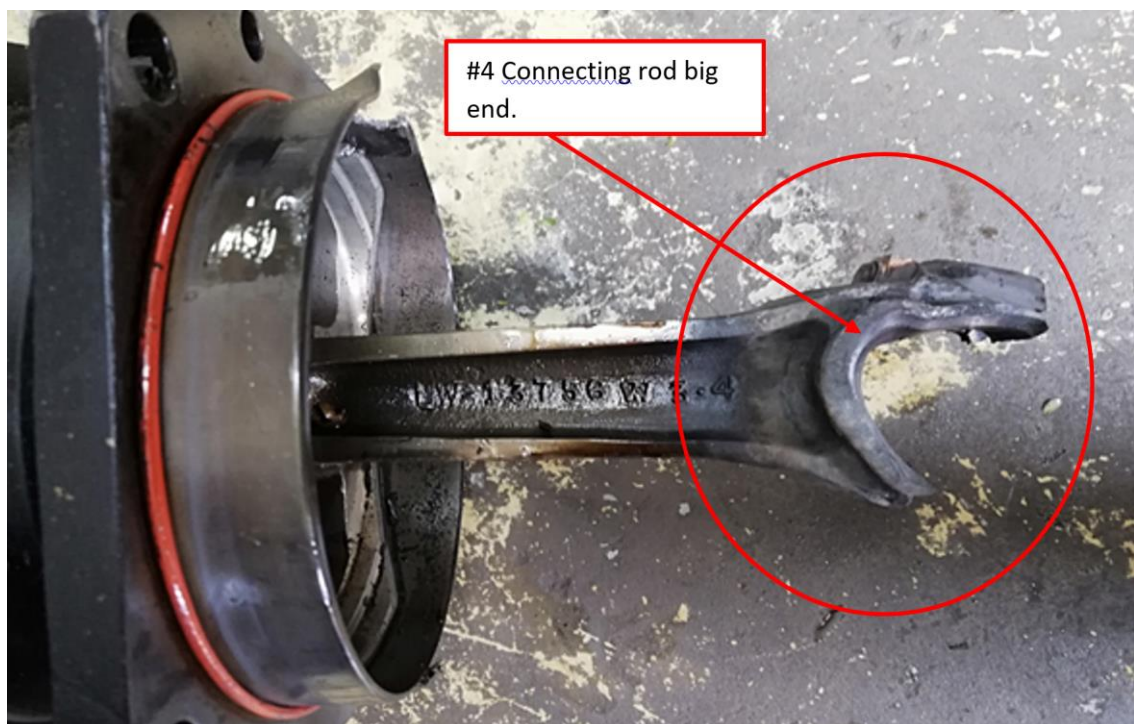
Figure 4: The failed #4 connecting rod

- 5.1. The engine failed during cruise because of failure of the connecting rod bearings as a result of oil starvation, hence, the subsequent unsuccessful forced landing.

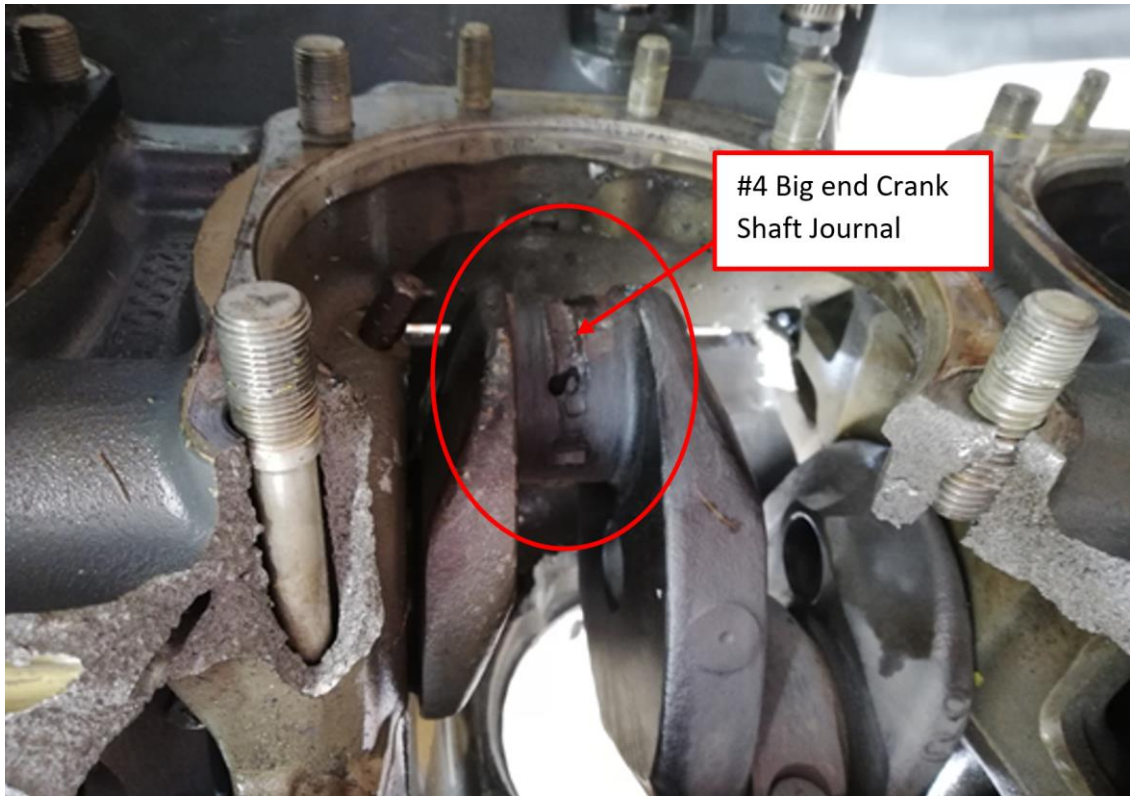
Figure 5: The damaged #4 big end crank shaft journal
