<b>AIRCRAFT ACCIDENT REPORT AND EXECUTIVE SUMMARY</b>
---

Reference:	CA18/2/3/9797		
<b>Aircraft Registration</b>	<b>ZU-IJP</b>	<b>Date of Accident</b>	11 June 2019	<b>Time of Accident</b>	1330Z	
<b>Type of Aircraft</b>	Radial Rocket		<b>Type of Operation</b>	Proving Flight (Part 24)		
<b>Pilot-in-command Licence Type</b>	Commercial Pilot Licence		<b>Age</b>	59	<b>Licence Valid</b>	Yes
<b>Pilot-in-command Flying Experience</b>	Total Flying Hours		1894	<b>Hours on Type</b>	3	
<b>Last Point of Departure</b>	Krugersdorp Aerodrome (FAKR); Gauteng Province					
<b>Next Point of Intended Landing</b>	Baragwanath Airfield (FASY); Gauteng Province					
<b>Location of the accident site with reference to easily defined geographical points (GPS readings if possible)</b>						
Baragwanath Airfield, at GPS position determined to be S26°20'54.65" E27°46'41.62" at an elevation of 5 423ft						
<b>Meteorological Information</b>	Wind direction: 160°; Wind speed: 02kts; CAVOK; Temperature: 20°C

**Reference Number** : CA18/2/3/9797  
**Name of Owner/Operator** : Frascada Projects CC  
**Manufacturer** : Altitude Group LLC  
**Model** : Radial Rocket  
**Nationality** : South African  
**Registration

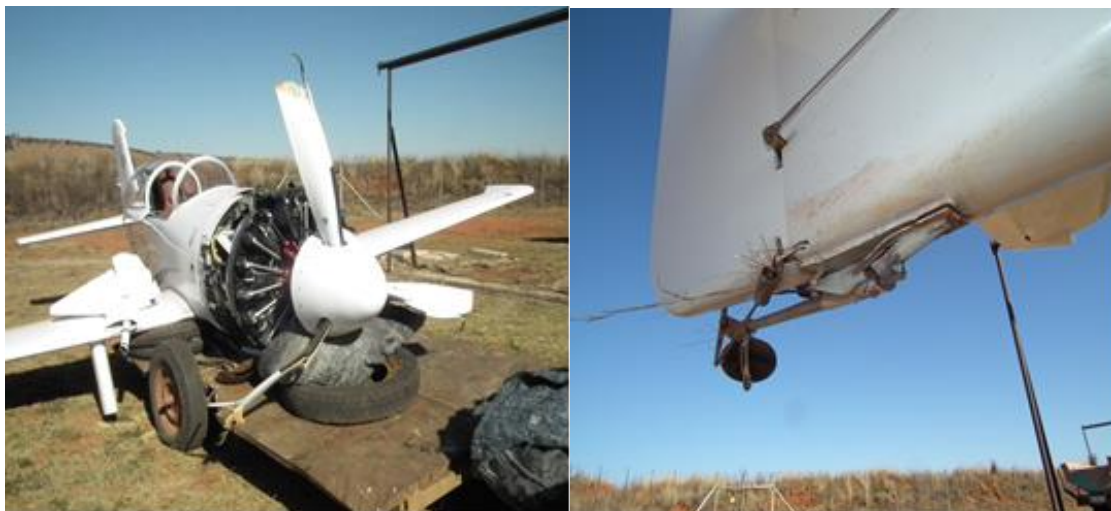
**Figures 1 and 2:** Show damage on the aircraft. (Source: Pilot)

1.12.1 The aircraft veered off the runway to the left, resulting in the left main wheel getting into a ditch. The aircraft sustained damage to the left- and right-hand main landing gears, tail gear, bottom of the left-hand wing and all three propeller blades.

3.9 The investigation revealed that the aircraft landed at high speed, resulting in a hard landing on all three gears which caused the tail gear to bend to the left.

4.1 The aircraft landed at high speed, resulting in a hard landing on all three gears which caused the tail gear to bend to the left.
