PARAGLIDER ACCIDENT REPORT AND EXECUTIVE SUMMARY

Reference: CA18/2/3/9798		
Paraglider Registration	N/A	Date of Accident	18 June 2019		Time of Accident	0844Z
Type of Paraglider	Gin Atlas XL		Type of Operation		Private (Part 105)	
Pilot-in-command Licence Type		Paraglider	Age	52	Licence Valid	Yes
Pilot-in-command Flying Experience		Total Flying Hours	31.7		Hours on Type	31.7
Last Point of Departure		God's Window paragliding launch, Ehlanzeni, Mpumalanga Province (S24°54'24", E030°51'58")				
Next Point of Intended Landing		God's Window paragliding launch, Ehlanzeni, Mpumalanga Province				
Location of the accident site with reference to easily defined geographical points (GPS readings if possible)						
At GPS Co-ordinates: S24°51'21", E030°53'24" near God's Window, Ehlanzeni						
Meteorological Information		Wind: 150°/6-10 kts (gusting 18kts), Temperature: 25°C, Visibility: CAVOK.				
Damage to Paraglider		None				
Number of People On-board	1	No. of People Injured	0	No. of People Killed	1

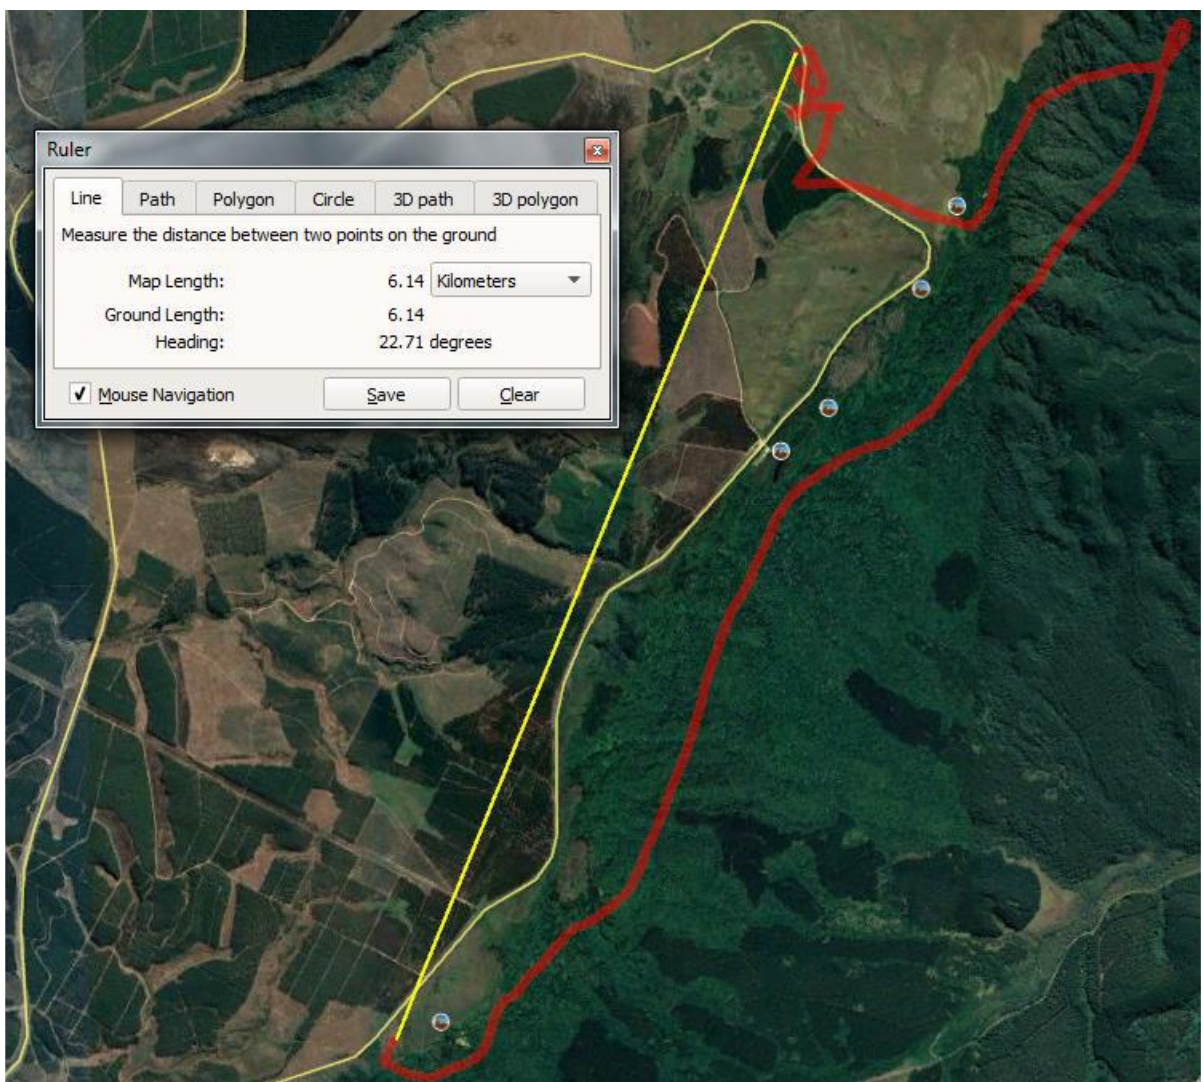
1.1.2 God's Window is characterised by a high cliff face with a plateau, facing primarily south-east. The tracklog of the flight is shown in Figure 1 and Figure 2. The straight-line distance from the launch site to the impact site is 6.14km (Figure 1). The distance from the impact site to the cliff is 1.5km in south south-east (SSE) direction (Figure 2).

Figure 1: Straight-line in yellow shows flight distance, and the red line shows flight path.
(Source: SAHPA)

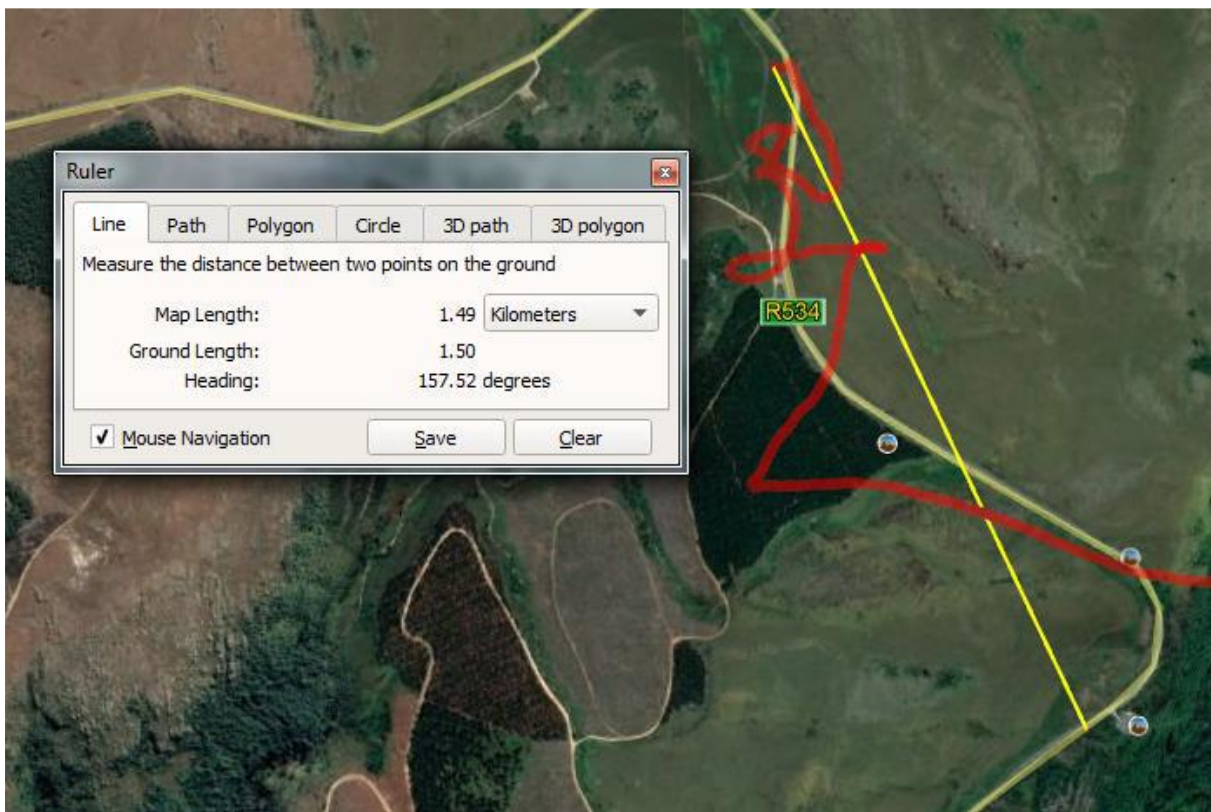
Figure 2: Distance of impact site from launch to the edge of the cliff in a wind direction of 157.5 degrees (SSE). (Source: SAHPA)

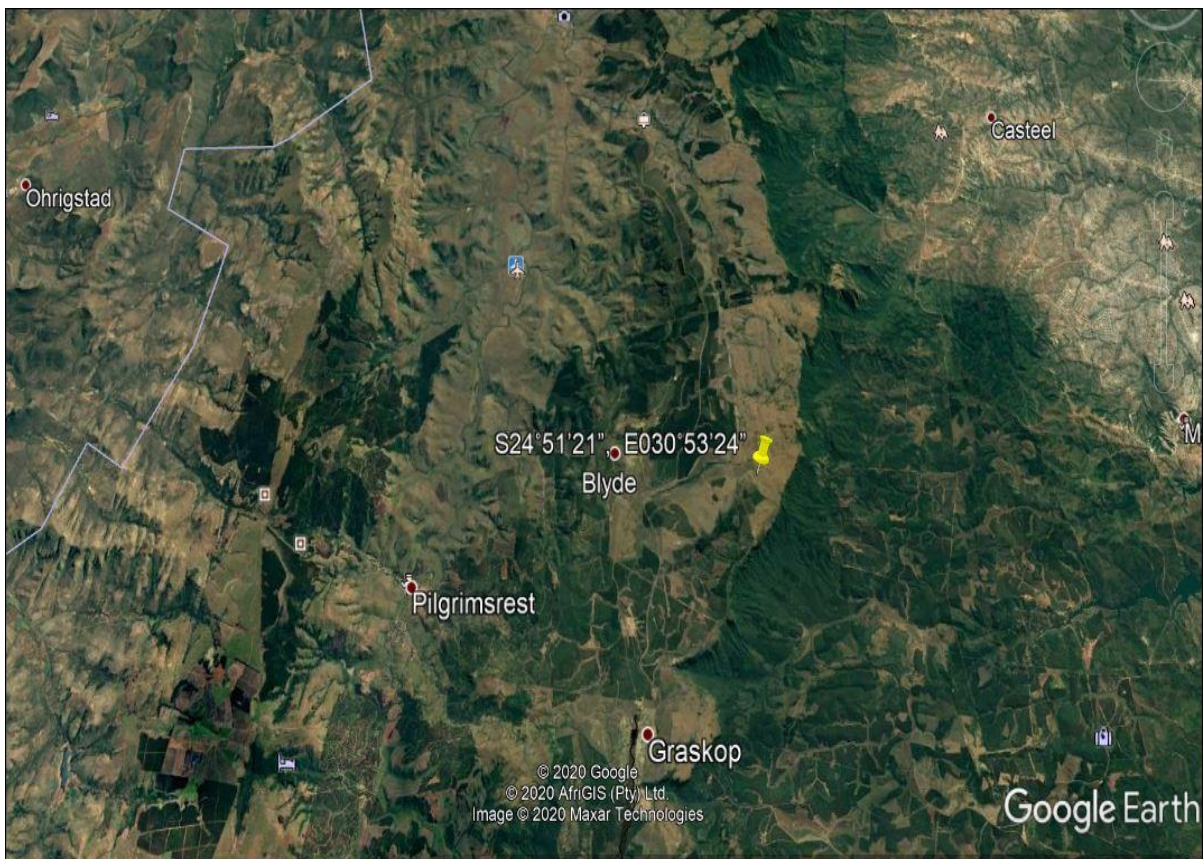
- 1.1.3 The paraglider was seen descending to the ground by witnesses who, upon reaching the accident site, found the pilot fatally injured. The paraglider was not damaged during the accident sequence.
- 1.1.4 The accident occurred during daylight at Global Positioning System (GPS) co-ordinates determined to be S24°51'21" E030°53'24" at an elevation of 1478ft above mean sea level (AMSL).

Figure 3: The aerial view of the accident site. (Source: Google Earth).

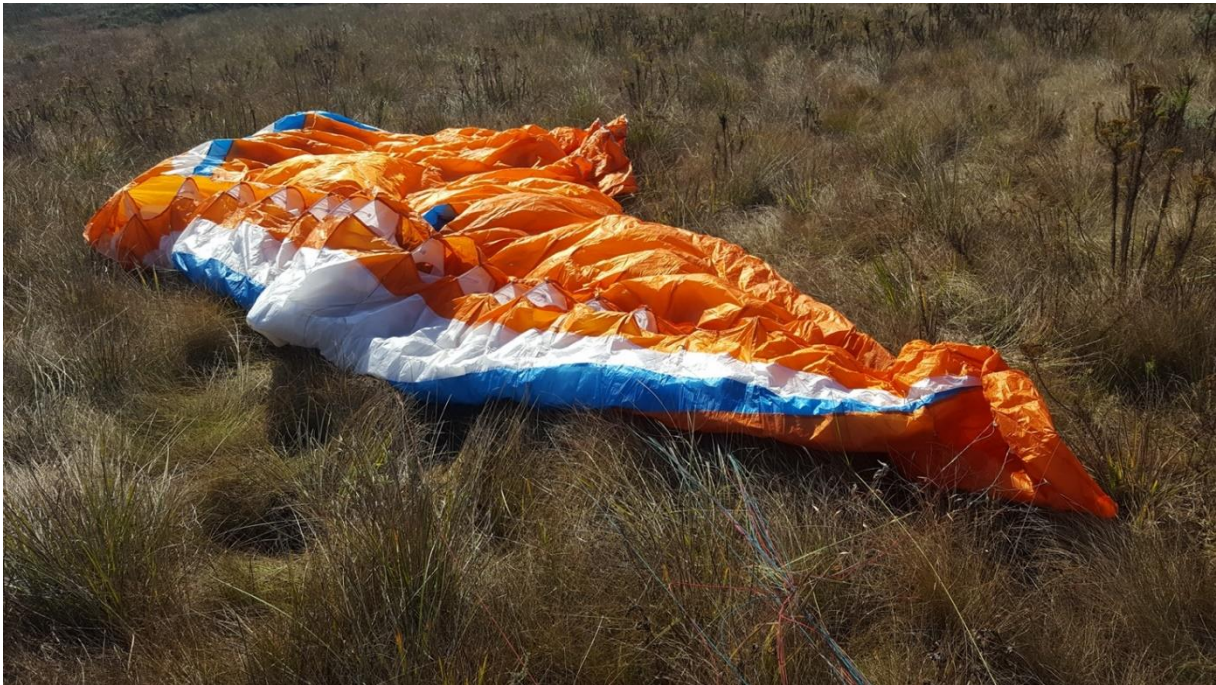
1.3.1 The paraglider was not damaged during the accident sequence.

Figure 4: No damage to the paraglider. (Source: SAHPA)

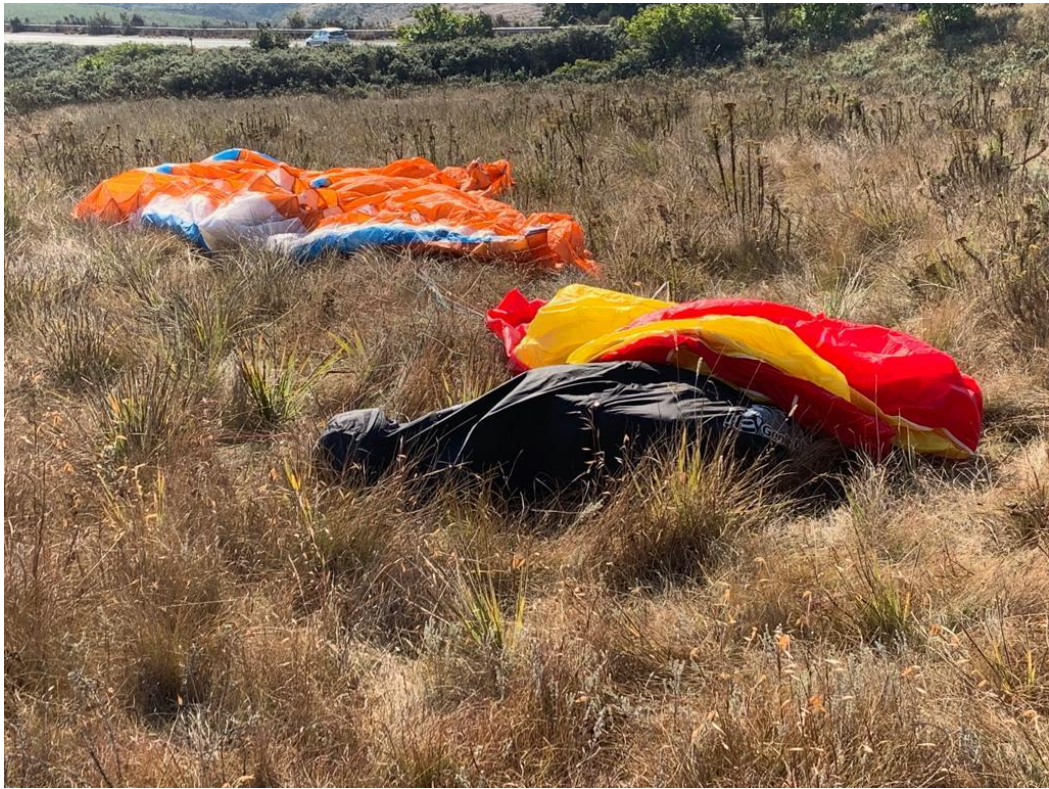
Figure 5: A harness, paraglider and reserve parachute which were not fully deployed. (Source: SAHPA)

1.6.2 There was no documented evidence found which could give an indication as to when the reserve parachute was last packed or inspected. During the on-site investigation, proof was found indicating that the reserve parachute was extricated, which also indicated that the paraglider pilot had deployed the reserve parachute. The reserve parachute (Beamer 38) was found outside the harness and without the deployment nappy and reserve handle. There was no damage to the reserve parachute.

1.12.6 The paraglider harness ended up on its right-side after impacting the ground. The side protection on the right-side harness was damaged. The side protection on the left-side was not damaged. The rest of the harness was still intact, all webbing and material were in good condition.

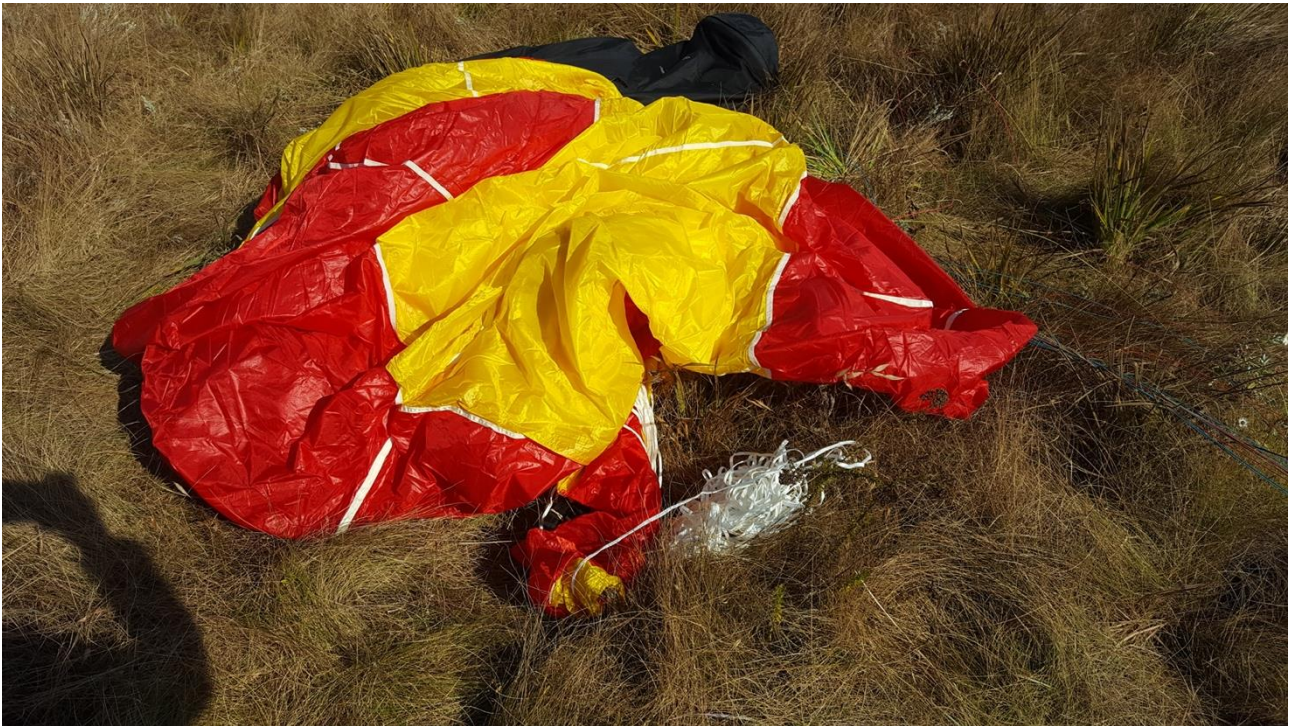
Figure 6: The reserve parachute at the accident site. (Source: SAHPA)

1.12.7 The reserve parachute was not damaged; however, it was not contained as expected. Elastic material of the reserve parachute was in good condition.

3.1.8 The reserve parachute was deployed by the pilot at a low altitude estimated to be not more than 150m above ground level (AGL).

3.3.1 The pilot did not deploy the reserve parachute at the correct or safe altitude.

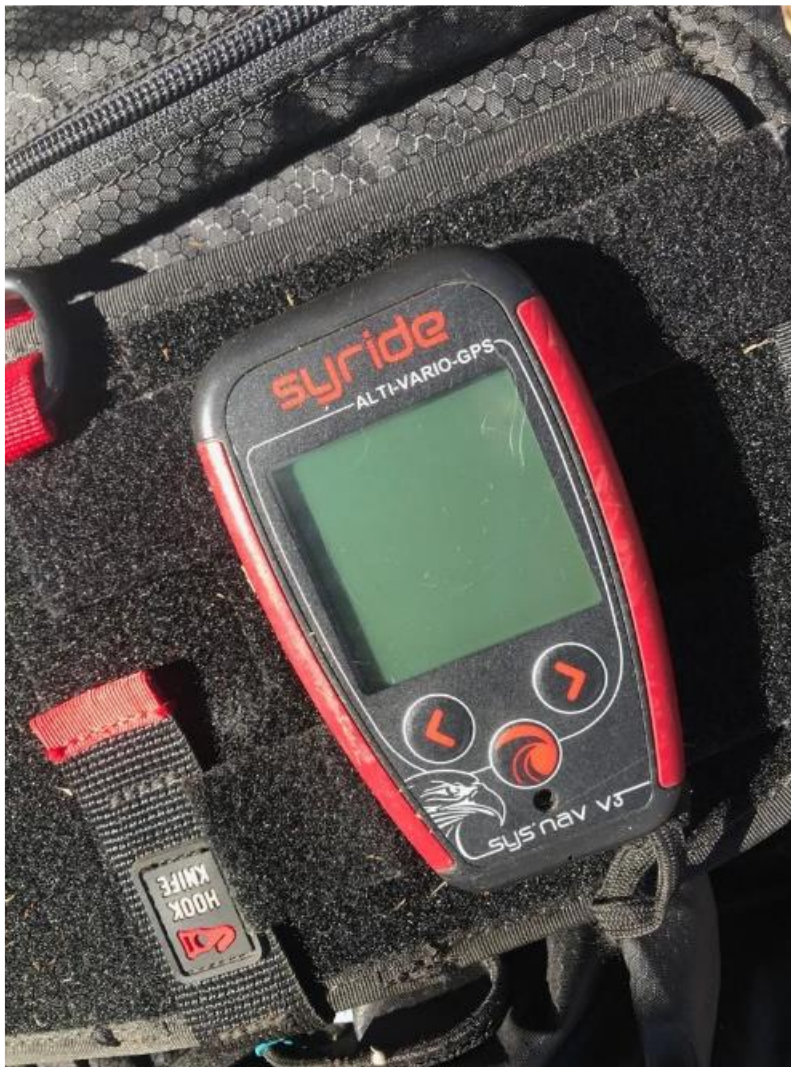
Figure 7: The Variometer instrument. (Source: SAHPA)

- 3.1.5 The paraglider pilot was fatally injured as a result of the accident.
- 3.1.6 The paraglider was not damaged during the accident sequence.
- 3.1.7 The flight instrument indicated that the paraglider was in an anti-clockwise spiral descending at a rate of -16 m/s as per the flight data information downloaded from the Variometer instrument.
