AIRCRAFT ACCIDENT REPORT AND EXECUTIVE SUMMARY

Reference:	CA18/2/3/9799	
Aircraft Registration	ZS-MGB	Date of Accident	3 July 2019		Time of Accident	1145Z
Type of Aircraft	Cessna 210T	Type of Operation		Private (Part 91)		
Pilot-in-command Licence Type	Private Pilot Licence	Age	65		Licence Valid	Yes
Pilot-in-command Flying Experience	Total Flying Hours		1780.2		Hours on Type	1512.7
Last Point of Departure	Pongola Aerodrome (FAPL), KwaZulu-Natal Province					
Next Point of Intended Landing	Rand Aerodrome (FAGM), Gauteng Province					
Location of the accident site with reference to easily defined geographical points (GPS readings if possible)						
Taxiway at Pongola Aerodrome at the following GPS co-ordinates: S27° 21' 59.77" E031° 36' 36.12" at an elevation of 918.4ft						
Meteorological Information	Wind: light and variable; Temperature: 25°C; Visibility: 9999m; Clouds: Nil					
Number of People On-board	1+0	No. of People Injured	0		No. of People Killed	1 (on the ground)

Reference Number : CA18/2/3/9799
Name of Owner/Operator : A. V. Worsdale
Manufacturer : Cessna Corporation
Model : C210T
Nationality : South African
Registration Marks : ZS-MGB
Place : Pongola, KwaZulu-Natal
Dat

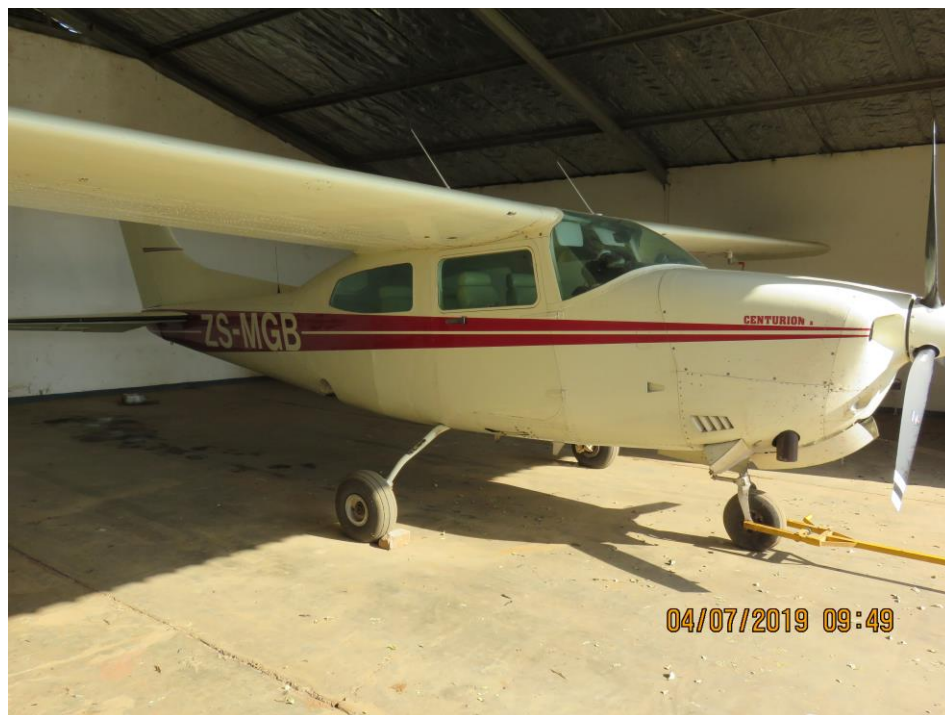
Figure 1: The parked ZS-MGB aircraft.

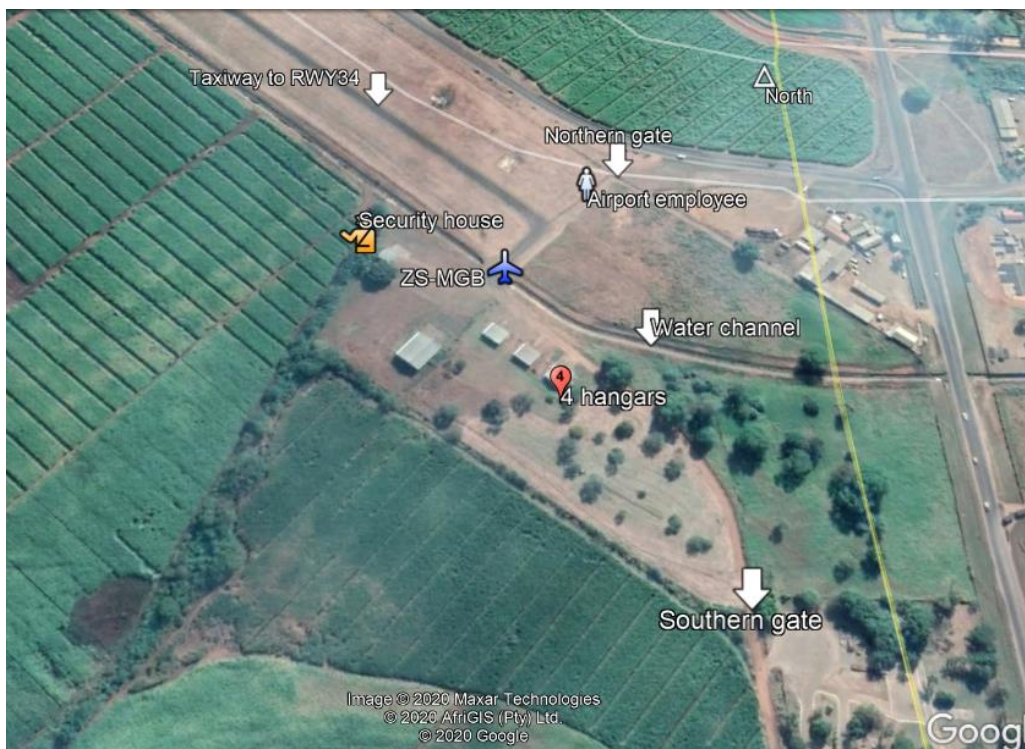
Figure 2: Pongola Aerodrome layout.

1.10.3.2 Supporting staff use a gate that is located on the northern side of the taxiway (Figure 2) when going to the shops. They cross the taxiway at any point as well as near the final approach for aircraft on Runway 34. This is in contravention of *CAR 2011, Part 139.01.29 (2C) as amended*.

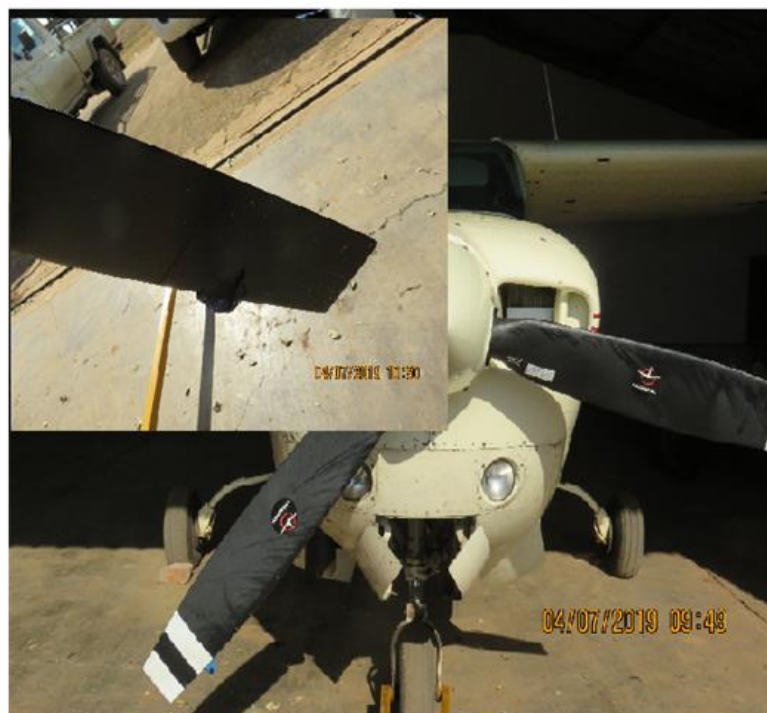
Figure 4: The front view of the propeller with white stripes has better visibility when spinning. The inset shows the rear of the propeller with no white stripes, which makes it invisible when spinning.

1.12.2 The front part of the propeller has two colours (black and white stripes) for visibility. The inset (Figure 4) shows the back (rear) of the propeller which has only one colour, black. The back part is meant to be invisible when the blade is spinning; it does not obscure the pilot's view.
