AIRCRAFT ACCIDENT SHORT REPORT

CA18/2/3/9803: Helicopter crashed during a game capture operation after a low main rotor RPM condition while manoeuvring at low level.

Aircraft registration : ZS-RMZ

Aircraft manufacturer and model : Robinson Helicopter Company, R22 Beta

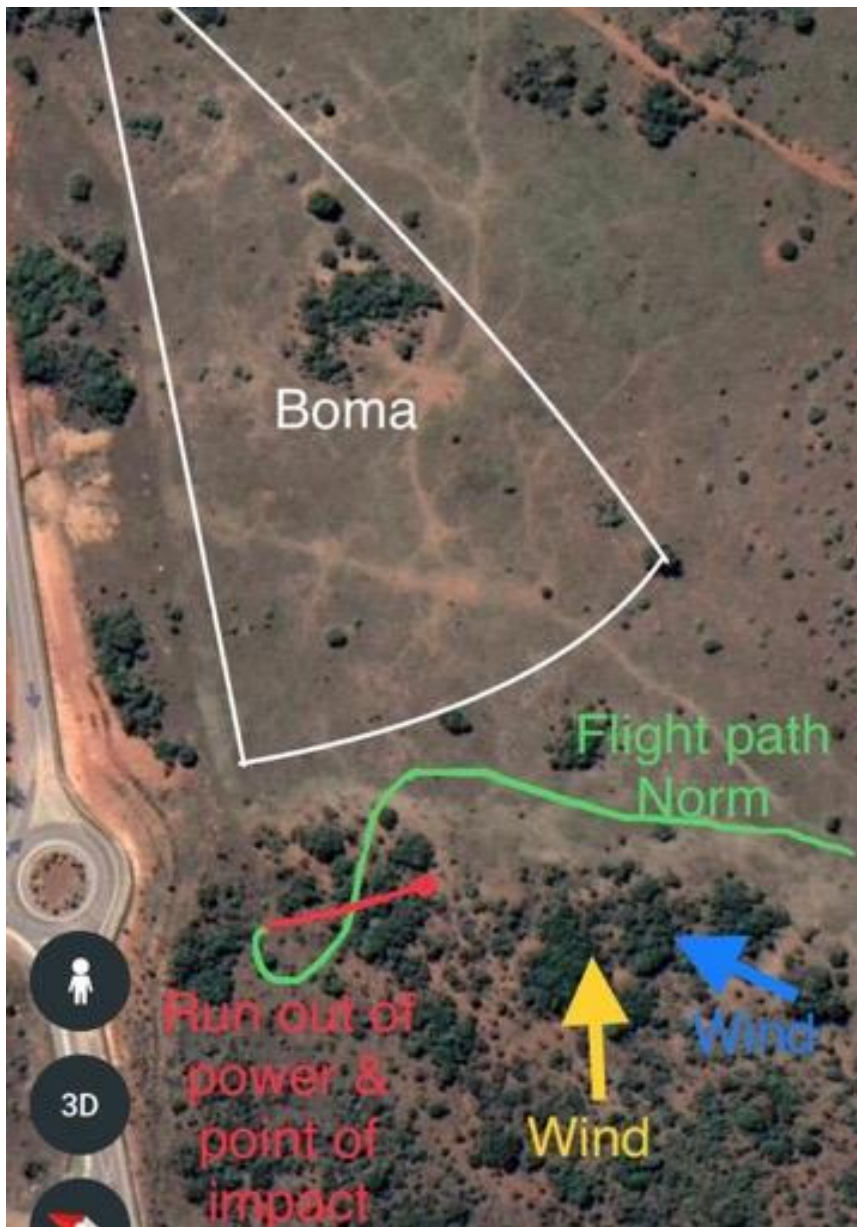
Figure 1: Google Earth overlay indicating the flight path of the helicopter. (Courtesy of the pilot)

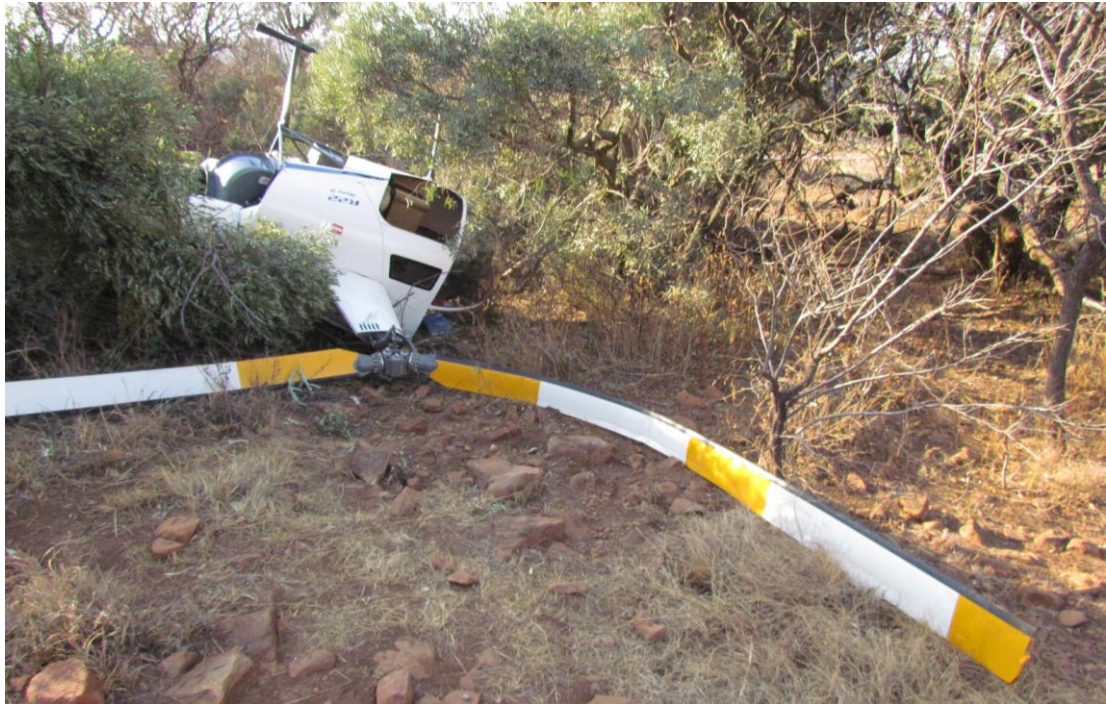
2.1.5 The helicopter sustained substantial damage, but the cockpit/cabin area remained intact. The pilot, who was properly secured by the three-point safety harness, sustained minor cuts and bruises.

Figure 2: The helicopter as it came to rest on its right side.

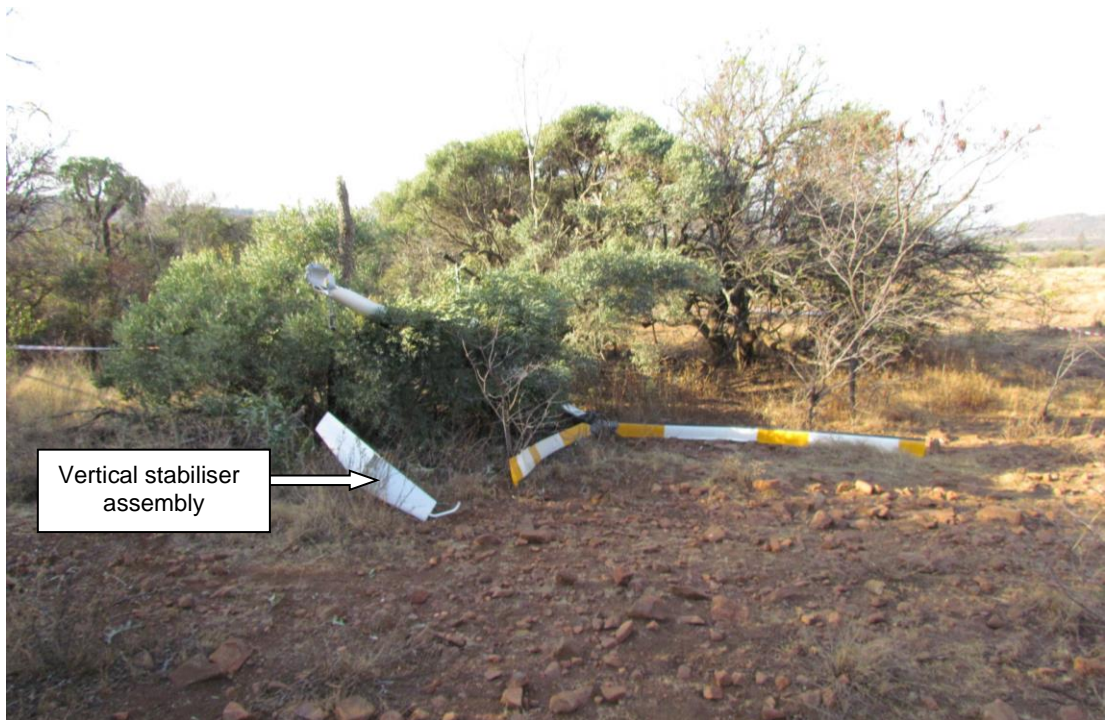
Figure 3: The vertical stabiliser assembly that broke off was found lying below the tail boom.

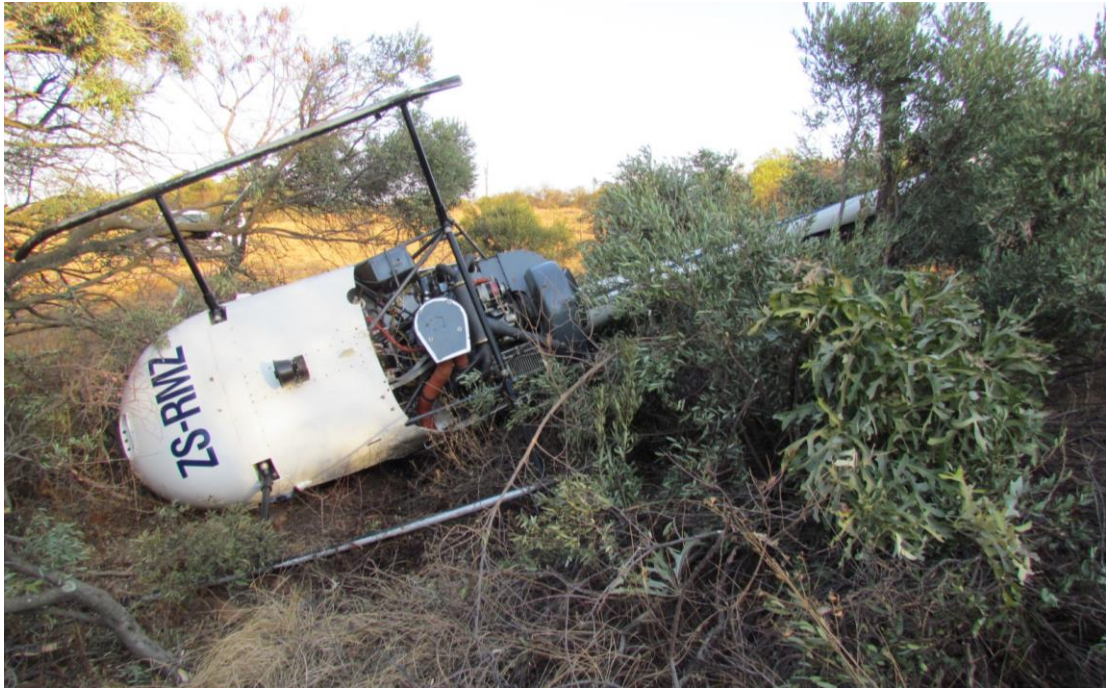
Figure 4: A different view of the helicopter as it came to rest.

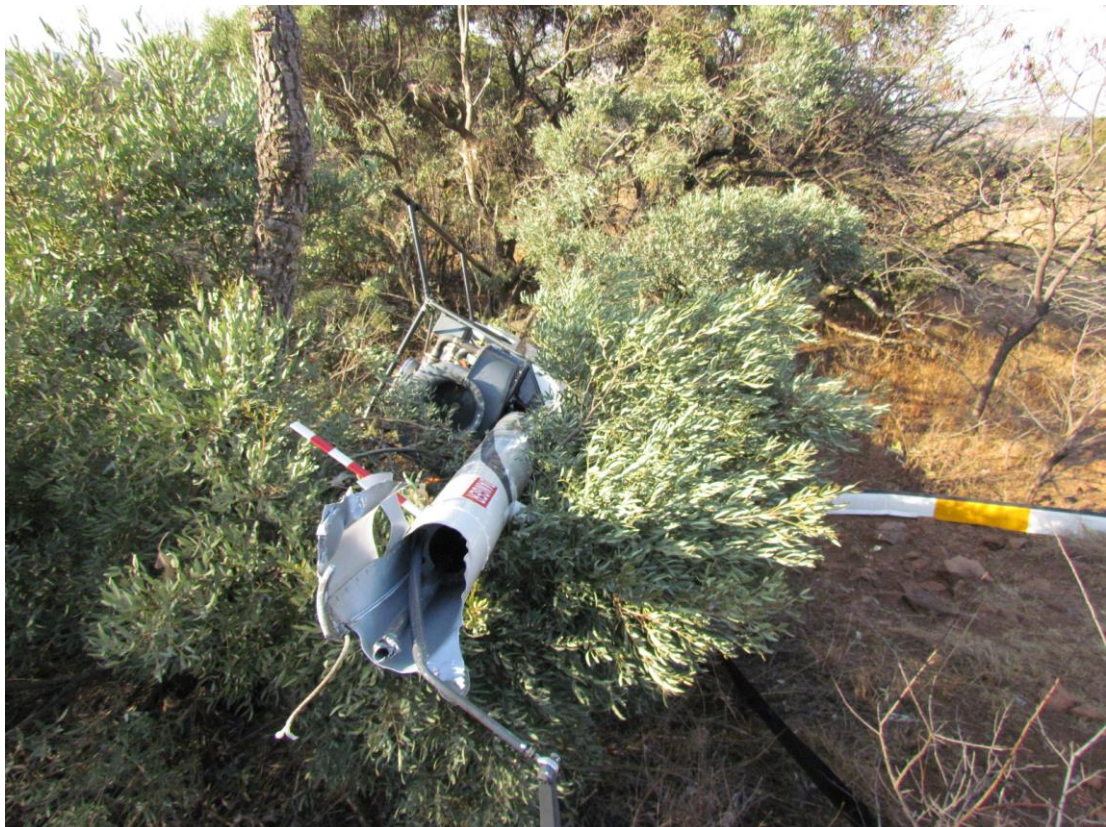
Figure 5: Aft view of the helicopter as it came to rest.

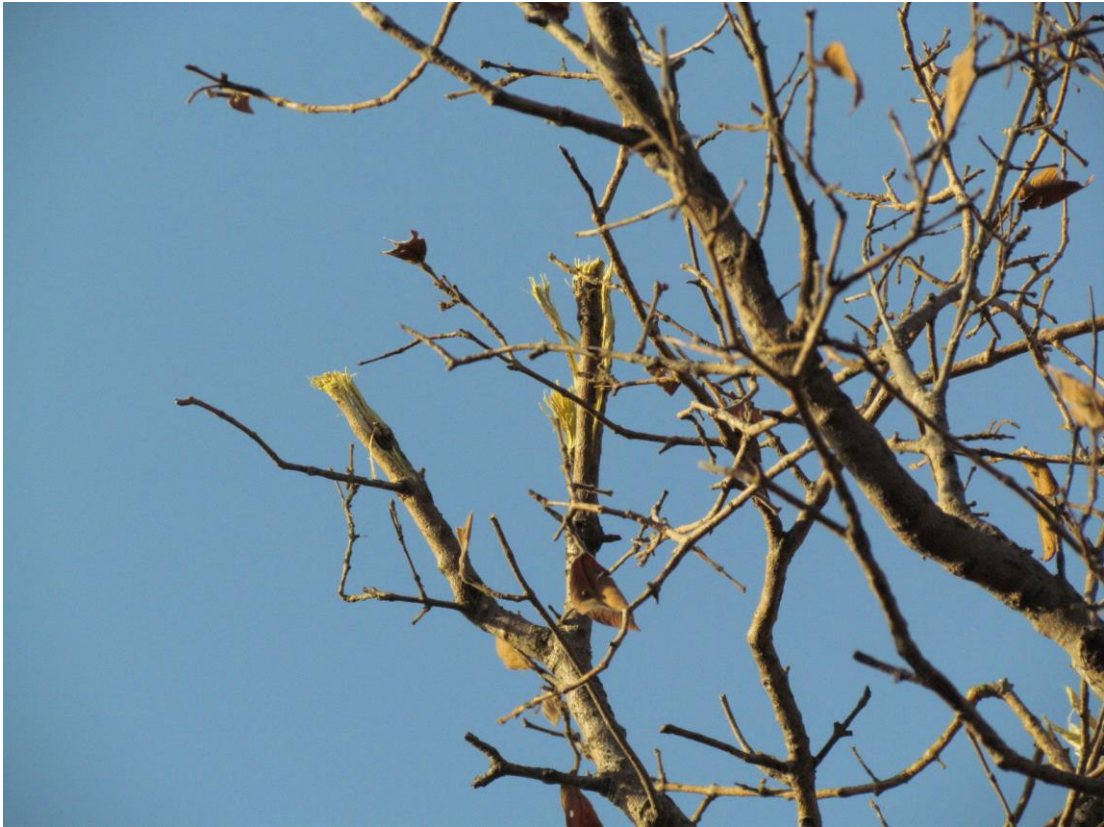
Figure 6: Damage to some of the tree branches, caused by contact with the tail rotor blade.

- 3.12 The investigation revealed that the pilot manoeuvred the helicopter at low level during a game capture operation in high-density altitude conditions. The helicopter encountered a low main rotor RPM condition, from which he was unable to recover. The tail rotor struck a tree, causing the pilot to lose control and the helicopter to crash.

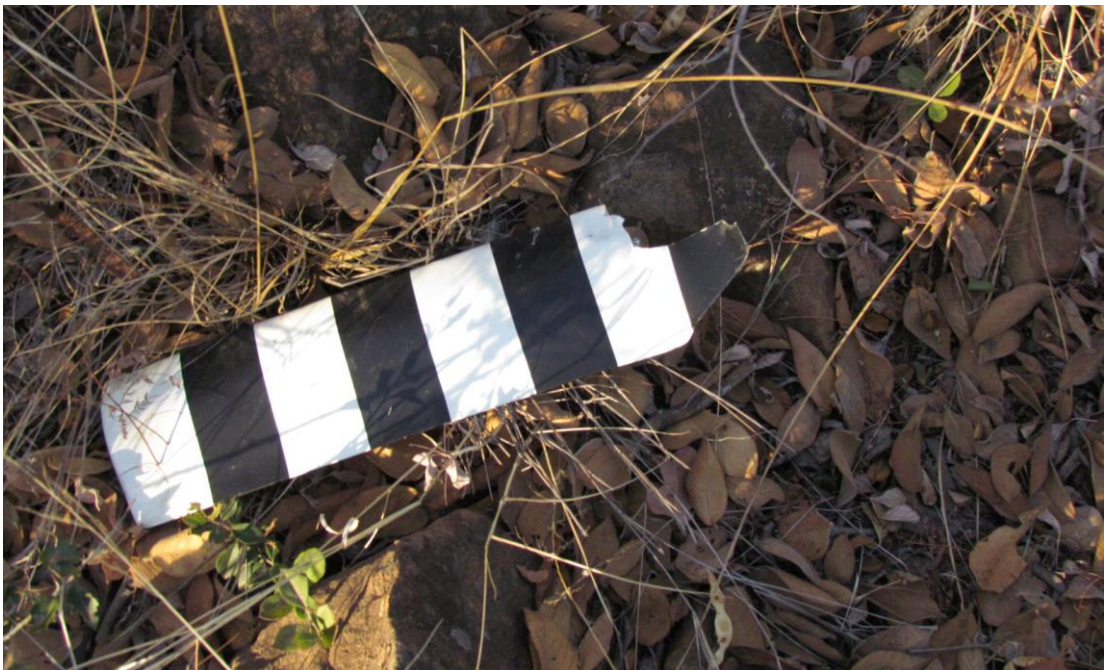
Figure 7: One of the fractured tail rotor blades that was located on-site.

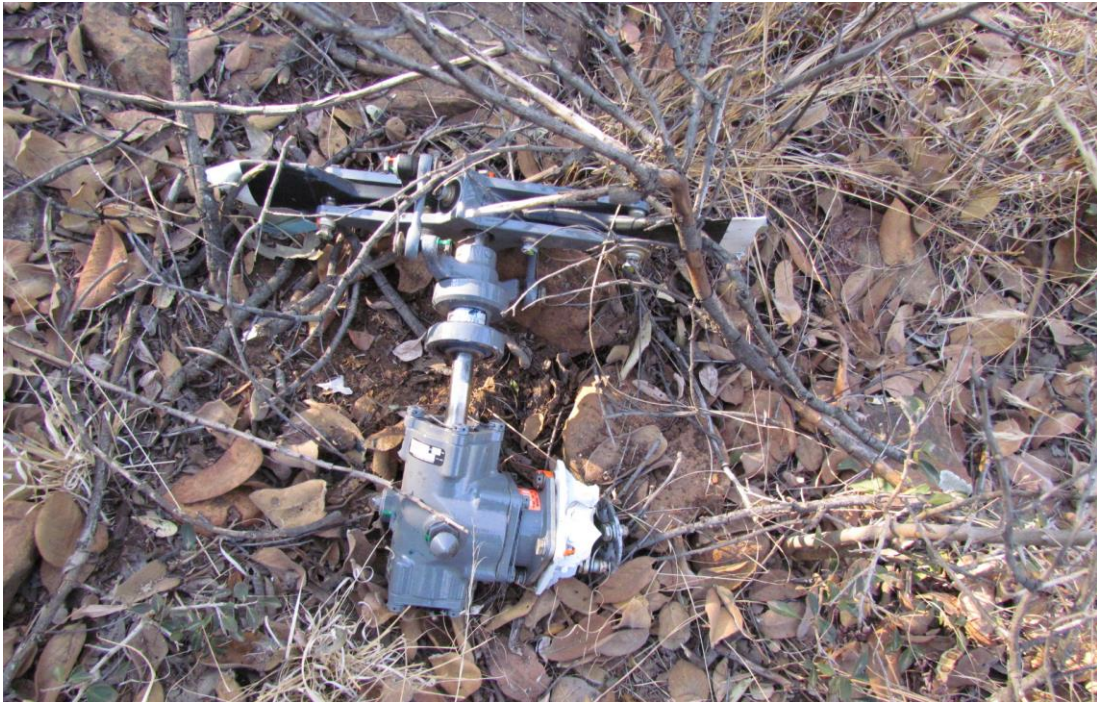
Figure 8: The tail rotor gearbox and hub assembly as they were found on-site.

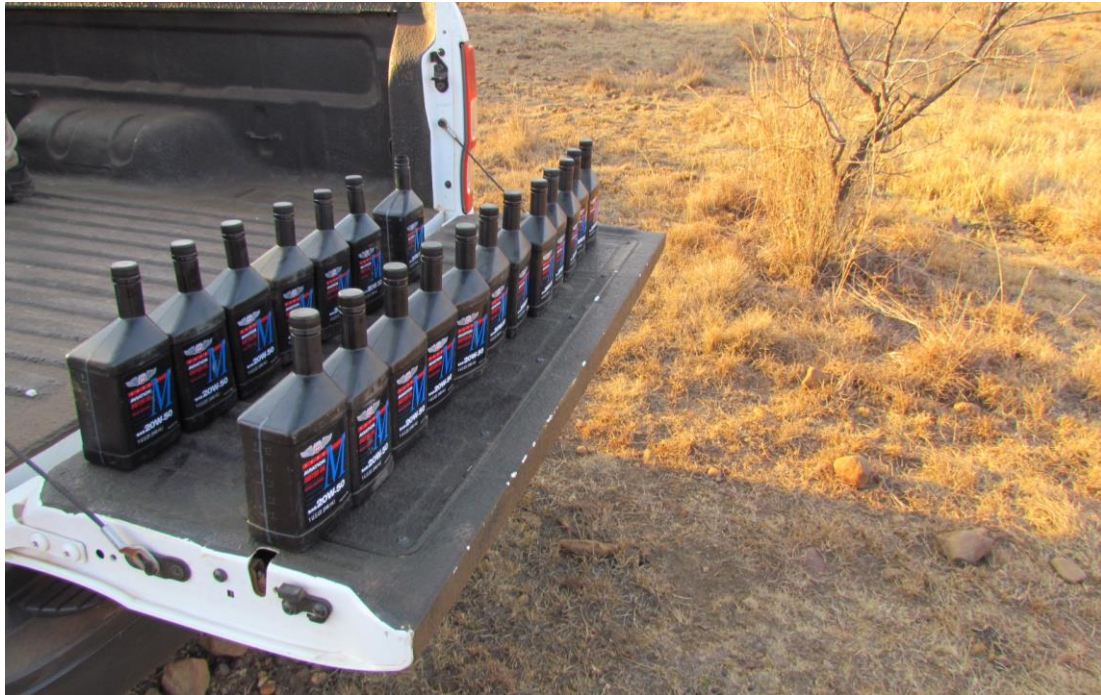
A total of 19 bottles of engine oil were recovered on-site (see Figure 9) with most of the oil stored in the baggage hold underneath the left seat. The volume of each bottle was 946 millilitres (ml), with a specific weight of 889 grams (g) per bottle, which amounted to a total weight of 16.9kg (37.3lbs). The dual controls, which consisted of the cyclic, collective pitch lever and the yaw pedals were also located in the baggage hold underneath the left seat. The weight of the dual controls amounted to 1.2kg (2.6lbs).

Figure 9: The 19 bottles of engine oil that were recovered from the cockpit/cabin area.

- 3.10 The weight of the helicopter at the time was within the weight limitations as stipulated in the POH for this helicopter type, even though there were 19 bottles of engine oil on-board at the time of the accident.
