<b>HELICOPTER ACCIDENT REPORT AND EXECUTIVE SUMMARY</b>
---

Reference:	CA18/2/3/9809		
<b>Aircraft Registration</b>	<b>ZS-HGY</b>	<b>Date of Accident</b>	30 July 2019	<b>Time of Accident</b>	0915Z	
<b>Type of Aircraft</b>	Bell 47G-3B-1		<b>Type of Operation</b>	Game Culling (Part 137)		
<b>Pilot-in-command Licence Type</b>	Private Pilot Licence (H)		<b>Age</b>	69	<b>Licence Valid</b>	Yes
<b>Pilot-in-command Flying Experience</b>	Total Flying Hours		12685.7	<b>Hours on Type</b>	316.9	
<b>Last Point of Departure</b>	Tshwarelano Game Lodge: Limpopo Province					
<b>Next Point of Intended Landing</b>	Tshwarelano Game Lodge: Limpopo Province					
<b>Location of the accident site with reference to easily defined geographical points (GPS readings if possible)</b>						
Tshwarelano game farm at GPS co-ordinates determined to be 22°41'52"S, 029°22'44"E and at an elevation of 2516ft						
<b>Meteorological Information</b>	Wind direction: 330°; Wind speed: 04kts; CAVOK; Temperature: 22°C; Q940hPA

**Reference Number** : CA18/2/3/9809  
**Name of Owner/Operator** : Gauteng 45 Business Management (PTY) LTD  
**Manufacturer** : Westland Aviation LTD  
**Model** : Bell 47G-3B-1  
**Nationality**

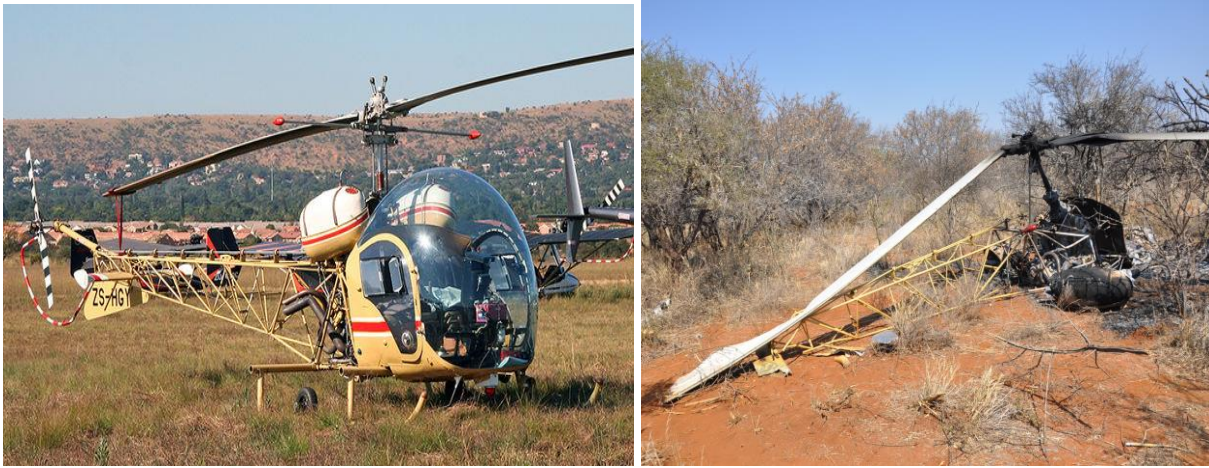
1.3.1 The helicopter was destroyed by post-impact fire.

**Figure 2 & 3:** The accident helicopter (left) before the accident (Source: Bruce Perkins) and the helicopter as found at the accident site (right).

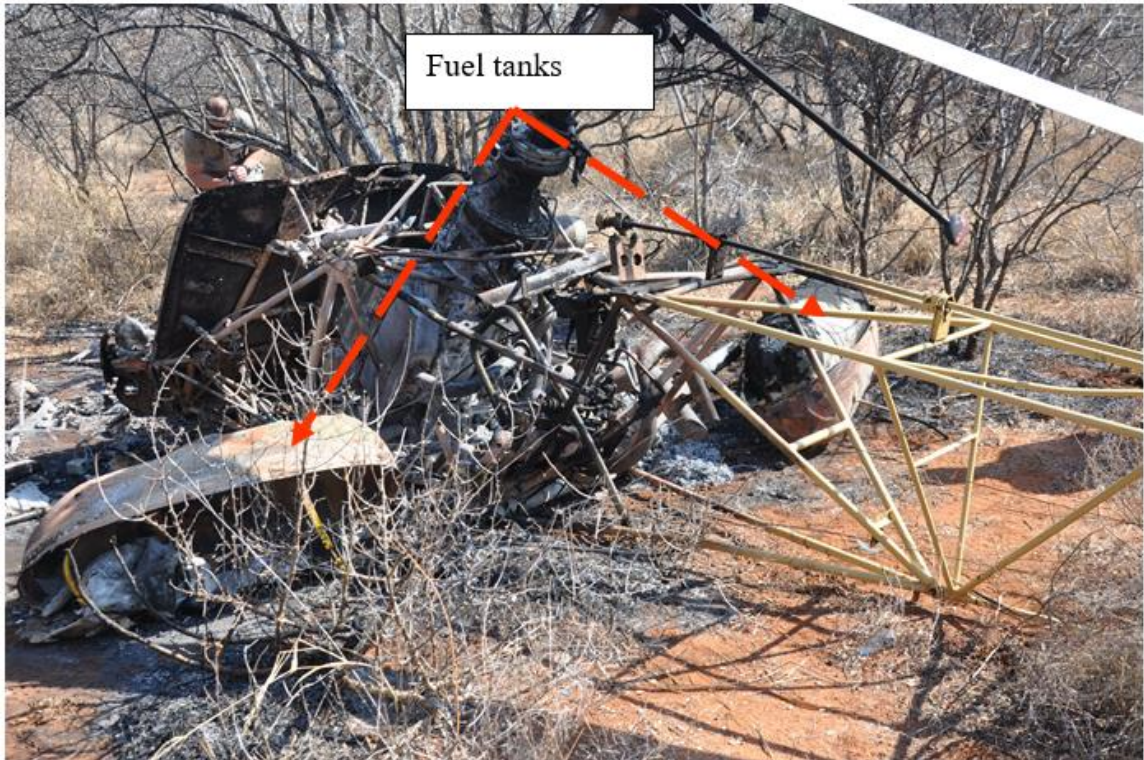
1.12.1 The passenger stated that approximately 15 minutes into the flight, the tail section of the helicopter started vibrating and, a few seconds later, the helicopter span clockwise about six times and the pilot lost control of the helicopter. The main wreckage was found intact with major components still attached. The two fuel tanks were found on the left and right side of the helicopter's wreckage. The left tank had shattered on impact, resulting in fuel-fed fire, and the right tank was distorted as a result of the impact.

**Figure 4:** Fuel tanks at the accident site.

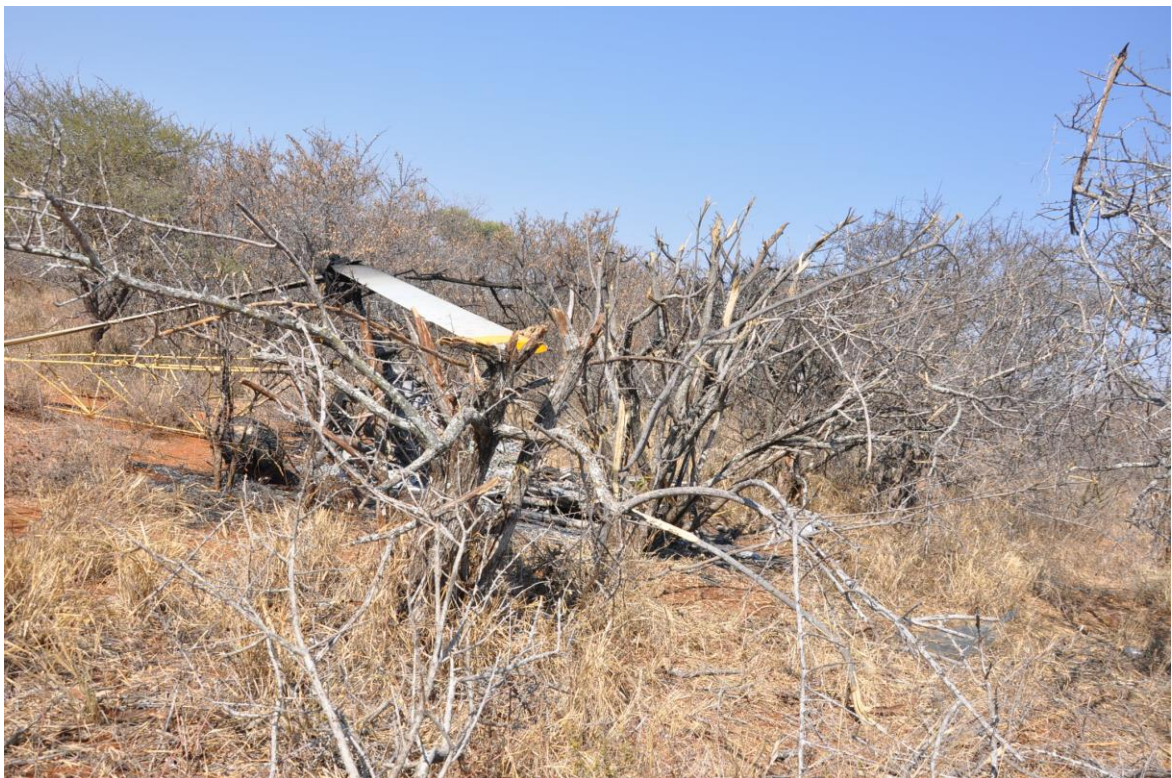
1.12.2 During the on-site investigation, it was evident that the engine still had power when the accident occurred. The main rotor blades struck and severed shrubs before the helicopter came to rest.

**Figure 5:** Right view of the severed shrub.

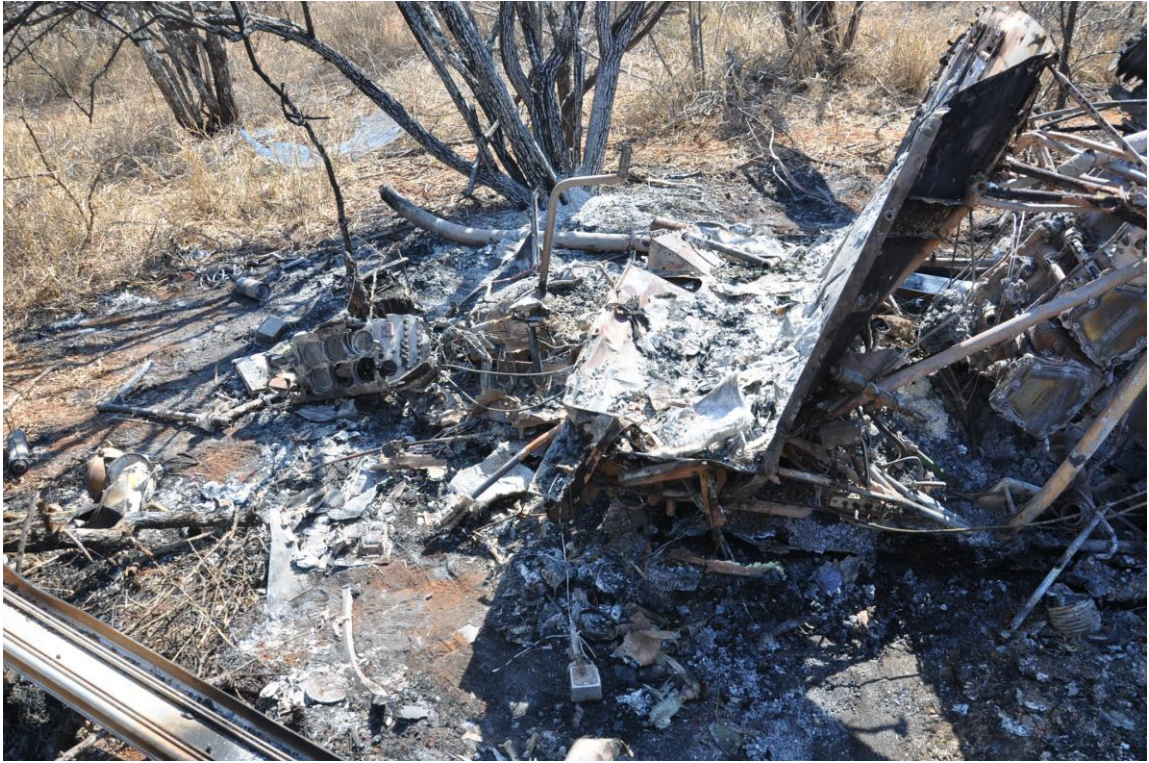
1.12.3 The helicopter cabin area and the instrument panel were destroyed by post-impact fire.

**Figure 6:** The cabin area after the accident.

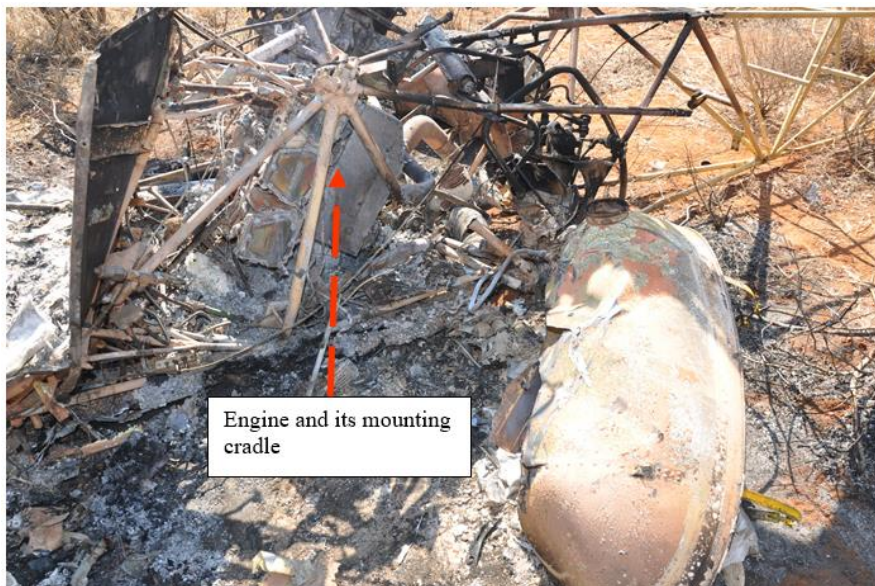
1.12.4 The engine and all its wiring were also destroyed by post-impact fire.

**Figure 7:** Burnt engine post-accident.

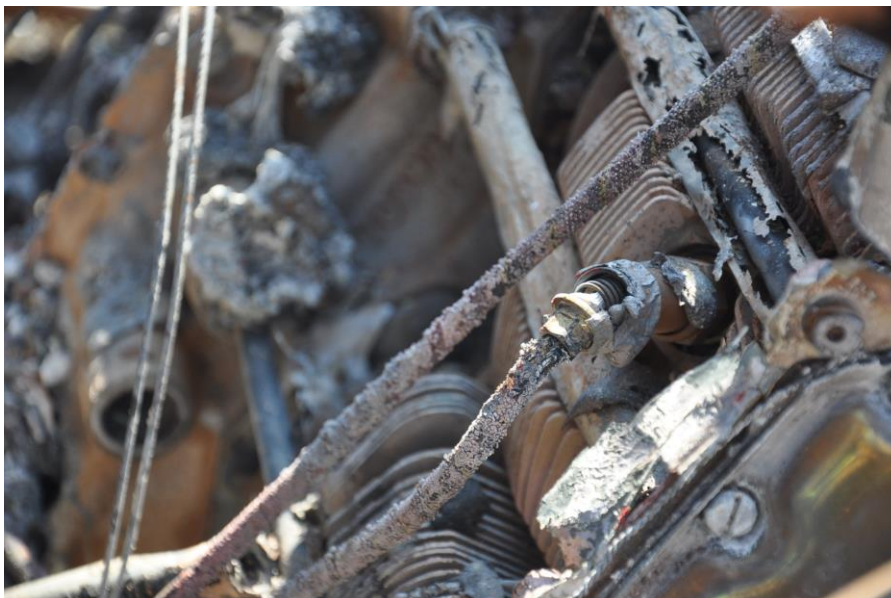
**Figure 8:** Engine wiring destroyed by post-impact fire.

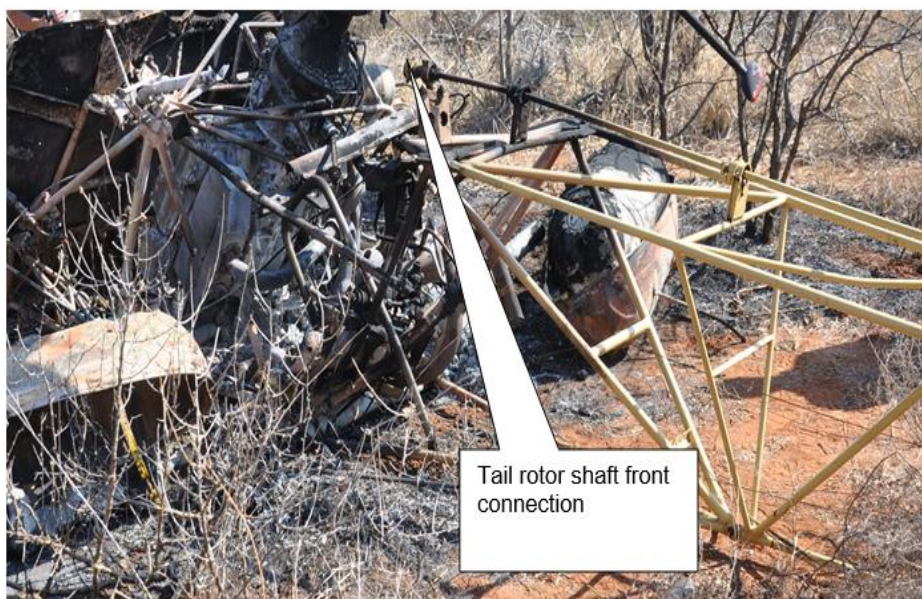
1.12.5 The tail rotor shaft was disconnected on impact from the engine and the tail rotor gearbox section.

**Figure 9:** The front tail rotor drive shaft.

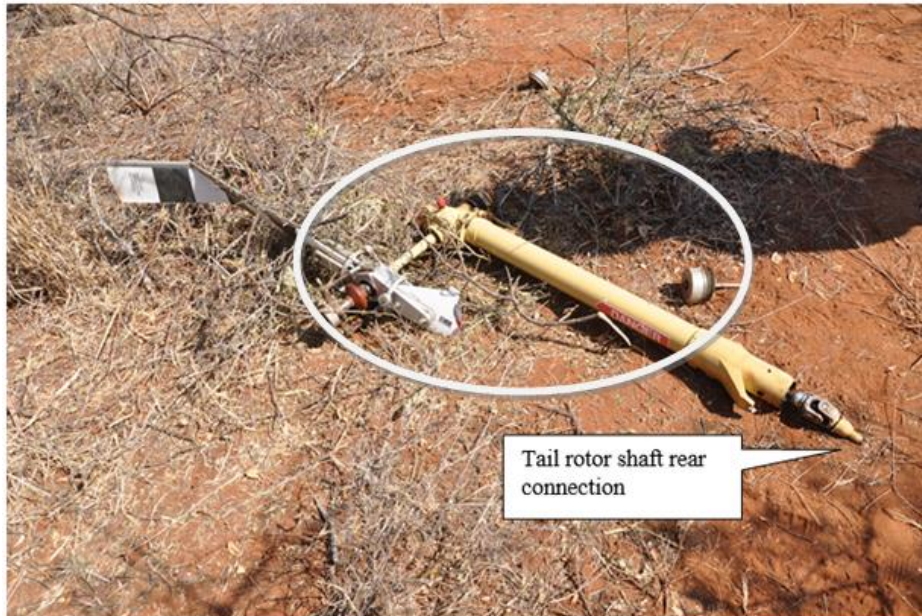
1.12.6 The tail rotor blades could be turned by hand post-accident. When the tail rotor shaft was turned, the tail rotor blades could not be turned, indicating a discontinuity between the tail drive shaft and the gearbox.

**Figure 10:** The rear tail rotor drive shaft.

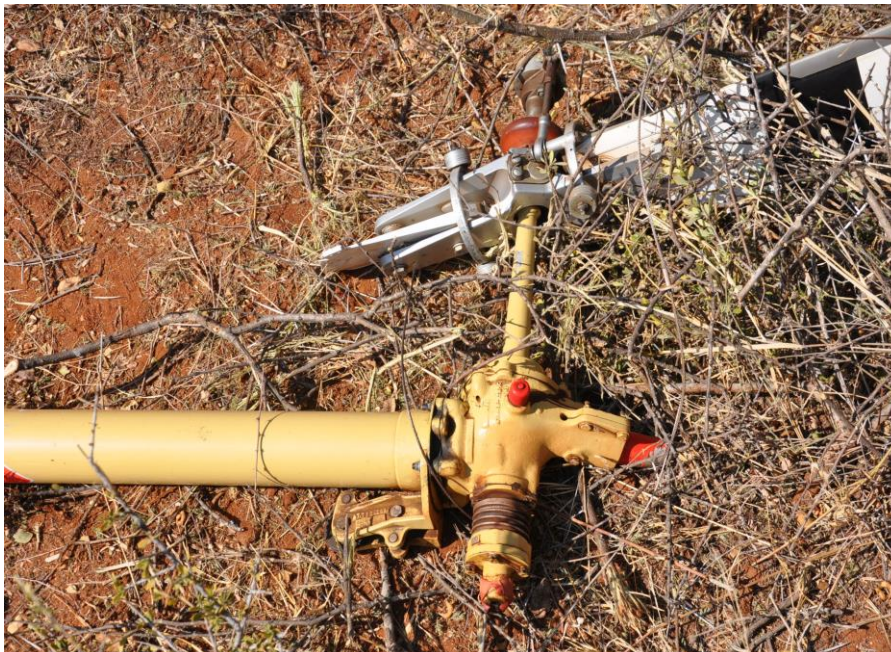
1.12.7 General inspection of the gearbox at the accident site showed no visual oil leaks in the vicinity of the housing. The oil cap was still attached and showed no visible signs of failure or of being loose.

**Figure 11:** The tail rotor gearbox as it was found on-site.

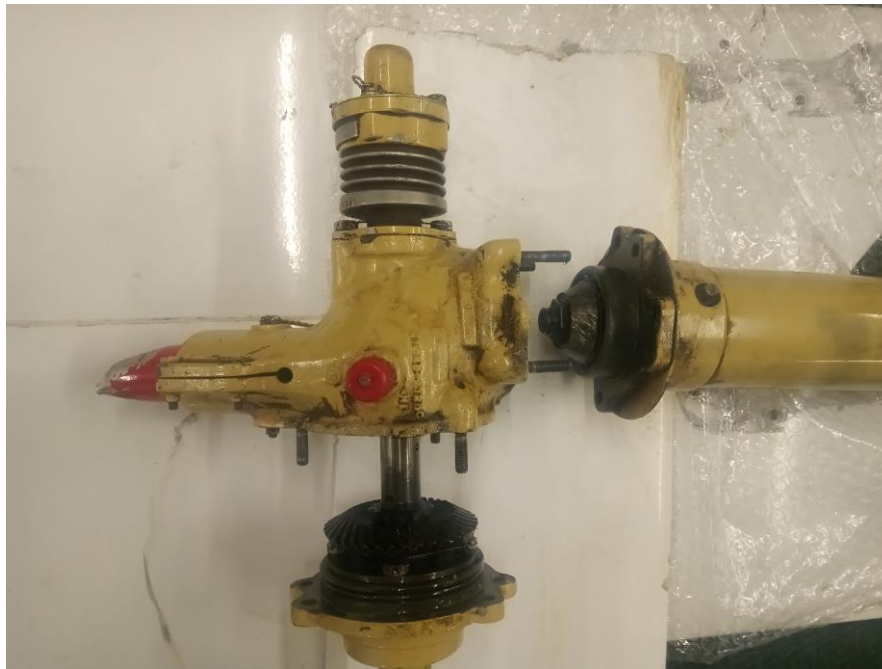
- The pitch change mechanism operated normally in both directions.
- During rotation of the drive shaft, it was observed that the tail gearbox output shaft rotation did not fit the rotation of the drive shaft properly. It was loose (during rotation) and appeared to be ragged.
- The long section of the tail drive shaft system had separated from the gearbox and the following was observed — the bearings that support the drive shaft were still intact and exhibited normal operation.
- The bearing of the output shaft was uneven during rotation, which is attributed to impact.

**Figure 12:** A completely worn pinion gear teeth and worn bevel gear teeth.

- 3.3.9 The tail gearbox was retrieved and subjected to a teardown inspection. The teardown inspection revealed that the pinion gear teeth and bevel gear teeth were worn, resulting in poor contact (operation) during rotation.

3.4.2.1 The gearbox was insufficiently lubricated, resulting in the gears overheating and rubbing against each other.

4.2.1 It is recommended to the Director of Civil Aviation to enhance oversight of NTCA aircraft especially at the time of Authority to Fly renewals. This presents the opportunity to review the aircraft maintenance records to determine if the aircraft had been in compliance with the manufacturers' instructions and the SACAA's requirements.

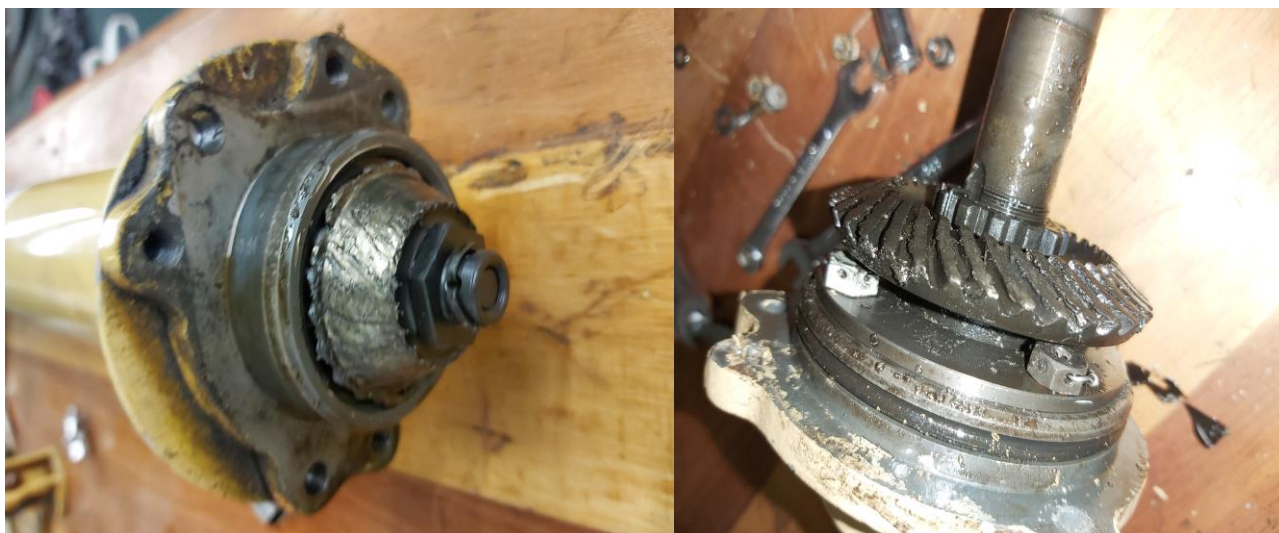
- The pinion gear teeth and bevel gear teeth were worn out of limits.

**Figure 13 & 14:** A closer look at the worn pinion gear teeth and worn bevel gear teeth.

2.1.3 The last two helicopter inspections indicated that the tail rotor gearbox was properly inspected. However, the condition of the gearbox housing and the wear on the gears indicated that the gearbox had “old” and insufficient oil that might have caused the damage on the gear teeth, resulting in the failure of the tail rotor assembly.

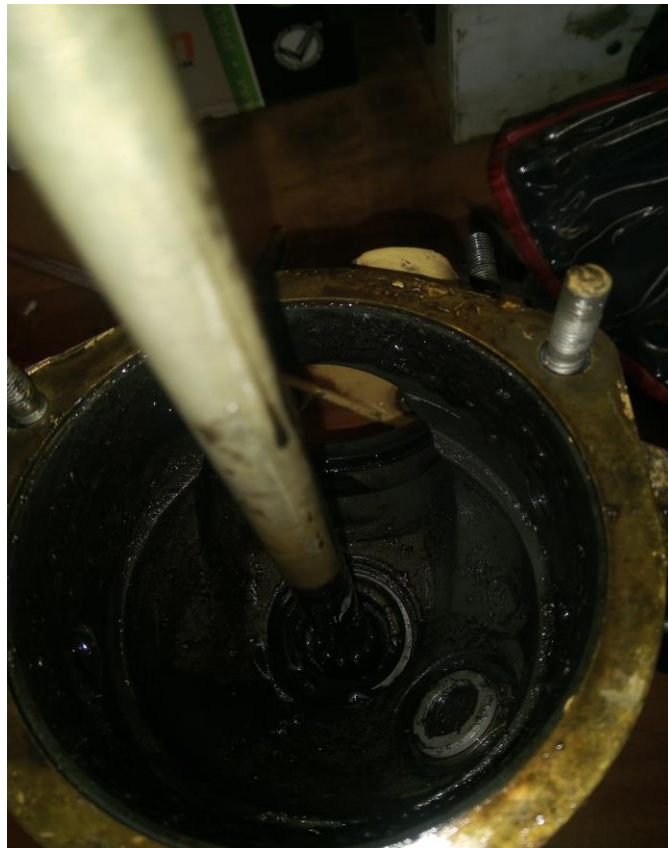
- The exterior condition of the casing was good with no cracks or rupture
- There was no visible oil inside the housing, an indication that there was insufficient oil prior to the accident
- There was a presence of metal pieces around the inside of the housing

**Figure 15:** The tail rotor gearbox housing.

- 3.3.8 Inspection of the tail gearbox did not reveal any signs of oil in the interior of the housing, an indication that there was insufficient oil prior to the accident.

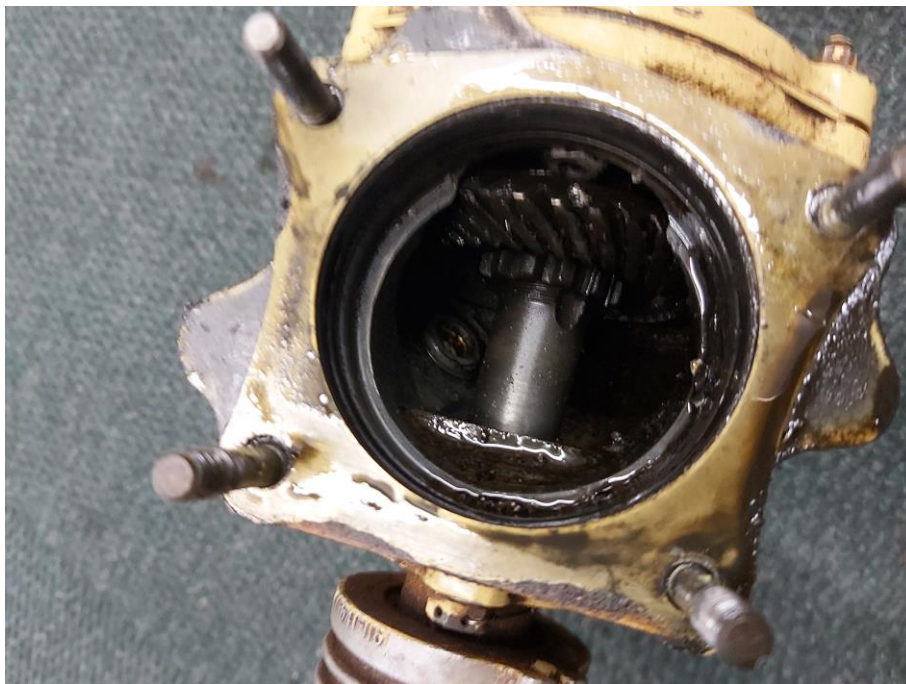
- The housing cavity exhibited some metal shavings mixed with sludge-like substance.

**Figure 16:** The gear side of the gearbox housing.
