AIRCRAFT ACCIDENT SHORT REPORT

CA18/2/3/9812: The helicopter impacted the water surface following a manoeuvre which caused the pilot to lose height due to the helicopter being above required weight.

Date and time	: 11 August 2019; 0935Z
Aircraft registration	: ZS-TTC
Aircraft manufacturer and model	: Robinson Helicopter Company, R44 Raven II
Last point of departure	: Private Farm in Vaalwater, Limpopo Province
Next point of intended landing	: Private Farm in Vaalwater, Limpopo Province
Location of incident site with reference to easily defined geographical points (GPS readings if possible)	: S24°08'44.75" E28°18'02.81" at an elevation of 4279 ft
Meteorological information	: Wind: 280°/7kt; Temperature: 21°C; Dew Point: 6°C, Visibility: CAVOK; QNH: 1026hPa
Type of operation	: Commercial Helicopter Operations (Part 127)
Persons on-board	: 1 + 2
Injuries	: 1 passenger – minor injuries
Damage to aircraft	: Sustained substantial damage

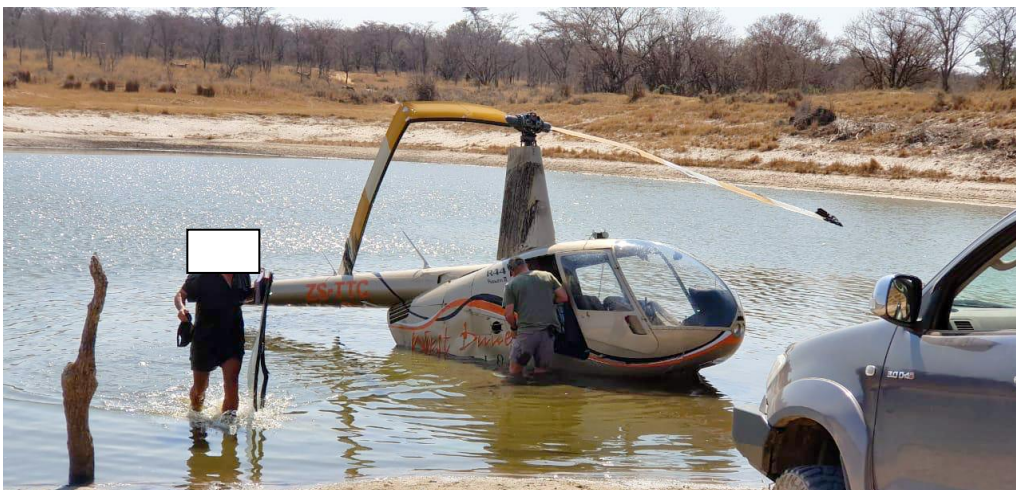
- 2.1.5. The helicopter was pulled out of the dam and recovered to a hangar in Wonderboom Aerodrome (FAWB). The helicopter sustained damage to the tail boom (tail rotor section), main rotor system, left-side front window and skids.

Figure 2: The helicopter as it was recovered.

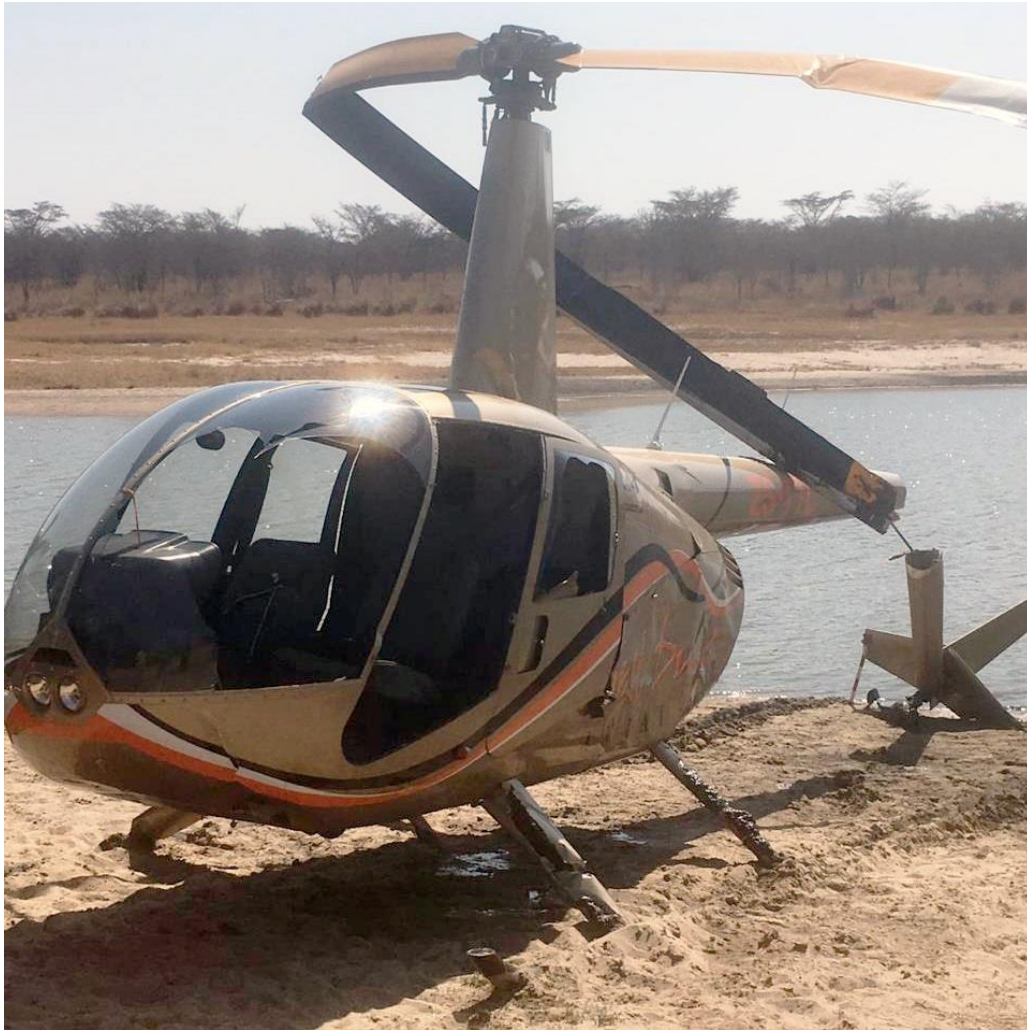
- 2.1.3. The pilot further stated that the main rotor revolutions per minute (RPM) decreased, causing a slight drop in engine power, which required more collective control input to maintain a stable transition. The pilot performed a flare attitude to allow more wind into the main rotor system to increase the main rotor RPM. However, the flare led to the tail rotor system guard (stinger) impacting the water; the main rotors flapped downwards and severed the tail boom.

Figure 3: The helicopter after recovery with damage to the main rotor system and tail rotor system.

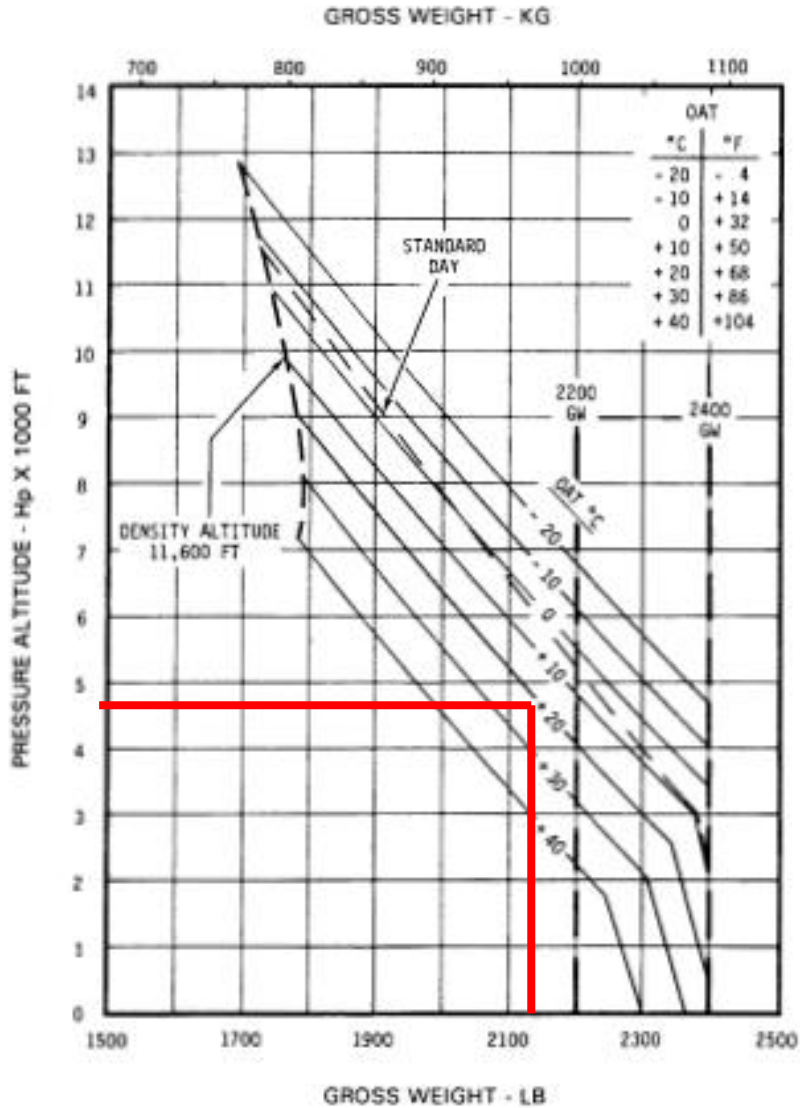
Figure 6: Out-of-ground effect ceiling vs gross weight graph.

2.1.9. Pressure altitude (PA) = (QNH – Standard pressure) X 1000ft + Field Elevation, therefore, PA = (30.38-29.92) X 1000ft + 4279ft = 4739ft. The outside air temperature was 20°C and that means the gross weight was supposed to be approximately 2120lb.

2.1.11 Review of the weight calculation submitted by the pilot and the out-of-ground effect (OGE) ceiling vs gross weight chart indicated that the weight of the helicopter should have been at or below 2120lb but was 270lb over the required weight.

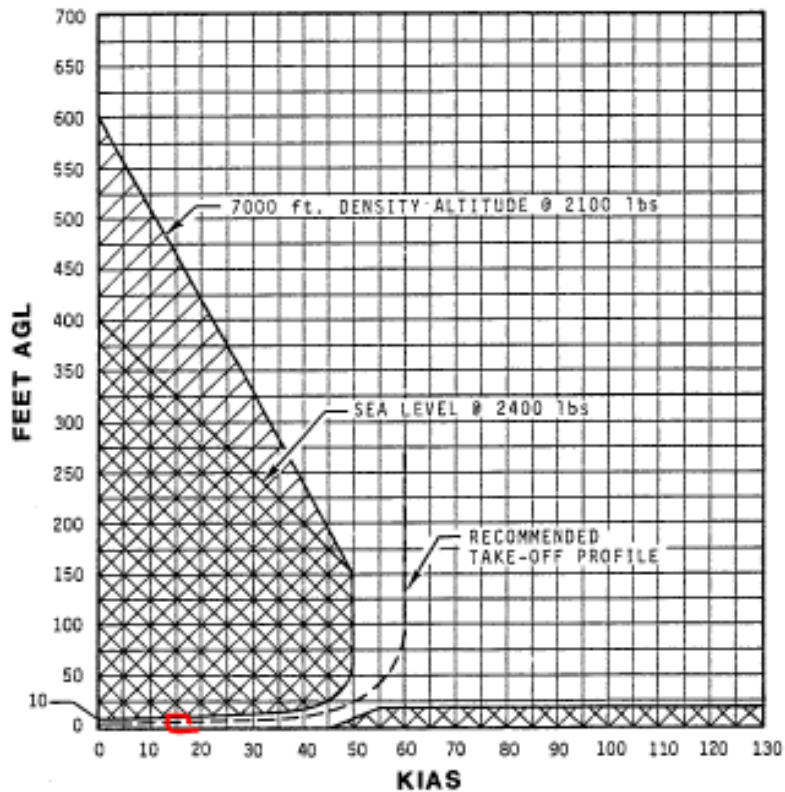
Figure 6: Height velocity diagram.

2.1.12 The helicopter was flying between 10 and 20kts when the accident occurred. For a safe transition and climb out, the helicopter would require an indicated airspeed of 50kts or above. The graph on Figure 6 advises against operating in the shaded area.
