AIRCRAFT ACCIDENT REPORT AND EXECUTIVE SUMMARY

Reference:	CA18/2/3/9815	
Aircraft Registration	ZS-LMI	Date of Accident	16 August 2019		Time of Accident	1700Z	
Type of Aircraft	Cessna 172		Type of Operation	Training (Part 141)			
Pilot-in-command Licence Type	Commercial Pilot Licence		Age	34	Licence Valid	Yes	
Pilot-in-command Flying Experience	Total Flying Hours		1514.7	Hours on Type	436.7		
Last Point of Departure	Grand Central Aerodrome (FAGC), Gauteng Province						
Next Point of Intended Landing	Grand Central Aerodrome (FAGC), Gauteng Province						
Location of the accident site with reference to easily defined geographical points (GPS readings if possible)							
On Plot 63 next to the N4 highway at Hartebeesfontein Road at GPS 25°32'59" South 027°55'58" East, at an field elevation of 3862 feet							
Meteorological Information	Wind: 150° at 06kt, Temperature: 20°C, Dew point: 0°C, Visibility: 10km and Query nautical height (QNH): 1020hPa

Reference Number : CA18/2/3/9748
Name of Owner/Operator : Lanseria Flight Centre (Pty) Ltd
Manufacturer : Cessna Aircraft Company
Model : Cessna 172M
Nationality : South African
Registration Marks : ZS-LMI
Place : Hartebeesfontein Road, Gau

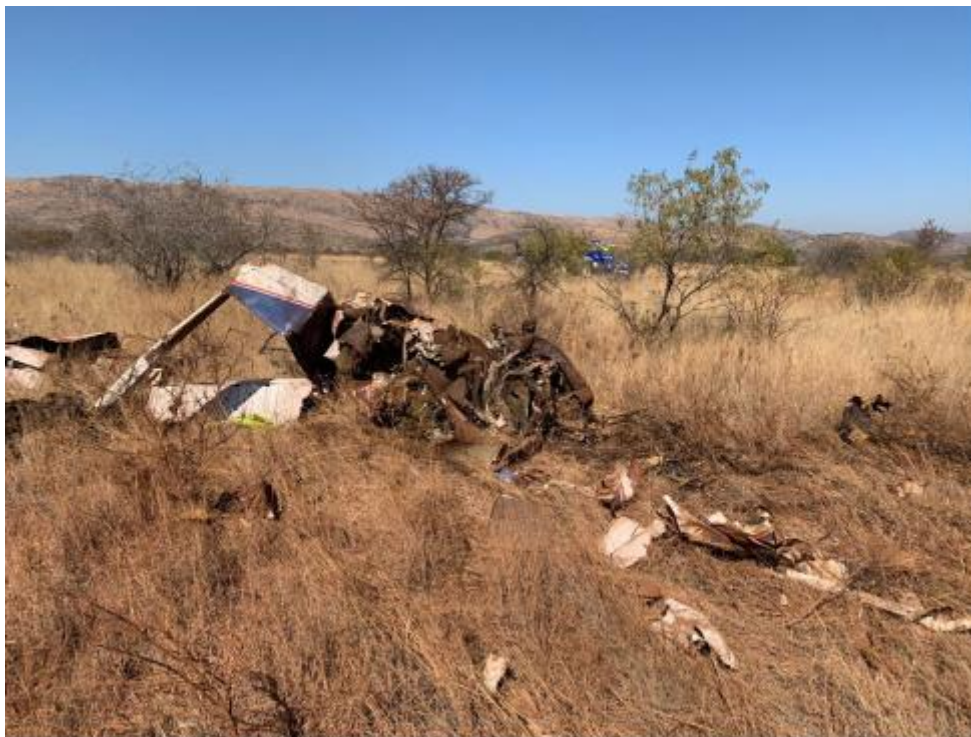
1.3.1 The aircraft was destroyed during the accident.

Figure 2: The wreckage of the Cessna 172 at the accident site.

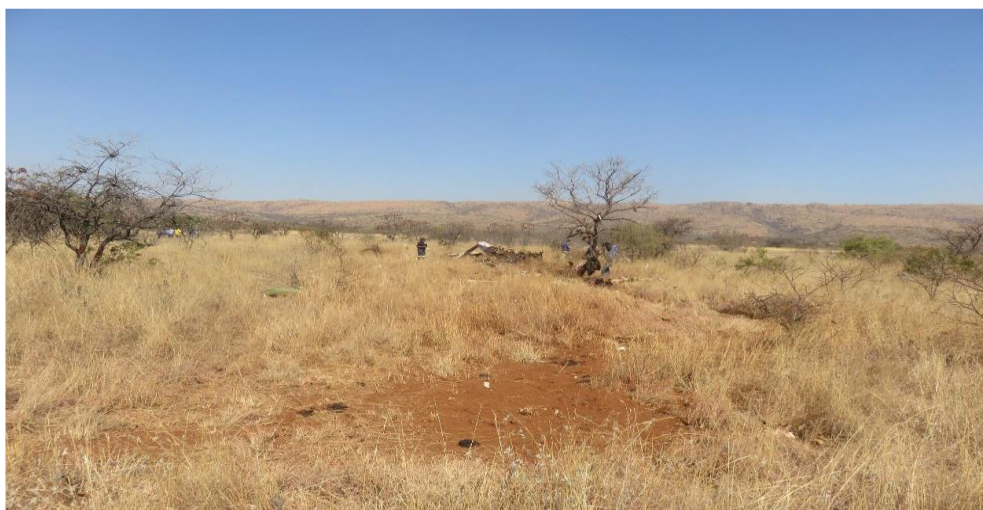
1.12.1 The aircraft approached from the east heading west at the time of the crash. It impacted a 2.5 metre tree first, and then the ground in a left-wing low and nose down attitude. The examination at the scene showed that the left-wing impacted the ground and the left-wing tip separated; the left-wing tip was found next to the tree. The aircraft then nosed over before coming to rest approximately 19.5 metres (from the first point of impact) before the right wing impacted the stem of the tree, causing the aircraft to disintegrate. The evidence that the propeller separated from the crankshaft flange indicated that the engine was operational at the time of impact (see Figures 6, 7 and 8).

Figure 4: The aircraft's first point of impact and the position where it came to rest.

1.12.3 The main wreckage and engine were found 33.2 metres from the first point of impact. There was an 'unfamiliar smell' and oil spillage on the damaged engine.

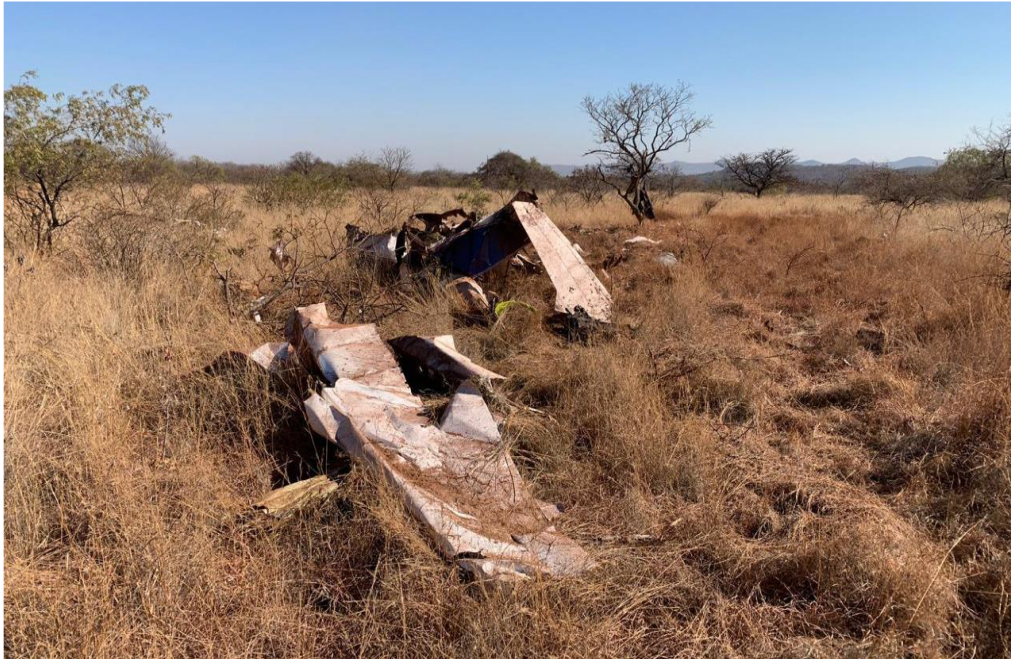
Figure 5: The wreckage distribution at the site.

1.12.4 The left wing was found 38.1 metres from the first point of impact. The roof of the aircraft was found 61.7 metres from the first point of impact. The engine cowl was found 4.2 metres from the wreckage, and the left wing was found 7.9 metres on the left side of the wreckage. The wreckage was spread within an area of 66.2 metres.

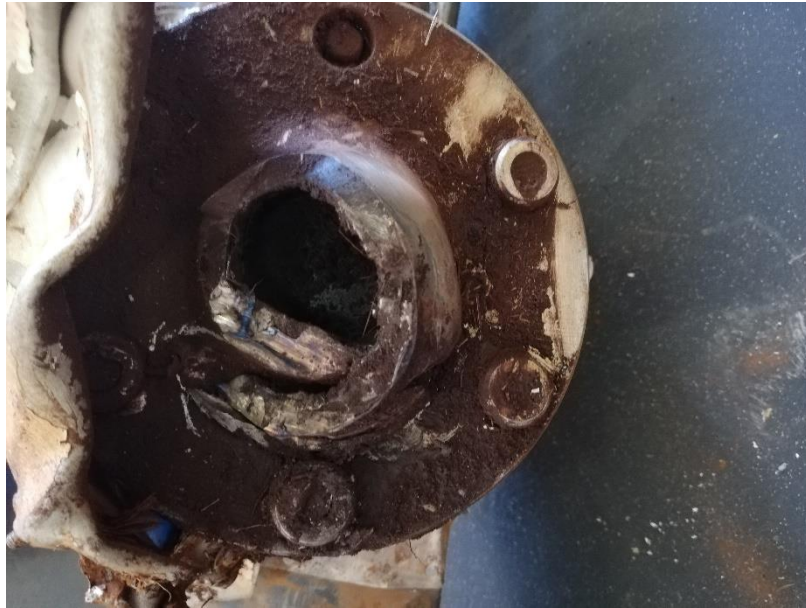
1.12.2 The propeller had separated from the engine during the impact sequence. The crankshaft flange separated as a result of the impact with the ground. The engine and the propeller showed rotational damage (see Figures 6, 7 and 8). The propeller was found approximately 2 to 3 metres in front of the engine (which had separated from the main wreckage). The engine and the propeller were recovered from the accident scene for further examination. The crankshaft flange failure mode was associated with an overload/ductile failure (45° edges around the circumference of the shaft). There was oil spillage from the first point of impact to where the aircraft came to rest.

1.12.9 The nature of the damage to the propeller and engine where it failed or separated (sign of discolouration on the failed area) indicated that the engine was turning at the time of impact with the ground. Therefore, it eliminated the possibility of engine failure prior to the accident.

Figure 6: Close view of the propeller that detached from the crankshaft flange.

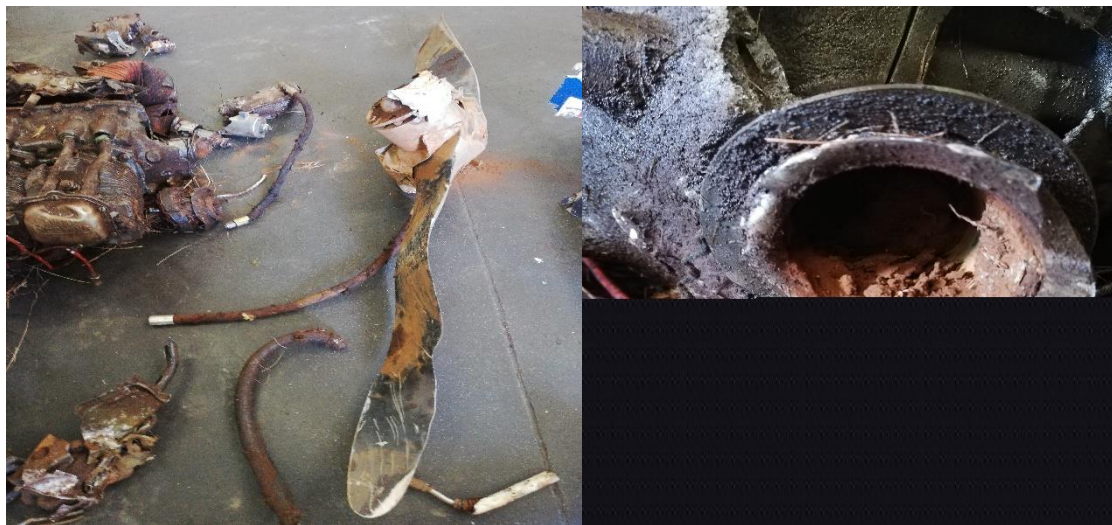
Figure 7: The propeller that detached from the crankshaft flange. **Figure 8:** The fractured surface of the crankshaft flange.

1.16.2.1 The engine, a Lycoming O-320-E2D serial number RL-50671-27A, was recovered from the accident site and was transported to an approved engine maintenance facility for further inspection and examination. Engine teardown was not conducted. The damaged propeller blade and the propeller assembly separation from the flange indicated that the engine was turning at the point of impact (see Figures 6, 7 and 8).

- 3.2.15 The aircraft was equipped with instrumentation and certified for both IFR and VFR flights. The aircraft was destroyed during the impact sequence and the engine was found to have been damaged due to the impact sequence. The propeller hub had separated from the crankshaft flange. The fractured part showed that the engine had power. It was evident from

these fractured pieces that the engine was delivering power when the aircraft impacted the ground.
