AIRCRAFT ACCIDENT SHORT REPORT

CA18/3/2/9816: Failure of the propeller due to a pre-existing crack.

Aircraft registration : ZU-DNI

Aircraft manufacturer and model : Micro Aviation New Zealand Ltd, Bantam B22J

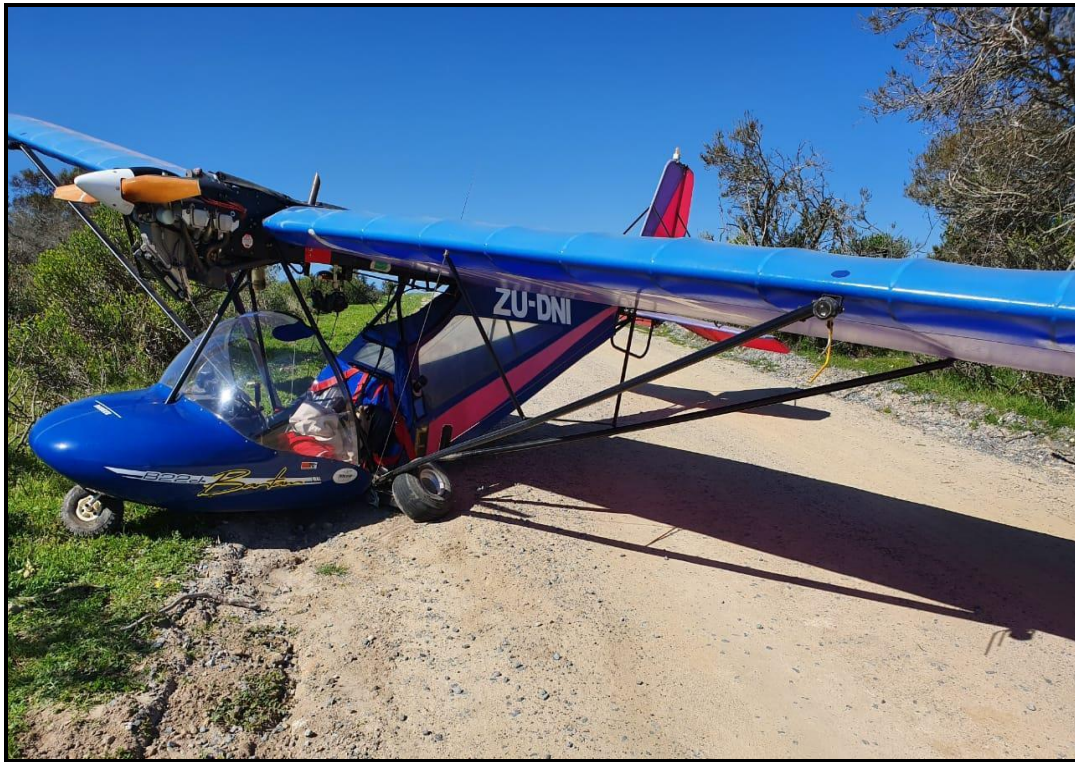
- 2.2 The pilot stated that 20 minutes into the flight, and 10 nautical miles (nm) north of Ysterfontein, the aircraft began to vibrate. When the vibration persisted, the pilot began searching for a suitable landing area. Meanwhile, both occupants heard a loud bang and, thereafter, the vibration intensified. The pilot shut down the engine and glided the aircraft towards a gravel road that he spotted while airborne. The pilot noticed a tree on the aircraft's path and pulled up to avoid collision. After clearing the tree, he flared the aircraft for touchdown, but the aircraft subsequently impacted the ground hard. The tyres burst on impact and the left-hand undercarriage bent outwards. The aircraft turned approximately 130° to the left before coming to rest.

Figure 1: The aircraft as it came to rest.

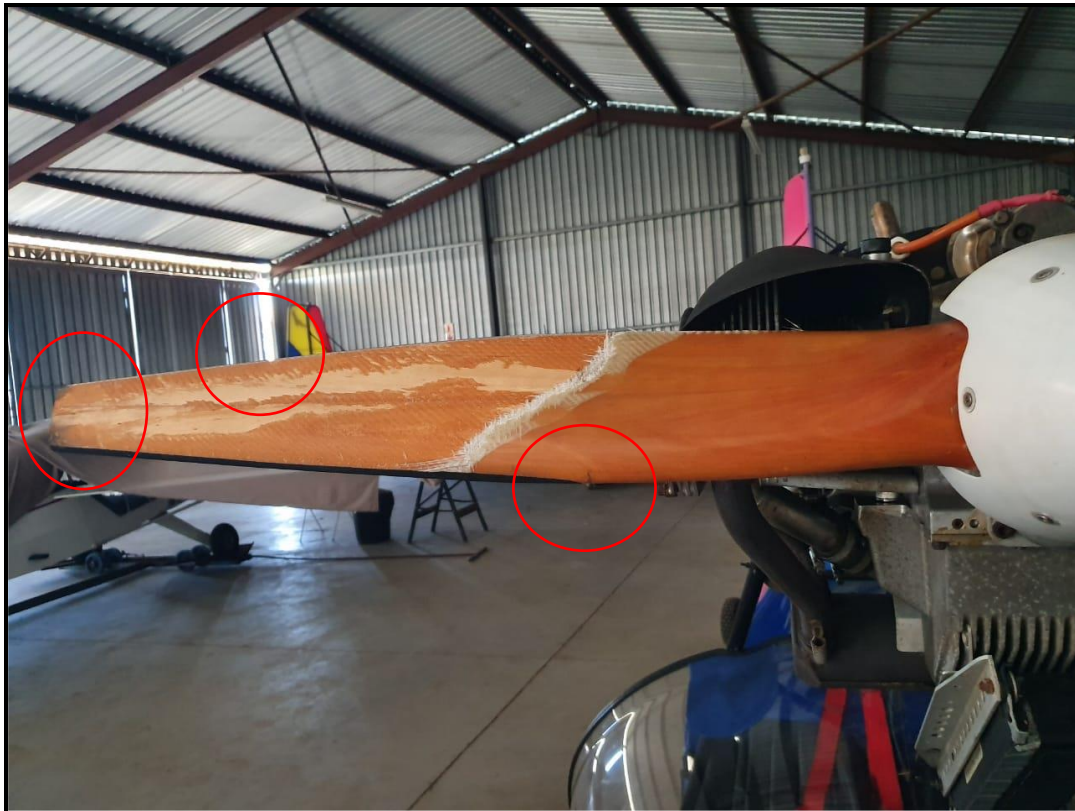
- 2.4.4 Post-accident inspection by the engine and propeller manufacturer revealed that one propeller blade was not damaged during the accident sequence, however, the other propeller blade showed signs of damage. As indicated in Figure 2, the manufacturer, after a closer inspection of the blade, concluded that: (i) the first red circle on the propeller tip appears to be blackened, this could be from wood rot; (ii) the second red circle appears to be a nick indicating physical damage; and (iii) the third red circle shows a crack on the leading edge, as if the propeller had struck an object.

Figure 2: Damage on the propeller blade.

- 3.7 No evidence of maintenance record of the propeller was submitted to the investigators by the owner or the AP during the investigation.
- 3.8 The manufacturer concluded that the failed propeller blade had pre-existing damage (crack) which occurred sometime during operation. It is, therefore, probable that the propeller had pre-existing impact damage which occurred during operation of the aircraft in the past and was not attended to, or there was no inspection or maintenance carried out on the propeller. The pre-existing damage on the propeller blade had caused vibration during the accident flight and that resulted in a forced landing.

- 4.1 The propeller failed due to pre-existing damage (crack) which was left unattended, causing vibration whilst the aircraft was in-flight. This led to an unsuccessful forced landing of the aircraft.
