AIRCRAFT ACCIDENT SHORT REPORT

CA18/2/3/9824 In-flight engine failure which resulted in an unsuccessful forced landing.

Date and time	:	2 October 2019; 0744Z
Aircraft registration	:	ZU-CVI
Aircraft manufacturer and model	:	Solo Wing; Windlass Aquilla
Last point of departure	:	Groutville Airfield, KwaZulu-Natal
Next point of intended landing	:	Groutville Airfield, KwaZulu-Natal
Location of accident site with reference to easily defined geographical points (GPS readings if possible)	:	Right-hand side of Runway 23 at Groutville Airfield, GPS estimated to be approximately 29°24'39.30" S, 31°16'43.24" E and at an elevation of 233 feet
Meteorological information	:	Wind: 120°/2-3kts; Temperature: 21°C; Dew point: 11°C; Cloud: High and scattered at ±6000ft
Type of operation	:	Training flight (Part 96)
Persons on board	:	2+0
Injuries	:	0
Damage to aircraft	:	Substantial

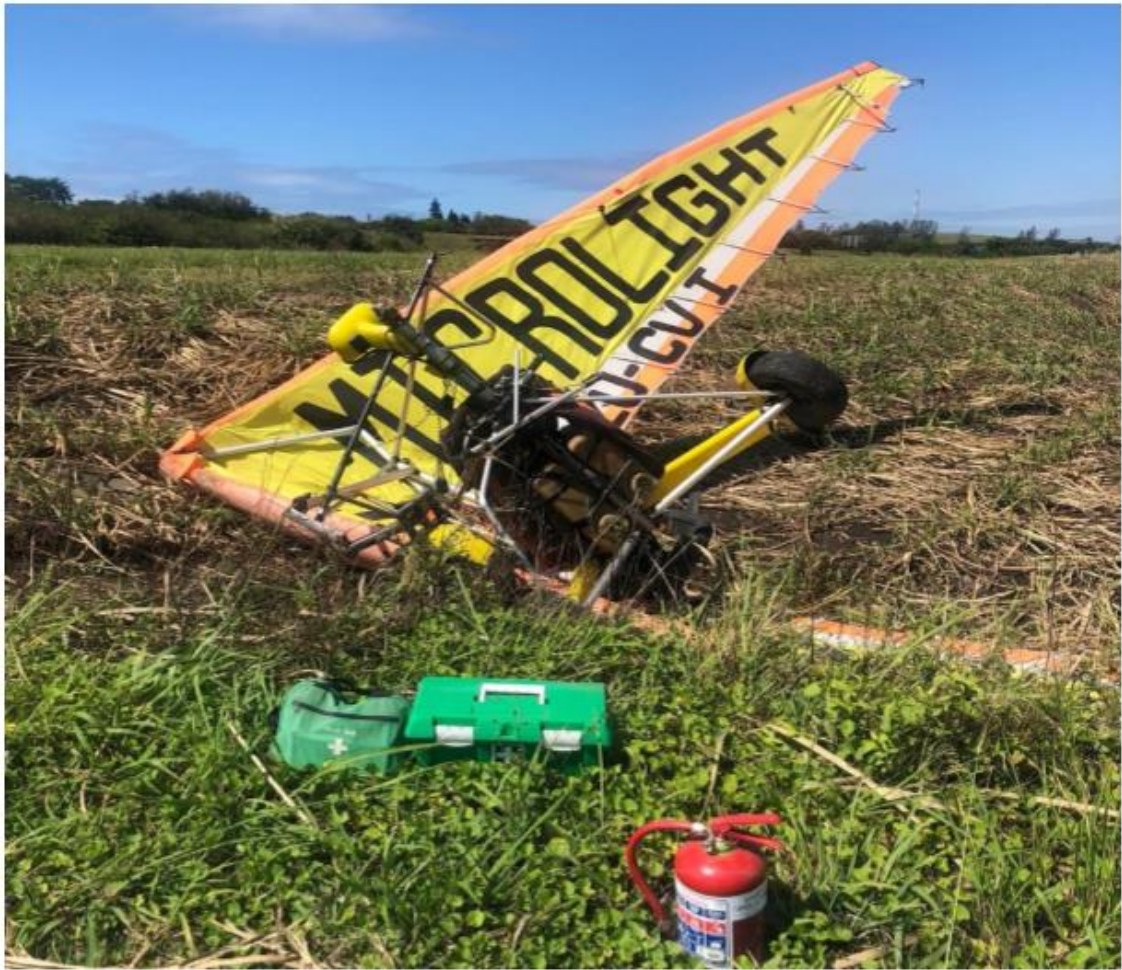
- 1.2 The aircraft was substantially damaged during the accident sequence; however, both occupants were not injured.
- 1.3 The investigation revealed that it is likely that the aircraft was refuelled with an incorrect fuel-to-oil mixture ratio, which resulted in the in-flight engine power loss before the engine stopped. The instructor opted to do a forced landing, which was unsuccessful.

- 2.3 The nose gear impacted a rock and broke off, causing the boom to dig into the ground. This resulted in the aircraft nosing over before coming to rest facing a westerly direction. The aircraft had substantial damage to the nose landing gear, right landing

2.4 gear, wing sail and battens, king post, nose plates, front suspension, front rim, dual steering and profile tube.

Figure 1: The aircraft at the accident site. (Source: Pilot)

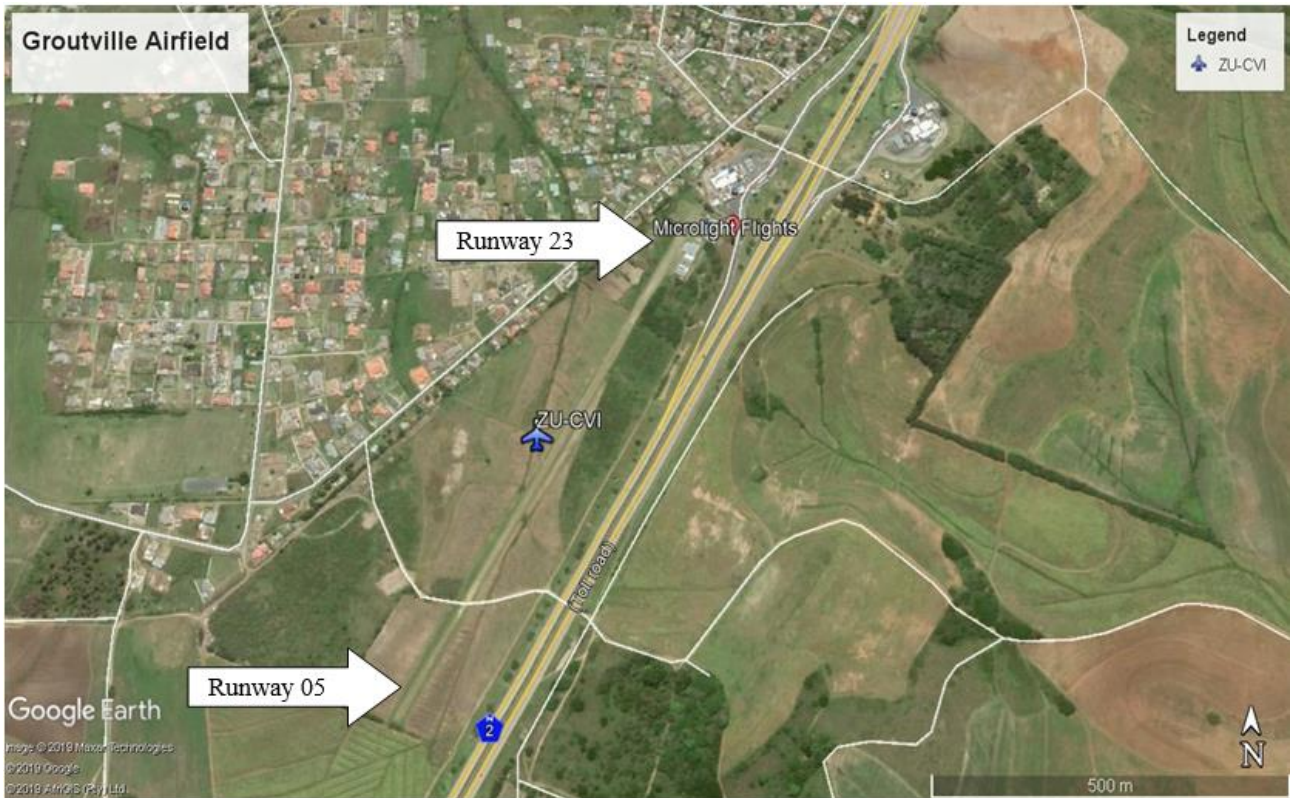
2.5 The accident occurred during daylight at Geographical Positioning System (GPS) determined to be S29°24'39.30" E031°16'43.24" and at an elevation of 233ft.

Figure 2: View of the accident site superimposed on Google Earth.
