Accident and Incident Investigations Division

AIRCRAFT ACCIDENT REPORT AND EXECUTIVE SUMMARY

Reference:	CA18/2/3/9828		
Aircraft Registration	ZS-EEZ	Date of Accident	6 October 2019		Time of Accident	1555Z	
Type of Aircraft	Piper PA-28-140		Type of Operation		Private (Part 91)		
Pilot-in-command Licence Type	Commercial Pilot Licence		Age	30		Licence Valid	Yes
Pilot-in-command Flying Experience	Total Flying Hours		255.4		Hours on Type	21.5	
Last Point of Departure		Vryburg Aerodrome (FAVB): North West Province					
Next Point of Intended Landing		Klerksdorp Aerodrome (FAKD): North West Province					
Location of the accident site with reference to easily defined geographical points (GPS readings if possible)							
Huhudi township, near Vryburg (GPS S 26° 58' 35.4" E 024°44'6.66"), elevation 3945 feet							
Meteorological Information		Surface wind: 300°/14kts gusting at 25kts; temperature: 33°C; dew point: 7°C; QNH: 1017hPa; Visibility: CAVOK					
Number of People on-board	1+1	No. of People Injured	1	No. of People Killed	1

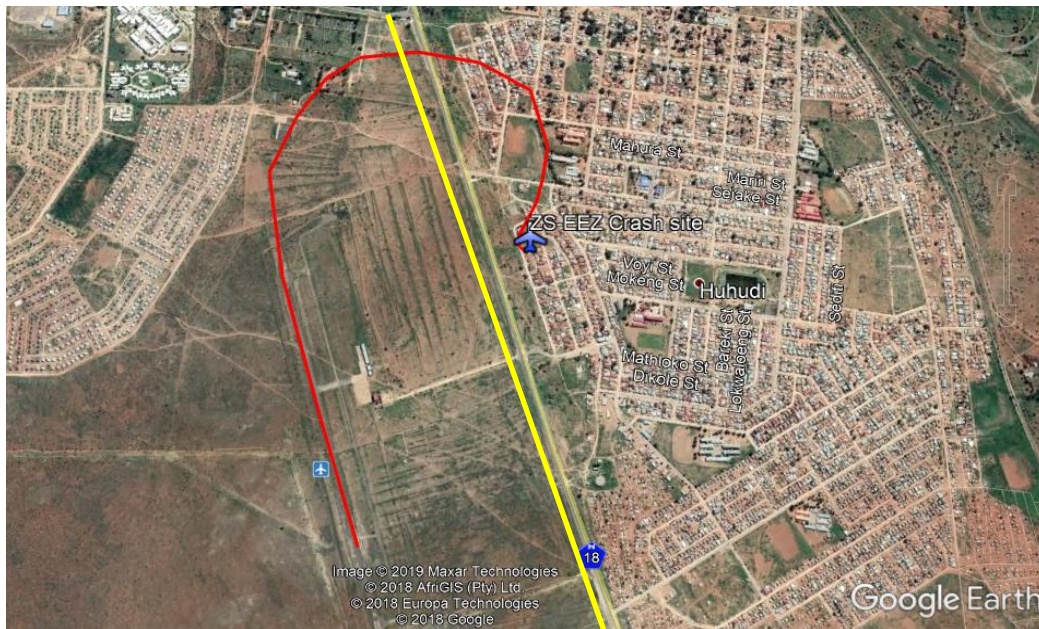
- 1.1.4 According to the passenger, they took off from Runway 36 at FAVB. All went well until the aircraft made a sudden right turn at the height (approximately 12m) of electric wires which ran parallel to the runway, and the pilot narrowly cleared them. The passenger recalled seeing the pilot making a lot of different inputs on the controls. However, the passenger could not confirm if there was anything wrong with the aircraft. The passenger further stated that he had asked the pilot if all was fine; however, the pilot did not respond but remained calm. The pilot had, then, added power and pulled back the flaps (flaps up position).

- 1.1.5 The aircraft continued with a right turn whilst losing height and impacted the road and, later, two trees in a right-wing low attitude about 0.9km from FAVB. The aircraft skidded for approximately 15 metres (m) before colliding with a property, damaging its parameter fence, a concrete pillar on the veranda, a windowpane, a garage wall, a garage door, a car parked in the garage and a tap before coming to a stop. No person was injured on the ground.

Figure 1: The flight path indicated by the red line; and the power lines indicated by the yellow line.

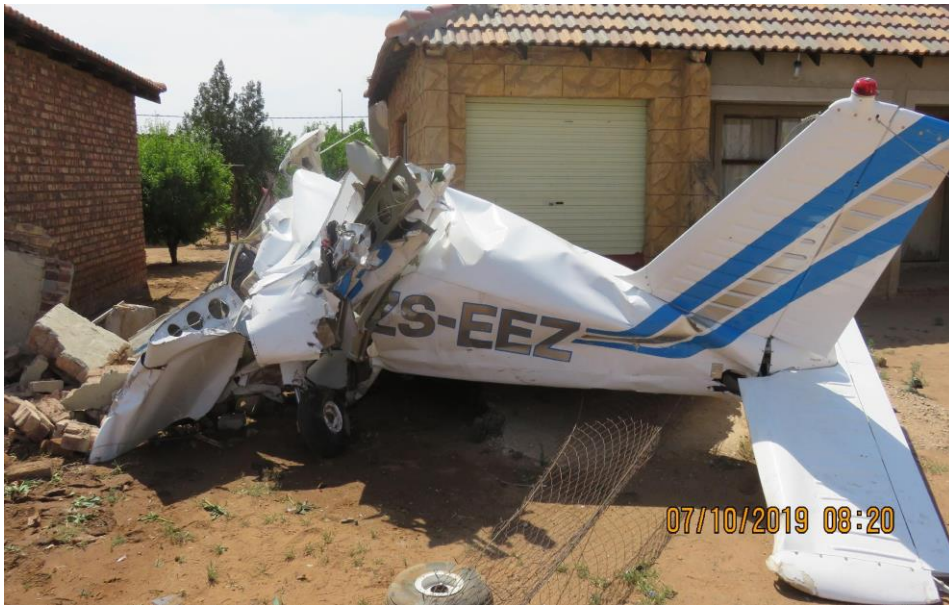
1.3.1 The aircraft was destroyed during the accident sequence.

Figure 2: The wreckage as found at the accident site.

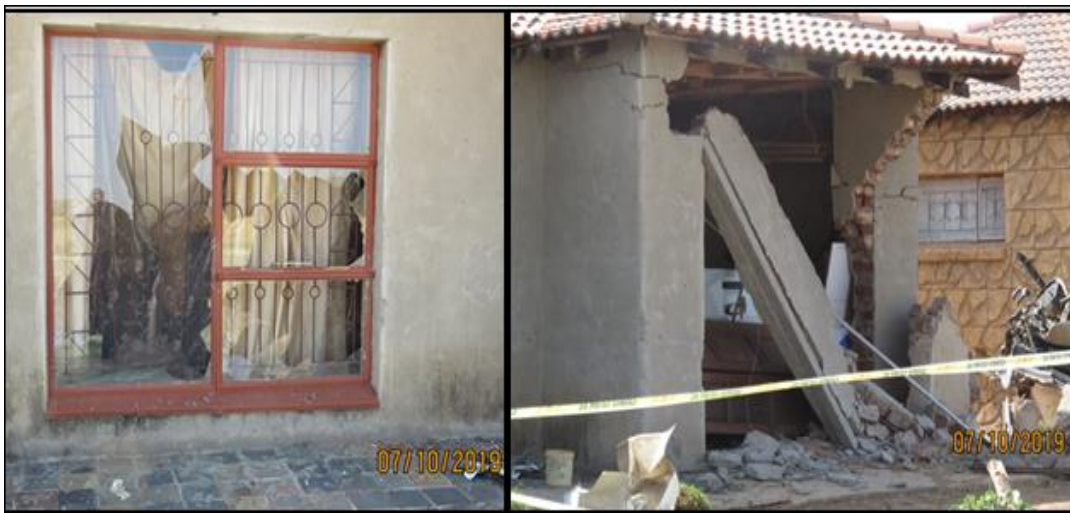
1.4.1 The house, window, garage door, vehicle taillight, a tap and a fence were also damaged.

Figures 3 and 4: Damage caused to the window of the house, the garage door and the parameter wall.

The vehicle which was parked in the garage (not visible in the picture) was also damaged.

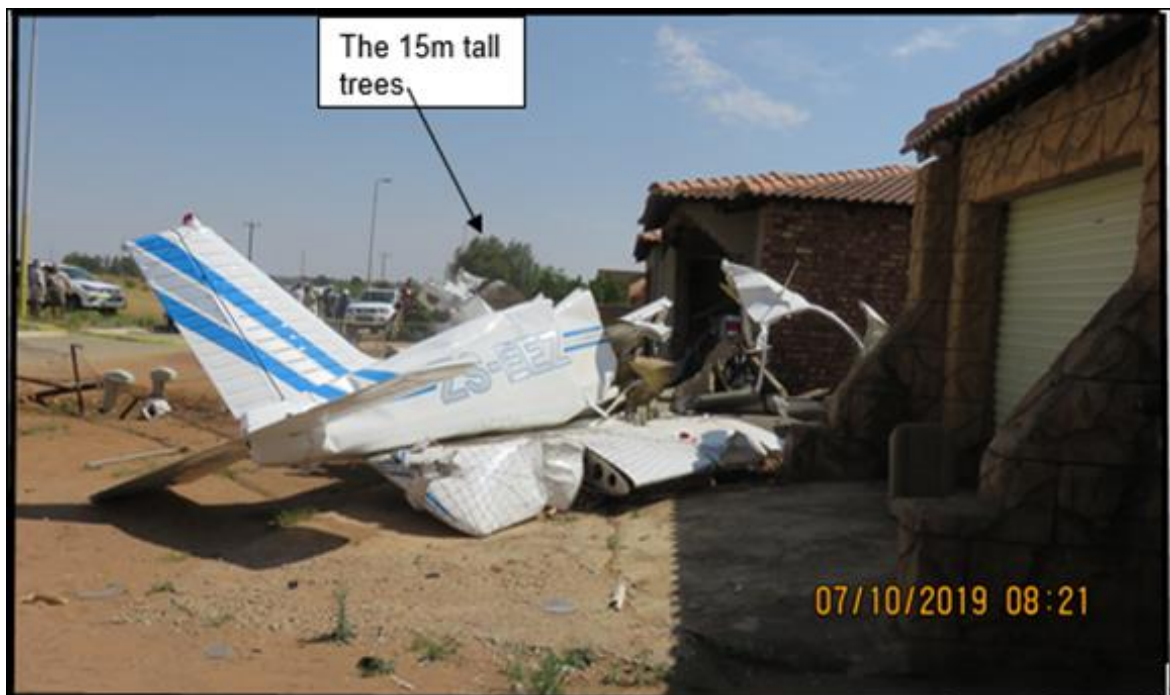
1.12.1 According to the eyewitness who saw the aircraft seconds before impact, the aircraft flew in a south easterly direction in a right-wing low attitude. It flew over two tall trees approximately 15m high (see Figure 6).

Figure 6: The location of the trees in relation to where the wreckage was found.

The aircraft first impacted the street pavement with its right-wing tip and the right-hand (RH) main landing gear wheel. This was indicated by blue and white paint marks on the street's surface and the black tyre marks towards the left-hand (LH) side of the street pavement.

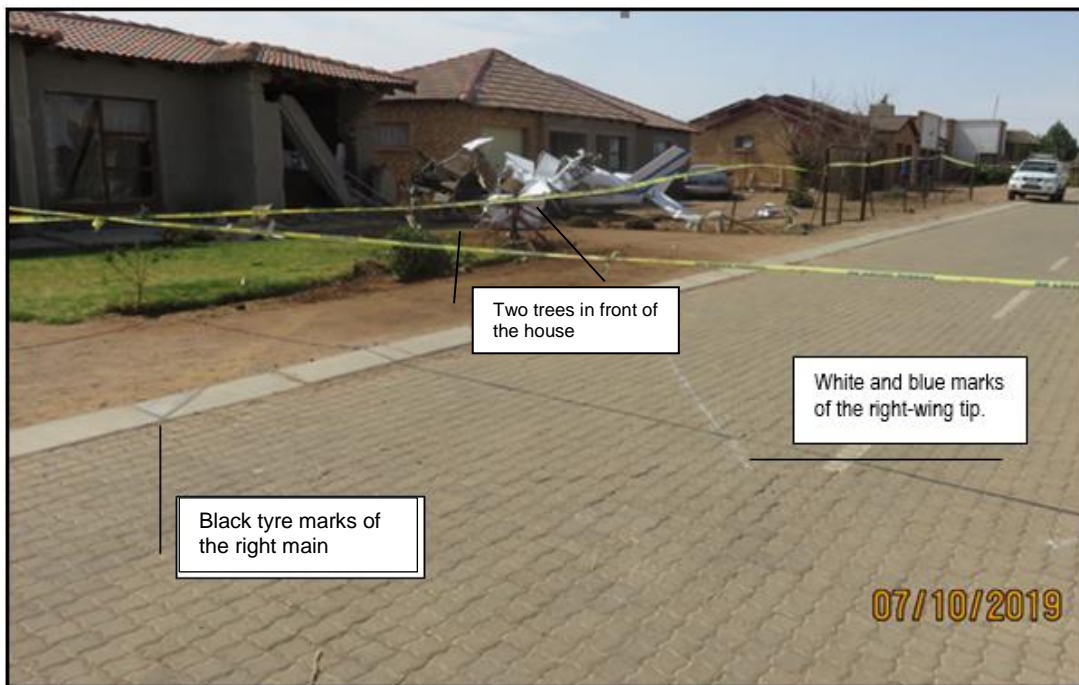
1.12.2 The aircraft's right-wing in-board leading edge collided with the first tree and then the outer right-wing leading edge collided with the second tree. The aircraft began to veer off to the right (see figure 7). Both trees were lining the street on the left side of the house.

Figure 7: The ground scars on the road.

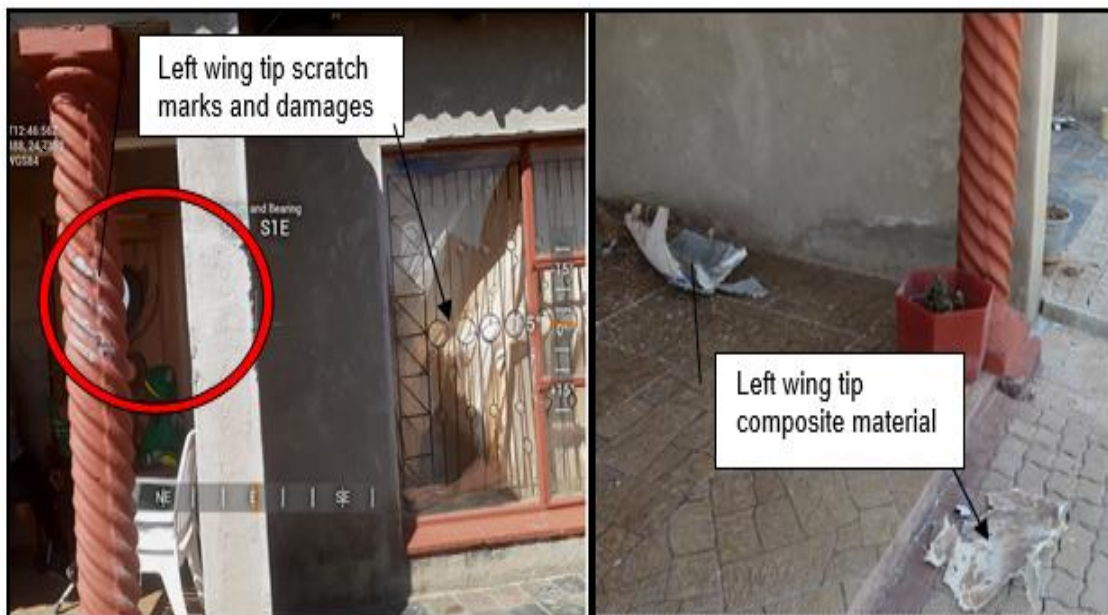
- 1.12.3 The left wing-tip collided with a building pillar on the patio of the house and then the wall. The LH main landing gear impacted the ground and broke off. The LH wing stroke the windowpane, breaking it, and impacted the garage wall and door. The aircraft's engine compartment impacted the garage's outer wall and demolished it, and the cockpit panel bent (turned) towards the right. The fuselage was torn into two parts from the middle, with the LH side (where the pilot was seated) folded backwards.

Figures 8 and 9: Scratch marks of the left-wing tip on the pillar and the damaged window.

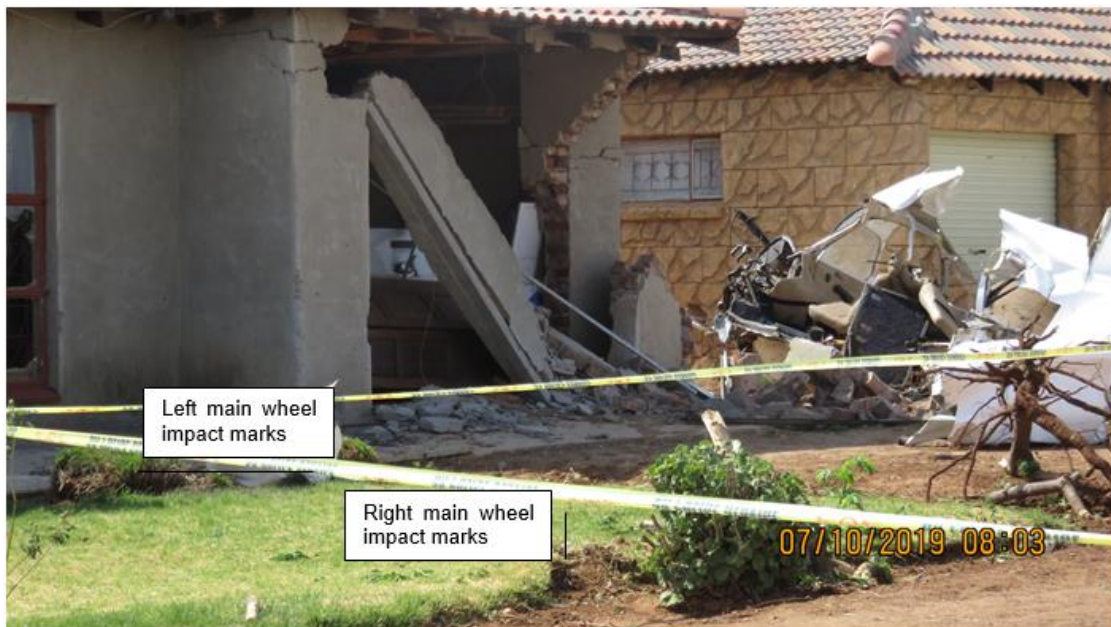
Figure 10: The impact points show the initial direction (southerly) of the aircraft before impacting the house. After impact, the aircraft turned left and came to a stop, facing north east.

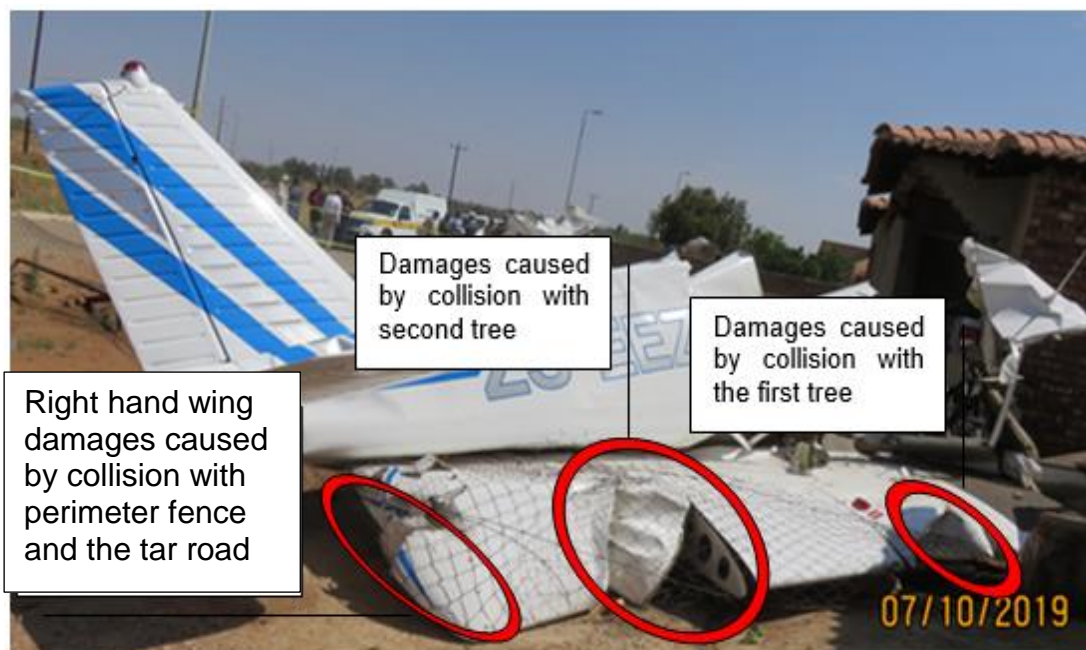
Figure 11: Damages on the right-wing leading edge and wing-tip.

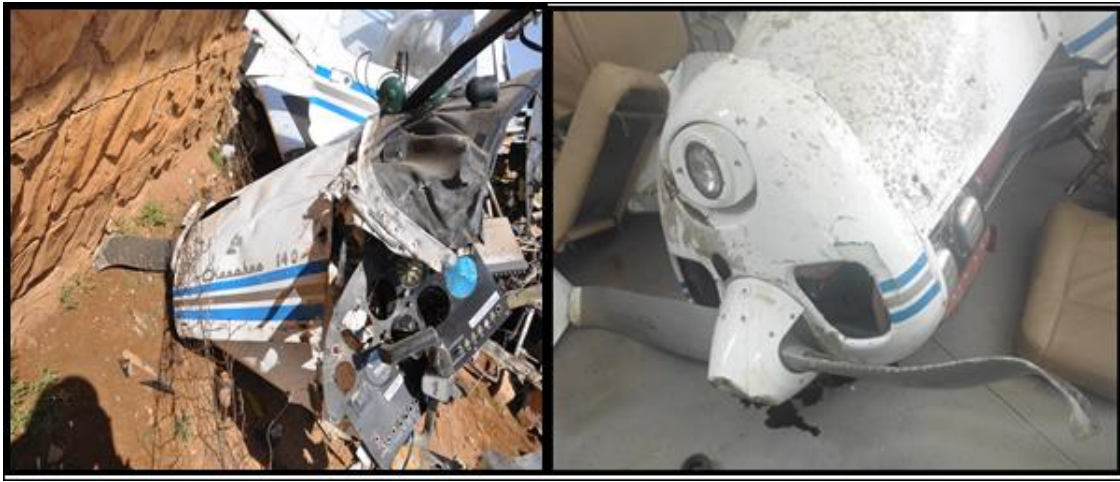
1.12.4 After impact, the LH wing main spar broke off and the rest of the wing was destroyed. The engine compartment was found resting on the propeller hub (see Figure 12) and the propeller blades had dug into the ground and both had bent forward (see Figure 13), indicating that the engine had power until the point of impact. The nose landing gear wheel had broken off from the mounting fork, which was also bent.

Figures 12 and 13 The aircraft and the propeller blade with the blade tips curled forward, indicative of a high-power setting.

1.16.1 The propeller blade tips had curled forward, indicative of a high-power engine setting. On 8 October 2019, the aircraft was recovered to a hangar at FAWB by an aircraft maintenance organisation (AMO) which inspected the engine for any possible failures prior to the accident. The AMO reported that all damages found were associated with impact during the accident.

- 2.2.7 The propeller condition indicated that the engine had sufficient power on impact, given that the blade tips were curled forward. None of the engine or airframe systems had any reported deficiencies prior to the accident and all damages observed on the aircraft at the accident site were a result of the crash.

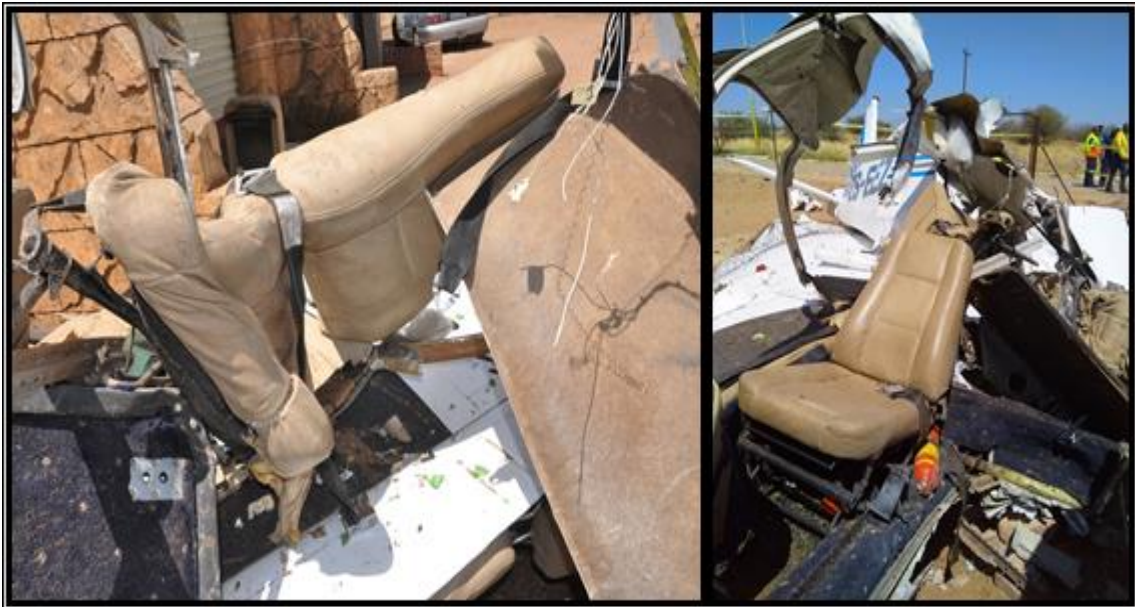
1.12.5 The cockpit was destroyed during the accident sequence and the LH front seat had broken off (see Figure 14). The LH rear seat was found on the RH side of the wreckage. The front LH seat harness was cut by the first responders to release the pilot. Both the RH side (front and rear) seats were still intact in their mounting positions (see Figures 14 and 15) and the passenger's safety harness was still intact. All flight control cables were still intact, and the continuity was established. The cables were cut during recovery. All flight control surfaces were accounted for.

Figures 14 and 15: The damaged pilot seat (left) and the passenger seat (right).

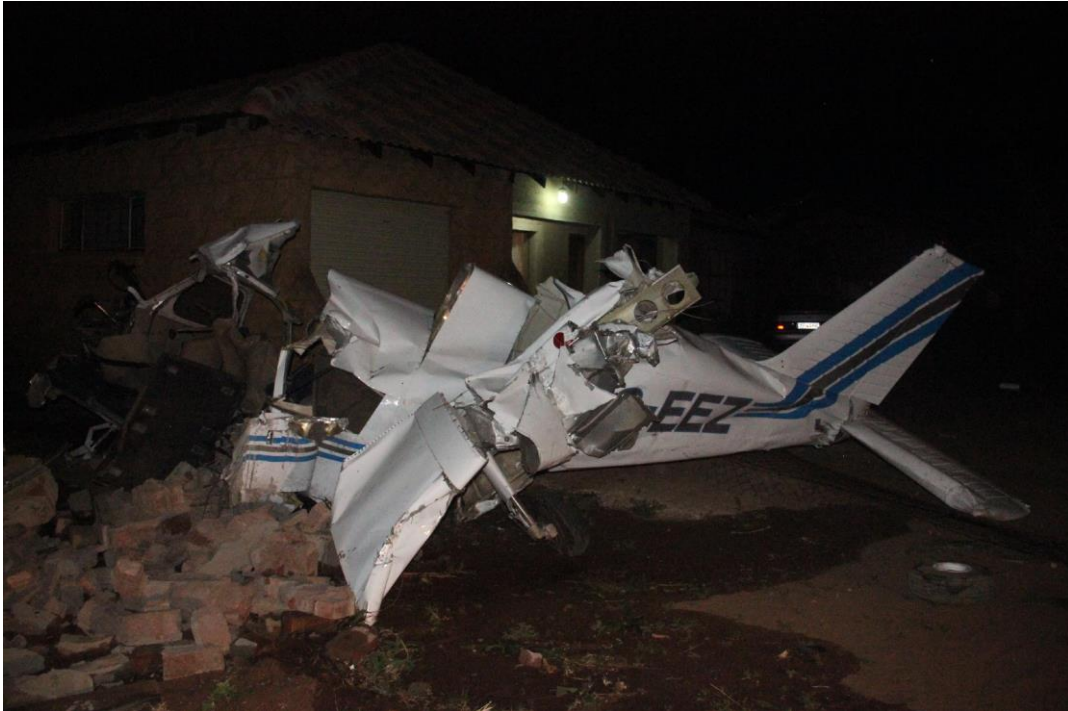
1.12.6 The fuel selector was found on the left-side of the wreckage (see Figure 16) and the LH fuel tank was destroyed by impact forces. The RH fuel tank was damaged during impact. The investigators had dipped a stick in the tank and found some fuel remaining in the tank. The damaged RH wing and the low volume of fuel made it difficult to drain the fuel to determine how many gallons were left in the tank. The owner of the house stated that there was fuel spillage after the accident and there was a large quantity of water from the

tap that was uprooted by the aircraft during impact (see Figure 16). There was also a strong smell of fuel at the accident site the day after the accident.

Figure 16: The wreckage and fuel and water spillage after the accident. (source: SAPS)
