AIRCRAFT ACCIDENT SHORT REPORT

CA18/2/3/9829: The left undercarriage collapsed during the landing roll.

Aircraft registration : ZU-MJB

Aircraft manufacturer and model : Alpi Aviation SRL, Pioneer 330

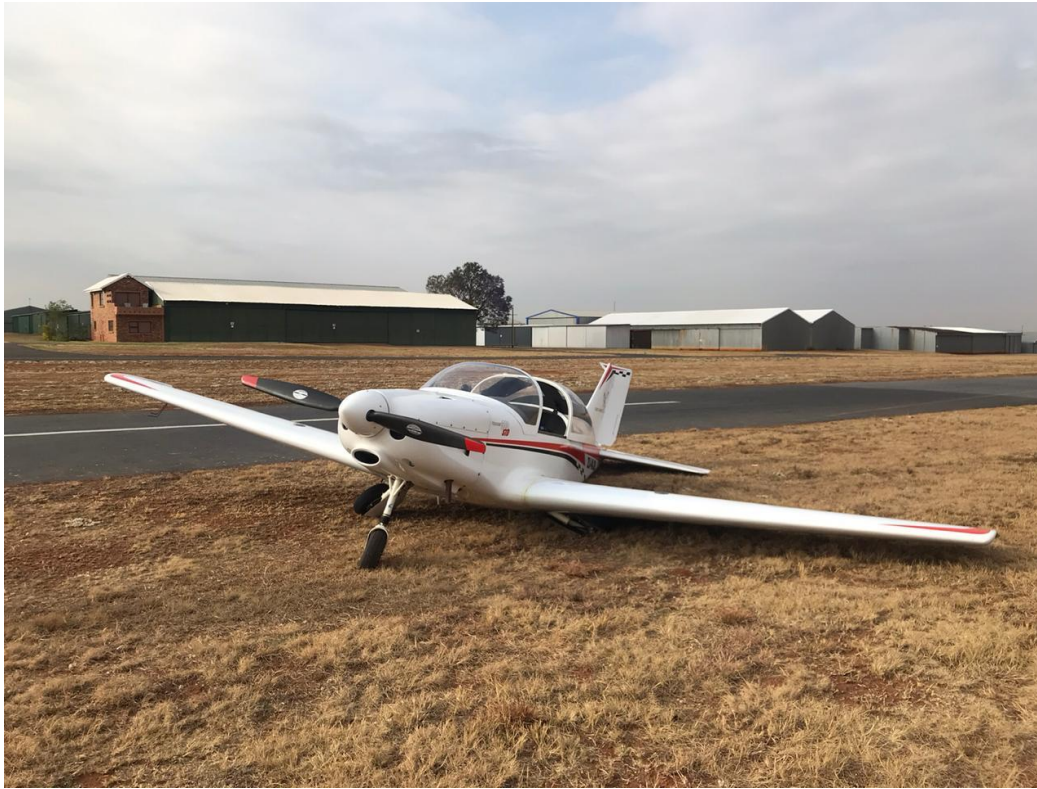
- 1.2 The pilot stated that after touch down on Runway 08 and during the landing roll, the left main undercarriage collapsed, and the left wing came into contact with the ground. The aircraft veered off to the left of Runway 08 and came to rest approximately 5 metres away from it (runway).

- 1.3 The aircraft sustained substantial damage to the left undercarriage, left wing and the underbelly. The pilot was not injured during the accident sequence.

Figure 1: The aircraft as it came to rest after the accident.

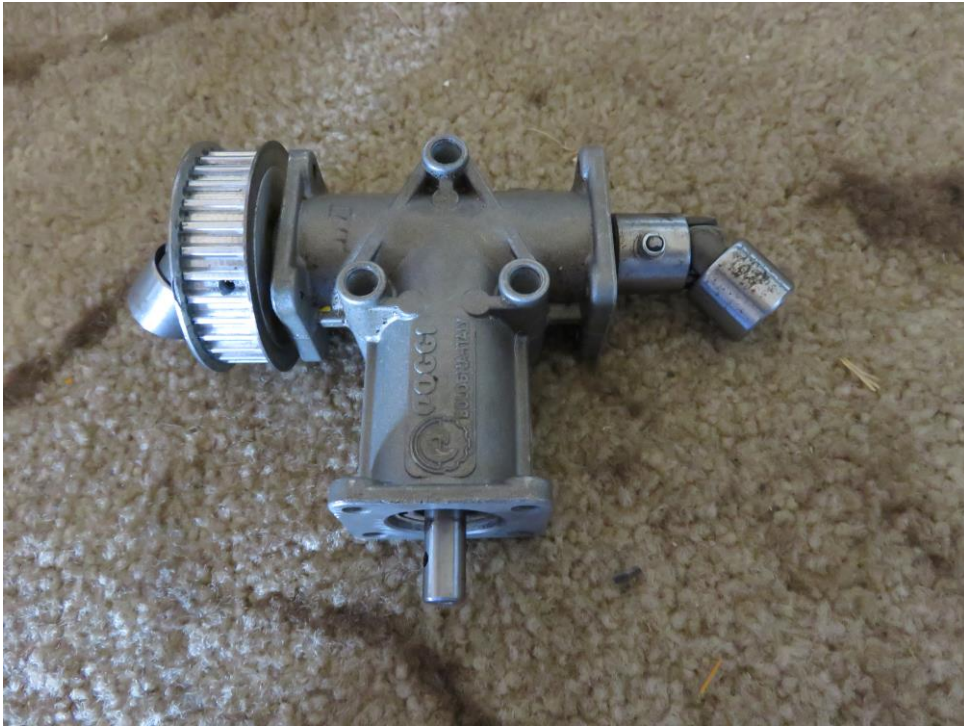
- 1.4 The investigation revealed that the main landing gear was fully extended during landing, however, the jacks that operate over the centre mechanism which lock the landing gear could not lock because of the broken lock pin in the undercarriage gearbox. This resulted in the left main undercarriage collapsing after touch down.

- 2.1.7 After the accident, the main landing gear gearbox was recovered and it was found that the centre lock pin had broken off and had become disabled, causing the left main landing gear to collapse. The lock pin was never recovered from the accident site.

Figure 2: The aircraft's undercarriage gear box.

- 4.1 The main landing gear was fully extended during landing, however, the jacks that operate over centre mechanism which lock the landing gear could not lock because of the broken lock pin in the undercarriage gearbox. This resulted in the left main undercarriage collapsing after touch down.

- 6.1 After the accident, the AIID had established that the maintenance and inspection of the gearbox was not covered in the manufacturer's maintenance program (Pioneer 300 Maintenance Program) for the aircraft type Pioneer 330 on all maintenance inspections conducted on the undercarriage gearbox. It is, therefore, recommended that the aircraft manufacturer, the Italy agent and Italy CAA come up with the maintenance program that will include the inspection of the landing gear gearbox.

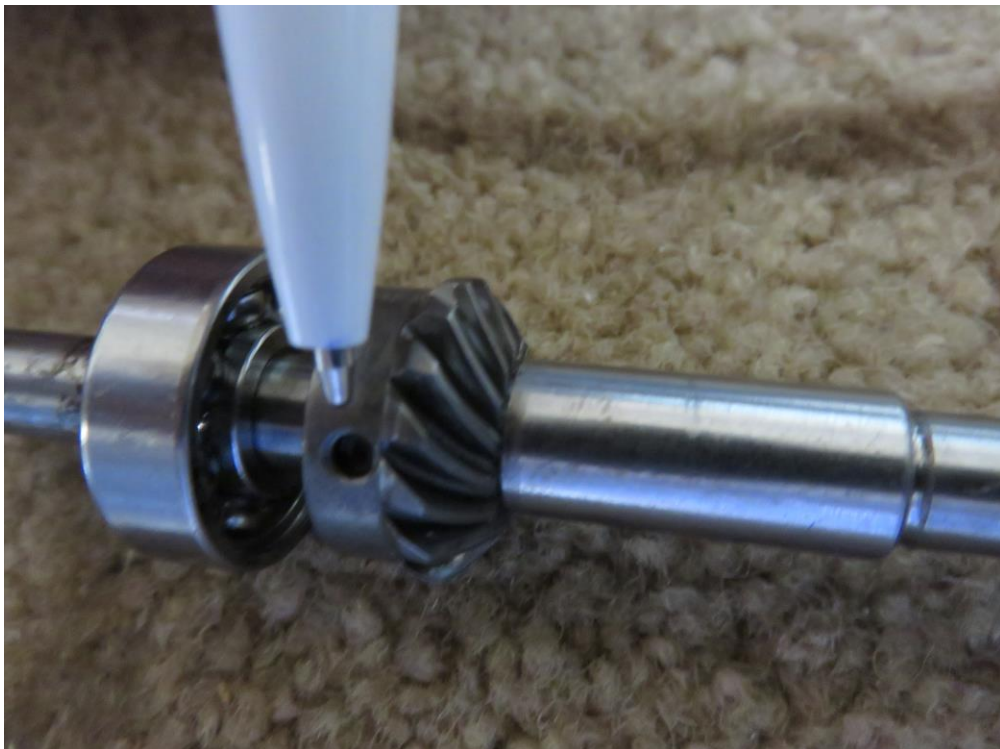
Figure 3: Picture of the lock pin hole.

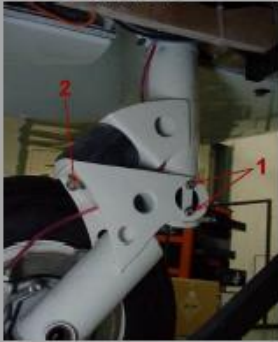
Picture 11

1 rotation pivot screws
2 plug pivot screw

Check bolts & nuts fastening and the bracket aft placed the pivot (Picture 11)
