AIRCRAFT ACCIDENT REPORT AND EXECUTIVE SUMMARY

Reference:	CA18/2/3/9830	
Aircraft Registration	ZS-OFP	Date of Accident	20 October 2019		Time of Accident	0808Z
Type of Aircraft	Cessna 402 B		Type of Operation	Commercial (Part135)		
Pilot-in-command Licence Type	Commercial Pilot Licence		Age	29	Licence Valid	Yes
Pilot-in-command Flying Experience	Total Flying Hours	706.6		Hours on Type	245.3	
Last Point of Departure	Rand Aerodrome (FAGM), Gauteng Province					
Next Point of Intended Landing	Ant's Nest Private Airfield, Limpopo Province					
Location of the accident site with reference to easily defined geographical points (GPS readings if possible)						
A private airfield at a farm 8NM south-east of Ant's Nest, GPS: 24°12'23.0" S; 028°05'51.0" E, elevation: 3814 feet.						
Meteorological Information	Wind velocity: 260°/02 kt; Visibility: 10km; Cloud: Nil; Visibility: 10km; Temperature: 24°C; Dew Point:06°; QNH:1019					
Number of people On-board	1 + 5	No. of People Injured	0	No. of People Killed	0

Reference Number : CA18/2/3/9830
Name of Owner/Operator : MCC Aviation
Manufacturer : Cessna Aircraft
Model : C402B
Nationality : South African
Registration Marks : ZS-OFP
Place : 8 NM

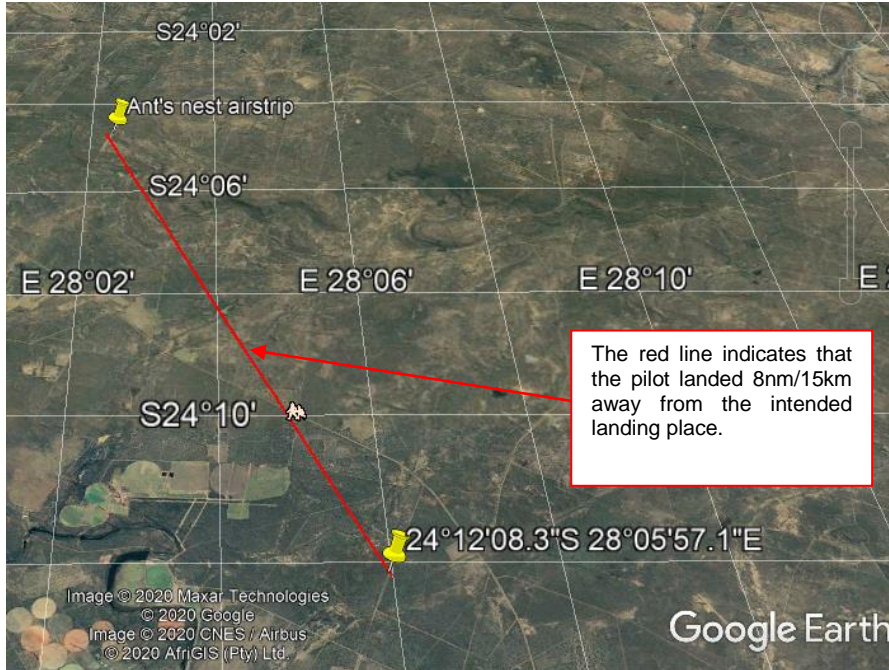
Figure 1: Distance between the active Ant’s Nest Lodge private airfield and the aircraft’s actual landing.

1.10.1 The occurrence took place at an unused grassy private airfield on a private farm 8nm or 15km south-east of Ant's Nest Lodge private airfield with GPS co-ordinates 24°04'52.26" S 028°02'18.6 E. Ant's Nest Lodge private airfield (Limpopo province) GPS co-ordinates are 24°12'23.0" S; 028°05'51.0" E, at an elevation of 3937ft AMSL. Information for both private strips is provided below:

4.2.1 Safety message: Pilots should ensure that they plan their flight taking into consideration the condition of the destination airfield and its co-ordinates.

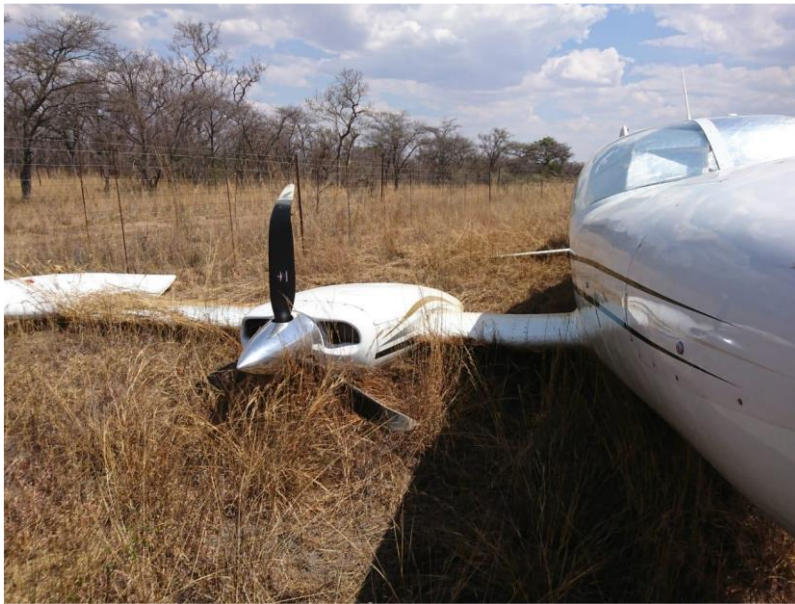
1.3.1 The aircraft sustained minor damage to the right engine propeller, right main landing gear door and the bottom of the right wing during the accident sequence.

Figure 2: Damaged aircraft's right wing.

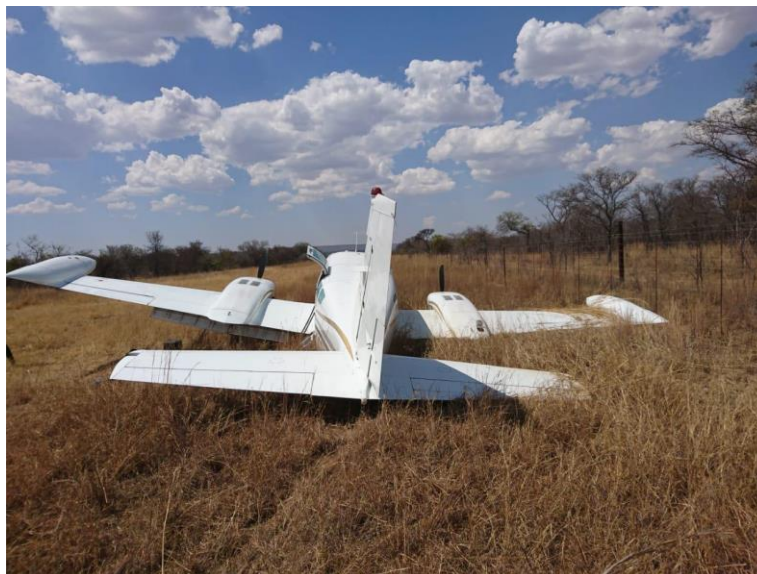
- 1.1.4 The aircraft veered off to the right of RWY04 where it came to rest. None of the occupants were injured during the accident sequence; they disembarked the aircraft unassisted. The aircraft was recovered post the accident where the landing gear was secured.

Figure 3: The aircraft as it came to rest after the accident.

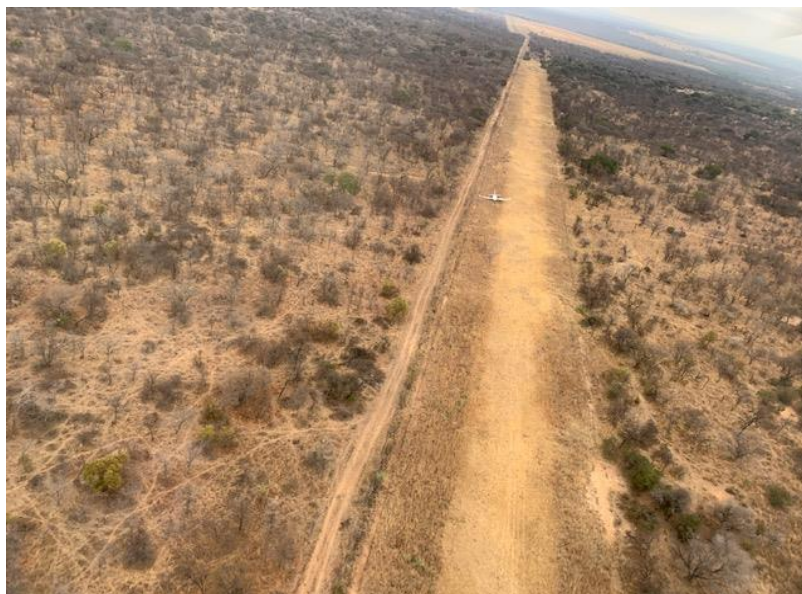
1.12.1 The aircraft accident occurred on a grassy runway during the landing phase. According to the pilot, the runway surface was unsuitable because it (surface) was uneven and soft. The aircraft came to rest on the right-hand side of RWY 04 with a collapsed right-hand main landing gear and damaged propeller. After recovery, it was noted that the aircraft sustained minor damage to the right engine propeller, right main landing gear door, right wing, as well as had a sheared main landing gear retracting linkage connecting bolt.

Figure 4: The view of the aircraft at rest at the accident site.

- 2.2.9 The investigation revealed that the aircraft landed on an unused and uneven private airfield and, during the landing roll, the right-hand main landing gear got into a ditch and collapsed, causing the aircraft to veer off to the right of the private airfield. The right-hand main landing gear collapsed because of the sheared off end fitting of the main gear retracting linkage.

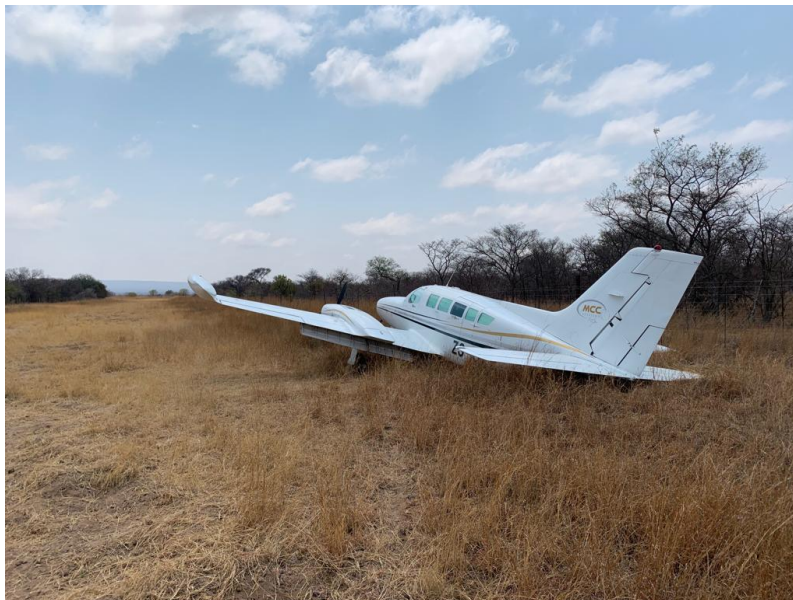
Figure 5: A close-up view of the aircraft at rest at the accident site.

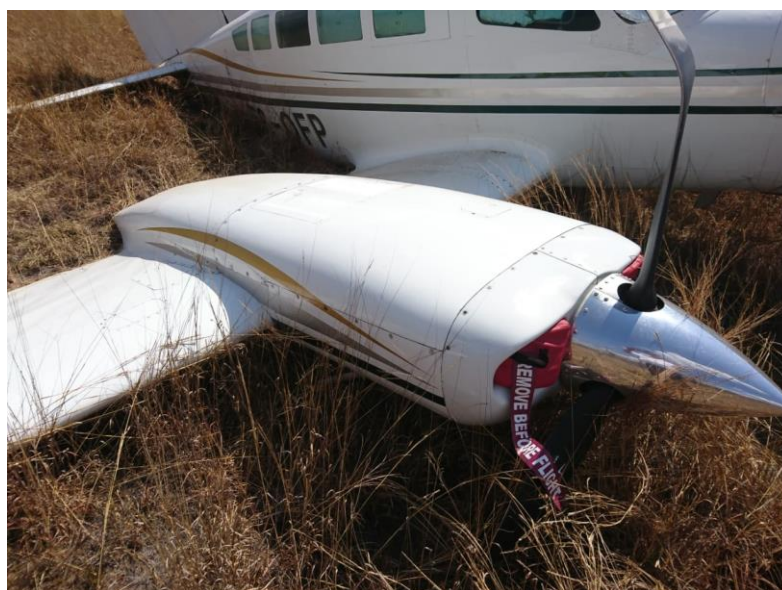
- 1.1.11 The aircraft maintenance engineer (AME) who conducted the post-flight inspection revealed that the right-hand main landing gear collapsed because of the sheared off end fitting of the main gear retracting linkage.

Figure 6: View of the damaged propeller following the collapse of the right-hand main landing gear.
