HELICOPTER ACCIDENT REPORT AND EXECUTIVE SUMMARY

Reference:		CA18/2/3/9832	
Aircraft Registration	ZT-RAL	Date of Accident	25 October 2019	Time of Accident	1030Z
Type of Aircraft	Robinson R44		Type of Operation	Training (Part 141)	
Pilot-in-command Licence Type	Commercial Pilot Licence		Age	70	Licence Valid Yes
Pilot-in-command Flying Experience	Total Flying Hours	7700.6	Hours on Type	134.1	
Last Point of Departure	Wonderboom Aerodrome (FAWB), Gauteng Province				
Next Point of Intended Landing	Wonderboom Aerodrome (FAWB), Gauteng Province				
Location of the accident site with reference to easily defined geographical points (GPS readings if possible)					
At position S 25° 40' 18.67" E 028° 12' 54.12" on Marjoram Ave position 0.6nm south of Runway 06 threshold					
Meteorological Information	Wind: 270°/14kts, Temperature: 36°C, Dew Point: 14°C, Visibility: CAVOK, QNH: 1018hPa and Clouds: Nil				
Number of People On-board	3 + 0	No. of People Injured	2 (minor) 1 (serious)	No. of People Killed	0

Reference Number : CA18/2/3/9832
Name of Owner/Operator : Delmart (Pty) Ltd t/a Powered Flight Training Centre
Manufacturer : Robinson Helicopter Company
Model : R44
Nationality : South Afri

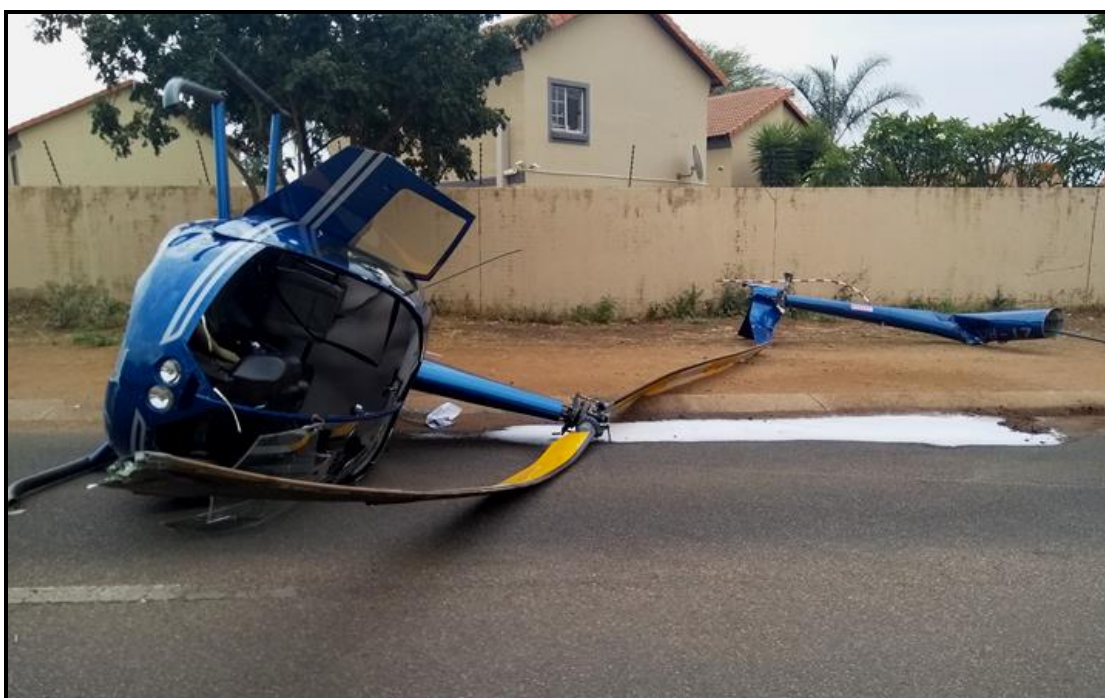
1.3.1 The helicopter was destroyed during the accident sequence.

Figure 2: The helicopter wreckage after the accident.

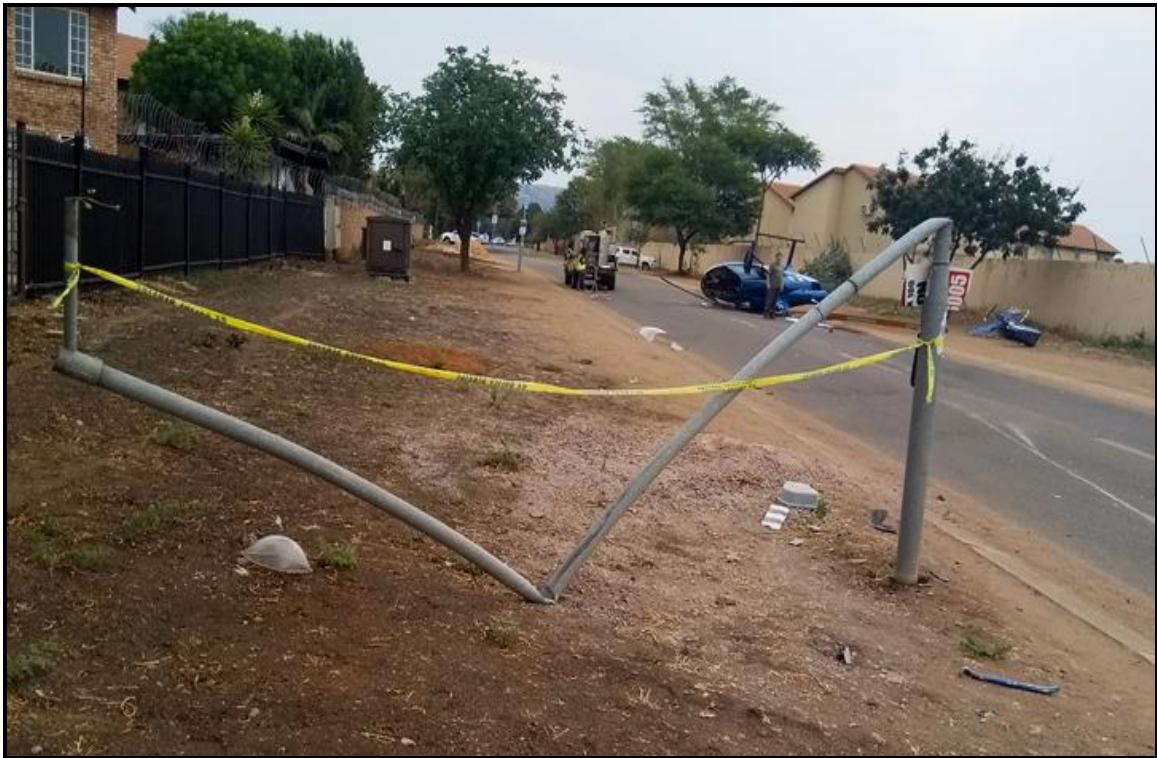
1.4.1 The helicopter struck the streetlight pole, damaging it.

Figure 3: The damaged streetlight pole.

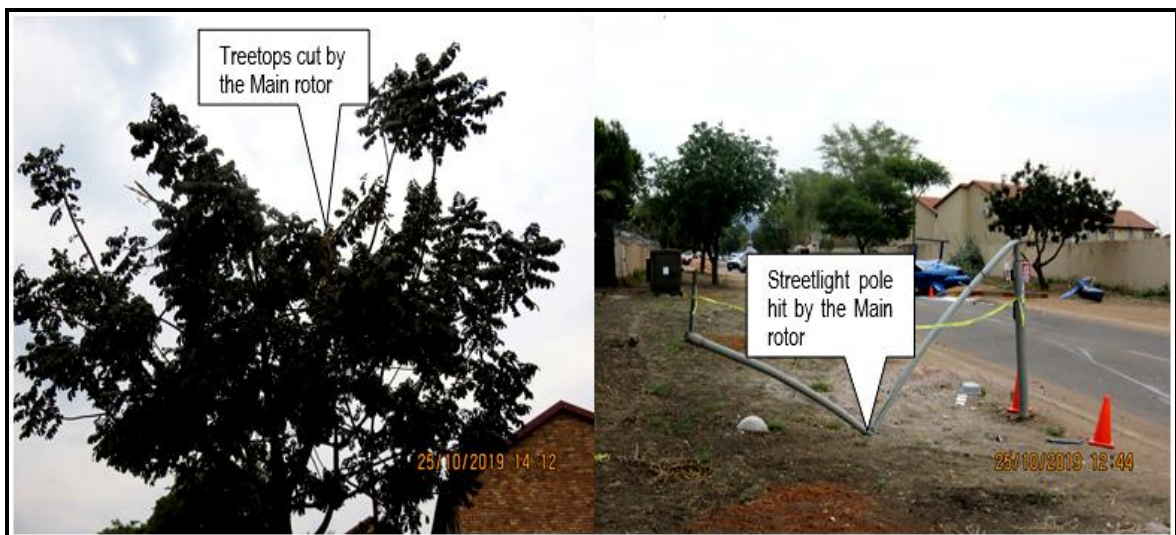
1.12.2 The helicopter approached from a north-eastern direction. During the forced descent as the helicopter began to flare, its main rotor clipped a treetop and cut off some branches before striking the streetlight pole. Upon striking the streetlight pole, the outer piece of the main rotor blade was severed. The streetlight pole was bent in two positions. Subsequently, the tail-boom was impacted by the main rotor disc as the helicopter impacted the ground hard, causing damage to the tail rotor skid as well as damage to the bottom vertical stabiliser, which bent towards the right.

Figure 7: Damage caused by the main rotor strike on both the tree and streetlight pole.

- 2.2.7 As the helicopter was low during a forced landing, it first clipped the treetops, then cut off some branches and, later, struck a streetlight pole with its main rotor. The part of the main rotor that struck the streetlight pole broke off; the pole was bent in two places. The helicopter impacted the ground hard on its landing gear skids, causing them to collapse and spread outwards. Subsequently, the fuselage belly impacted the ground hard and got damaged. The helicopter skidded approximately 20m along the road's surface and came to a stop before rolling onto its left-hand side.

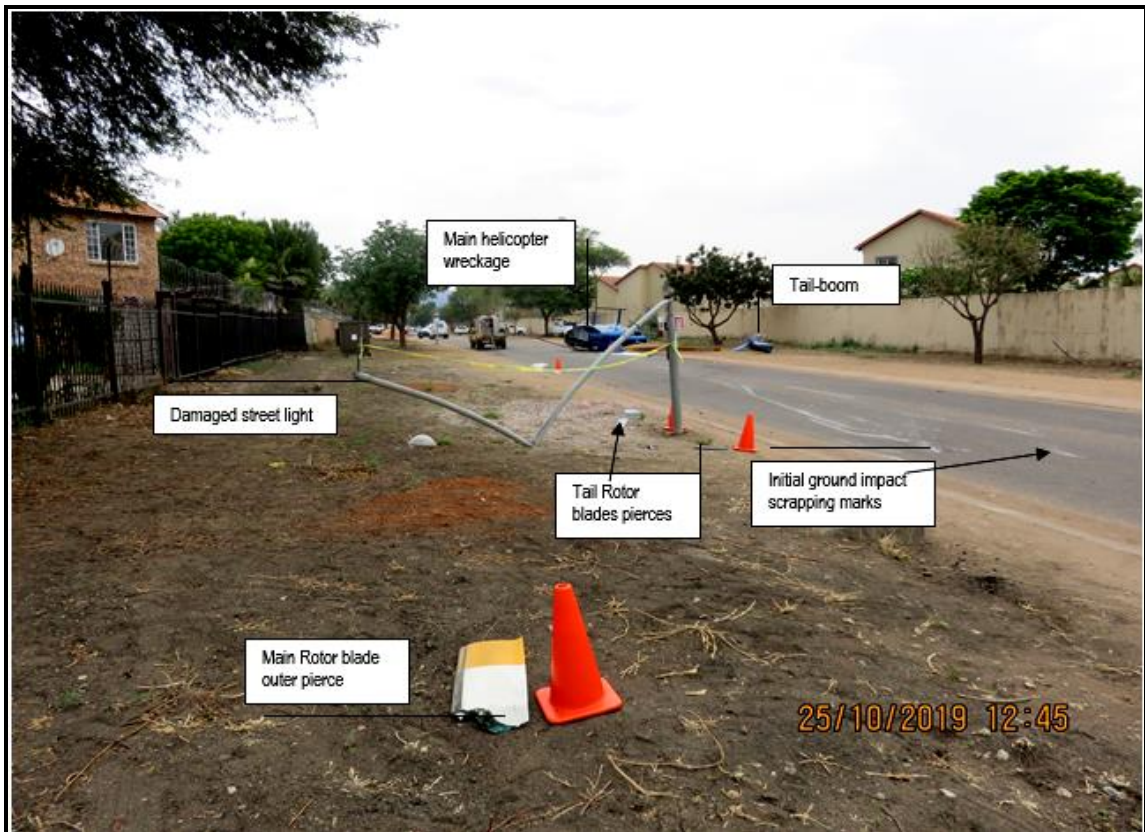
The helicopter then impacted the ground hard, causing both skid gears to bend sideways. Subsequently, the helicopter's belly impacted the ground hard and skidded along the road's surface, further sustaining scrapping marks. The marks on the helicopter's belly indicated that the helicopter was scrapping from its right-hand side along its belly.

Figure 8: The wreckage distribution as it was observed at the accident site.

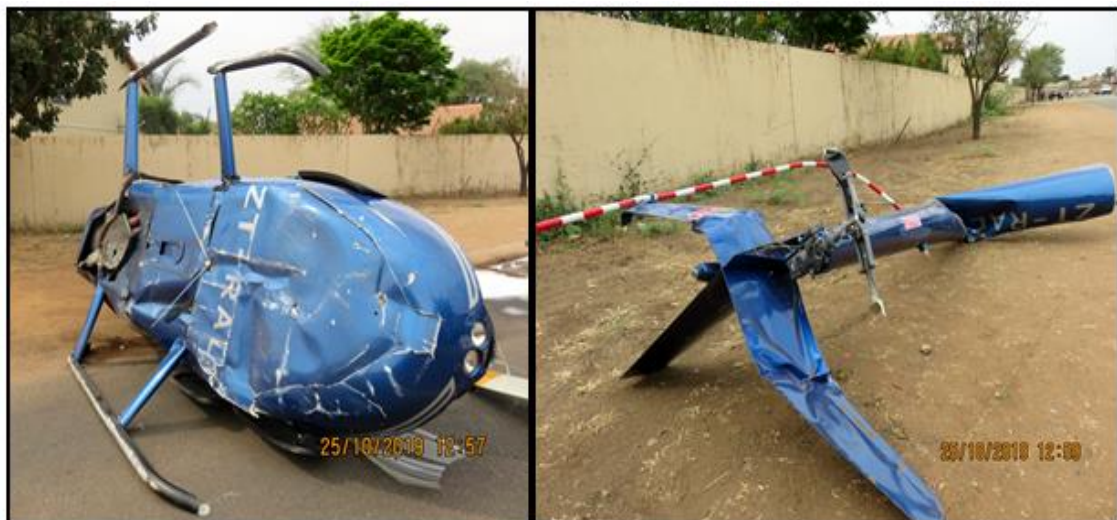
1.12.3 There were skid marks which were approximately 20m, starting from a position near the streetlight pole along the road to where the main wreckage was found lying on its left-hand side. The tail boom followed through as it was attached, however, it later broke off completely and was found lying behind the main helicopter wreckage. A large piece of the helicopter's windshield Perspex material was found approximately 10m from the initial point of ground contact.

Figure 9: Main wreckage (belly and thain boom).

1.12.4 The main wreckage bottom belly damage is consistent with hard impact and skidding along the street, leaving marks on the surface. The landing gear skids were bent sideways, leaving the belly to hit the ground hard. The right-hand side skid gear was fractured towards the front.

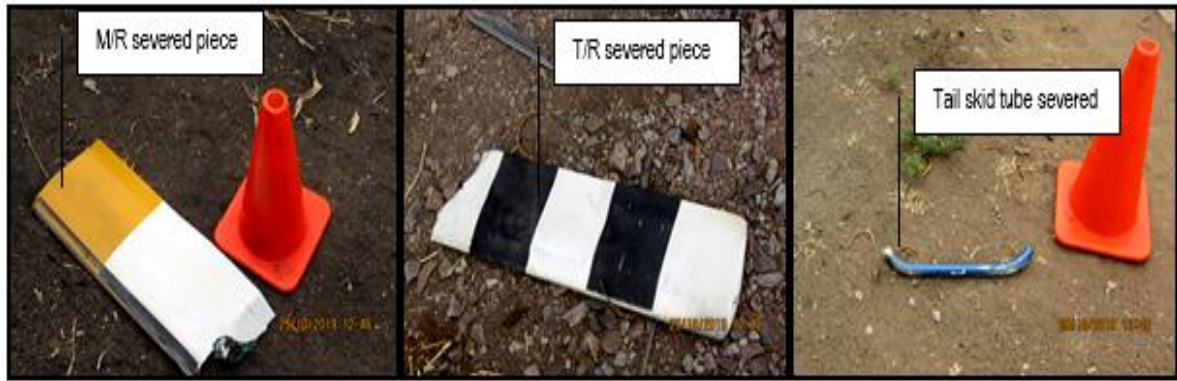
Figure 10: The main rotor blade outer piece and the tail rotor blade.

- 1.12.5 A piece of one of the main rotor blades' outer piece, one of the tail-rotor blades and the tail skid were found around the damaged streetlight pole. Damage on both rotor blades pieces is consistent with the damage caused when the helicopter engine was running at high-power settings.

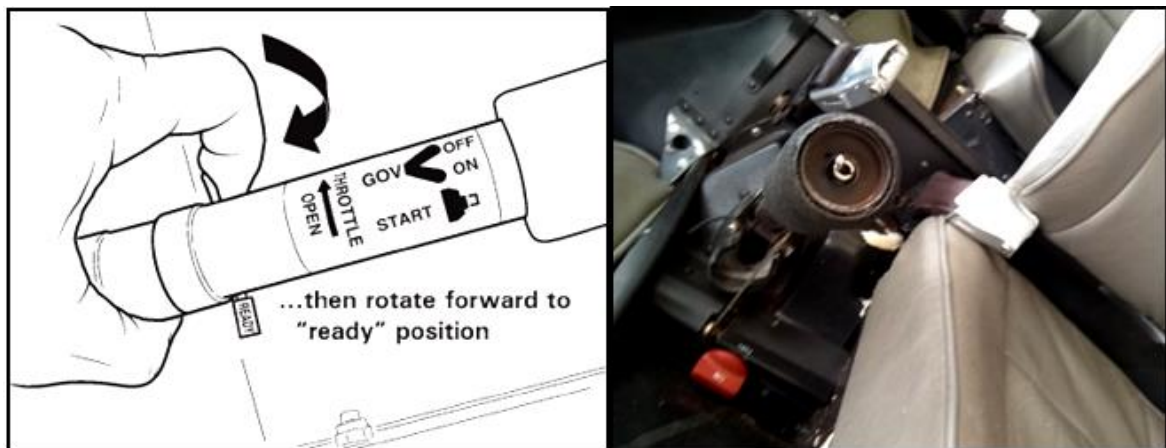
Figure 11: The governor switch in ON position.

- 1.12.6 Hydraulic fluid spillage was observed near the main helicopter wreckage. The main rotor connecting links were damaged. Both blades were severely damaged. Upon arrival of the airport fire and rescue services, a fire extinguishing foam was poured over the area where there was spillage to prevent any possibilities of fuel ignition. The fuel tanks, which are bladder type, did not rupture during the accident sequence. There was still enough fuel on-board in both fuel tanks. The RPM governor switch was on an "ON" position after the accident.

- 2.2.8 The RPM governor switch was found in "ON" position. The governor is designed to assist in controlling RPM under normal conditions. It may not prevent over or under speed conditions generated by aggressive flight manoeuvres (pull-ups and lowering of collective) during the climb and turn.
