AIRCRAFT ACCIDENT REPORT AND EXECUTIVE SUMMARY

Reference:	CA18/2/3/9834	
Aircraft Registration	ZS-EXI	Date of Accident	11 November 2019		Time of Accident	0500Z	
Type of Aircraft	Piper PA 28-140		Type of Operation	Training (Part 141)			
Flight Instructor Licence Type	Commercial Pilot Licence		Age	32	Licence Valid	Yes	
Flight Instructor Flying Experience	Total Flying Hours		351.4		Hours on Type	52.6	
Last Point of Departure	Springs Aerodrome (FASI), Gauteng Province						
Next Point of Intended Landing	Springs Aerodrome (FASI), Gauteng Province						
Location of the accident site with reference to easily defined geographical points (GPS readings if possible)							
Olympia Road, Springs (GPS co-ordinates: 26°15'21.33" South 028°23'43.26" East) at elevation of 5377 ft AMSL							
Meteorological Information	Wind: 040° at 09kt, Temperature: 24°C, Dew Point: 11°C, Clouds: Few at 4000ft, Visibility: 9999m, QNH: 1020hPa						
Number of People on Board	2+0	No. of People Injured	2	No. of People Killed	0

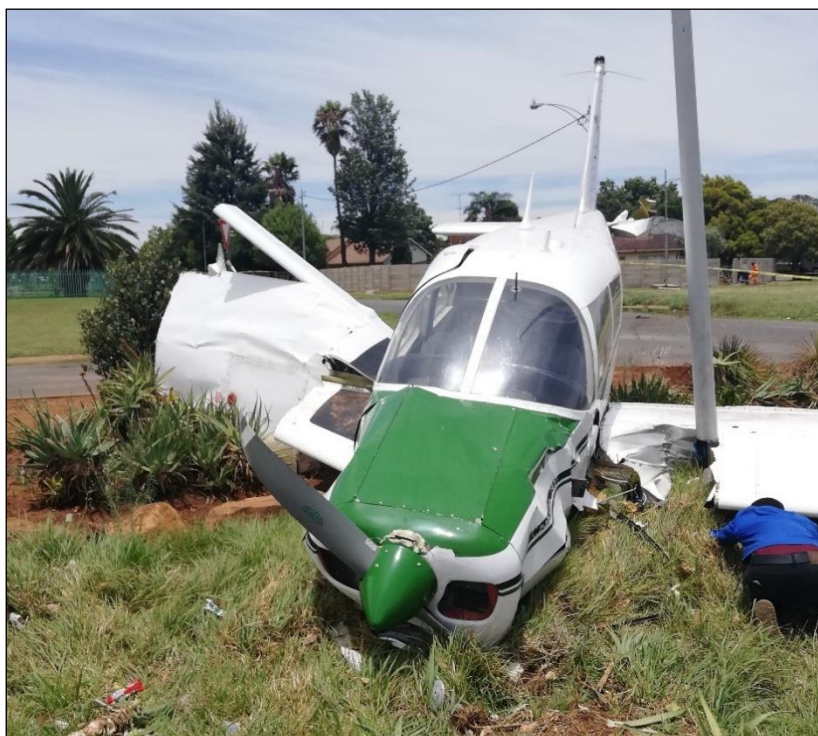
1.3.1. The aircraft was substantially damaged.

Figure 2: Aircraft damage following the accident sequence.

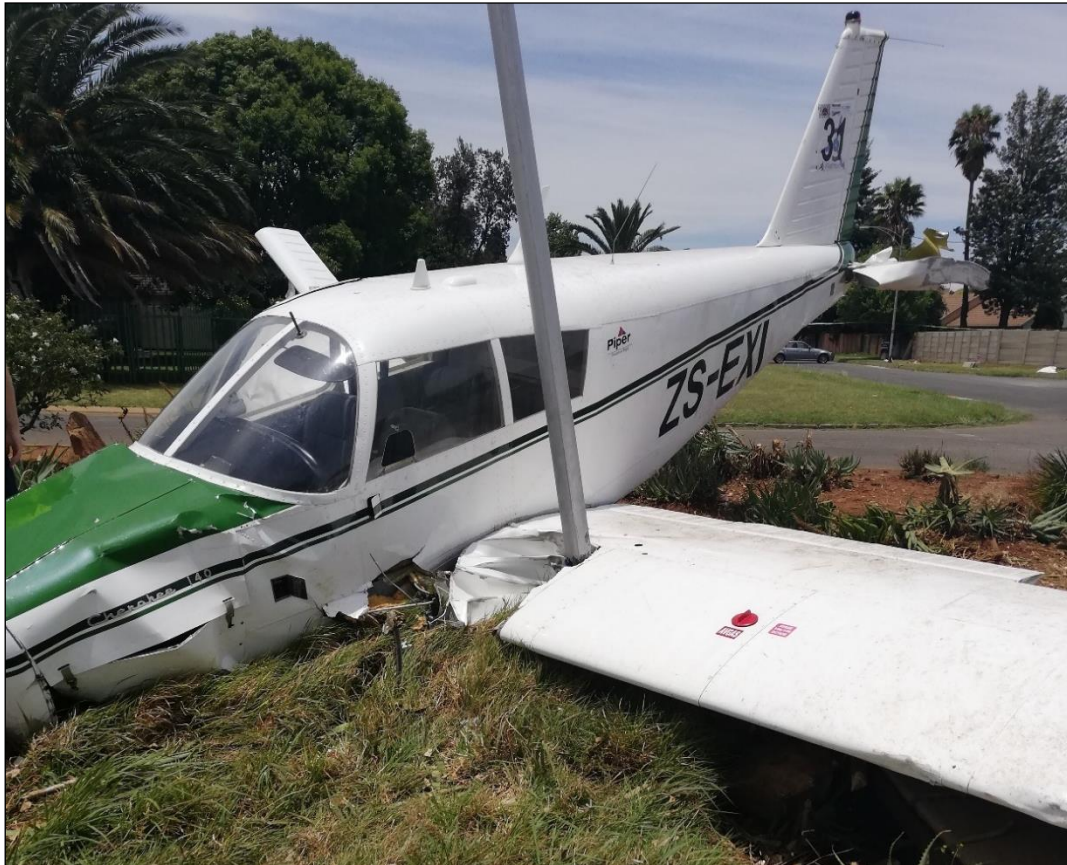
1.12.2. The aircraft first collided with a lamp pole with its left-side elevator and skidded for about 70m on the road before striking the second lamp pole where it came to a halt on a grass patch with a nose-down attitude pitch angle of about 10°. Metallic strike marks showed that the aircraft struck the first lamp pole in a slightly left-wing low and nose-low attitude on a northerly heading.

Figure 3: Overall damage to the aircraft.

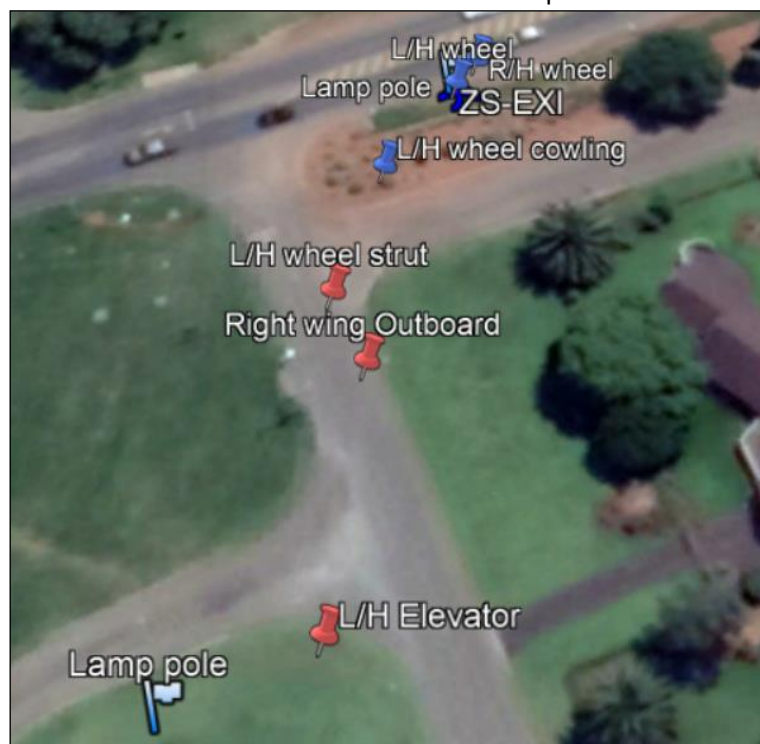
1.12.3. All the major components were found within the wreckage trail, and all damage occurred during the accident sequence. There were skid tracks on the asphalt found along the flight direction of the aircraft after first impact. The aircraft first impacted a 50ft high lamp pole with its left-side elevator. The right-side elevator had remained intact and was found in the down position.

Figure 4: Location of components found at the accident site.

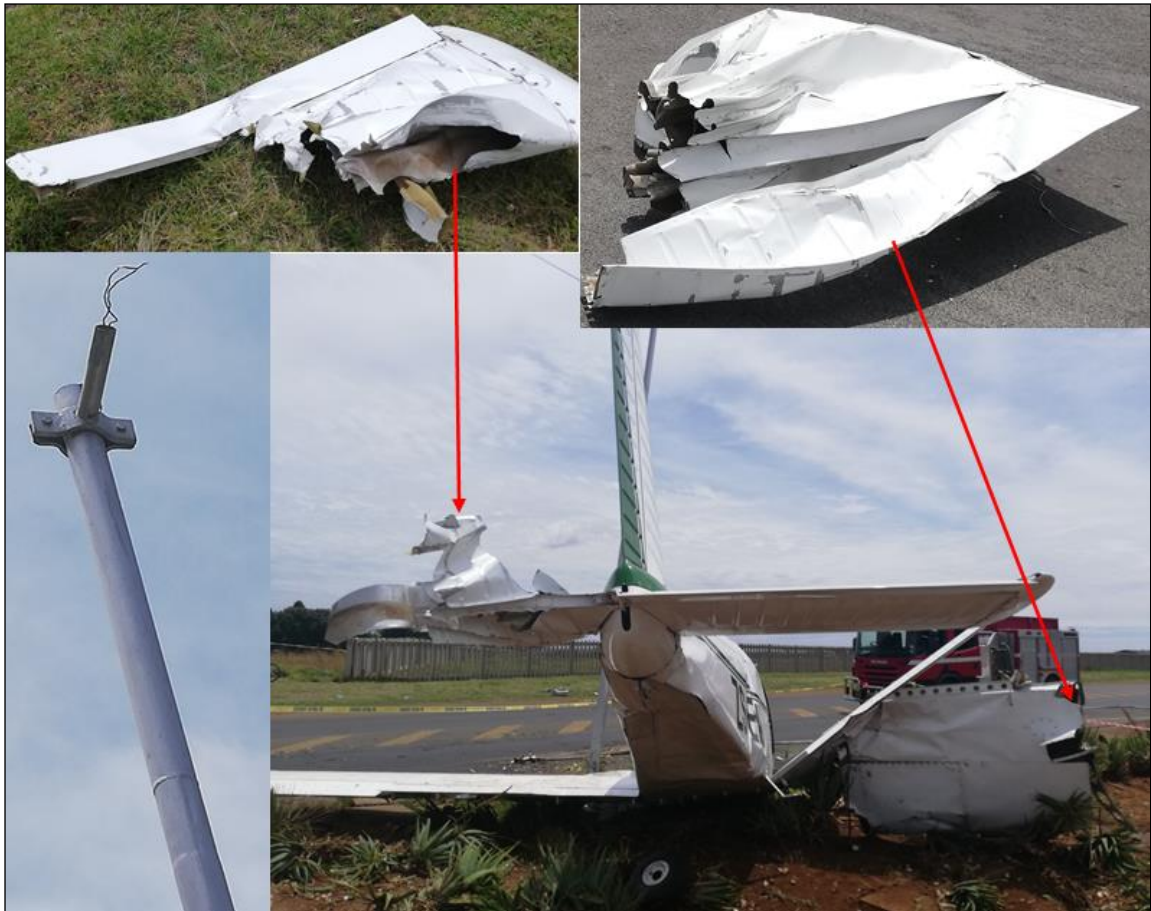
1.12.4. The outboard half of the right-side wing had detached from the fuselage during the accident sequence, and the remaining part of the right-side wing had partially separated from the fuselage due to impact forces.

1.12.5. The fixed type tricycle landing gear system was destroyed, and all three assemblies had broken off from the fuselage.

Figure 5: The first lamp pole the aircraft collided with (bottom left), debris of the left-side elevator (top left), debris of the outboard right-side wing (top right), and the aircraft wreckage (bottom right).

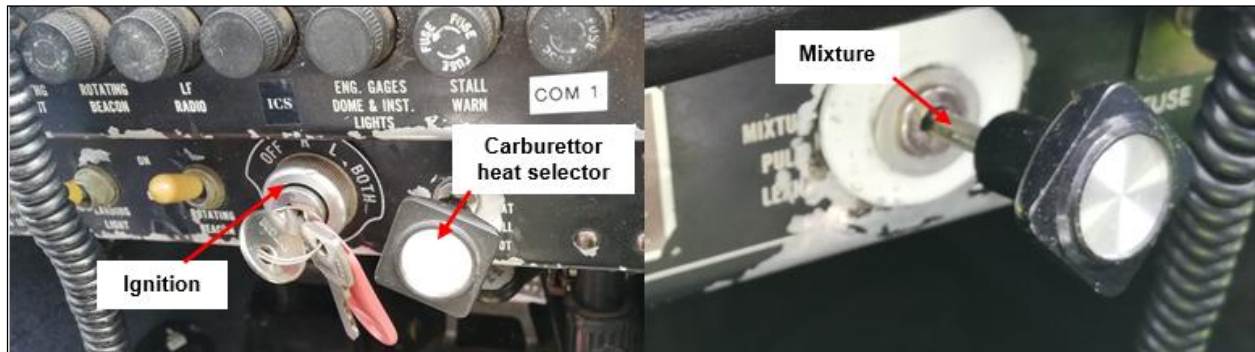
- 1.12.10. The carburettor heat selector was found in the "on" position; the fuel mixture was full rich (1 inch out) and the fuel pump was in the "on" position.

- 1.12.11. The battery master and ignition switches were "off". These were switched off by one of the eyewitnesses who had arrived at the accident site before emergency services.

Figure 6: Images showing positions of the ignition and carburettor heat selector (left), and mixture selector (right).

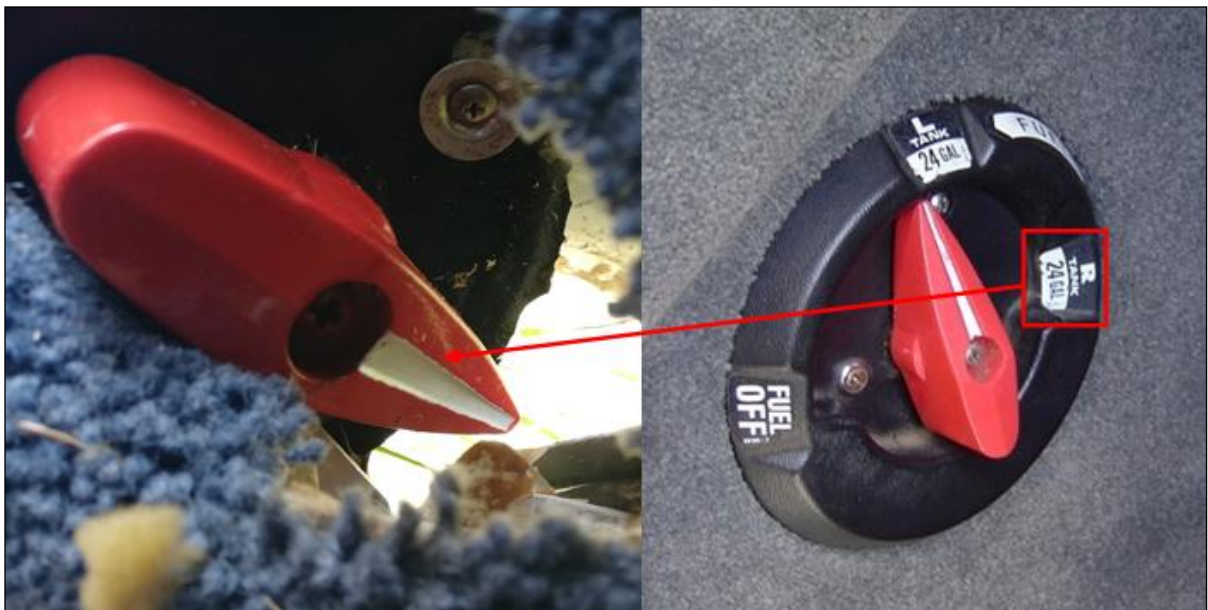
1.12.12. The fuel selector valve was found dislodged; however, it was determined that the selector was set to the right tank. The amount of fuel remaining in the right-side fuel tank could not be determined as the tank was destroyed by impact forces.

Figure 7: The accident aircraft's damaged/dislodged fuel selector valve (left); and an image of a similar aircraft's fuel selector valve (right). (Source: <https://aviation.stackexchange.com/>)

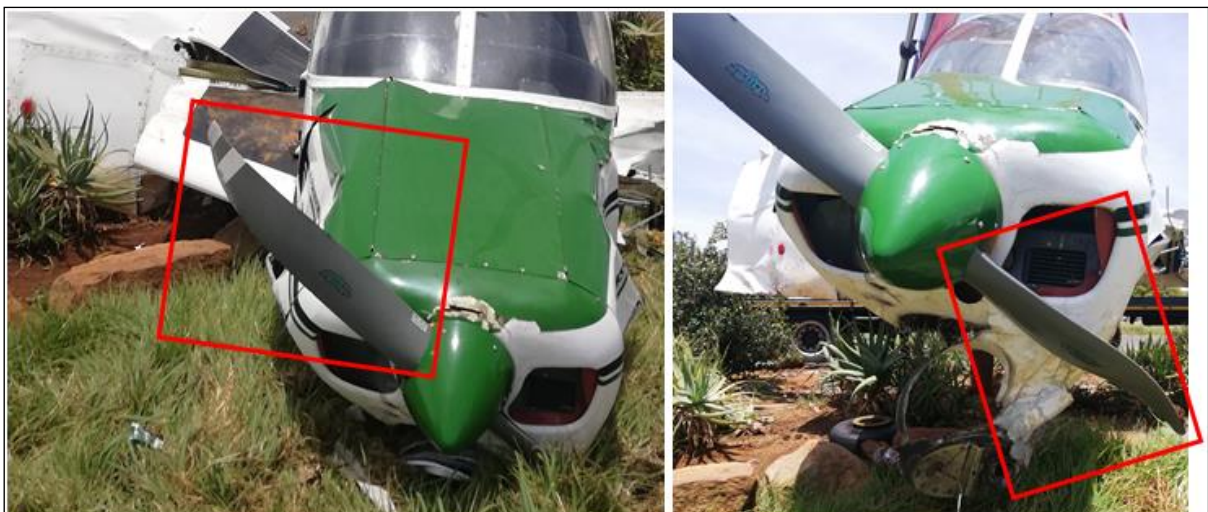
1.12.13. Damage observed on the propeller blades indicated that the engine was producing little or no power upon impact, this was consistent with the requirements of carrying out a glide approach landing. One of the propeller blades was bent slightly backwards while the other was slightly bent forward; both had minor scars on the leading edges. One of the blades that was found squeezed between the ground and the engine was more bent than the other (see Figure 8).

Figure 8: (Left) Propeller blade bent backwards. (Right) Propeller blade bent forwards.

3.2.3.4. The damage to the propeller indicated that the engine delivered low power or was shut off.
