| <b>AIRCRAFT ACCIDENT REPORT AND EXECUTIVE SUMMARY</b> |

| | | Reference: | | CA18/2/3/9835 | |
| <b>Aircraft Registration</b> | ZS-NEE | <b>Date of Accident</b> | 15 November 2019 | <b>Time of Accident</b> | 0956Z |
| <b>Type of Aircraft</b> | Jabiru J430 | | <b>Type of Operation</b> | Training (Part 141) | |

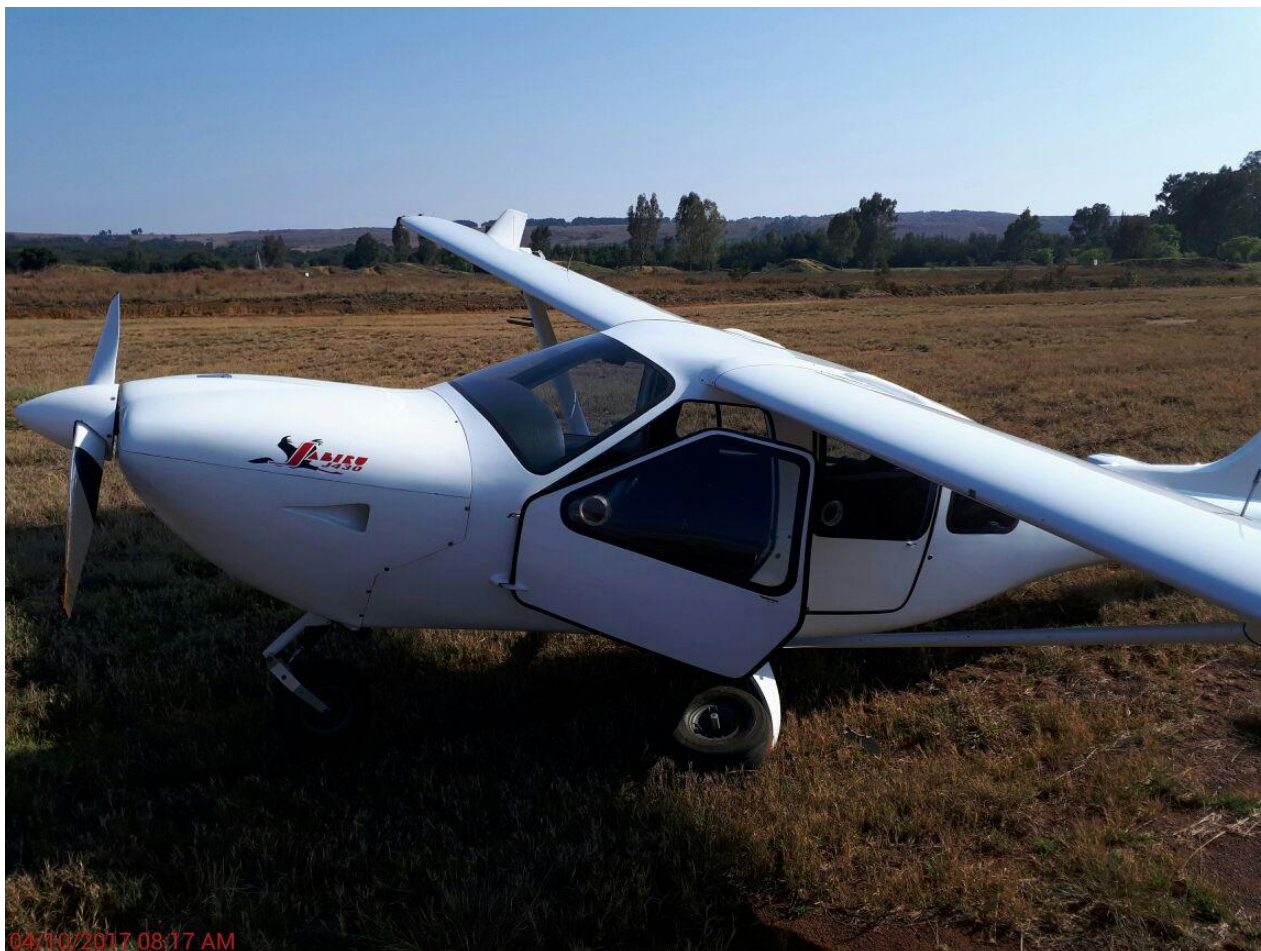
- 1.1.4 The two occupants disembarked the aircraft un-assisted and without injuries. The aircraft had substantial damage to the propeller, left main landing gear and left wing.

1.3.1 The aircraft had substantial damage to the left main landing gear, propeller and left wing.

Figure 2: Damage to the aircraft after the accident. (Source: Pilot)

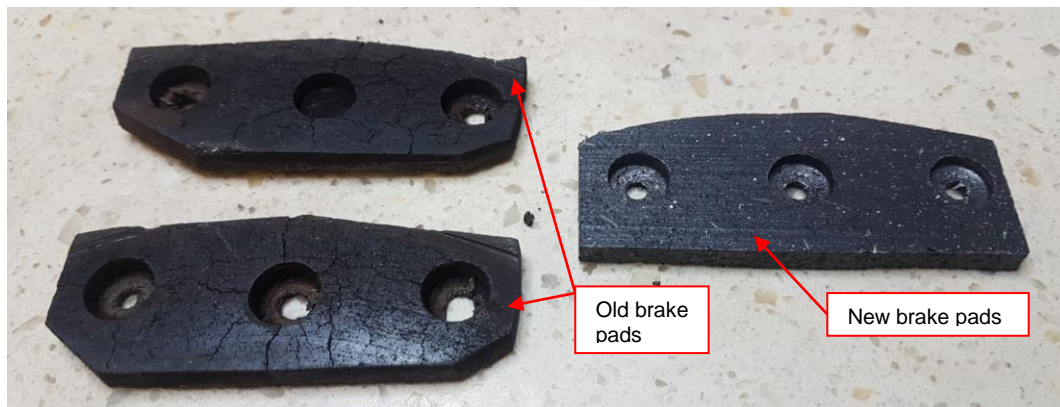
1.16.1 An Authorised Person (AP) replaced the aircraft's brake pads after the accident. The old (removed) brake pads were compared to the new brake pads. The removed brake pads were still functional.

Figure 3: Two brake pads removed from the aircraft after the accident (left) and a new brake pad (right). (Source: Approved Person)

- 2.2.9 The AP found the brakes damaged, but not out of limits; and he changed them. There was no evidence that the brakes failed, however, after analysing the instructor pilot's actions (zig zag manoeuvre), the conclusion was that it was likely that the aircraft approached the aerodrome at a

high speed, resulting in a deep landing on the runway at a fairly high speed and it (aircraft) overshot the runway.
