AIRCRAFT INCIDENT SHORT REPORT

CA18/2/3/9836: During landing, the aircraft experienced wind shear, landed hard on Runway 27 and veered off to the left of it (Runway 27).

Date and time	: 19 November 2019, 0830Z
Aircraft registration	: ZU-FAT
Aircraft manufacturer and model	: Shadow Lite CC Jabiru J160
Last point of departure	: Rhino Park Airfield, Gauteng Province
Next point of intended landing	: Rhino Park Airfield, Gauteng Province
Location of incident site with reference to easily defined geographical points (GPS)	: 26°16'6,34" South 030°17'52,20" East, elevation 5 600 feet
Meteorological information	: Wind: 310°/8kt, Temperature: 28°C, Visibility: 10km
Type of operation	: Private (Part 94)
Persons on board	: 1 + 0
Injuries	: None
Damage to aircraft	: Substantial

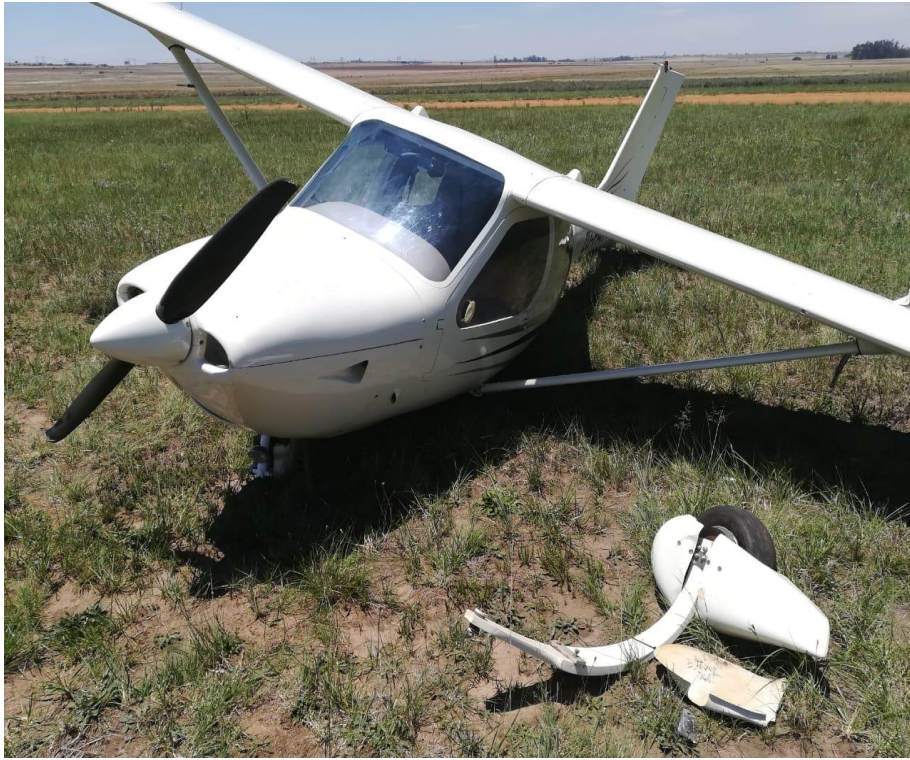
2.1.4 The aircraft sustained damages to the nose landing gear, the left main landing gear, the propeller tips and the left wingtip. There were no injuries reported.

Figure 2: The damaged aircraft.

3.4 The aircraft sustained damage to the nose gear, left main gear, left wingtip and propeller during the impact sequence.

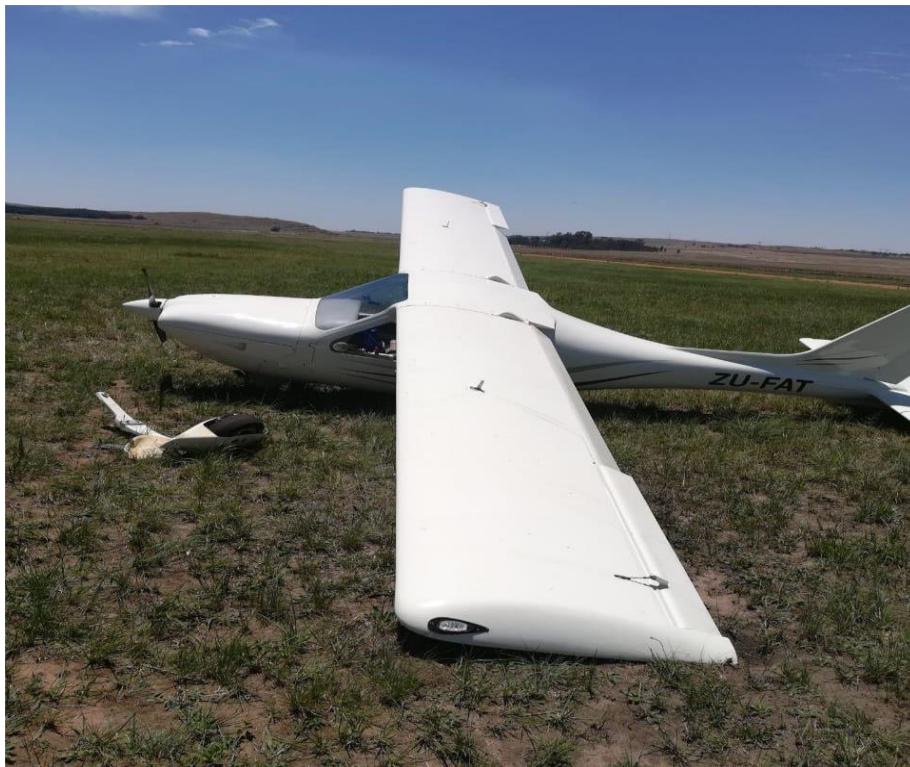
2.1.3 During the hard landing, the left main wheel broke off from the aircraft, resulting in the aircraft veering off to the left of Runway 27 before coming to a stop after impacting a perimeter fence 50 metres from the runway. The runway length of the airfield is 800 metres. The pilot reported that the aircraft touched down on the runway 20 metres from the beginning of the threshold, and that the aircraft was serviceable.

Figure 3: The aircraft as it came to rest.

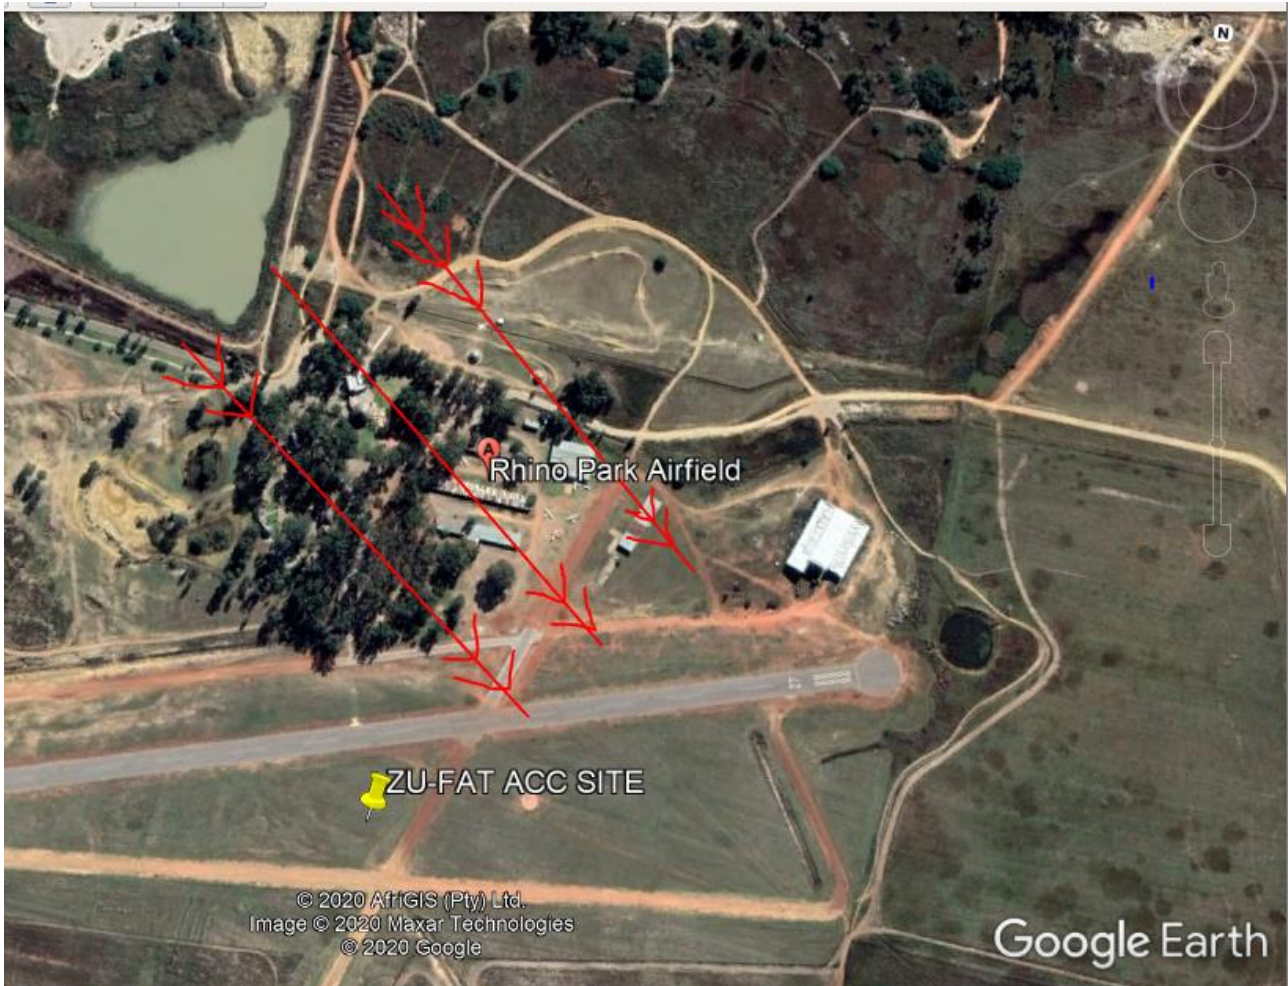
2.1.6 Rhino Park Airfield is unlicensed. A section of it has trees, and hangars are located to the right of threshold of Runway 27 (Figure 4).

Figure 4: The red lines indicate the direction of the prevailing wind which could be affected by the huge trees and hangars.

3.8 The aircraft was stable on approach for Runway 27 with the wind direction reported to be 310 at 8kts. As the aircraft was getting ready to flare, there was a change in wind speed conditions due to the trees and hangars that were affecting the wind flow from the right, resulting in the aircraft losing the airflow over the wings and the aircraft landing hard 20 metres from the threshold before veering off the runway.
