HELICOPTER ACCIDENT REPORT AND EXECUTIVE SUMMARY

Reference:		CA18/2/3/9839	
Helicopter Registration	ZT-RDR	Date of Accident	28 November 2019		Time of Accident	0852Z	
Type of Helicopter	Bell 505		Type of Operation		Private (Part 91)		
Pilot-in-command Licence Type	Private Pilot Licence		Age	61	Licence Valid	Yes	
Pilot-in-command Flying Experience	Total Flying Hours		2 260.0		Hours on Type	21.7	
Last Point of Departure		Kimberley Aerodrome (FAKM), Northern Cape Province					
Next Point of Intended Landing		Kimberley Aerodrome (FAKM), Northern Cape Province					
Damage to Helicopter		Substantial					
Location of the accident site with reference to easily defined geographical points (GPS readings if possible)							
Outside a military base in Kimberley (GPS position: 28°38'59.11" South 024°34'39.56" East) at an elevation of 3 888 feet							
Meteorological Information		Surface wind: 260°/5kts; temperature: 36°C; Visibility: CAVOK					
Number of People On-board	1 + 3	Number of People Injured	1 + 3	Number of People Killed	0	Other (On Ground)	0

Reference Number : CA18/2/3/9839
Name of Owner : Diaruk (Pty) Ltd
Name of Operator : Kimfly Charters
Manufacturer : Bell Textron
Model : 505
Nat

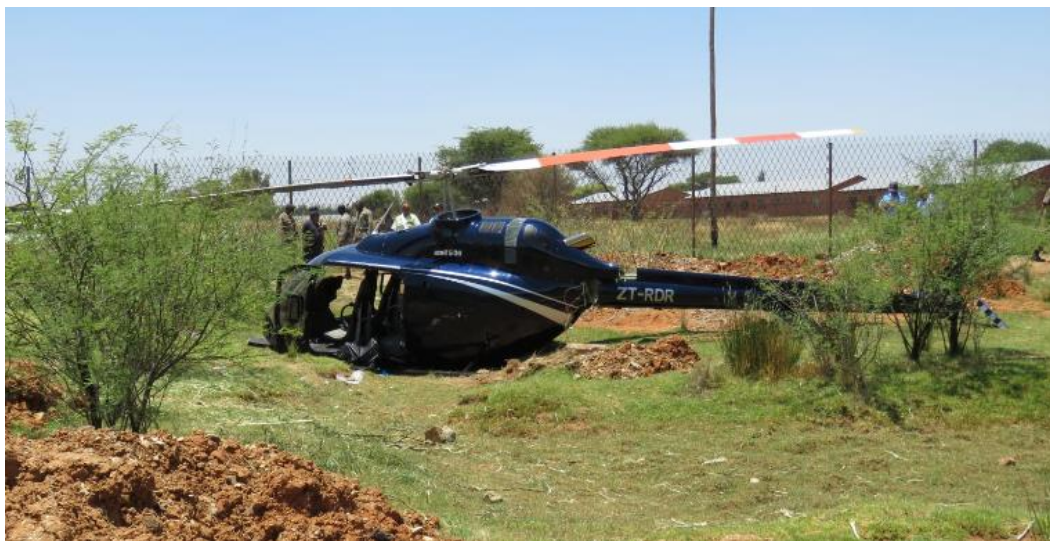
1.3.1 The helicopter sustained substantial damage during the accident sequence.

Figure 2: The helicopter as it came to rest.

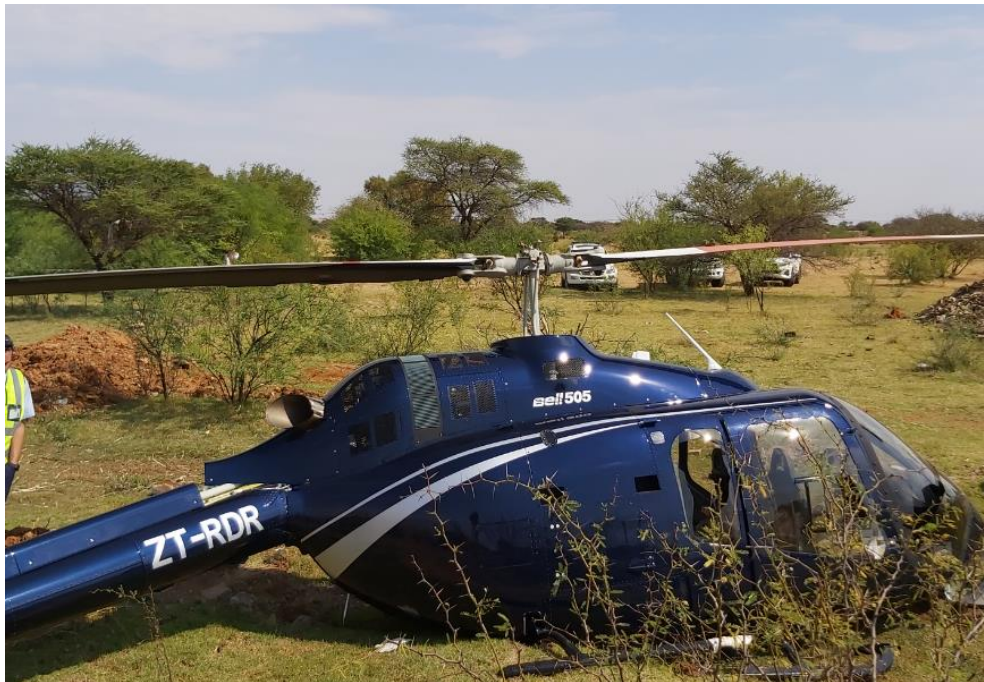
1.12.1 The helicopter was found in an upright position (on its belly) with the nose facing north north-east.

Figure 6: The helicopter post-accident.

Both skids of the helicopter were found bent outwards, indicative of high vertical energy impact (Figure 6). The right skid gear broke off in the middle as a result of overload, but it was found still attached to the helicopter. The initial impact of the skids was observed on the uneven ground surface. Ground scar marks showed that the helicopter bounced and made an anti-clockwise (left) turn before it came to rest. The marks and soil (dirt) on the front right-side of the nose cone indicated that the fuselage had a slight right bank in a nose-down attitude before it came into contact with the ground (Figure 9).

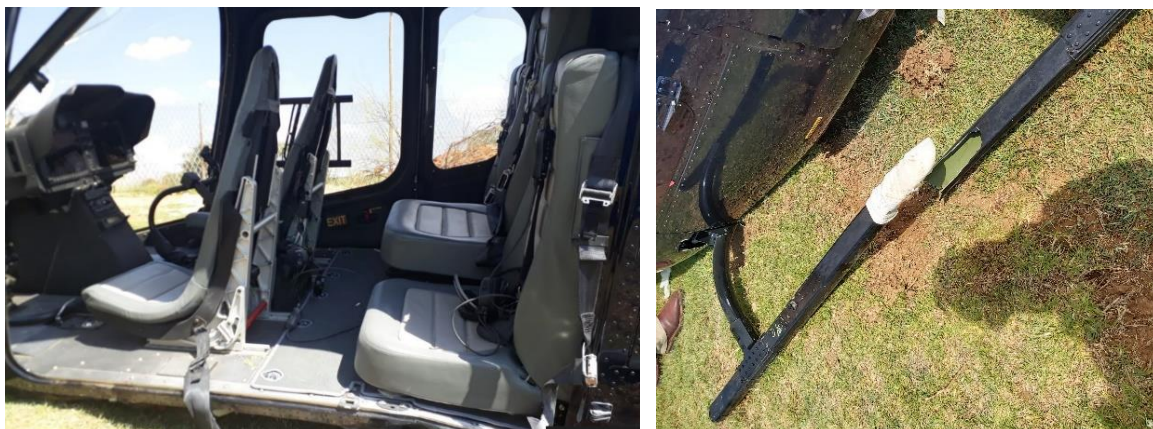
1.12.3 The impact damage observed indicated that the helicopter was yawing on impact. The passengers' seats had collapsed, except for the pilot's seat which collapsed only on one side (right-hand side) (Figure 7). The pilot was seated on the right-side seat.

Figures 7 and 8: The collapsed seats (left image), and the left and right skid gear (right image).

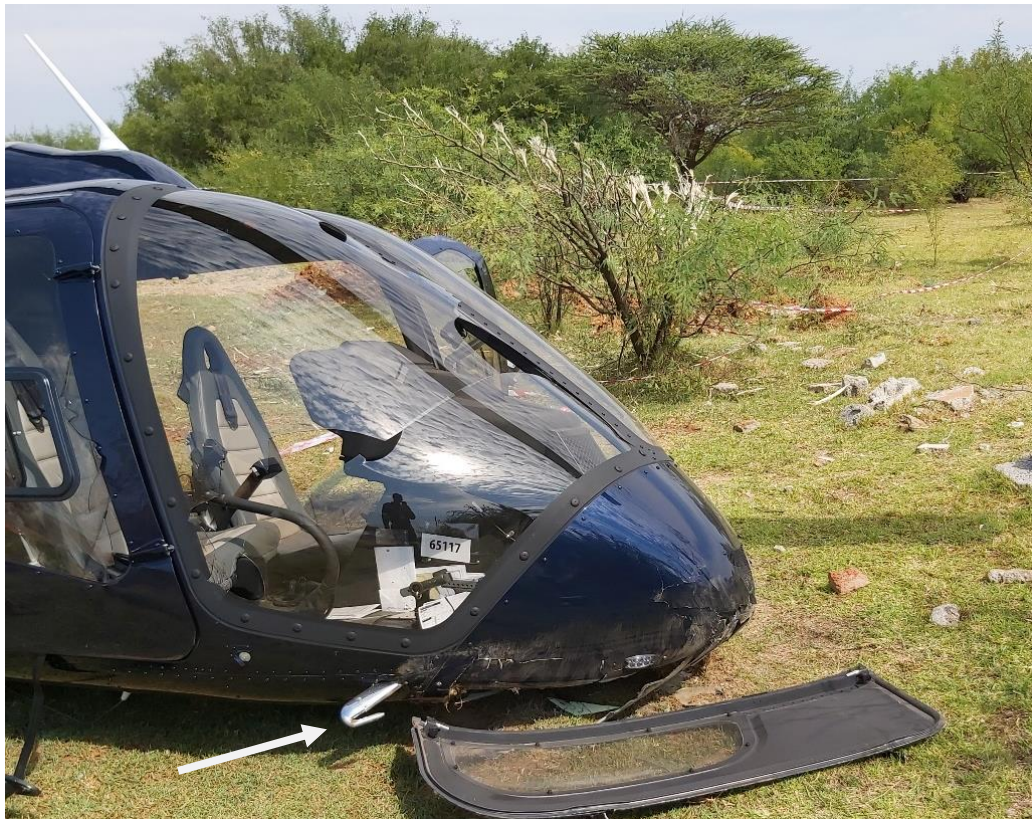
Figure 9: Bent pitot tube, dirt and marks on right-side of the nose section.

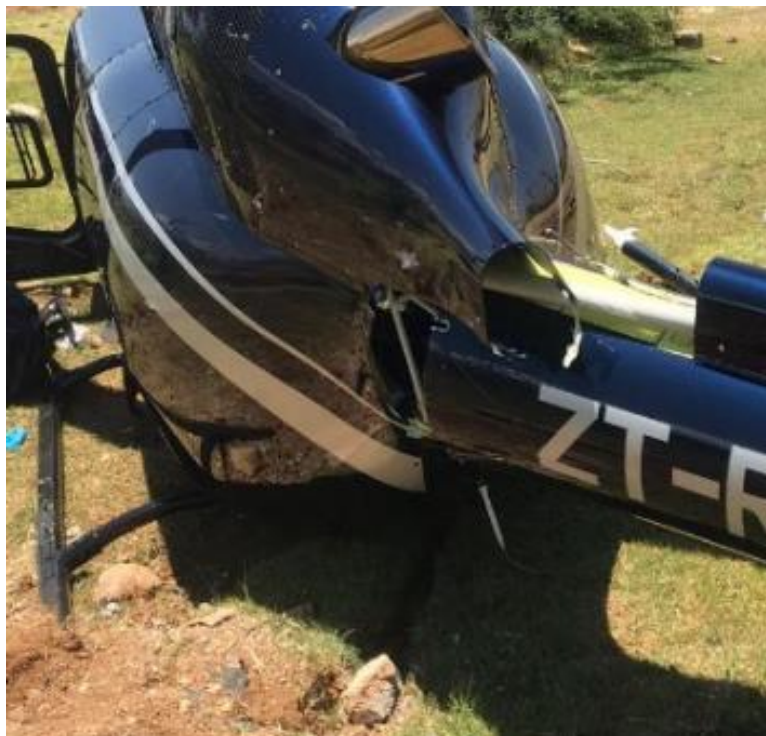
The tail boom was observed to have tilted slightly to the right due to overload; but it did not detach completely. The skin where the tail boom attaches had sheared off from its rivets due to overload and, as a result, the middle tail drive shaft disconnected from the front shaft. The tail rotor vertical fin was found buckled at the bottom, indicative of contact with the ground; it was also twisted slightly to the left, indicating a lateral motion on impact. The tail rotor guard and the horizontal stabiliser were still attached and intact and appeared undamaged.

Figure 10: An opening between the fuselage and tail boom shows a detached tail boom.

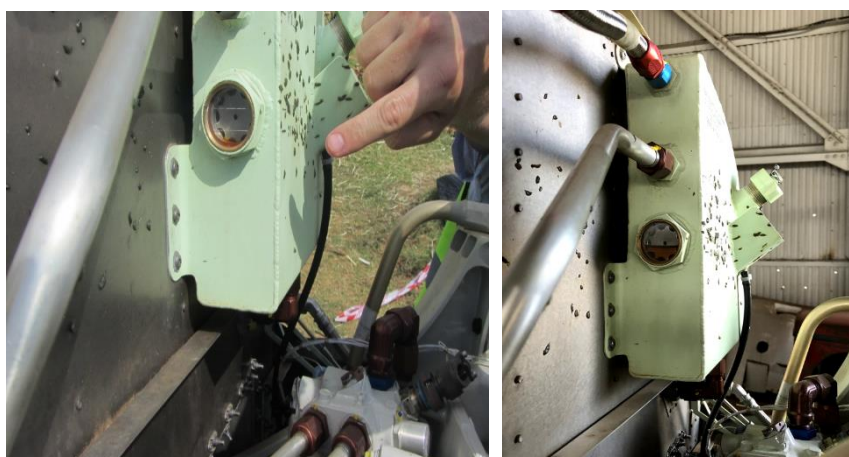
The engine was still attached on its mountings. The oil level indication was showing zero. The engine was cranked by the aircraft maintenance engineer (AME) in the cockpit at the accident site and there was freedom of movement and no abnormal noise was heard. The oil level indicated full after cranking. The engine driveshaft was rotating freely when rotated by hand and the sprag clutch freewheel was engaging and disengaging, showing signs of no abnormality.

Figures 11 and 12: Oil level before the engine crank (left) and oil level after the engine crank (right).

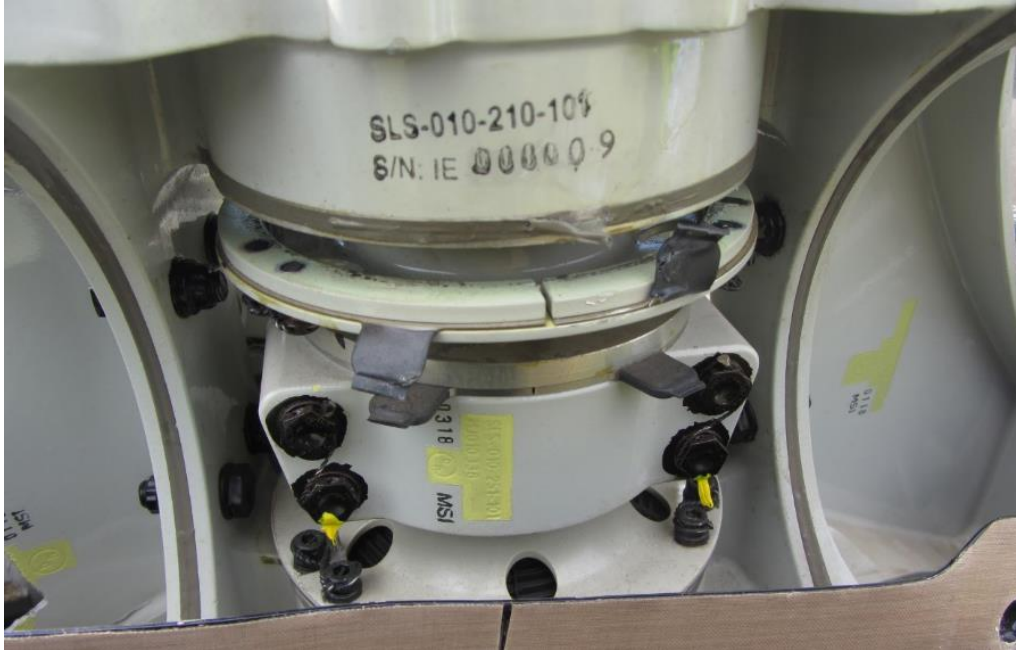
1.12.6 The main transmission was still intact although the left attaching mounting (SN: 000009) was observed to have failed/collapsed as a result of impact. The mast and the swashplate were intact. The left control tube was severed near the point where it attaches to the non-rotating star. There was no visible sign of hydraulic leaks that were observed in the transmission deck, servo actuators or pipes. The three actuators were still attached to their mounting points. The level of the fluid indicated $\frac{3}{4}$ full (Figure 14).

Figure 13: Damaged transmission mounting.

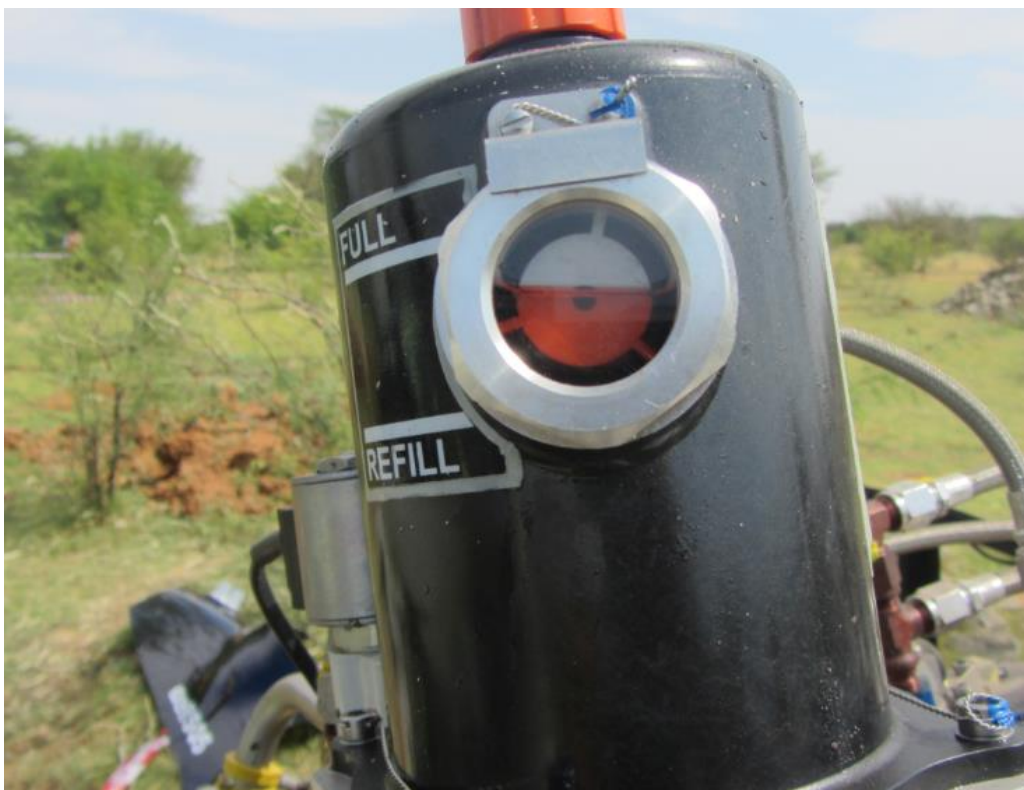
Figure 14: Hydraulic fluid level in the resevoir.

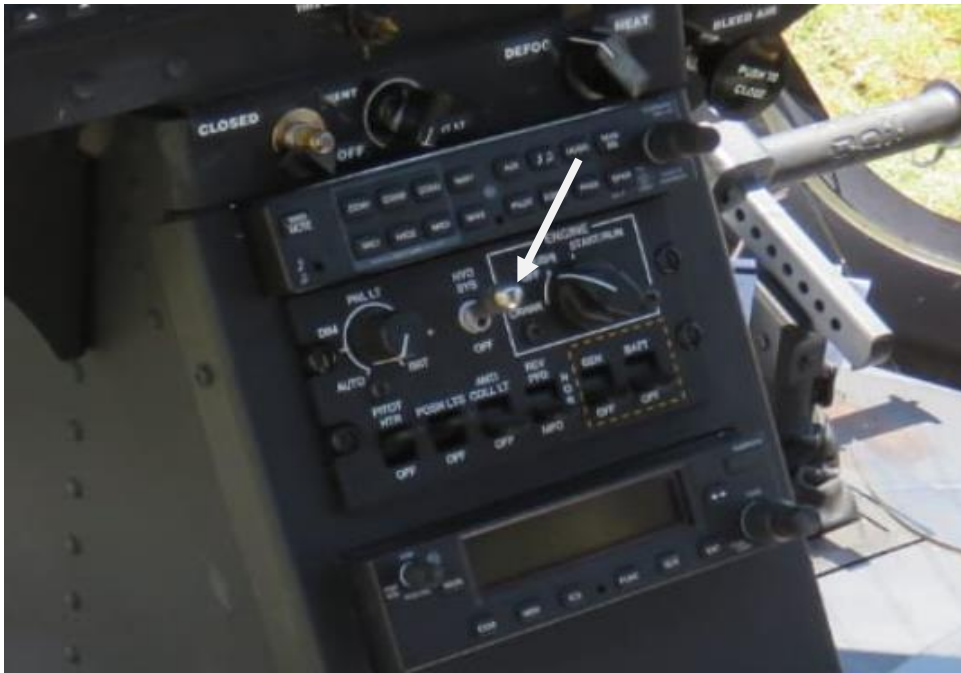
Figure15: Hydraulic switch position as found on the instrument panel.

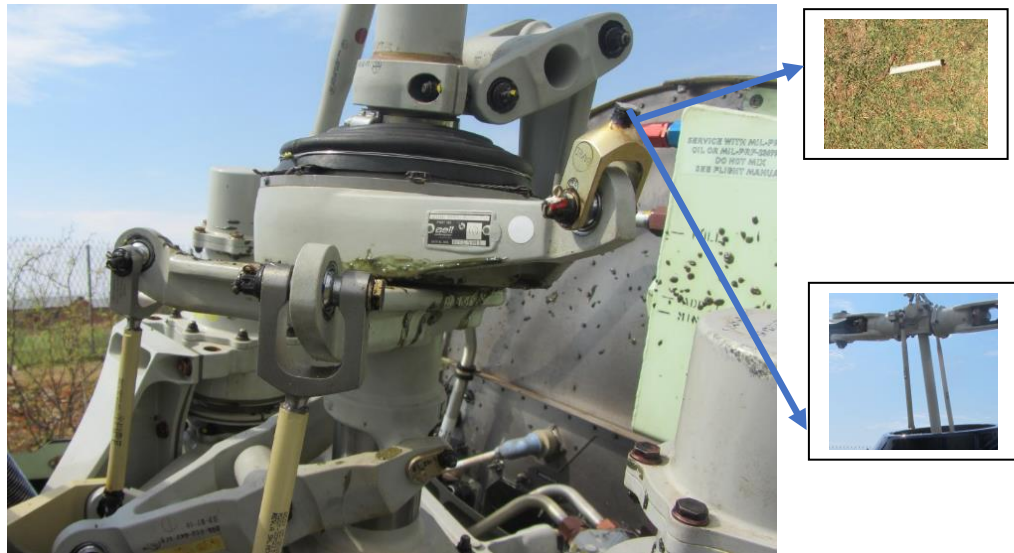
- 1.12.8 Flight controls continuity checks were performed on the anti-torque pedals, cyclic stick and collective stick by moving the controls. The anti-torque left and right pedal movement was transmitted to the pitch change of the tail rotor blades through steel cable, which were still intact. Cyclic and collective movement was transmitted through control tubes and linkages, although movement was limited as a result of hydraulic jam/lock on the servo actuators and a disturbed pitch change control tube that was severed by the transmission cowling, as well as a jam on the bellcranks. The piece of the severed pitch control tube was found lying on the ground (right-side) next to the helicopter. The throttle position switch on the collective stick was found in flying mode position and with the pilot collective fully raised or applied. The helicopter was fitted with dual controls except for the collective for the co-pilot, which had been blanked off. The co-pilot cyclic was found lying on the floor between the anti-torque pedals. According to available information, the co-pilot cyclic was removed post-accident to facilitate medical help and recovery for the occupant who was seated on the left front seat.

Figure 16: Damaged clevis bolt of bottom pitch control tube.

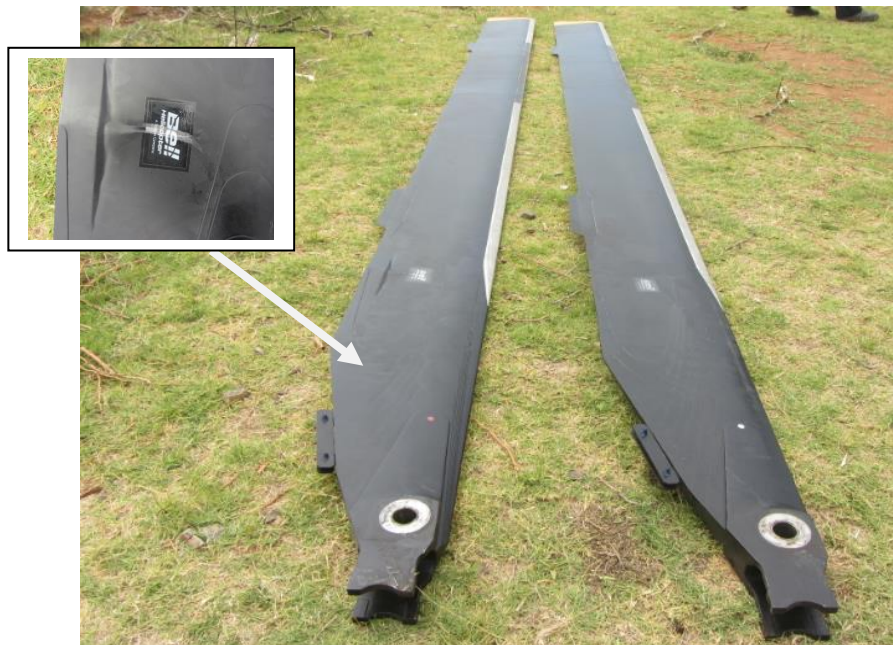
1.12.9 Both main rotor blades were still attached to the main rotor head. The main rotor blades did not exhibit any significant damage. However, it was noted that there was a shrub that was severed by one of the main rotor blades. Both main rotors exhibited identical signs of compression load stress at the same place near the blade root lower skin. One of the blades had a fracture as a result of the compression stress.

Figure 17: The main rotor blades after they had been recovered.

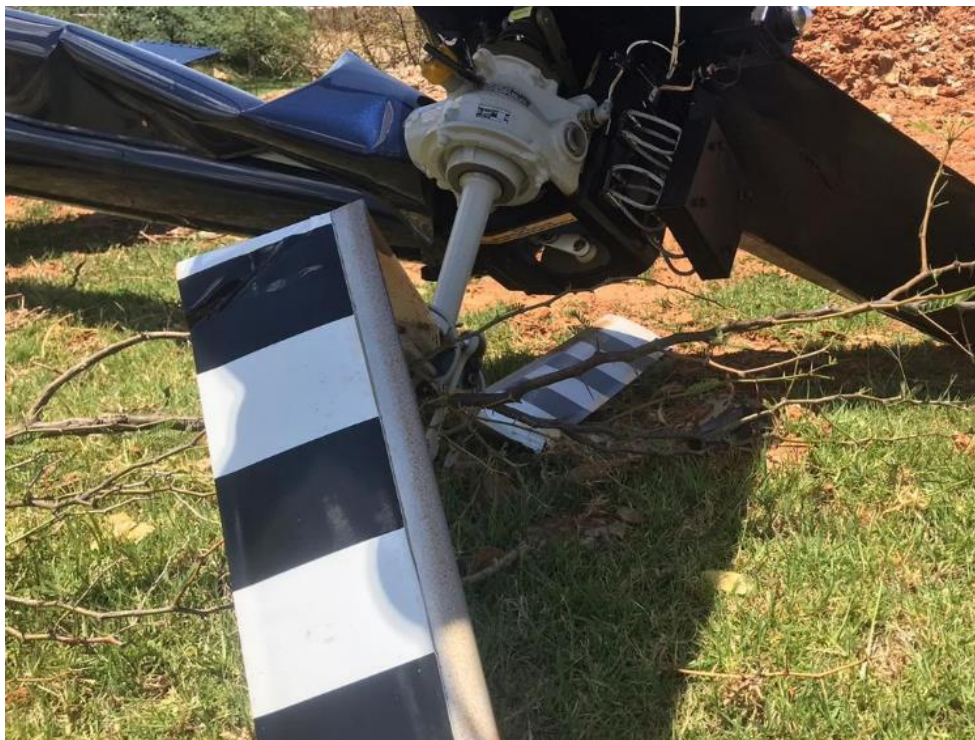
The tail rotor blades were still attached to the tail gearbox and both had 90° bends as a result of impact. The tail rotor pitch change links were found in good condition and still attached to the tail rotor (Figure 18). The oil sight glass had cracked, indicative that it was

shattered by the balance weight during impact. The electrical magnetic plug was removed and inspected for metal fillings/flakes, and none were found.

Figure 18: Damage sustained by the tail rotor blades.

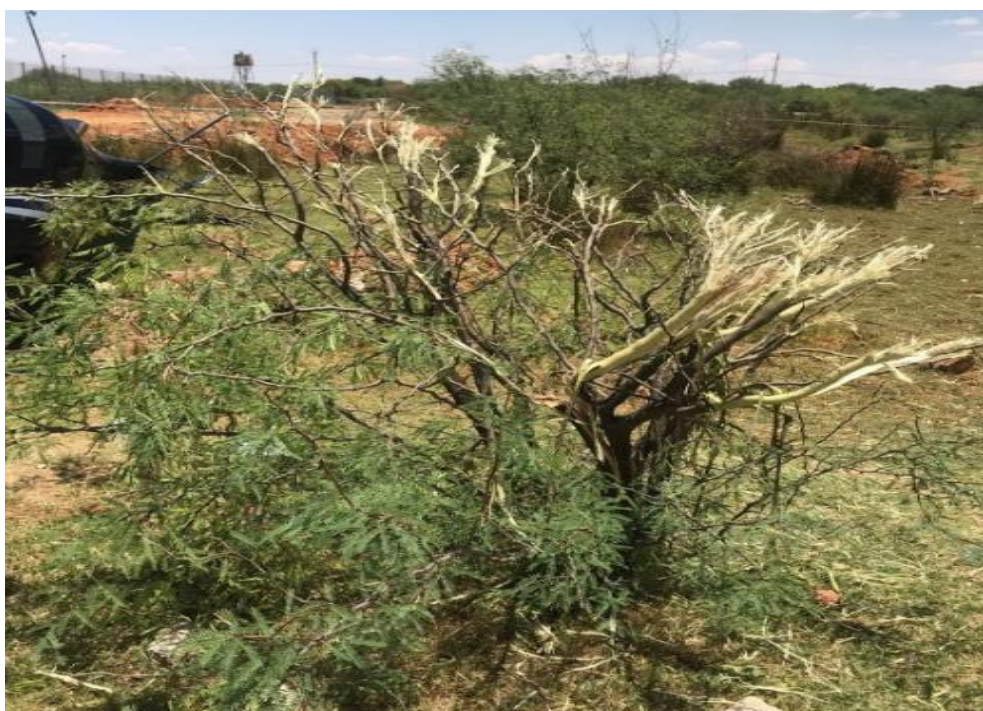
1.12.11 The shrub-tops that were severed by the main rotor blades indicated that the blades were turning at speed on impact.

Figure 19: A shrub that was severed by the main rotor blades.

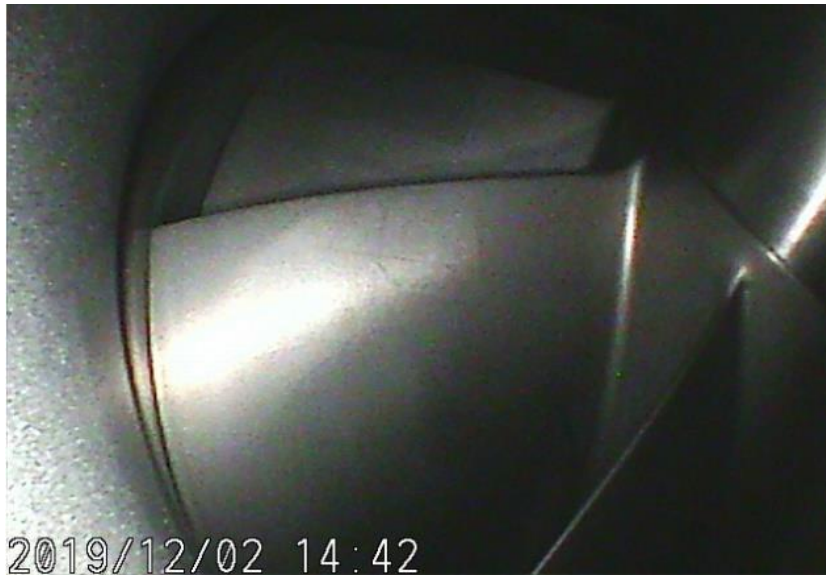
1.16.5 Following the accident, a thorough examination of the engine was conducted by the technical representative from the engine manufacturer in the presence of the AIID investigators. A borescope inspection was conducted on the hot and cold section of the engine. The inspection of the centrifugal compressor blades, gas generator turbine blades and power turbine blades did not reveal any signs of damage.

Figure 20: The centrifugal compressor blades.

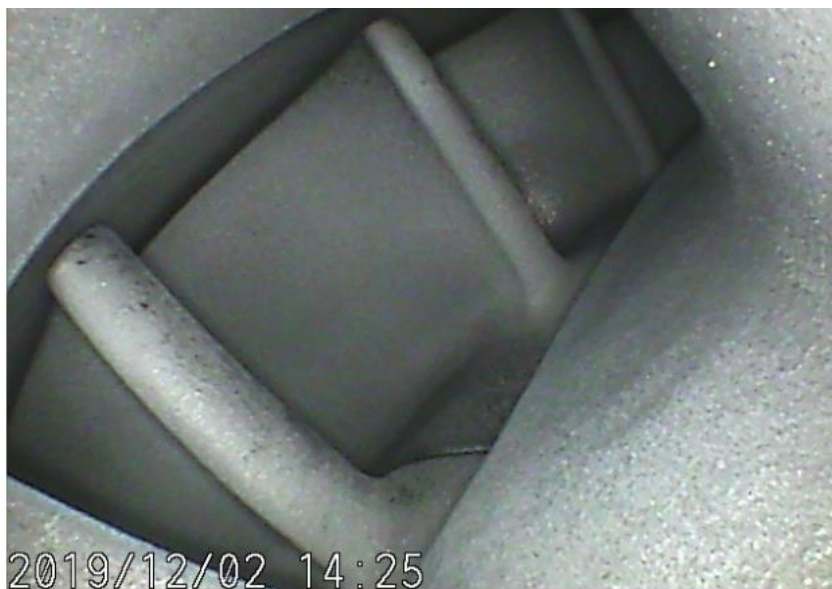
Figure 21: The gas generator turbine.

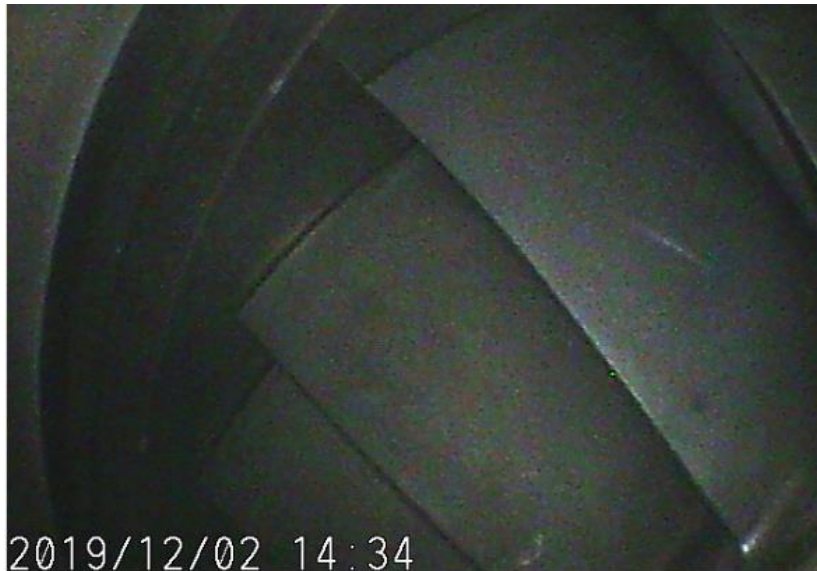
Figure 22: The power turbine blades.

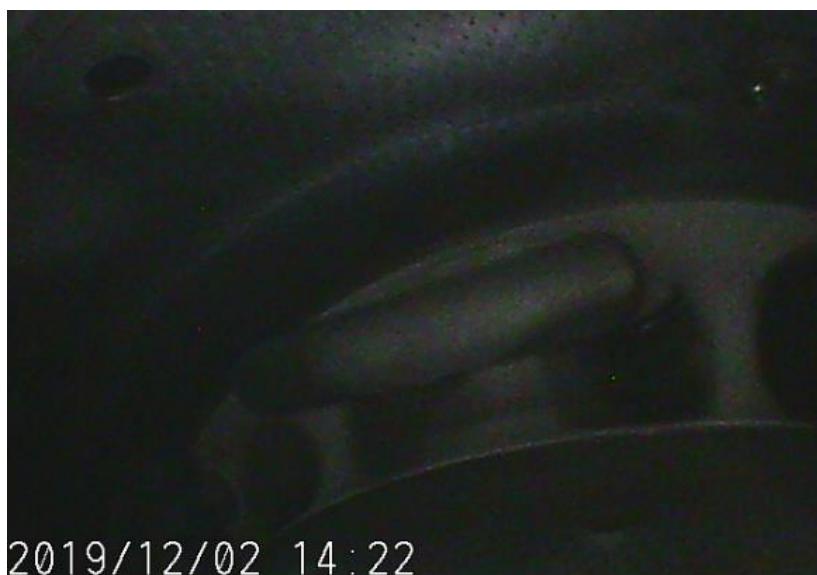
Figure 23: The flame tube.
