## 1. SYNOPSIS

- 1.1 On 29 November 2019, the pilot on-board a Sportsman GS-2 aircraft with registration marks ZU-JVN took off on a private flight from Driemskraal Aerodrome in the Western Cape province with the intention to land at Porterville Aerodrome in the same province.

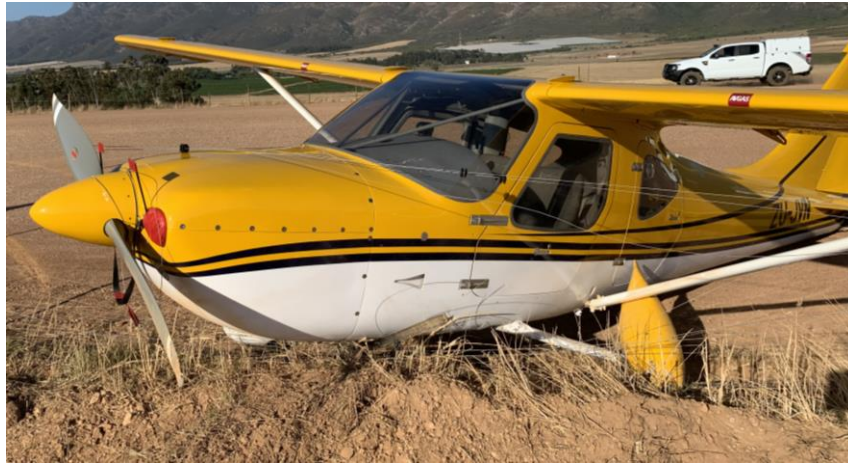
- 2.1.4 The aircraft sustained substantial damage to the left-hand main landing gear, left wing tip and the propeller. The pilot was not injured in the accident sequence.

**Figure 1:** The location where aircraft came to a stop. (Source: Pilot)

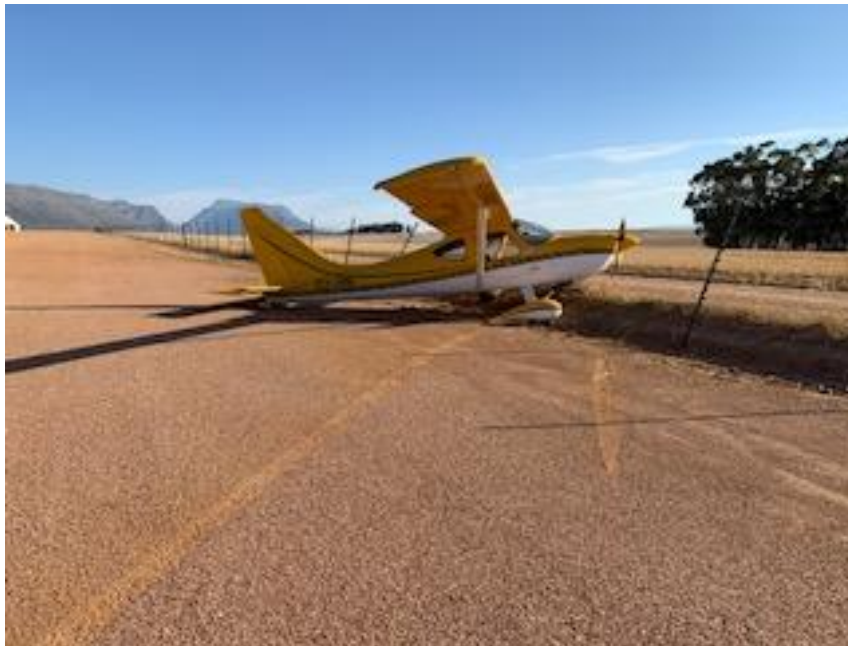
**Figure 2:** Starboard view and the ground scars leading to the perimeter fence.  
(Source: Pilot)

2.1.6 Upon examination of Figure 2, the aircraft probably landed close to the threshold, but the pilot most likely lost directional control, which resulted in the aircraft veering to the right-hand side of the runway with the left main landing gear in contact with the runway's surface, while the right main landing gear was airborne. The right main landing gear eventually touched down while the aircraft was still heading for the embankment on the right side of the runway. The right main landing gear then impacted the embankment as the aircraft was approaching (the embankment) at an angle. At this point, the tail landing gear had still not touched down as there were no visible marks on the runway's surface. This sequence of events then resulted in the aircraft pivoting on its vertical axis, making a ground loop.

3.3 Figure 2 indicates that the aircraft was probably rolling with the left main landing gear while the right main landing gear was airborne. The right-hand landing gear then made contact with the runway while the aircraft was still rolling towards the embankment on the right-hand side of the runway. There was no evidence of the tail wheel being in contact with the runway's surface as there were no visible marks on the runway. The aircraft was approaching the embankment at

an angle before it collided with it. The right main landing gear then impacted the embankment first, causing the aircraft to pivot on its vertical axis to the left of the runway.

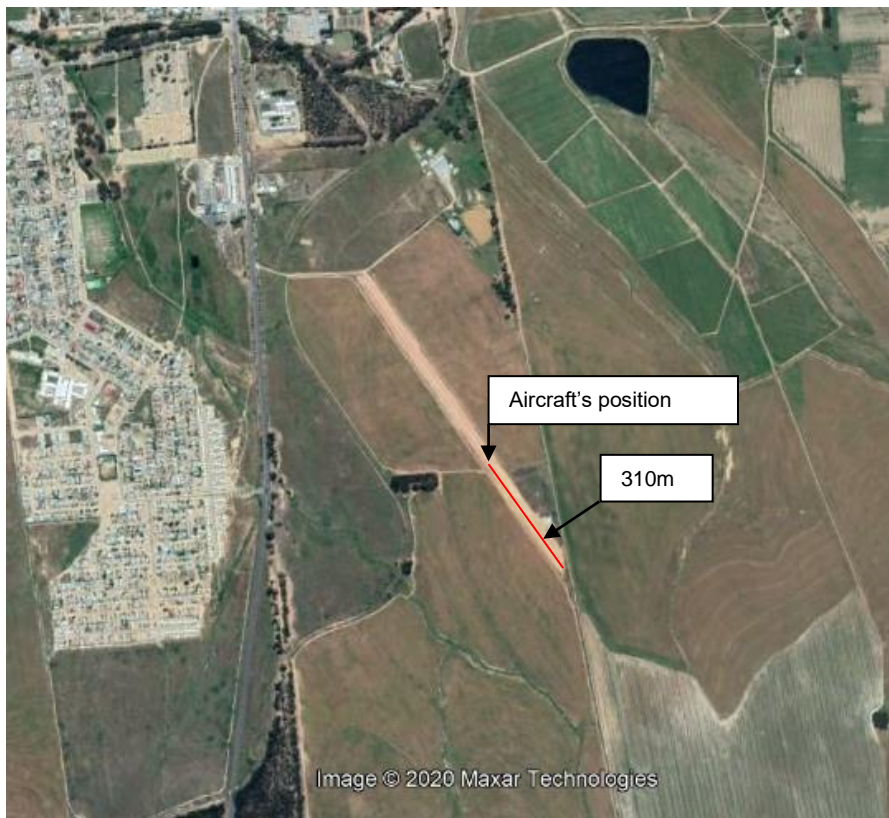
**Figure 3:** Overlay of the accident site. (Source: Google Earth)

3.4 Figure 3 indicates that the aircraft's position after impact with an embankment was abeam a set of trees next to the runway. The distance from the beginning of the runway to the position of the aircraft was 310m. According to the Pilot's Operating Handbook (POH), short-field landing can be achieved at distances of between 200m and 243m without hard braking on a heavy aircraft.

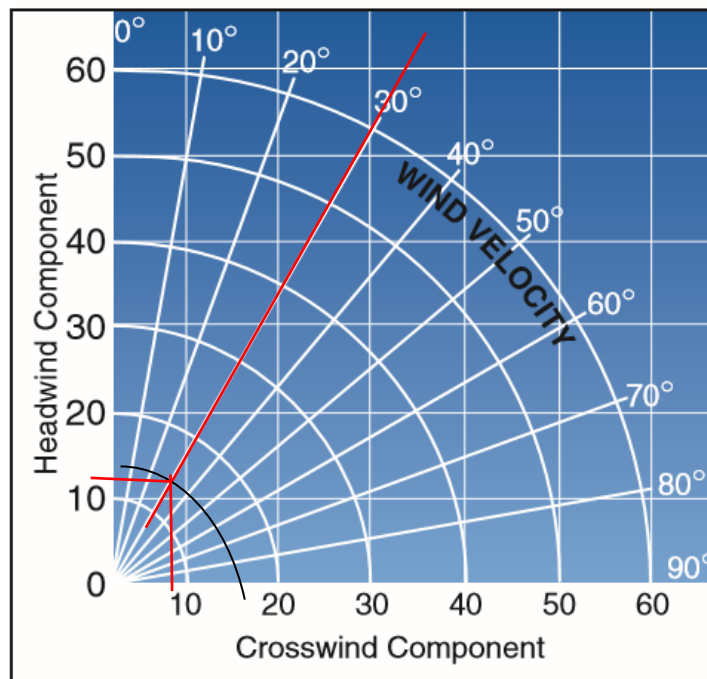
Crosswind component chart. (Source: FAA Airplane flying hand book H-8083-3B)

**Figure 4:** The wind component graph on the day of the accident.

3.2 To obtain headwind and crosswind calculations on Runway 35, the wind was 320 which gave a resultant heading of 30 degrees ( $350-320=30$ ). The resultant wind direction was used to plot the graph (Figure 4) which gave the resultant headwind of 11 knots and a crosswind component of 8 knots. The weather was not considered a factor in this accident as the crosswind was not strong enough to blow the aircraft off course during the landing roll as the pilot had stated.
