AIRCRAFT ACCIDENT REPORT AND EXECUTIVE SUMMARY

Reference:	CA18/2/3/9841	
Aircraft registration	ZS-UUA	Date of accident	2 December 2019		Time of accident	1555Z
Type of aircraft	Scheibe SF25D Falke		Type of operation	Commercial (Part 96)		
Pilot-in-command licence type	Commercial Pilot Licence	Age	67	Licence valid	Yes	
Pilot-in-command flying experience	Total flying hours	24 961.1		Hours on type	280.6	
Last point of departure	Plettenberg Bay Aerodrome (FAPG), Western Cape Province					
Next point of intended landing	Plettenberg Bay Aerodrome (FAPG), Western Cape Province					
Damage to the Glider	Destroyed					
Location of the accident site with reference to easily defined geographical points (GPS readings if possible)						
Plettenberg Bay Botanical Estate (GPS position: 34°05'22.31" South; 023°20'18.45" East), elevation 443 feet						
Meteorological information	Surface wind; 248°/17kts gusting 24kts, temperature; 21.9°C					
Number of people on-board	1 + 1	No. of people injured	0	No. of people killed	2

Probable Cause/s and/or Contributory Factors						
The pilot failed to maintain flying speed and, most probably, the glider entered an inadvertent stall due to the wind gradient, w

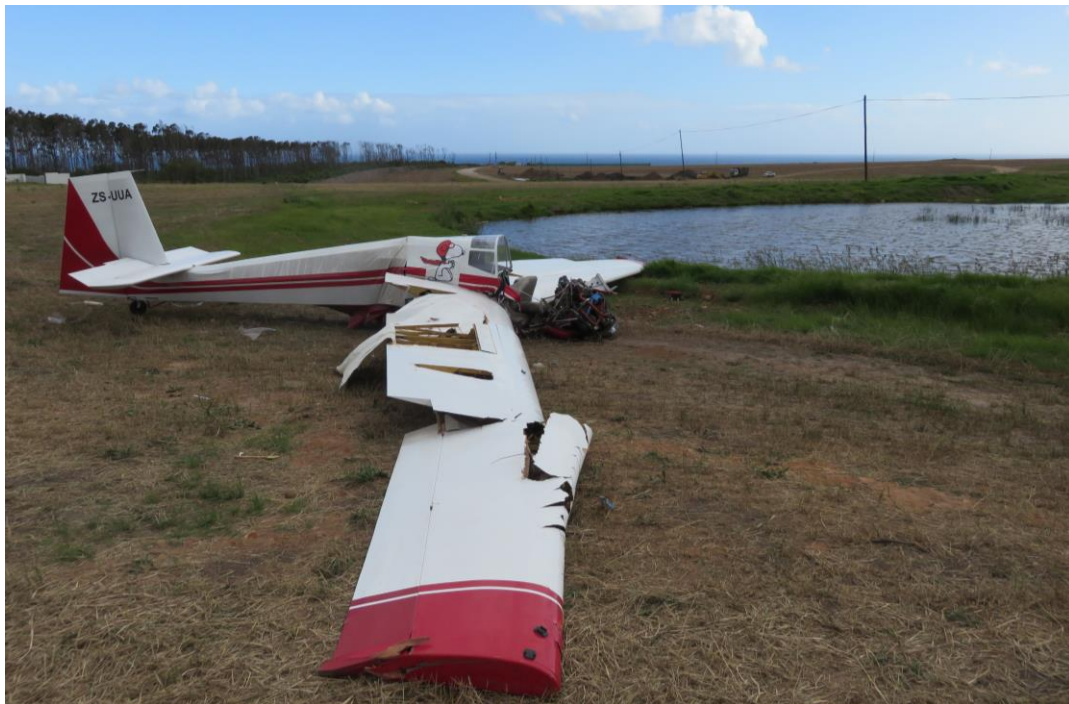
1.3.1 The motorised glider was destroyed during the accident sequence.

1.3.2 To free the two occupants from the wreckage, emergency personnel had to cut open the cockpit area. The engine, forward fire wall structure and the instrument panel of the aircraft were pulled forward using a winch fitted to one of the emergency vehicles to free the occupants. The areas that were cut open were

Figure 2: The motorised glider as it came to rest.

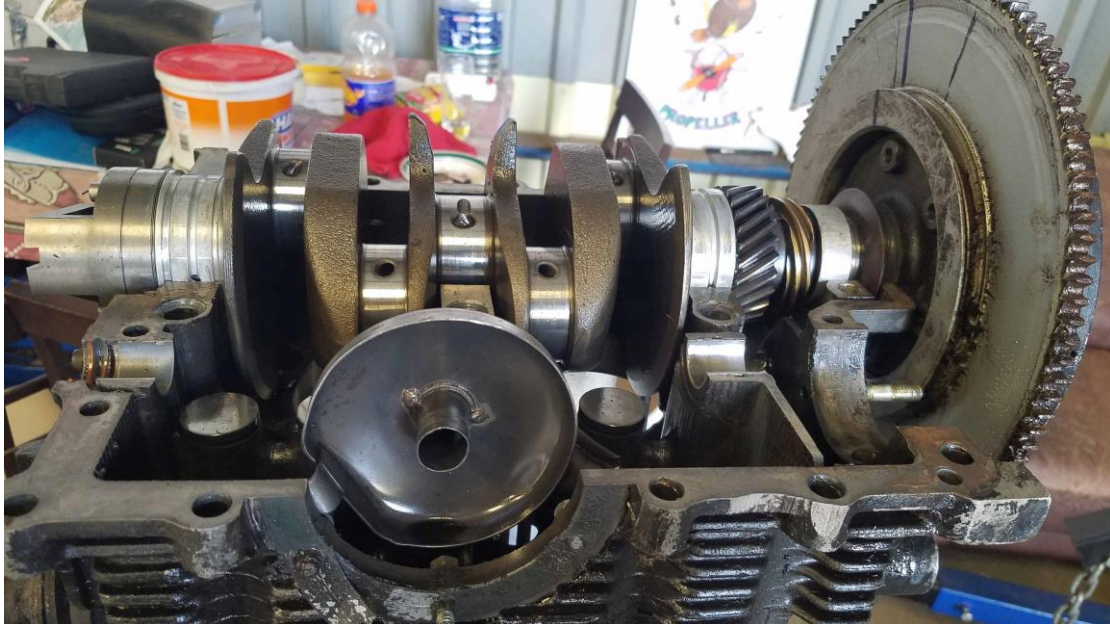
An engine teardown inspection was conducted by an approved person (AP) who made the following observations: *On investigation, we could not find firm evidence that would indicate that the engine was or was not turning at the moment of impact, other than the fact that both propeller blades had broken off, which would point to an engine under power on impact.*

It was observed that the impact was violent as a piece of the wooden propeller had compressed into a recess in the front of the engine. If we look at the angle between the white aluminum straight edge, that is held against the plane formed along the

silencer, oil filter and front of the engine, and the horizontal axis, it would appear that at one stage during impact, the engine was at an angle of approximately 36° to the horizontal axis.

No mechanical failure was observed that would have prevented normal engine operation during flight and ground impact.

Figure 4: The engine after the upper crankcase section was removed.

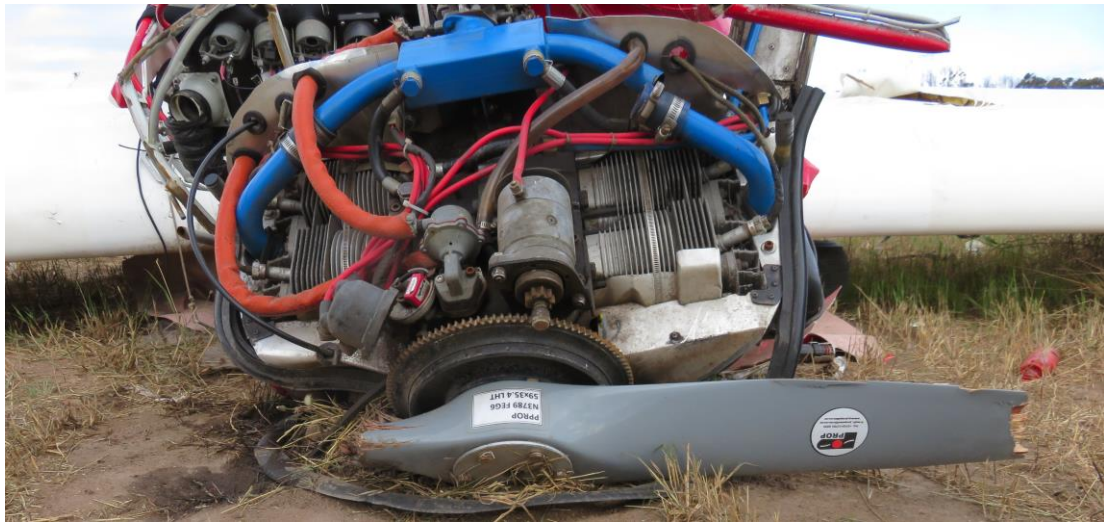
Figure 5: A photograph of the propeller as it was found on site.

- 1.12.2 Several pieces of the wooden propeller were observed from the point of impact, along the impact line until the point where the glider came to rest. One of the propeller blades was destroyed all the way to the hub assembly where it attaches to the crankshaft flange. The second blade also displayed substantial evidence of rotation.

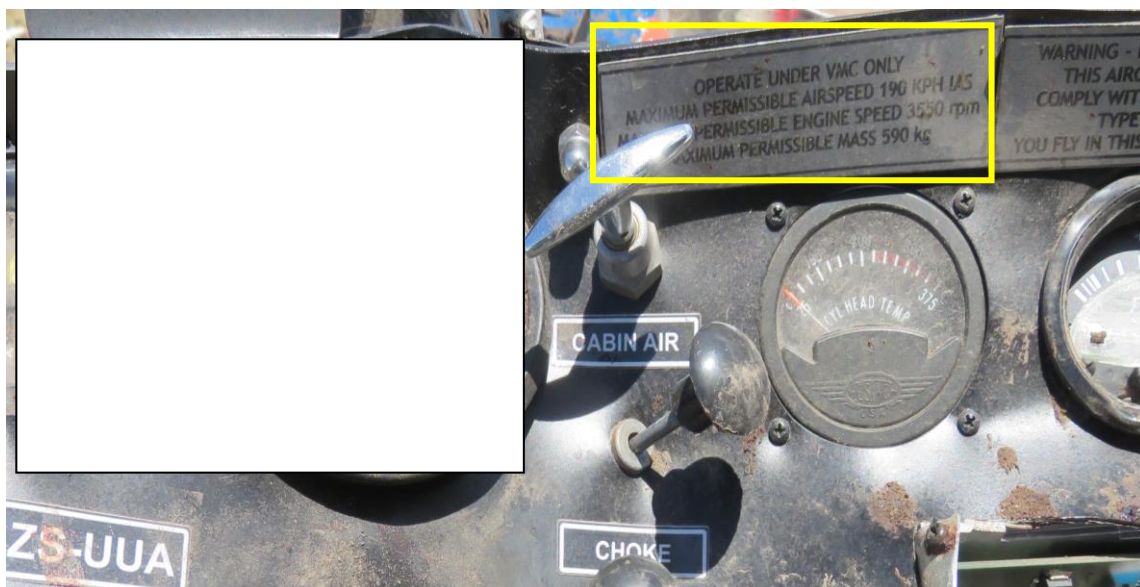
During the on-site investigation, it was noted that there were several placards on the instrument panel of which one states that the maximum permissible mass is 590kg (see Figure 4). According to available information received from the OEM, they had not built a glider with a MTOW of 590kg.

Figure 6: The placard, in the yellow window, indicates the maximum permissible mass as 590kg.

These conflicting maximum take-off weights were concerning. No reference could be obtained as to where the weight of 590kg displayed on the cockpit placard originated from as this was in direct conflict to the FOM that was recovered on site, which indicated the MAUW to be 610kg. It was also noted that the FOM that was recovered on site was not a SACAA-approved document even though this was an approved operator conducting commercial operations.

4.2.2 It is recommended that the Director of Civil Aviation mandates the inspection for conformity to manufacturers' issued standard on all FOMs and placards used by similar aircraft type as the one involved in this accident.

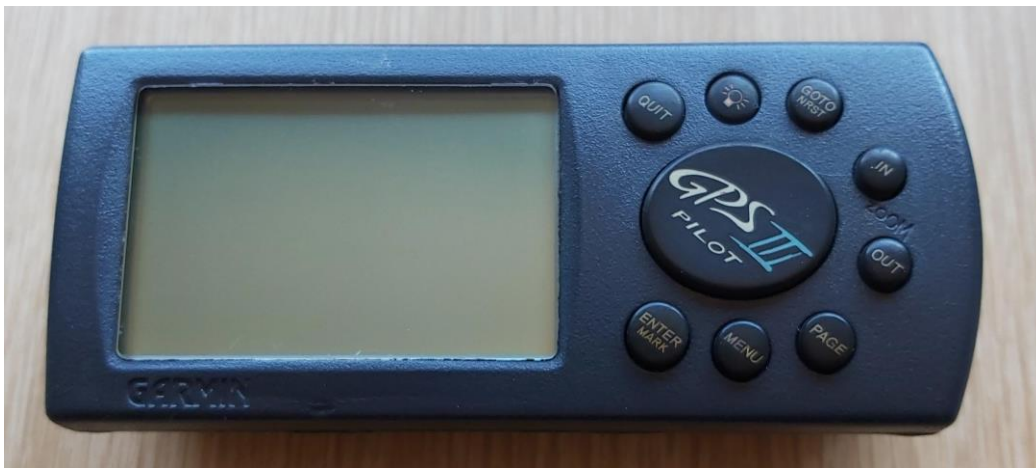
A portable Garmin GPS III Pilot unit was found on-board the glider. The unit was recovered from the accident site as it contained minor damage and was taken to an approved avionics maintenance facility to assist with the download of any possible data pertaining to the flight. Unfortunately, there was no data captured pertaining to the accident flight on the unit.

Figure 7: The GPS unit that was found on-board the glider.

- 3.2.29 The approach speed could not be determined as the GPS unit that was on-board and intact did not capture any data for this flight.
- 3.2.30 The glider failed to maintain flying speed and, most probably, entered an inadvertent stall as the pilot flying might have underestimated the wind gradient at the time. The fact that once the nose dropped and no change in attitude of the glider was observed until ground impact is indicative of the elevator's ineffectiveness in raising the nose, and this was most probably aggravated by the forward centre of gravity (CG) position which was exceeded, as well as the overweight condition of the motor glider at the time. This resulted in a situation that was not rectifiable within the height that was available to the pilot.

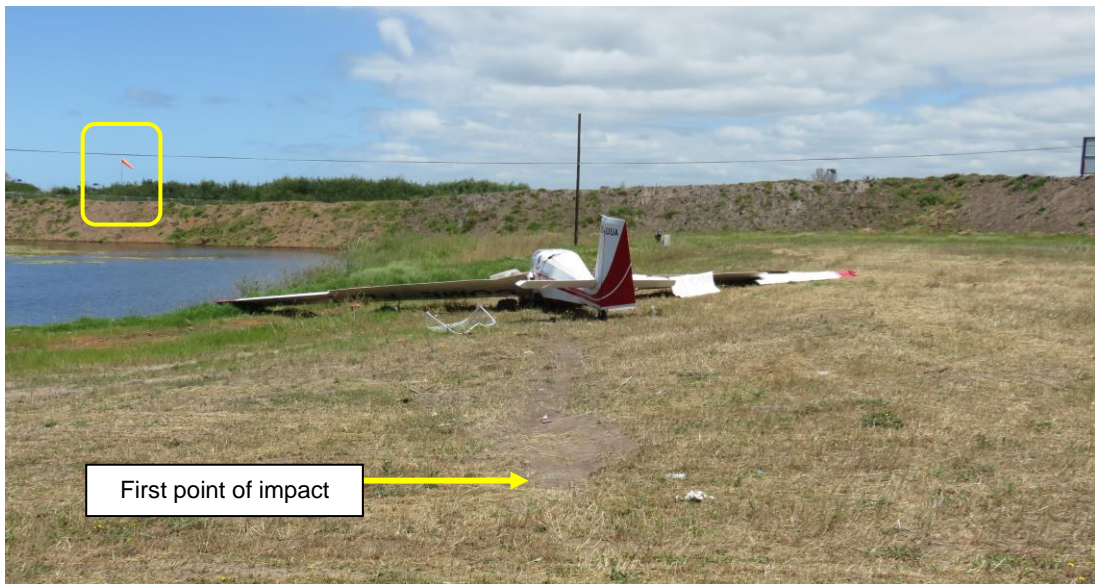
Figure 8: Aft view of the glider as it came to rest, with the windsock visible at the aerodrome.

Figures 14 to 17 of this report) and was approximately 1 100m from the accident site. There was also a windsock located in line with the threshold of Runway 30 (see Figure 8), which would have been clearly visible to the pilot during approach from where he could have made a proper assessment of the prevailing wind conditions. A pilot would be expected to increase the approach speed accordingly to allow for a prompt and effective recovery at any sign of a stall, however, no change in the nose-down attitude of the glider was observed prior to ground impact, probably due to the motorised glider being at a low height as it was landing.

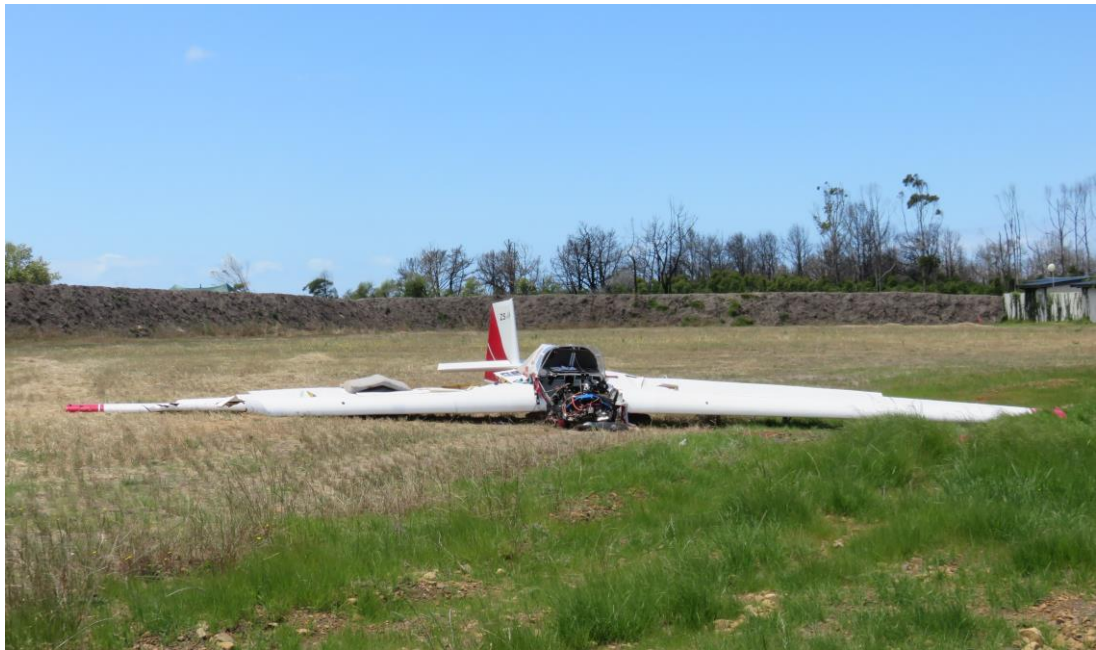
Figure 9: Front view of the glider as it came to rest.

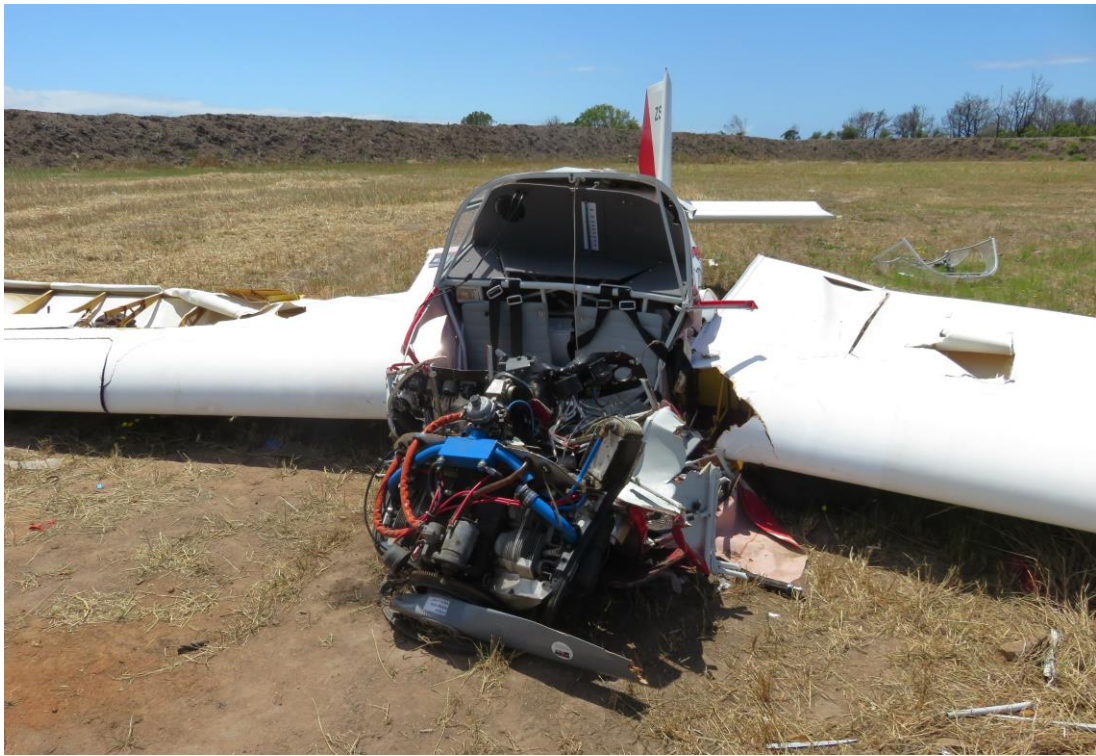
Figure 10: Close-up view with one of the propeller blades destroyed up to the hub assembly.

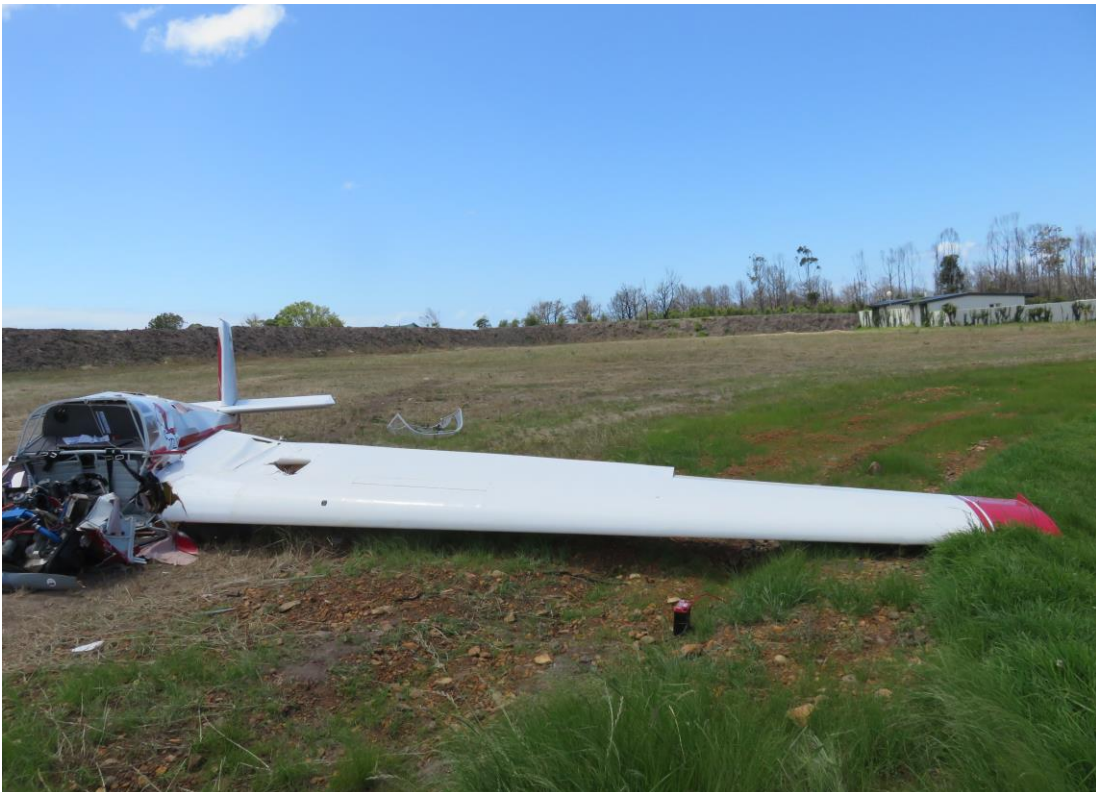
Figure 11: A view of the left wing, which displayed substantially less damage than the right wing.

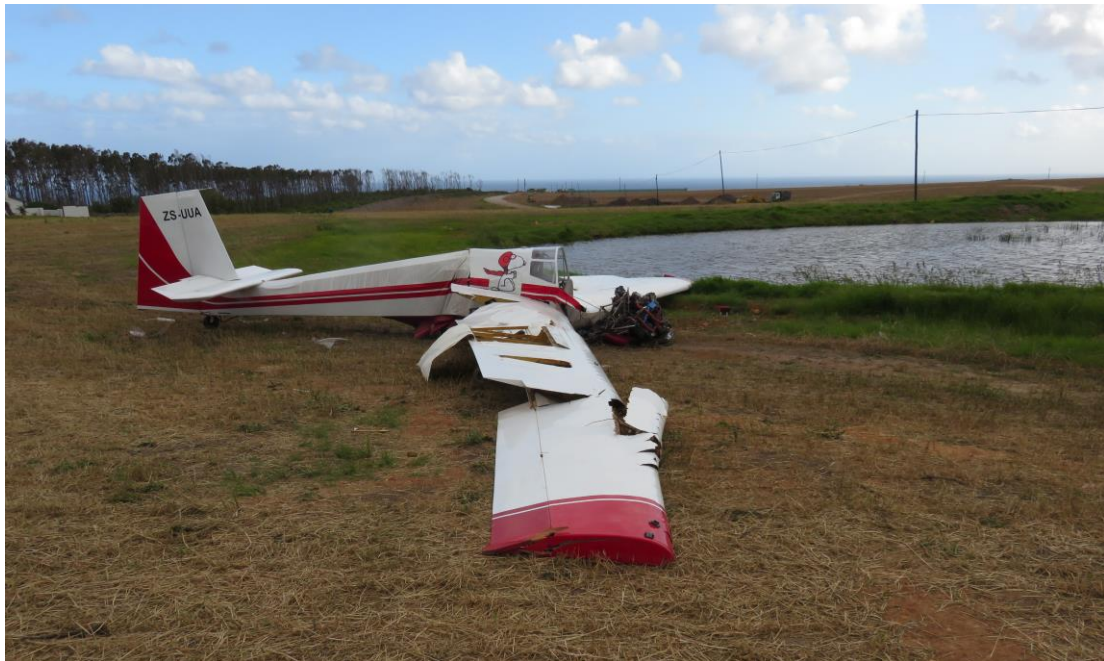
Figure 12: A view of the right wing, which displayed substantially more damage than the left wing.

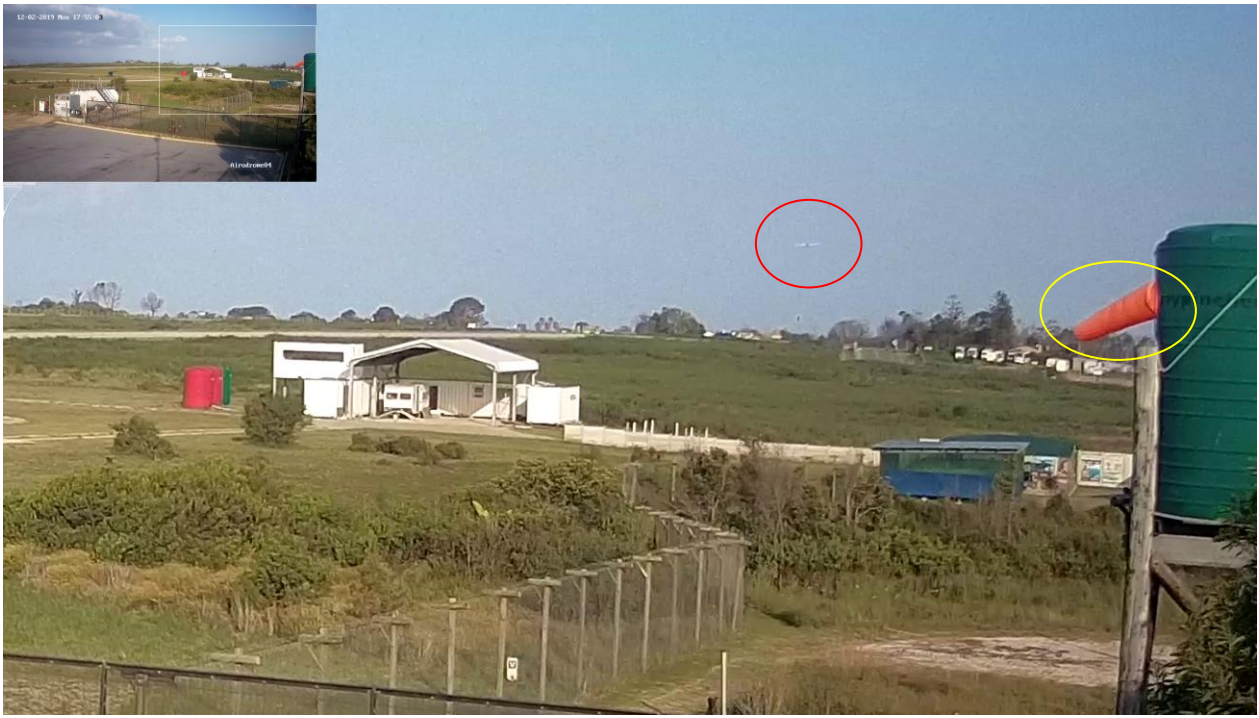
Figure 14: Snapshot from the video (17:55:03) with glider on approach for Runway 30 in wings level attitude.

Another question to be considered is: *“was the final approach stable or should the pilot have opted for a go-around?”* With the video footage available, the glider appeared to be on a stable approach with the wings level, flying on the runway centreline. The only time a change was observed in the glider’s attitude was at 17:55:05 (camera time), when the right wing dropped by approximately 20°. Following this change in attitude, the glider returned to a wings level attitude briefly, and immediately thereafter, the nose pitched down and the glider remained in a nose-down attitude until ground impact.

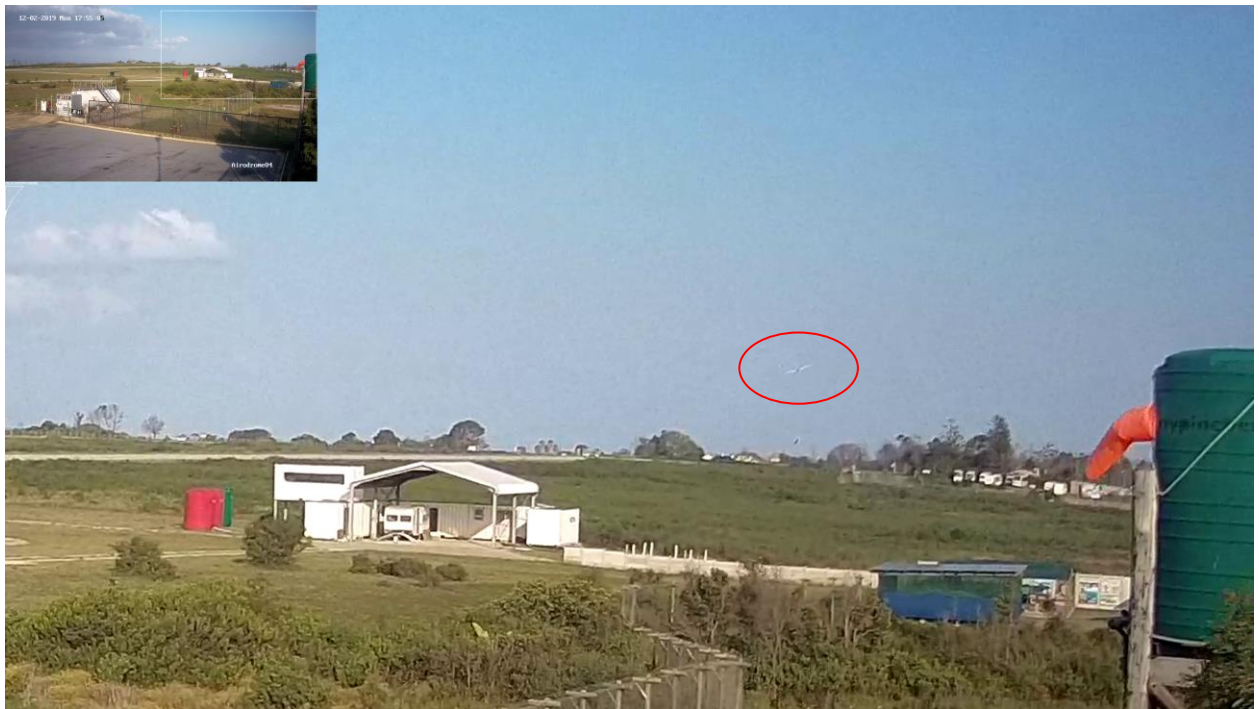
Figure 15: Snapshot from the video (17:55:05) with the glider on approach in a right-wing low attitude.

Video footage was obtained with the glider visible on final approach for Runway 30. The glider was observed to be in level flight as it approached the runway. At 17:55:05 (camera time) the attitude of the glider changed with the right wing dropping by approximately 20°. Immediately following the change in attitude, the

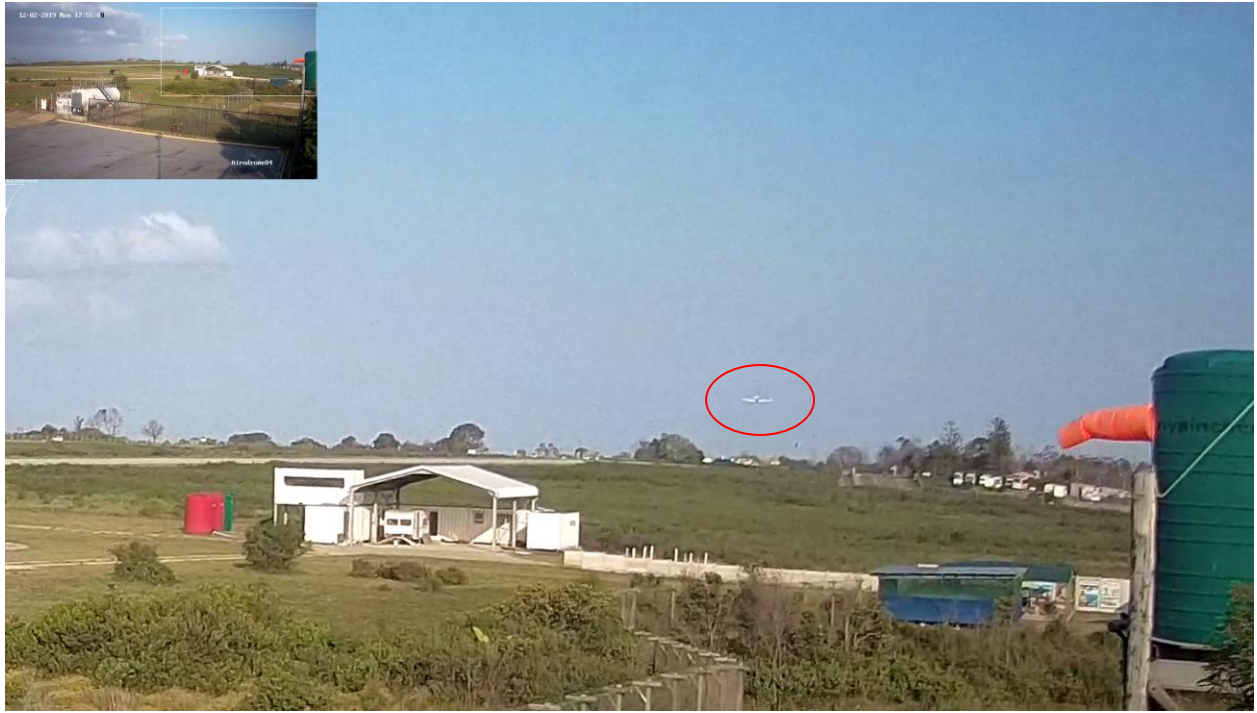
Figure 16: Snapshot from the video (17:55:08) with the glider in a nose-down attitude.

2.11 The glider failed to maintain flying speed and, most probably, entered an inadvertent stall as the pilot flying might have underestimated the wind gradient at the time. The fact that once the nose dropped and no change in attitude of the glider was observed until ground impact is indicative of the elevator's ineffectiveness in raising the nose, and this was most probably aggravated by the forward centre of gravity (CG) position which was exceeded, as well as the overweight condition of the motor glider at the time. This resulted in a situation that was not rectifiable within the height that was available to the pilot.

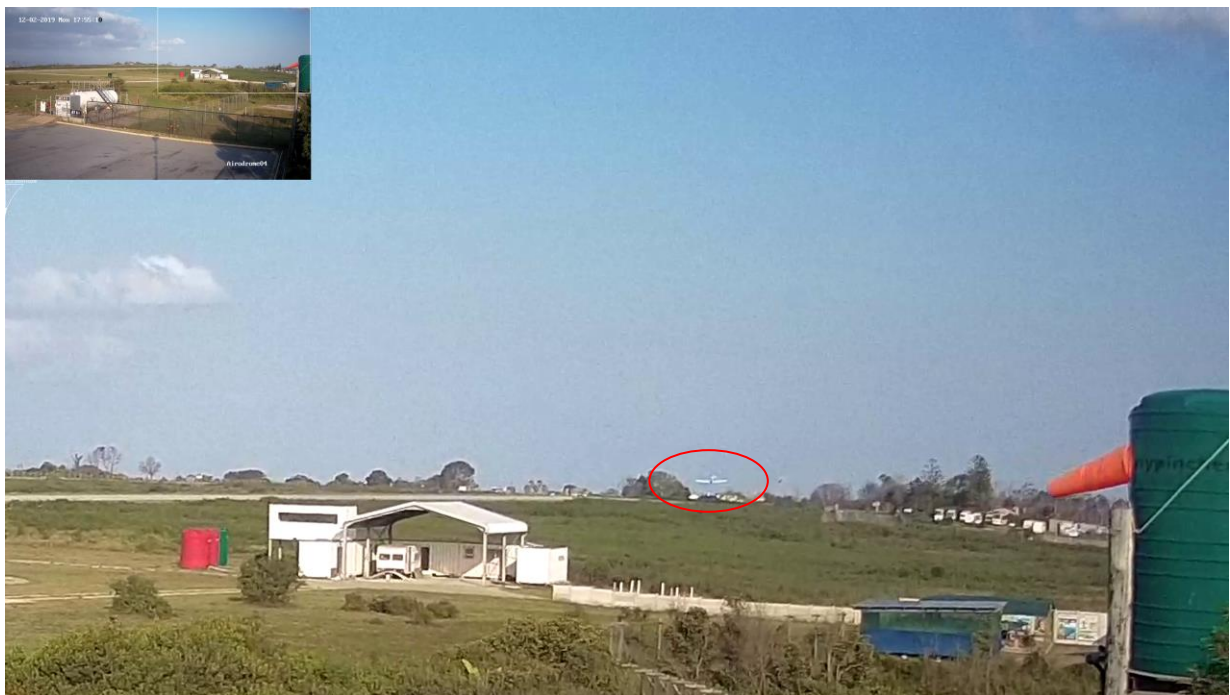
Figure 17: Snapshot from the video (17:55:10), the glider still in a nose-down attitude until ground impact.

- 3.2.27 Strong wind conditions prevailed during the flight, with the wind gusting from the sea towards the land indicated by the windsock visible in the CCTV camera screenshots (Figures 14 to 17).
- 3.2.28 The headwind at the time of approach was approximately 22 knots, which would have required the pilot to increase his approach speed to ensure flight control effectiveness was not compromised.
