AIRCRAFT ACCIDENT REPORT AND EXECUTIVE SUMMARY

Reference:	CA18/2/3/9842	
Aircraft Registration	ZS-RRS	Date of Accident	5 December 2019		Time of Accident	0900Z
Type of Aircraft	Robinson R44		Type of Operation		Agriculture (Part 137)	
Pilot-in-command Licence Type	Commercial Pilot Licence (Helicopter)		Age	34	Licence Valid	Yes
Pilot-in-command Flying Experience	Total Flying Hours	3903.8		Hours on Type	3557.4	
Last point of Departure	Entumeni, KwaZulu-Natal Province					
Next Point of Intended Landing	Semungu, KwaZulu-Natal Province					
Location of the accident site with reference to easily defined geographical points (GPS readings if possible)						
Private farm at Semungu 11 nm south-west of Eshowe, KwaZulu-Natal (GPS position: be 29°02'54.81" South 031°22'1.72" East, at an elevation of 1255 feet)						
Meteorological Information	Wind: 225° 6kts gusting 17kts, Temperature: 16°C, Dew Point: 14°C, Visibility: 9999m, QNH: 1026 hPa					
Number of People On-board	1+0	No. of People Injured	0	No. of People Killed	1

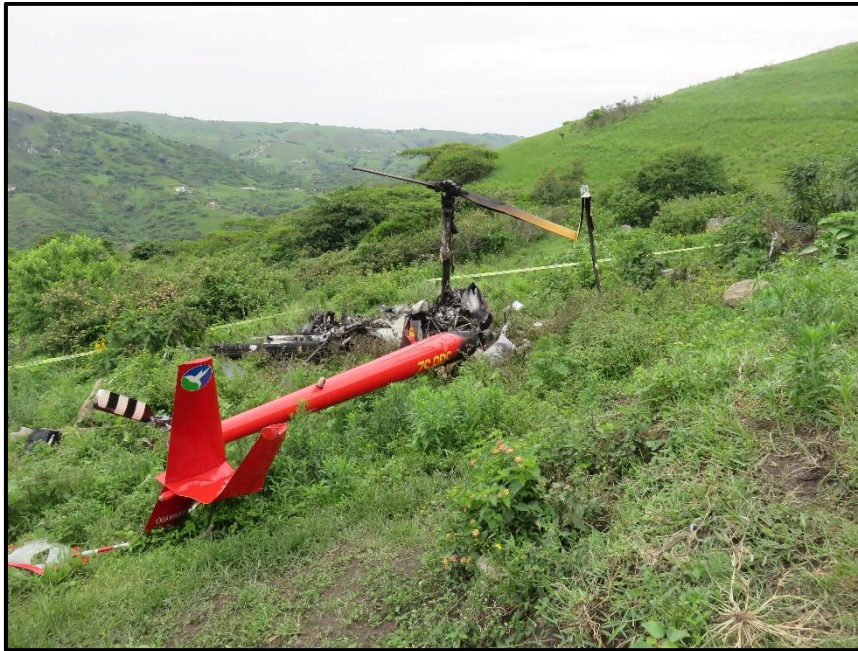
1.3.1 The helicopter was destroyed during the accident sequence.

Figure 2: The helicopter wreckage post-impact.

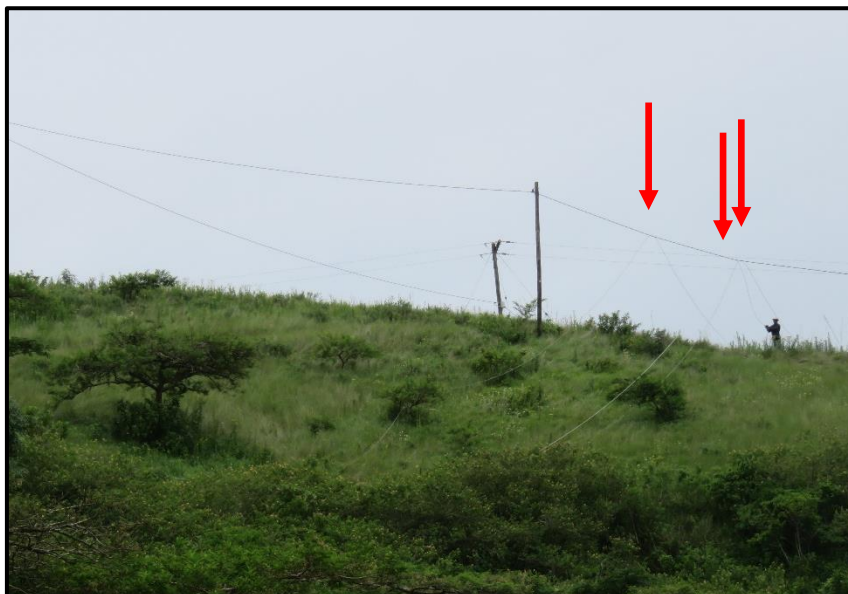
1.4.1 The helicopter had struck powerlines that spanned along its flight path, which were approximately 10 metres from the ground. The cables were severed by the main rotor blades.

Figure 3: Damaged high-tension wire.

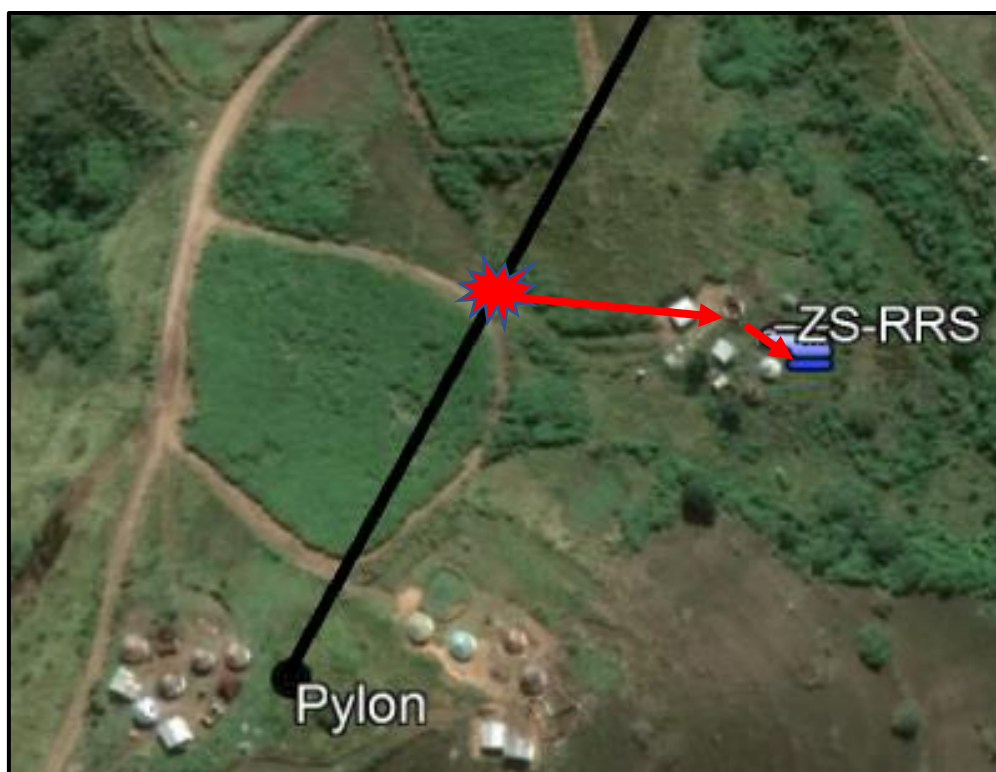
1.12.1 The helicopter approached the eastern farm from the west and, as the helicopter attempted to fly over the farm, one of the main rotor blades impacted the powerlines which were running from a south-westerly to a north-easterly direction. After impacting the powerlines, one main rotor blade detached from the helicopter and the pilot lost control before the helicopter flew towards the farm houses. The helicopter flew over the house next to where the farm owner was standing, turned right towards the kraal, and impacted the ground on its right-side before settling on both skids.

Figure 5: The flight path of the helicopter's impact with powerlines and, later, the ground.
(Source: Google Earth)

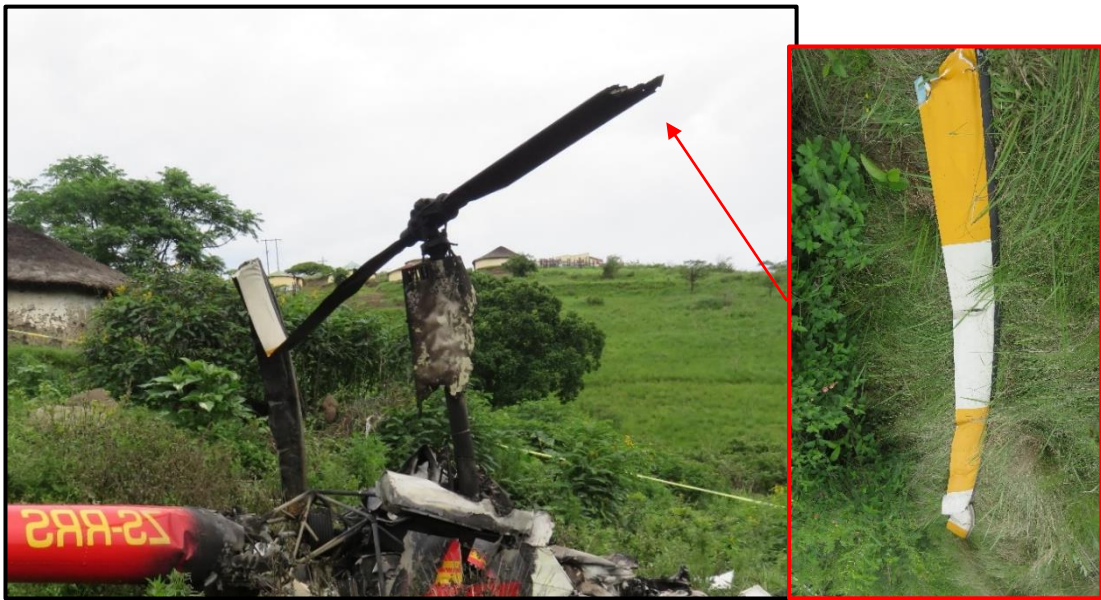
1.12.3 One of the main rotor blades remained attached to the main rotor hub. It displayed signs of an impact damage (bends at two points). A part of the other main rotor blade was severed when the helicopter impacted the powerlines; it was located in tall grass approximately 200m to the west of the wreckage (same position where the powerlines were severed).

Figure 6: The main rotor blade assembly after the accident.

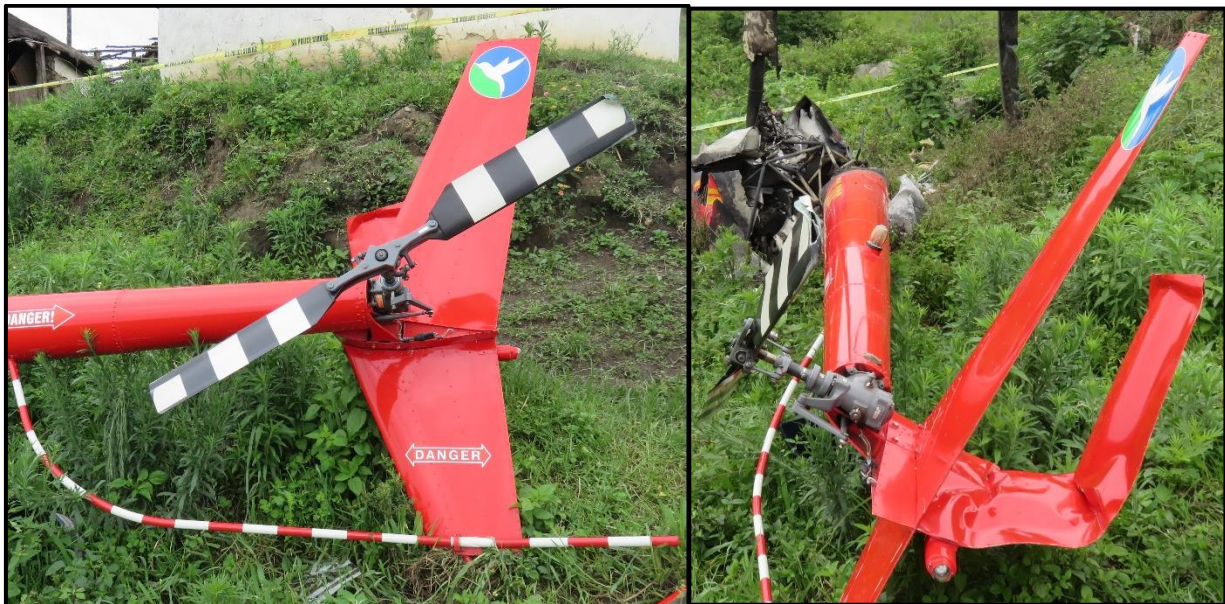
1.12.4 The tail boom root section exhibited compression load stress, indicative of high-energy impact, and was also bent (See Figure 7). The vertical fin was intact, but the horizontal fin was bent, an indication that the helicopter impacted the ground on its right-side before settling on both skids. The tail rotor blades were still attached to the tail rotor hub, with one of the blades exhibiting damage on the tip; an indication of impact with the ground. The tail stinger was not damaged. The tail gearbox showed no signs of damage on the shaft and there were no signs of oil splatter.

Figure 7: Tail rotor section: the first frame shows the left-side view and the second frame shows the rear view.

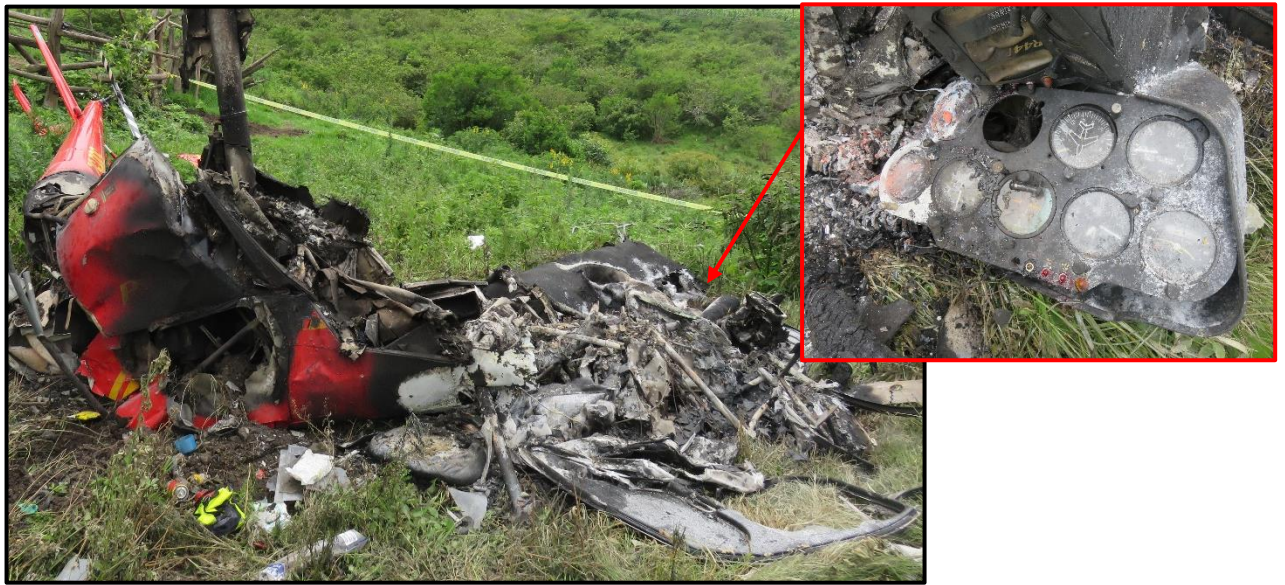
1.12.5 The cockpit and the cabin section were consumed by post-impact fire. The turn co-ordinator on the instrument panel indicated that the helicopter was banking to the right before impact.

Figure 8: Destroyed cockpit and cabin area.

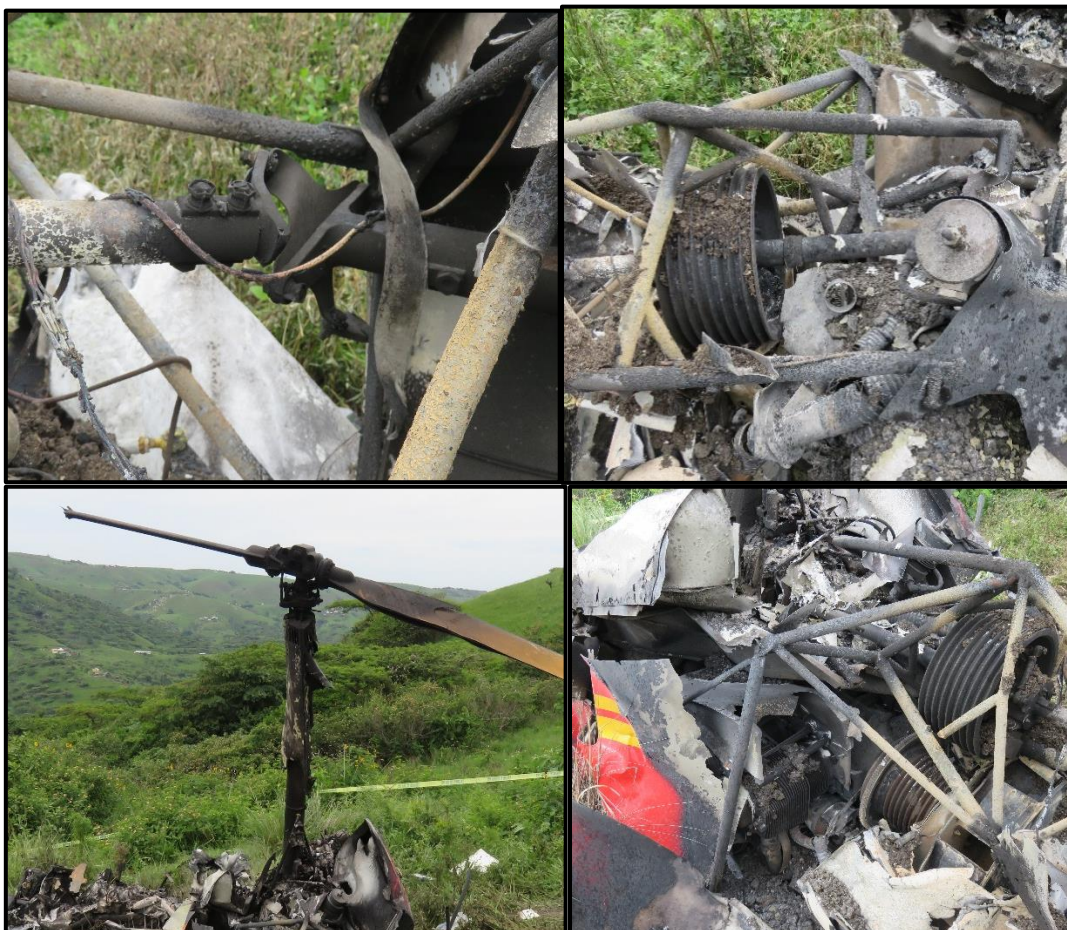
1.12.6 The tail rotor drive shaft had signs of being twisted as a result of the tail boom bending (away) from the rest of the helicopter during impact (see Figure 9, top-left frame). The vee belts on the sheave that are directly bolted onto the engine output shaft were severed as a result of sudden stoppage, indicative of an engine that was producing power when the helicopter impacted the ground (see Figure 9, top-right frame). There was a crack that spanned all around the mast, also indicative of a sudden stoppage; half of the mast cover was burnt (see Figure 9, bottom-left frame). The engine was still attached onto its mounts in a relatively good condition, with outer burn marks (see Figure 9, bottom-right frame).

Figure 9: The drive system section.

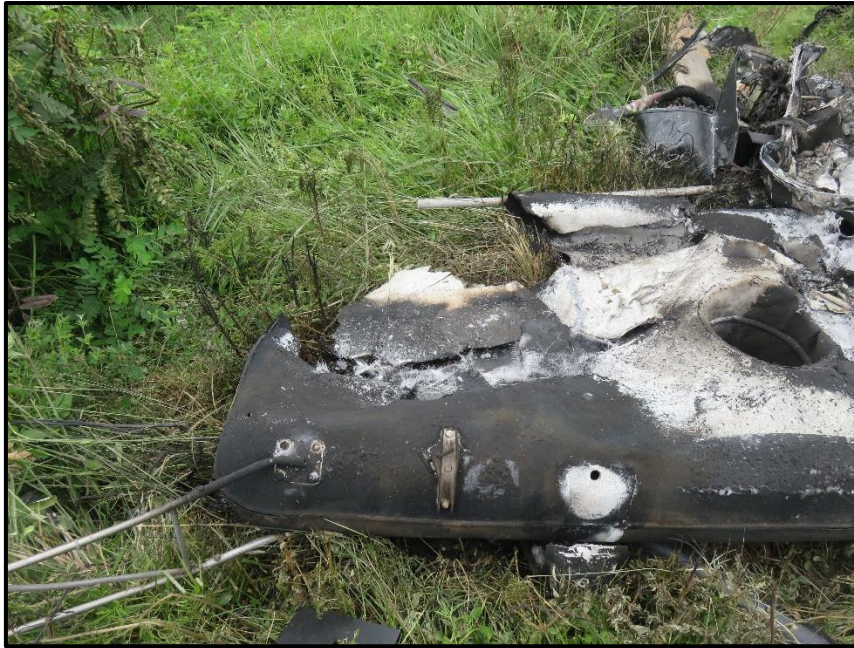
1.12.7 The bottom half and part of the top half of the crop-spraying tank were burnt. The tank was found on the left-side of the wreckage. The tank's strainer was found under the wreckage while the hoses were recovered on the left- and right-side of the wreckage.

Figure 10: The crop-spraying kit.
